New York Canal

Canal Assessment Session – Denver, Colorado

May 14, 2008

New York Canal Special Review

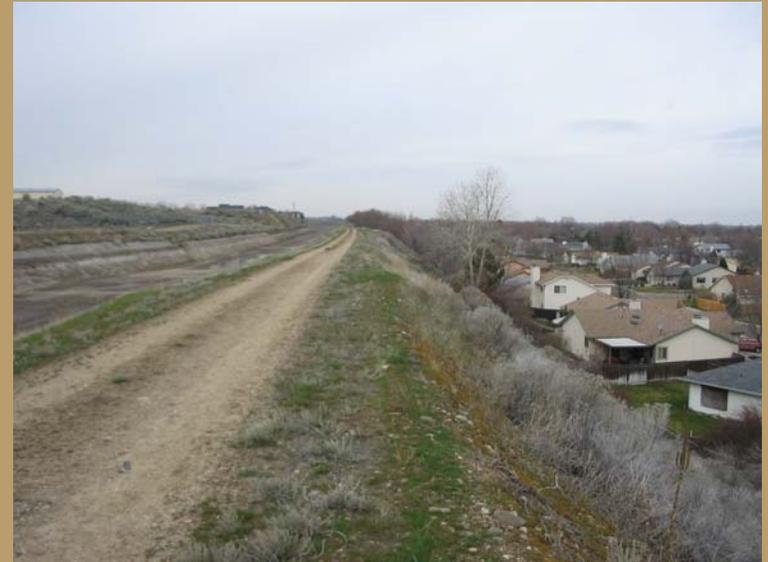
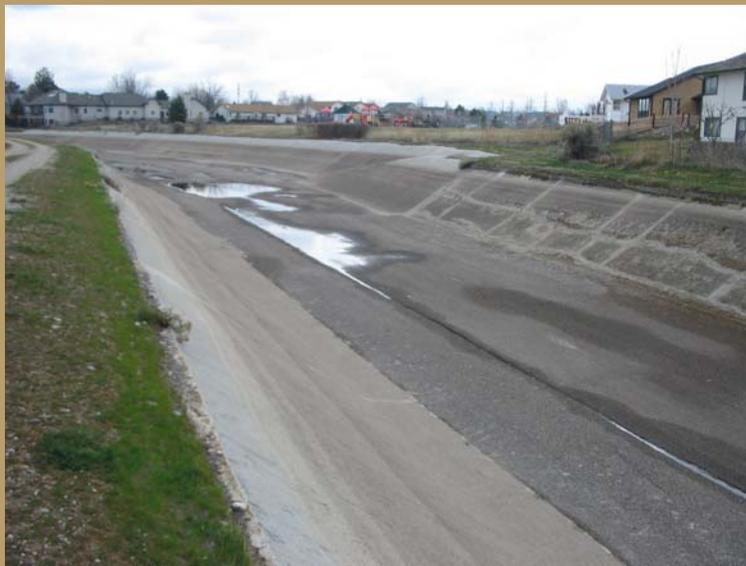
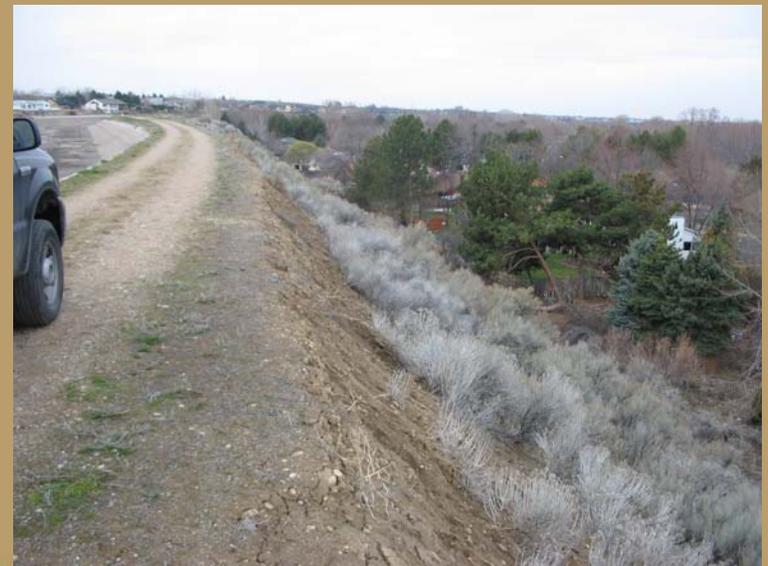
New York Canal Special Review 3-25-2008

- “Annual Physical”
- Vegetation
- Historical seepage areas
- Cracking and buckling of lining

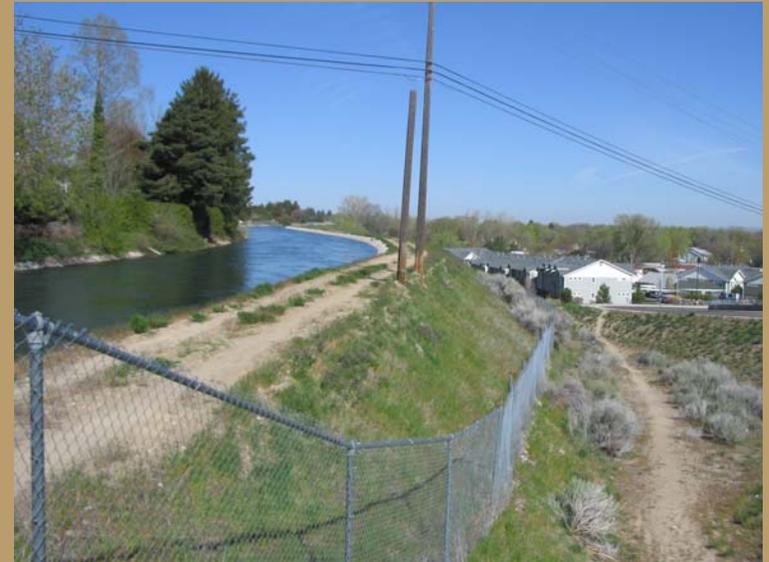
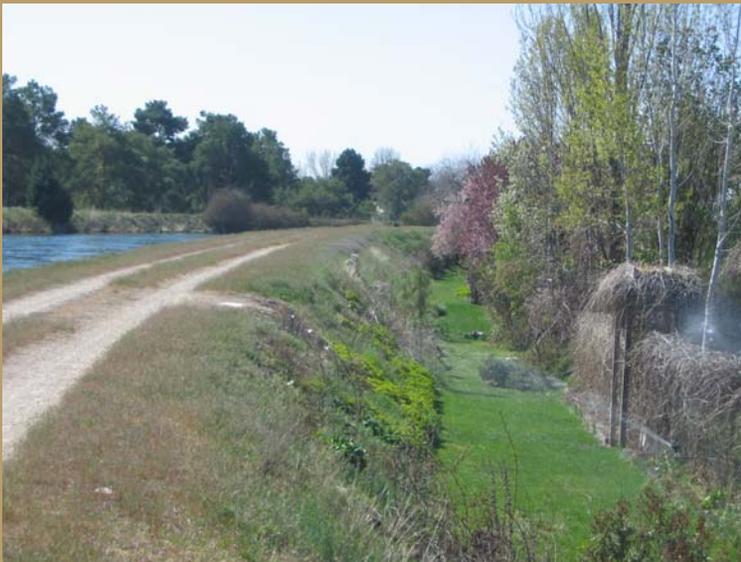
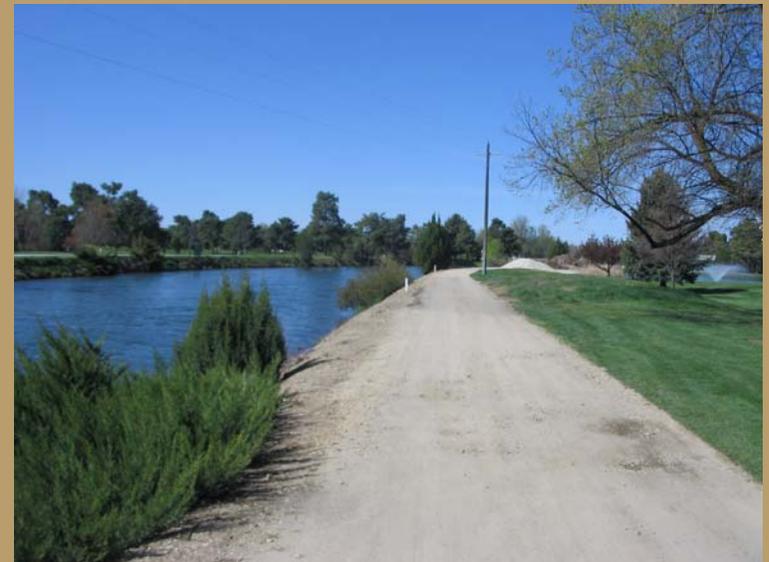
New York Canal Special Review 5-2-2008

- Encroachment of ROW
- No burrowing animals
- **Conclusion: Provides a general indication of condition**
- Fresh eyes may identify new areas of concern

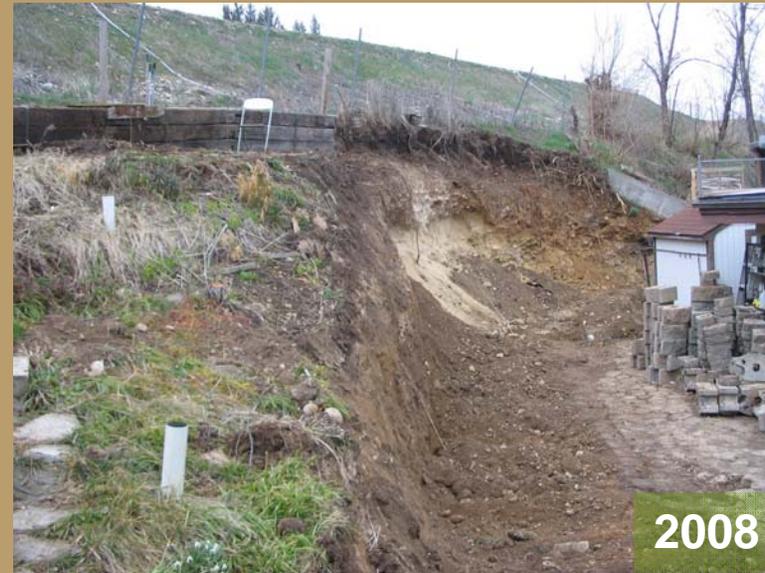
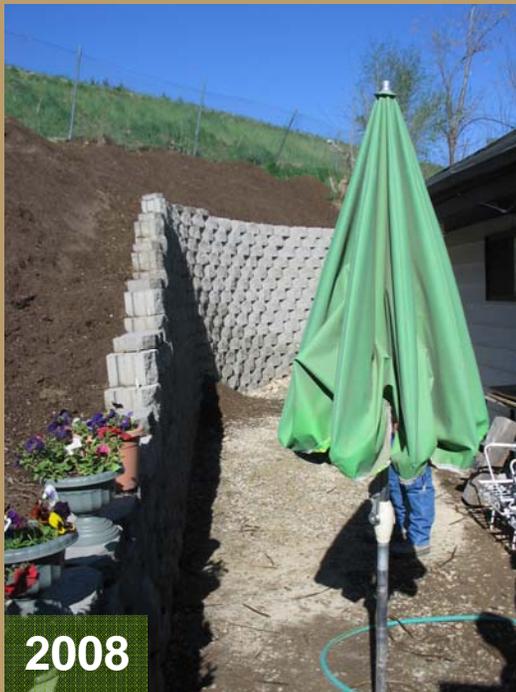
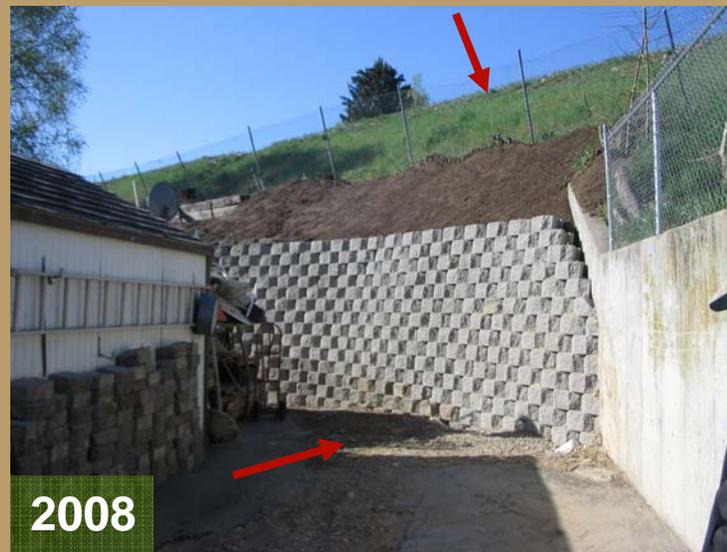
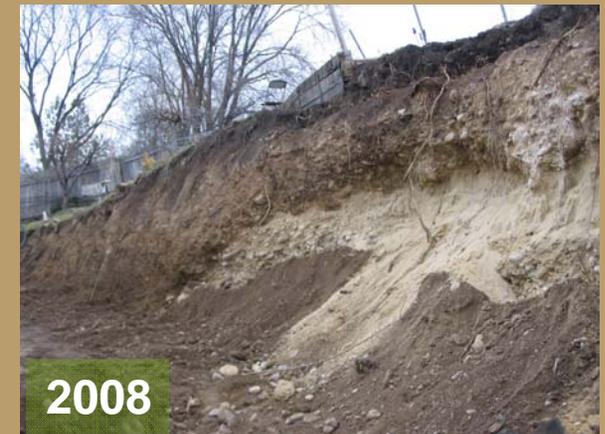
- **Bacon Property**

- Seepage
- Drain(s)
 - Base of retaining wall
- Observation Wells
- Engineering Management
- Cost

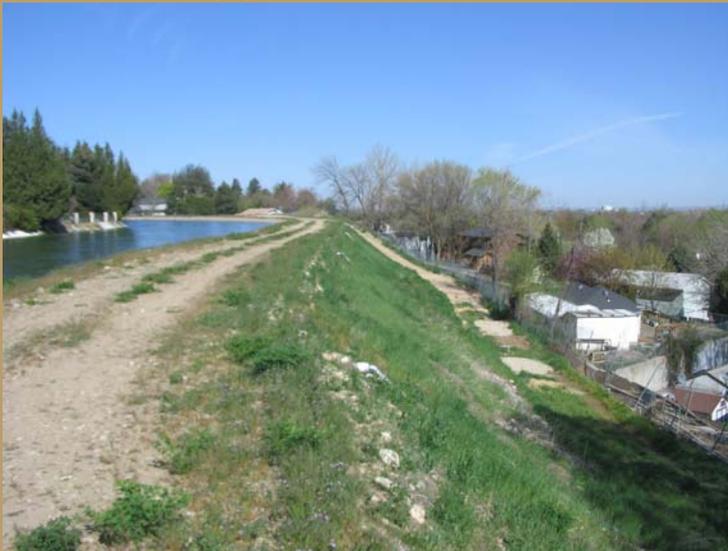
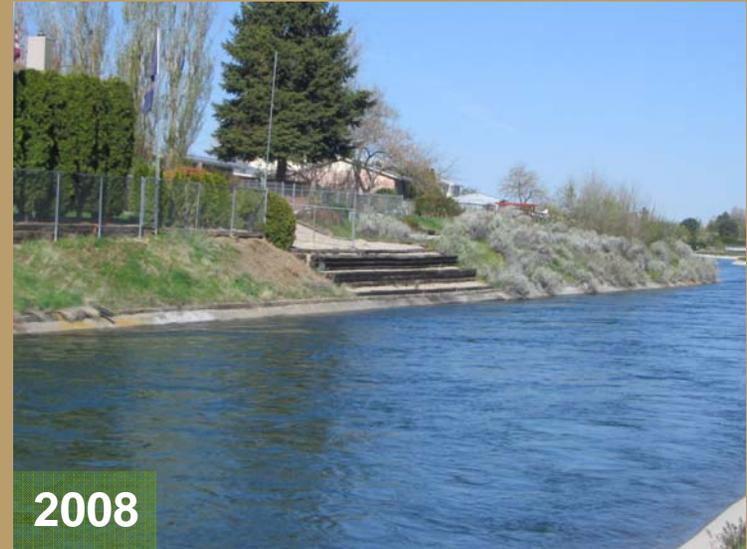
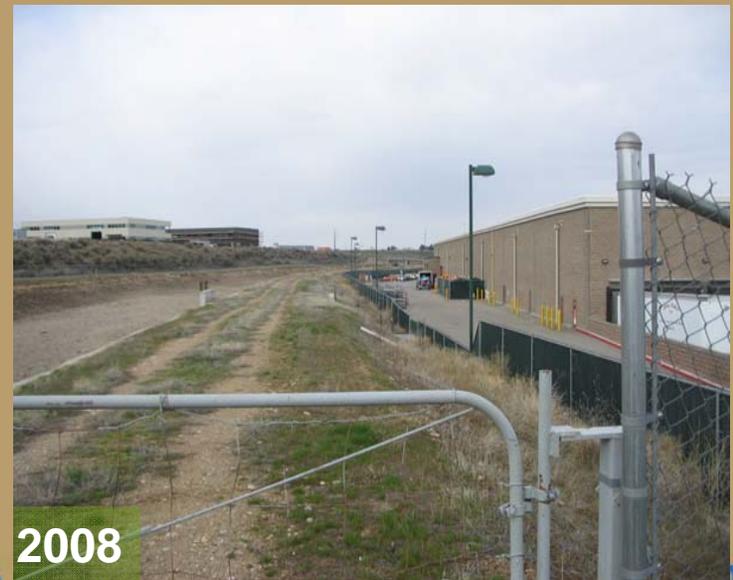
- **Encroachments**

- Make our job even more difficult
- Difficult enforcement for districts and Reclamation
- Cities and Counties cannot be depended upon
- Toe of embankments even more difficult to protect
- Need bigger enforcement hammer
