Final Risk Assessment

Truckee Canal Issue Evaluation Report of Findings

**Newlands Project, Nevada
Mid-Pacific Region**

March 2008

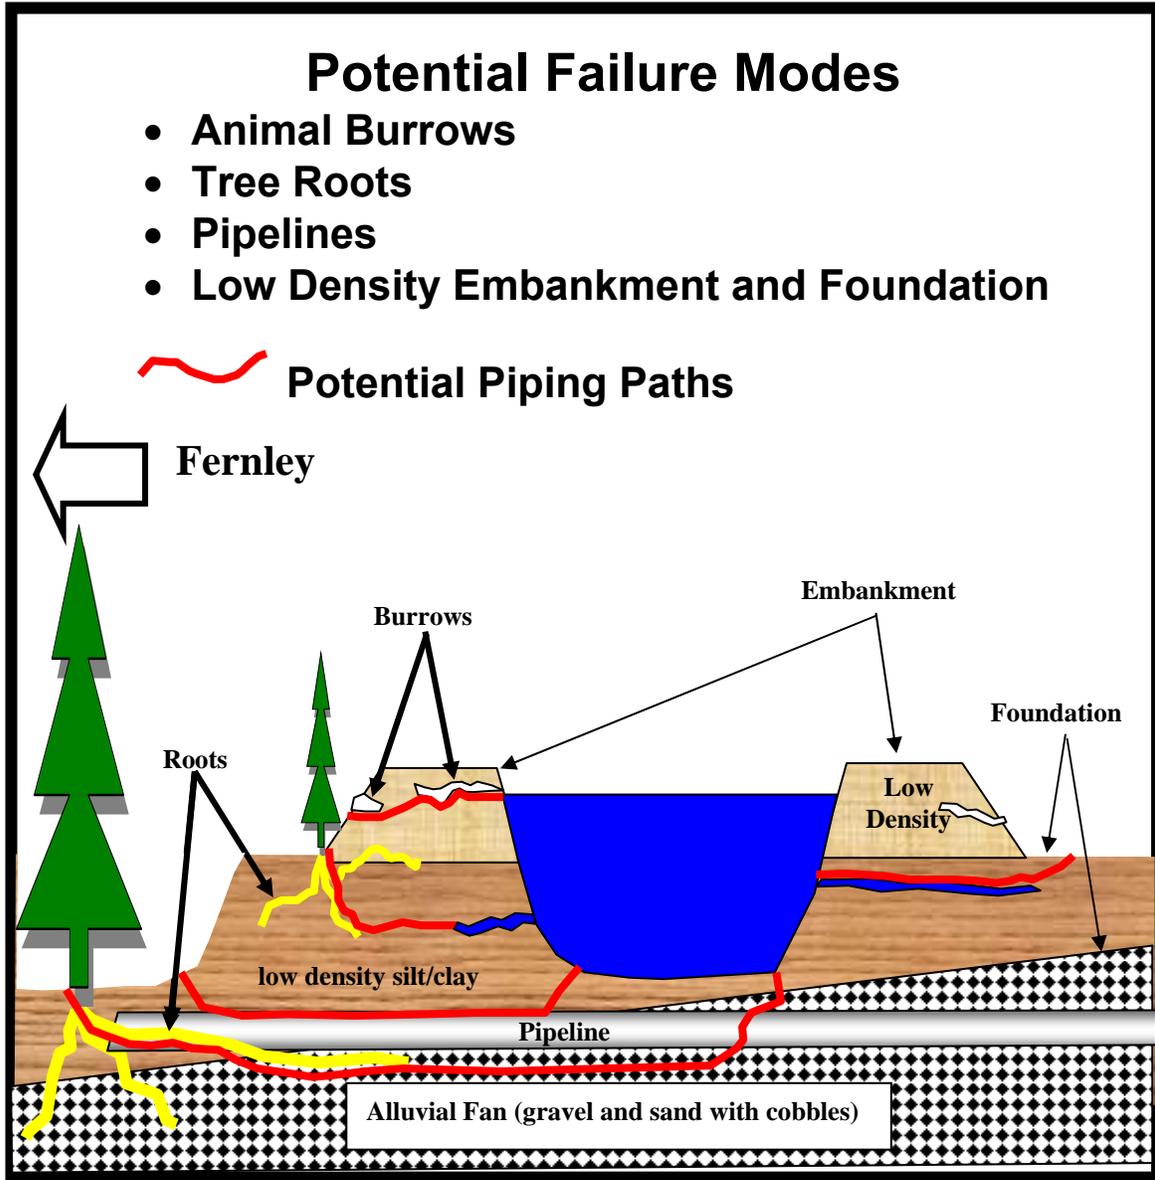
Figure 1. Potential Internal Erosive Failure Modes

Due to the Forensic Evaluation Team's preliminary draft report finding that the most probable cause of the Canal's failure was water flowing through animal burrows penetrating the embankment, and the need for a timely initial risk evaluation, the RA Team focused their evaluation on the two static failure modes caused by internal erosive forces; (1) failure through the Canal embankment, and (2) failure through the Canal foundation. Figure 1 depicts the possible internal erosion failure modes.

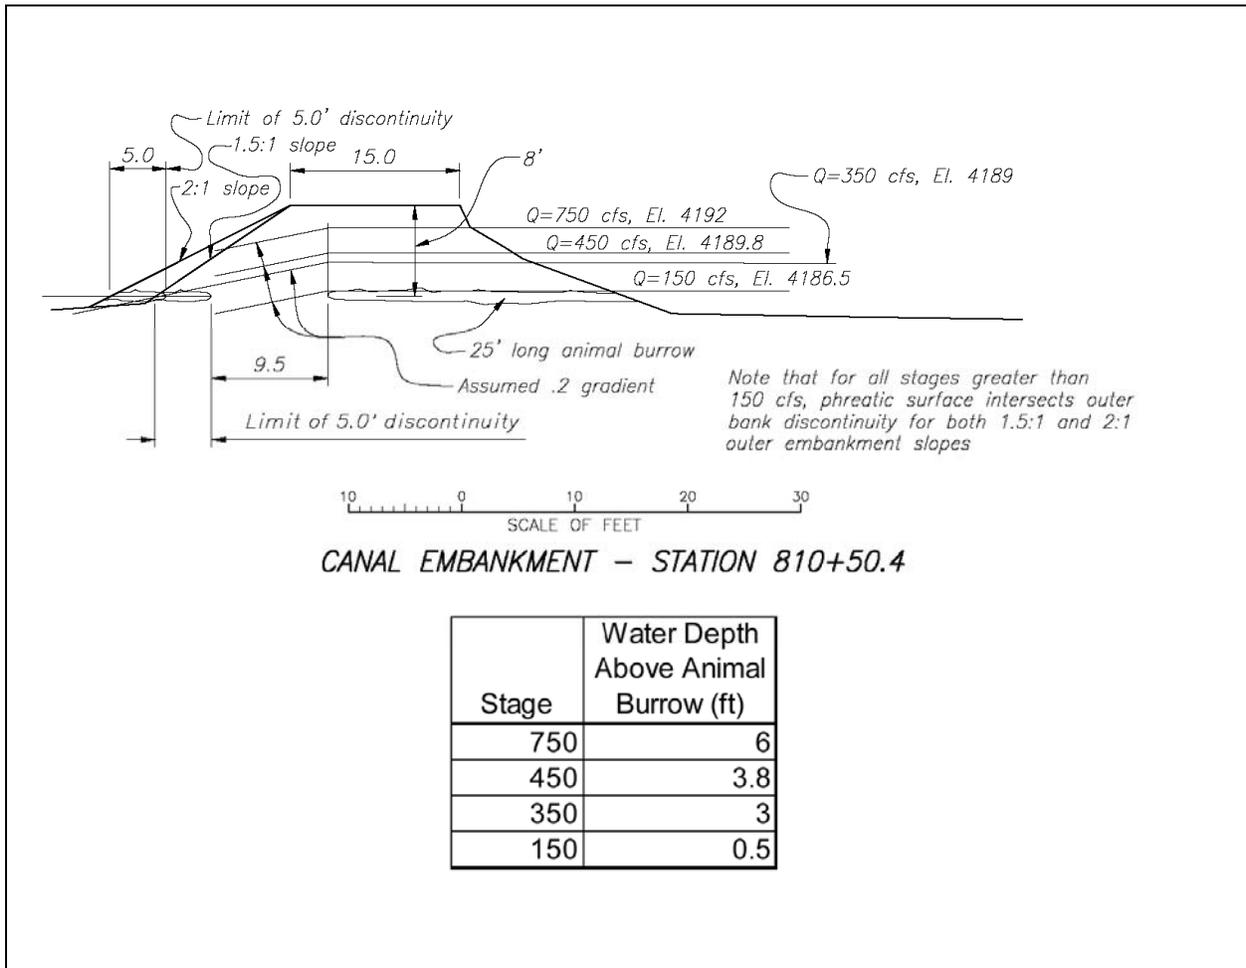
Figure A-1. Embankment Seepage

The RA Team spent a great deal of time discussing seepage gradients through the Canal embankment. The team concluded that a reasonable seepage gradient through an embankment of this material would be 0.2 feet/foot. Figure A-1 below represents a section through the left canal embankment at Station 810+50.4. The 15.0 foot operation and maintenance (O&M) road width is assumed. The figure also depicts outboard side slopes for the embankment of both 2:1 and 1½:1. The Canal section shows a 25-foot long animal burrow into the embankment from the canal side. At least one animal burrow of this length is documented on the Canal. A 5-foot long discontinuity is depicted on the outboard side of the embankment. This discontinuity could be the result of decaying tree roots, erosion, excavation, or even another animal burrow. Also depicted on the section are water surface stages for 750 ft³/s, 450 ft³/s, 350 ft³/s, and 150 ft³/s. The figure shows the likely phreatic water surfaces through the embankment for all of the flow levels, along with the gradient of 0.2 feet/foot for flows downstream of the 25-foot long animal burrow. For all stages greater than 150 ft³/s, the gradient exits into the outboard discontinuity; a condition that would be conducive to piping.

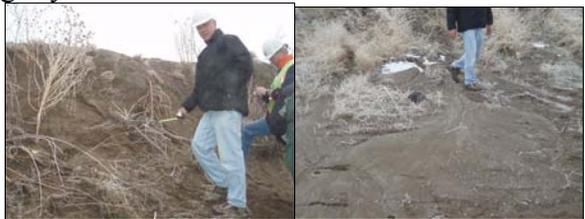
Likely Factors	Unlikely Factors
<p>A burrow was found only 250 feet from the 2008 breach site that penetrated 12 feet (about one-half the embankment width). The “inlet” of the burrow was about at the 350 ft³/s flow line. The burrow was “cast” by grouting it with polyurethane grout. Upon excavation, the cast indicated that the burrow penetrated about 25 feet, be open all the way, and have a diameter of about 2 to 6 inches. Some gullying was found directly opposite this burrow and a delta of sand had been deposited at the base of the gully.</p>

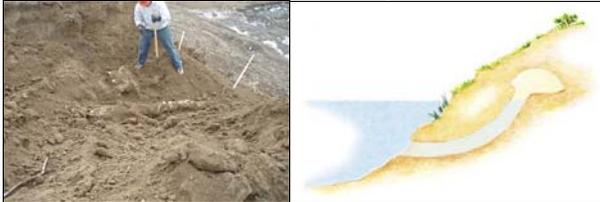
<p>Multiple side channels were found. The layout of the hole was similar to that conceptualized by FEMA.</p>

<p style="text-align: center;">Source: FEMA Manual 473, September 2005</p>	<p>Excavation of the embankment crest at this burrow/gully location did not find evidence that the burrow penetrated completely through the embankment. Based upon survey data, the crest at this location looks to have a dip that would collect and concentrate rainfall. Eventually the dip could overflow and over time cause erosion to the embankment. The thinning embankment could promote seepage/piping conditions.</p>
