SUBJECT: SECURITY OF MASONRY DAMS ON EARTH FOUNDATIONS
AGAINST FAILURE FROM UNDER-SEEPAGE OR PIPING

TECHNICAL MEMORANDUM NO. 140

By E. W. Lane, Research Engineer

Denver, Colorado, April 26, 1930

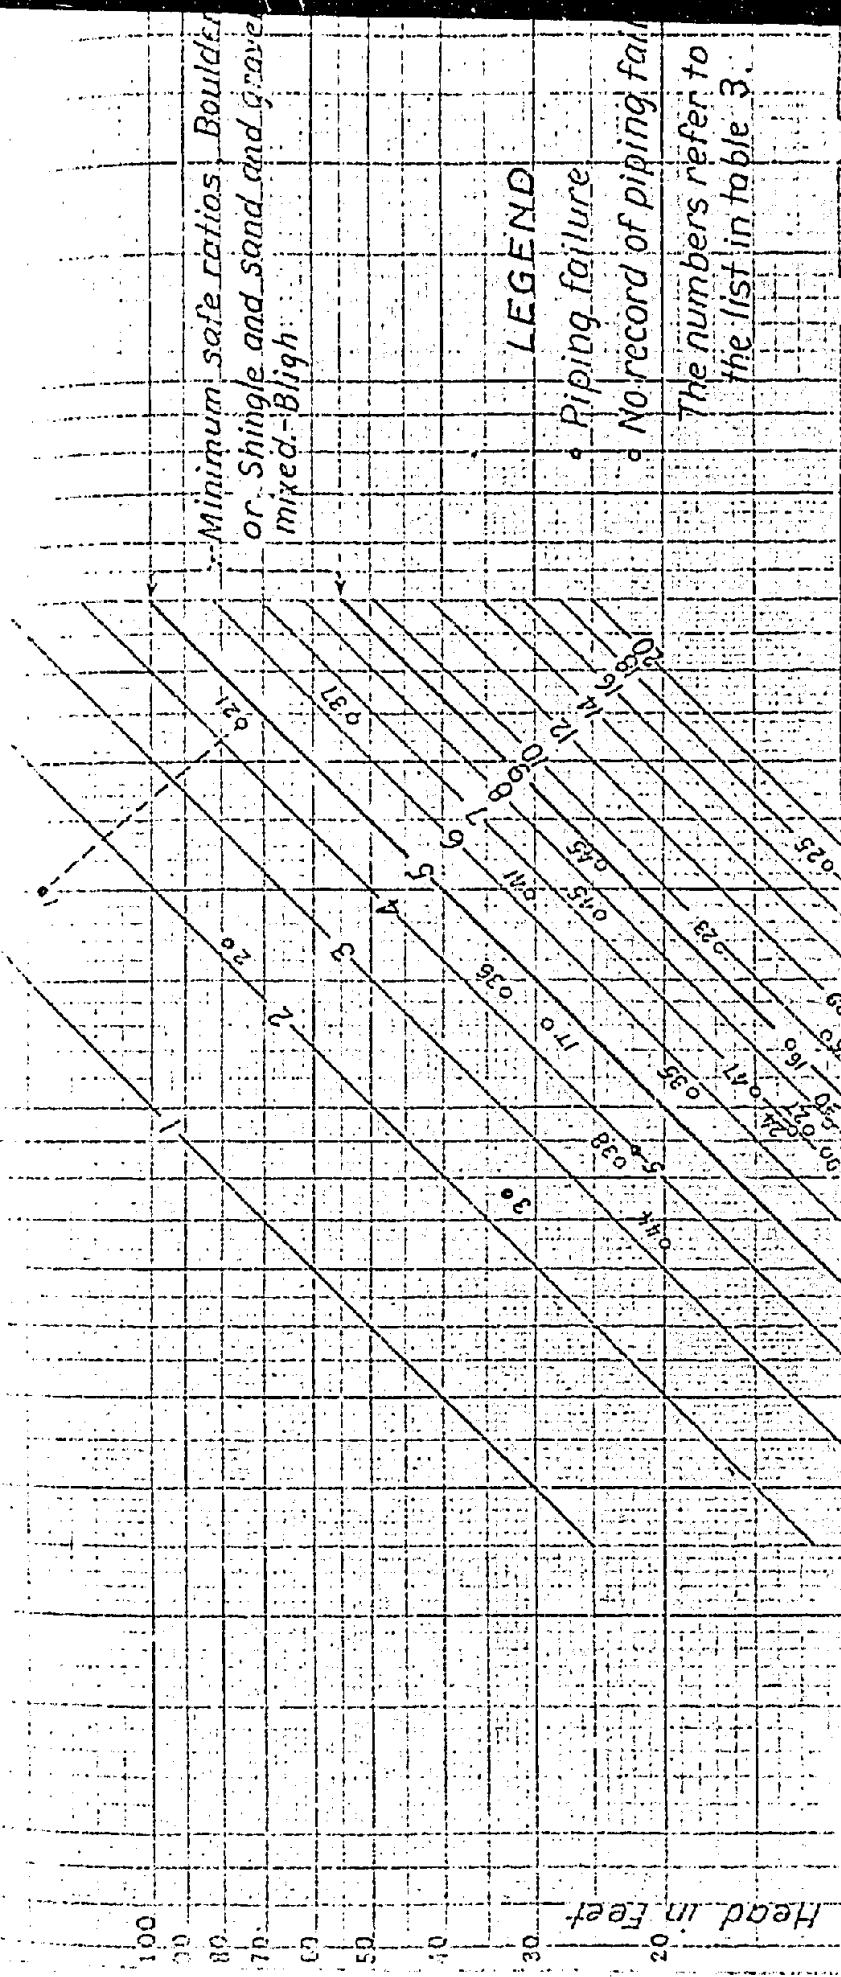
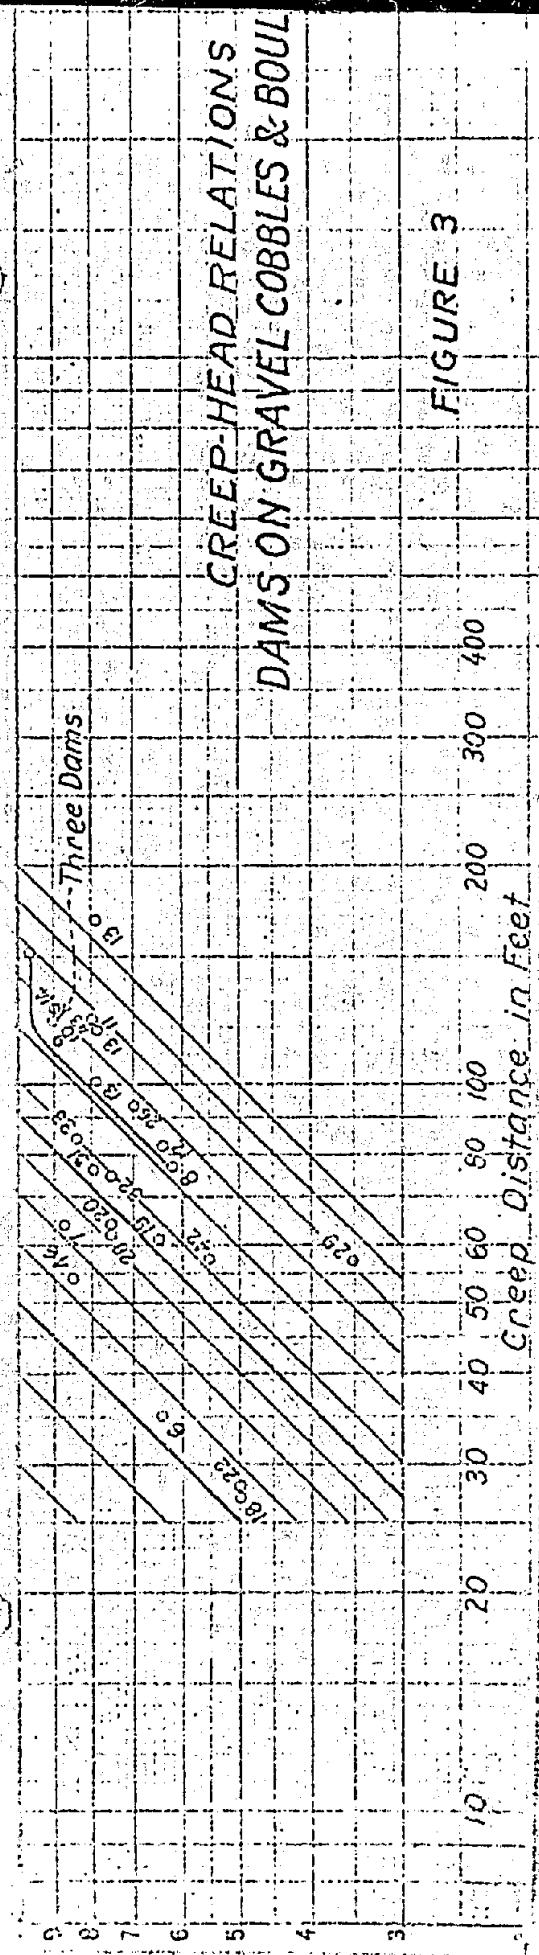
FIGURE 3

Figures 3 and 4 give the results of analyses of dams founded on gravel, cobbles and boulders. Dams on foundations composed largely of sand but with a considerable proportion of gravel are included in the figure. They represent an intermediate condition between coarse sand and gravel, and to include them in this classification is on the safe side of conservatism. The results of the creep-load analyses indicate

Most of the failures occurred with ratios much lower than 5.
The 17-ft. dam was constructed in 1925-31 and it is not surprising
that, given the knowledge of that day, so radical a design should be
attempted. The dam had stood thru previous years with ratios as low
as 4.1, the low ratio at failure being due to a blowout in the down-
stream slope. The New Angeles Dam (ratio 2.1) would seem almost sure
to fail, & it is difficult to say how a dam would be built under
the conditions as recent a date. The Pittsfield Dam was also

The only case of failure in a dam approaching the ratios
given by Eligh is that at Flettsburg with a ratio of 4.0. The cause
of this failure is not evident. An analysis of the foundation ma-
terial, as nearly as could be determined from the data given, is
shown on figure 1. This indicates a much more impervious material
than at Prairie du Sac, which stood with a ratio of 4.5. Part
of the Flettsburg Dam stood with a ratio of 3.2. It seems not im-
possible that there was some defect in construction or an unusual
concentration of coarse material at the point of failure.

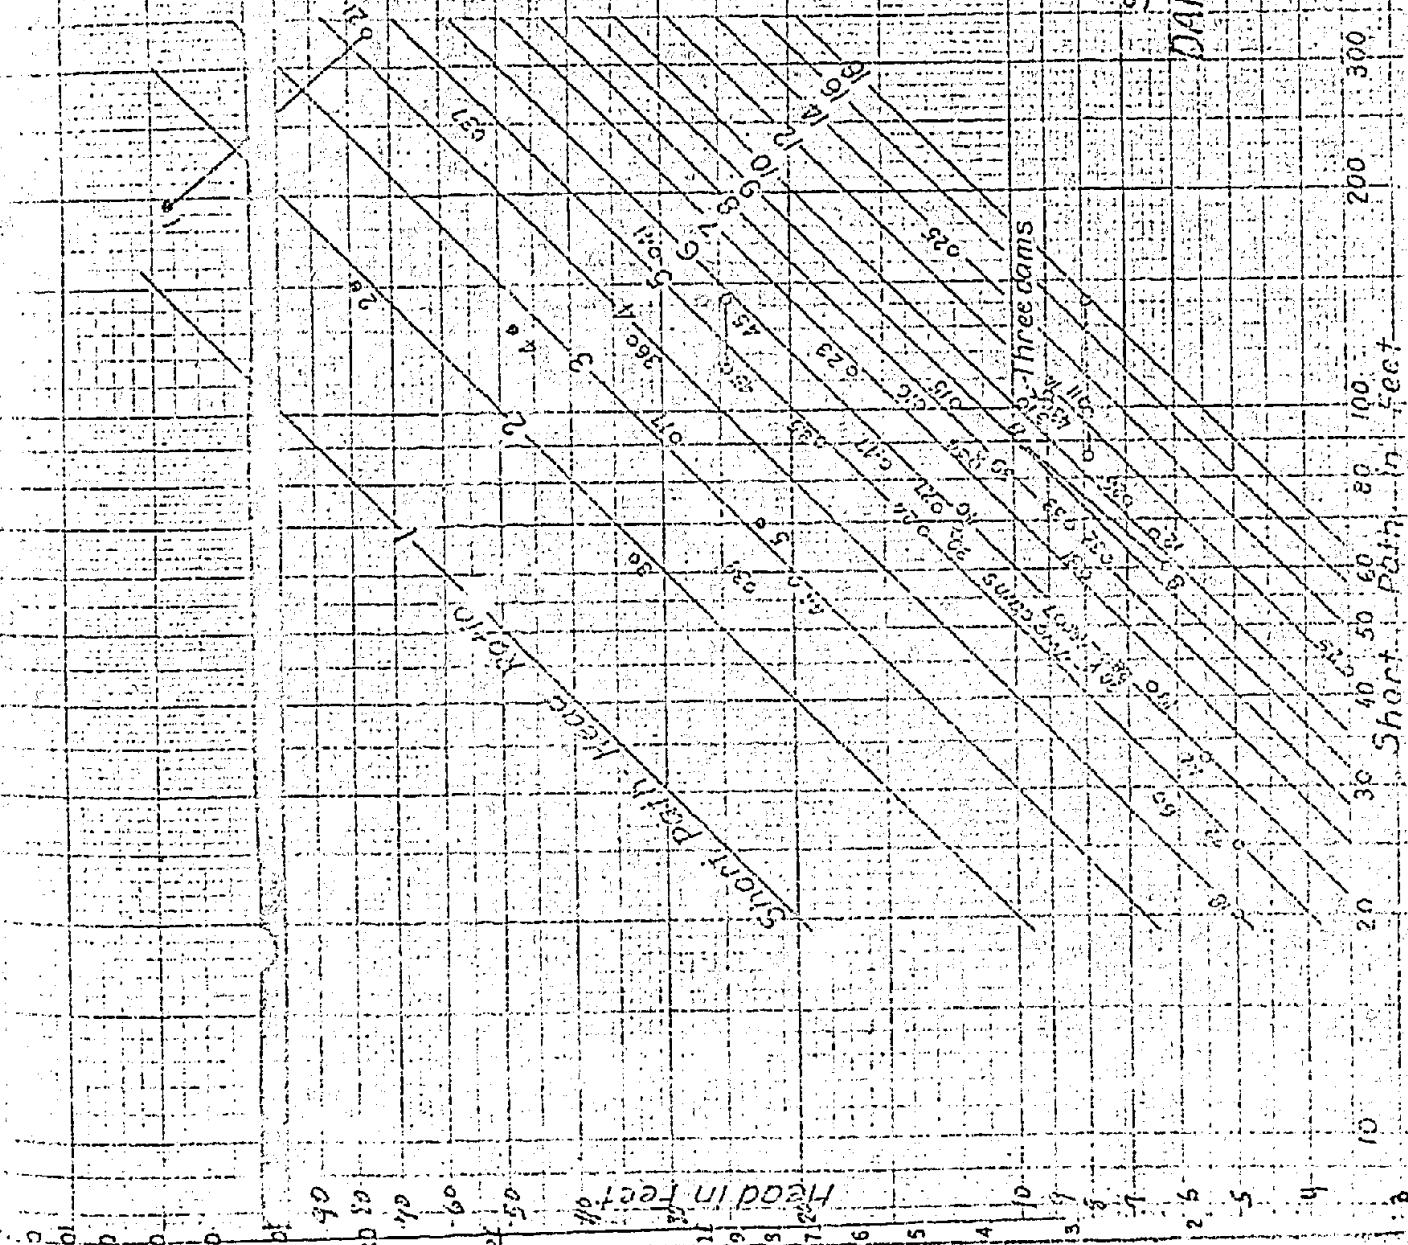
FIGURE 4

SHORT PATH-HEAD RELATIONS DAMS ON GRAVEL, COBBLES & BOULDERS

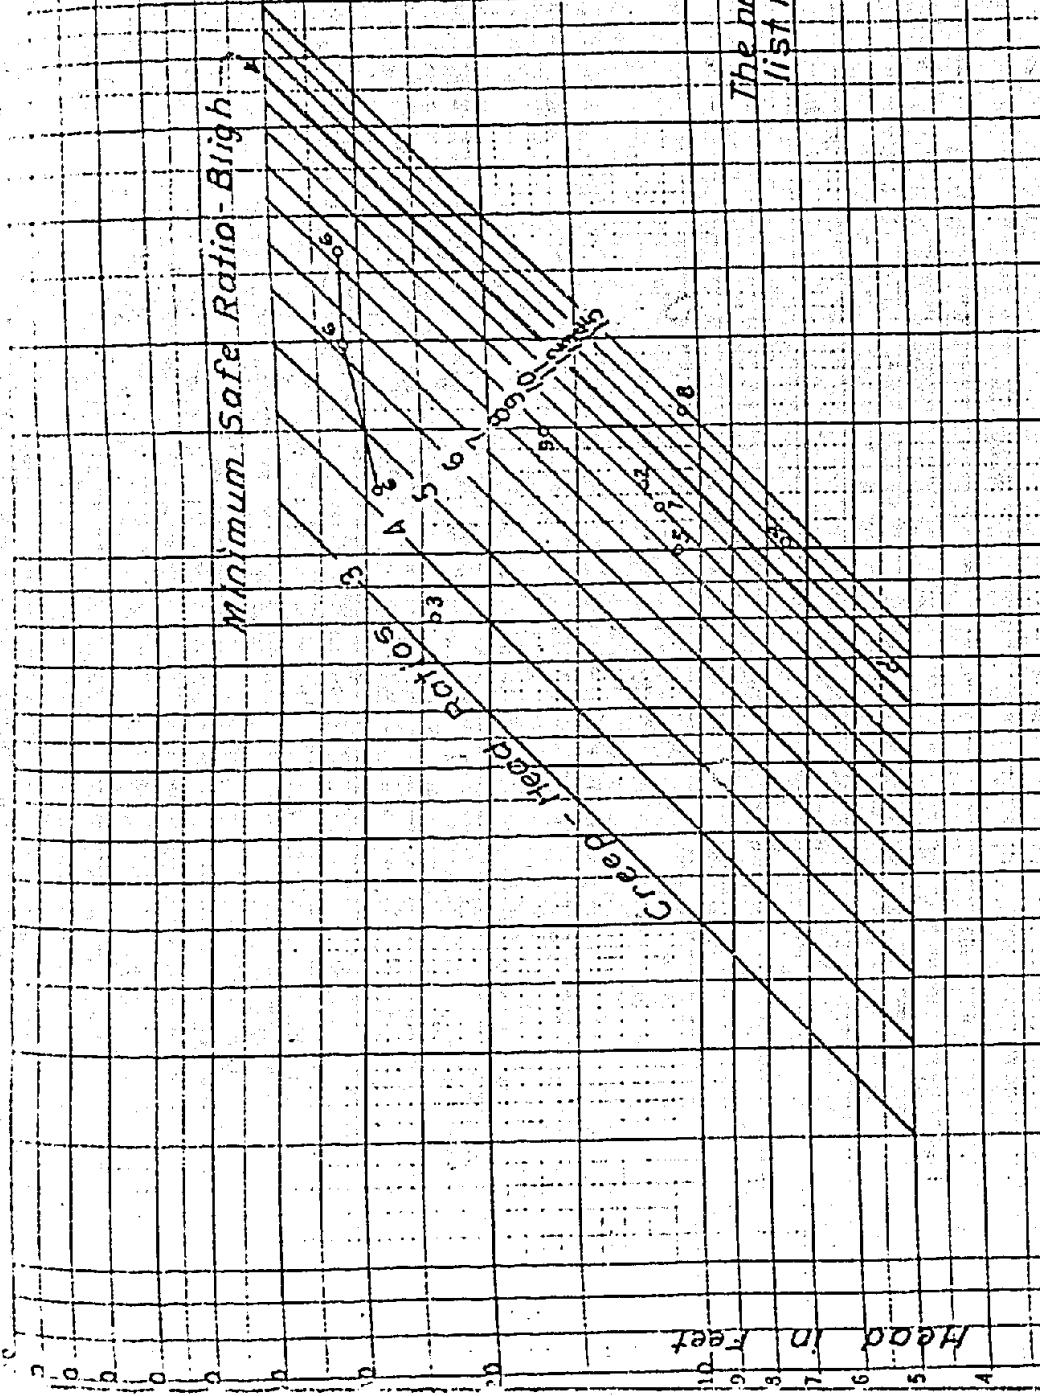
CREEP-HEAD RELATIONS
DAMS ON COARSE SAND

Figures 5 and 6 show graphically the results obtained in the analyses of dams on a coarse sand foundation on the basis of the Bligh and Sorensen theories respectively. No failures were found in this class except the Upper Colercon weir, which was due to a defective apron, and is therefore not included. In this classification are included those on the border between coarse and fine sand as placing them in this class rather than the fine classification is more conservative. The results indicate that Bligh's factor of 12 is unnecessarily conservative. The Riverdale Dam held at least 5 years with a ratio of 3.4, and the foundation was said to be full of springs during construction. The riprap revetment below may have acted somewhat as a filter and assisted in the stability of the dam by filtering the flow beneath the dam, thus preventing the removal of the fine material. The Prairie du Sac Dam has been in service 15 years, part of the time with a ratio 4.3 and the remainder of the time with a ratio of 3.2. It is possible that the riprap filling in this dam assists somewhat in acting as a filter. Under the power house, where there could be no such filter action, it has stood for 15 years with a ratio of 3.3. In fact, it has sustained even higher ratios, but these may have occurred only after the river bottom above had silted up. In fact, two thirds of the dams have values less than that given by Bligh and there is no record of failure, even when the ratio was only 22% of Bligh's.

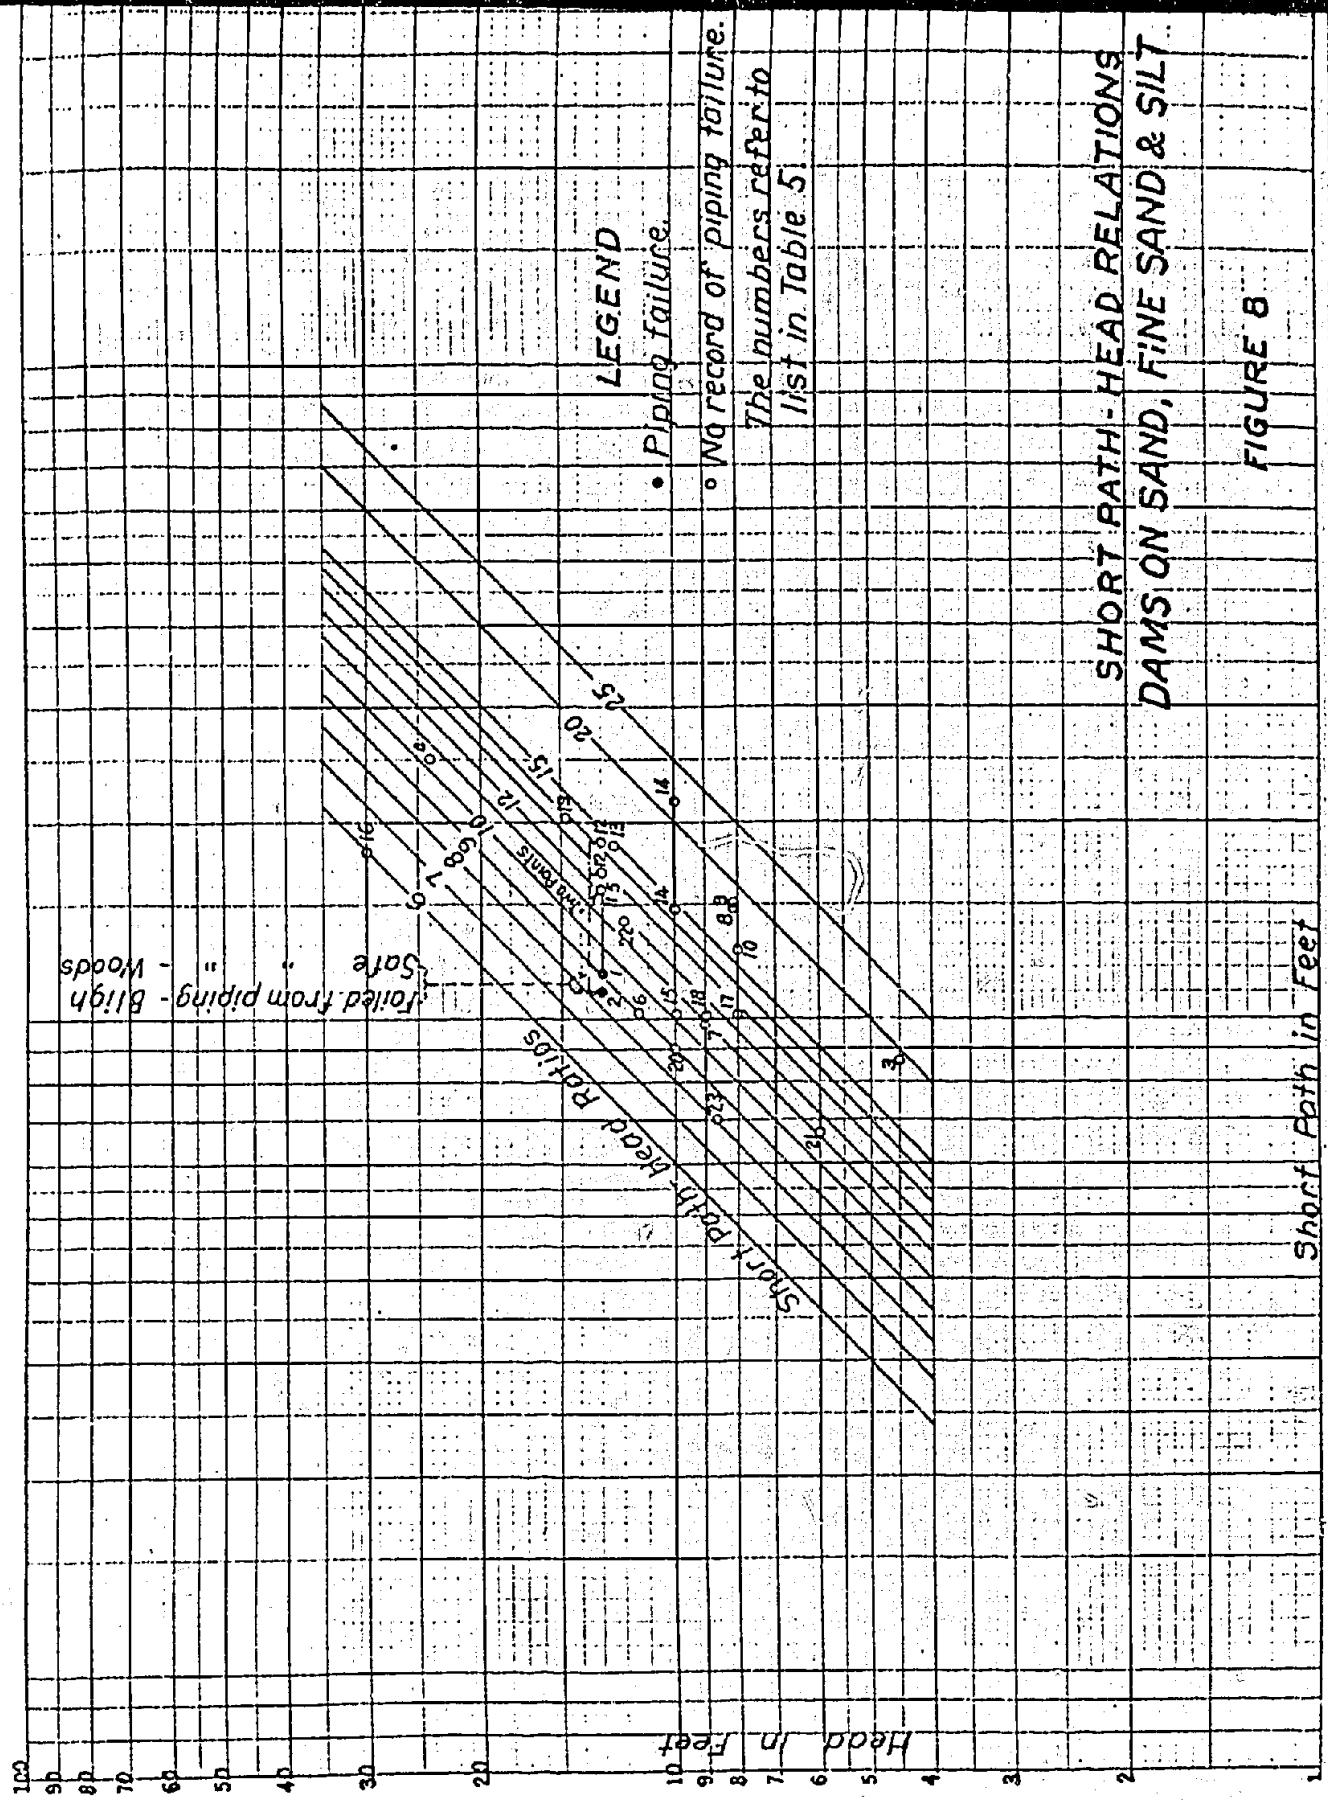
FIGURE 8

SHORT PATH-HEAD RELATIONS
DAMSON SAND, FINE SAND & SILT
