REPAIR OF 58-INCH BALANCED VALVES  
IN LOWER OUTLET TUNNEL  
SHOSHONE DAM

Hydraulic Laboratory Report No. Hyd-117

OCTOBER 30, 1942

Subject: Repair of 58-inch balanced valves in lower outlet tunnel -  
Shoshone Dam - Shoshone Project.

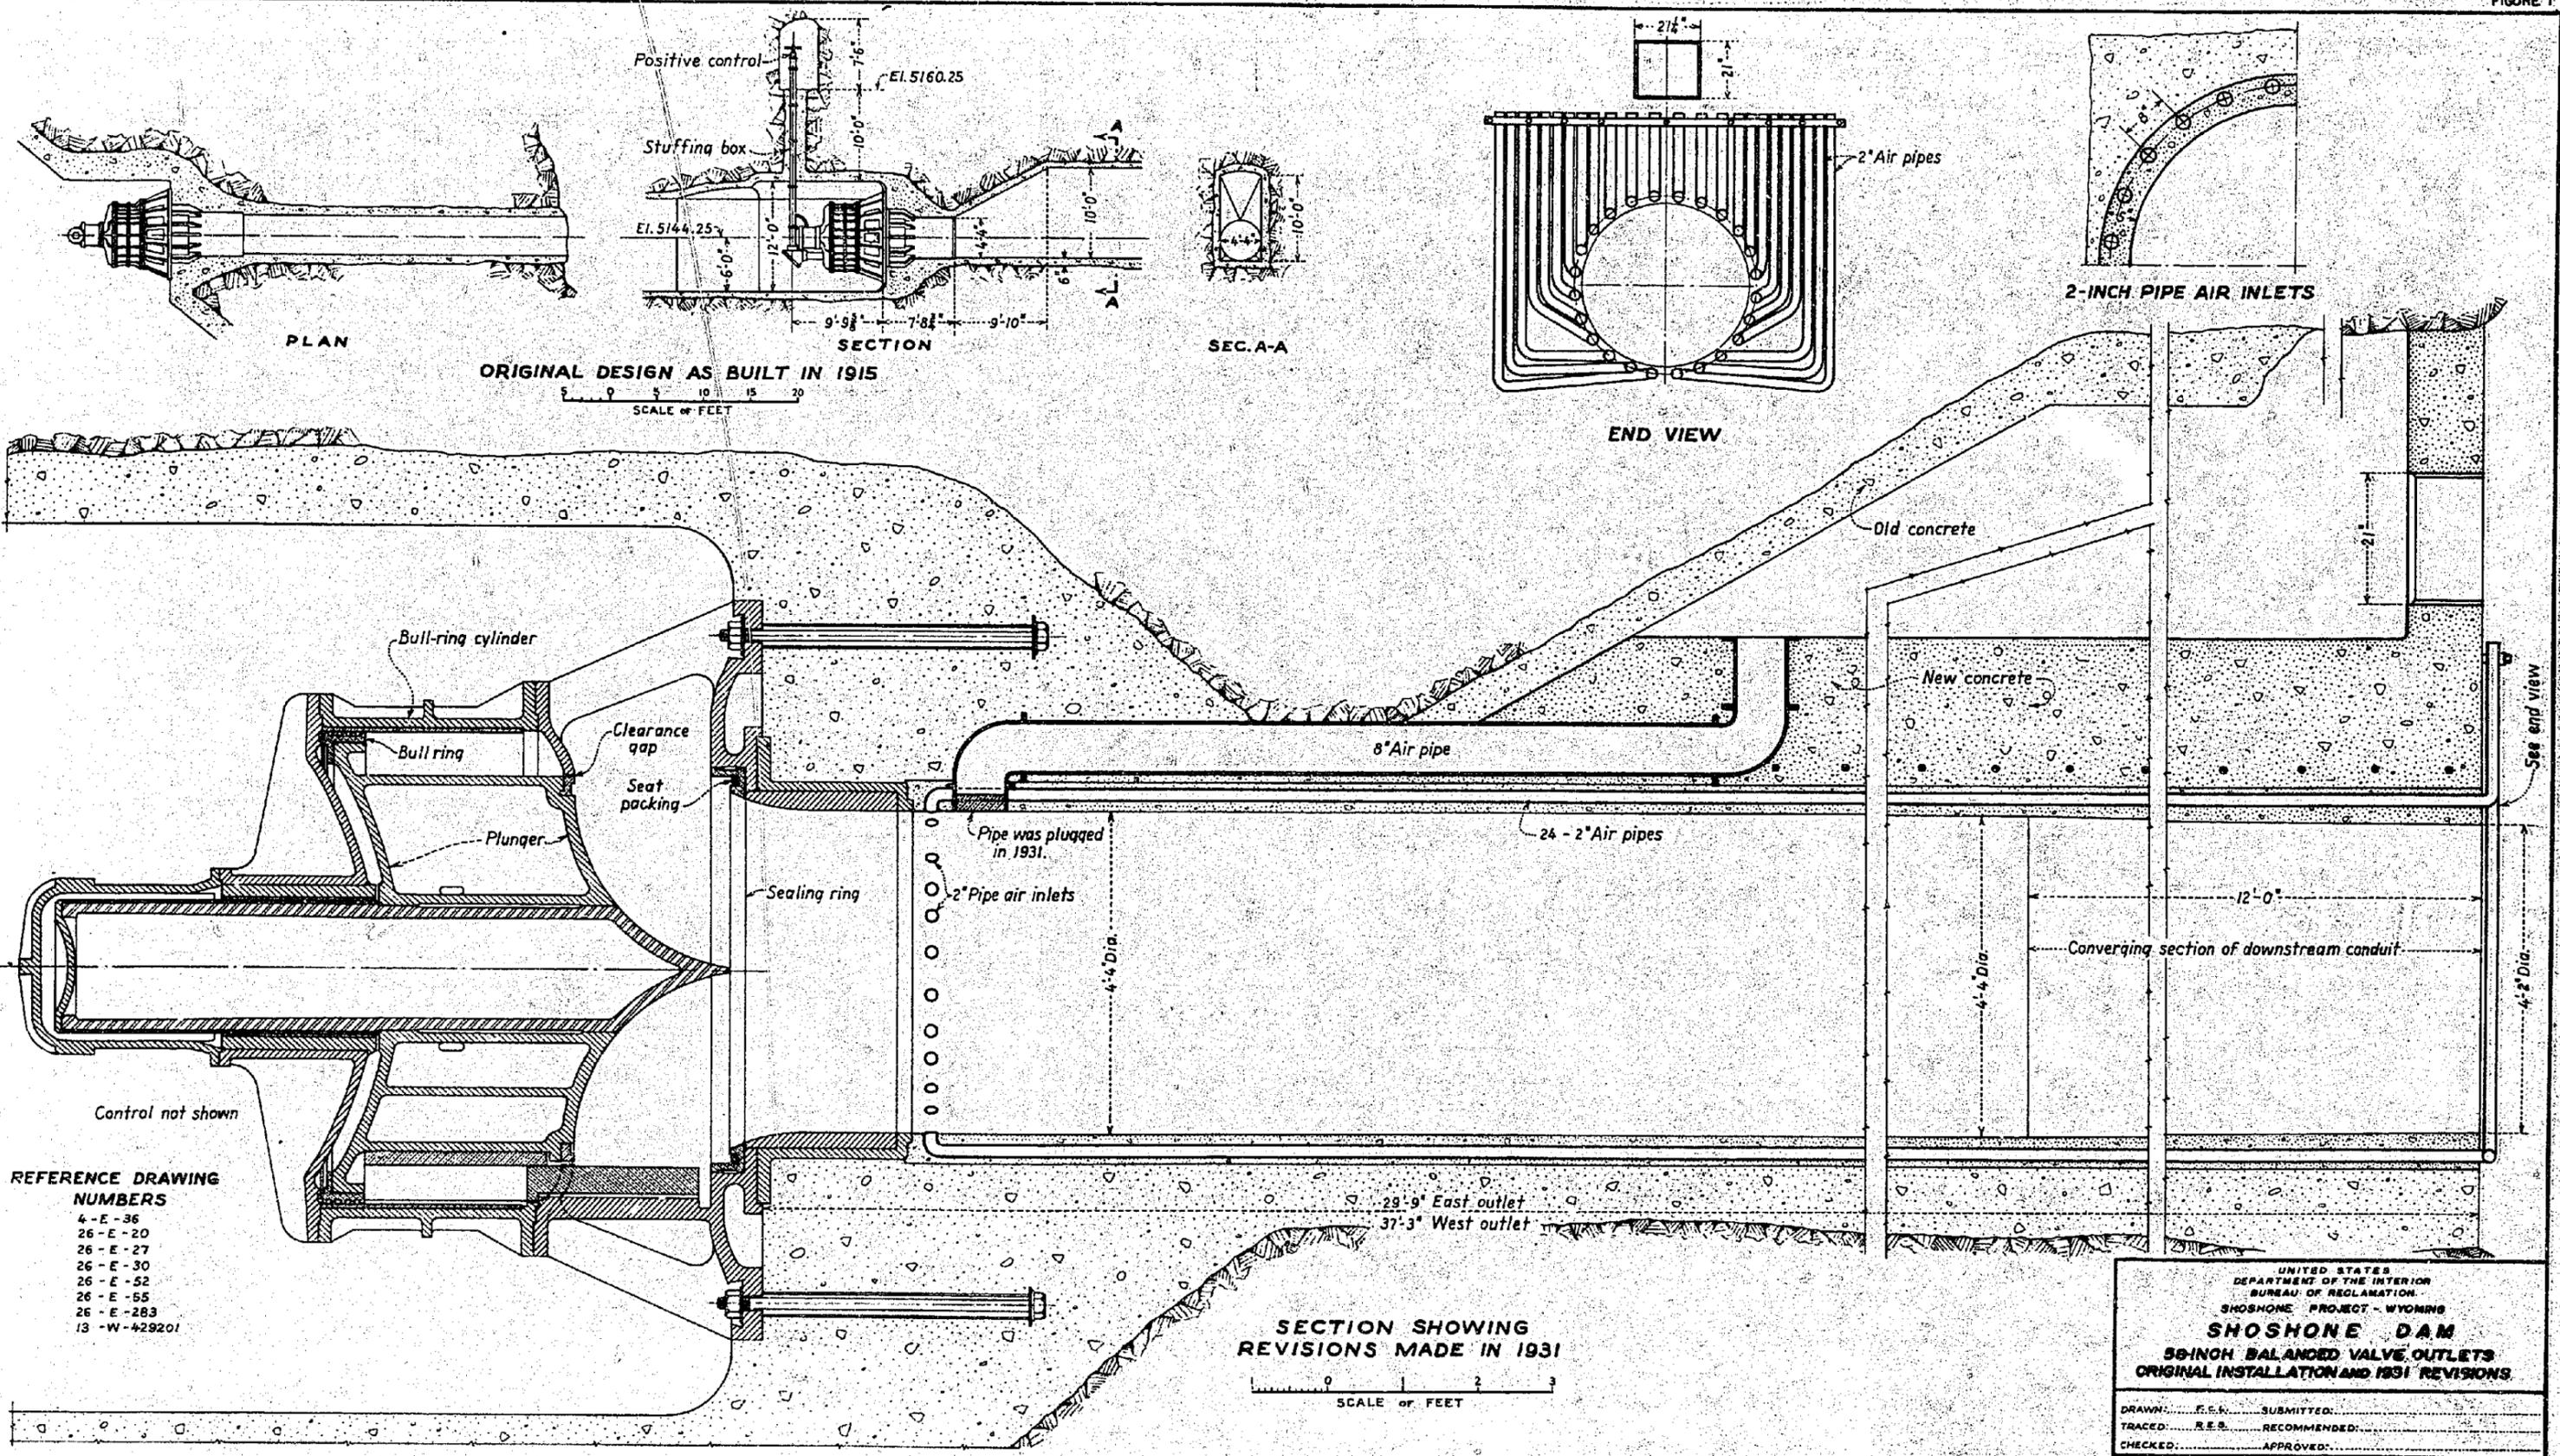
Twenty-four 2-inch standard pipes are embedded in the conduit lining parallel to the center-line of each outlet, and equally spaced around the conduit. The inlet ends of these pipes (figure 1) are on the face of the cliff (figure 2A) at the discharge end of the conduits and the outlet ends are opposite the tip of the needle in the closed position of the valve. These pipes were installed to relieve the

sub-atmospheric pressures in the conduit downstream from the valve. In addition, an 8-inch pipe in each conduit was provided to conduct air from the space between the roof of the conduit and the roof of the original opening. The outlet end of the 8-inch pipe is downstream from the outlets of the 2-inch pipes.
