HYD-137

EXPERIENCES OF THE BUREAU OF RECLAMATION

BY JACOB E. WARNOCK,¹ M. AM. SOC. C. E.

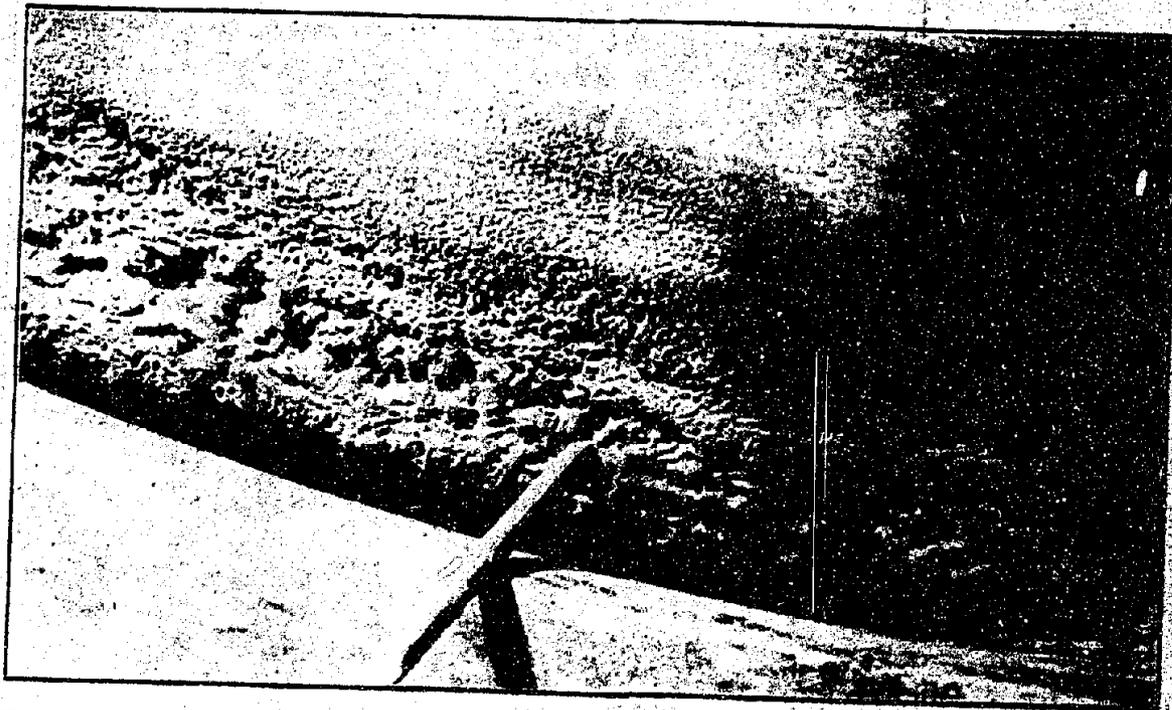
FIG. 32.—ENLARGED VIEW OF SECTION IN FIG. 31 EMPHASIZES THE SEVERE PITTING ON THE SURFACE OF THE NEEDLE VALVE WHICH REQUIRES EXPENSIVE MAINTENANCE BY WELDING

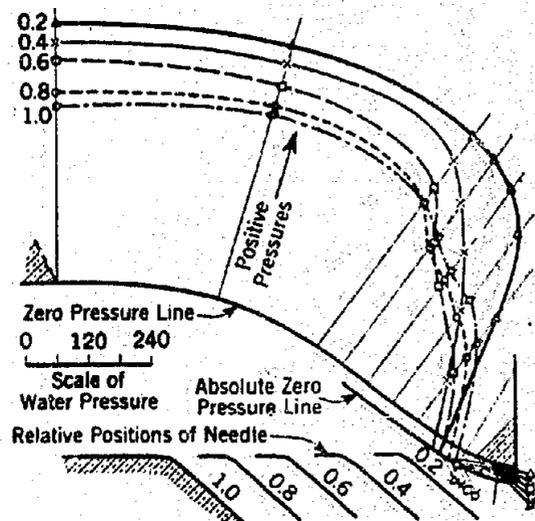
FIG. 33.—PRESSURE DISTRIBUTION ON THE NOZZLE OF A 72-IN. NEEDLE VALVE (HEAD, 516 FT) SHOWS REGIONS OF LOW PRESSURE WHICH CORRELATE PERFECTLY WITH THE OCCURRENCE OF PITTING

Piezometers installed in the nozzle of one of the 72-in. valves at Boulder Dam showed pressures near absolute zero in a zone (Fig. 33) immediately upstream from the region of erosion or pitting throughout the entire range of the valve. Since the installation of pressure equipment in one of the 72-in. needles would have been intricate, a homologous needle valve with an exit diameter of 5 in. was installed for testing in one of the tunnel-plug outlets at

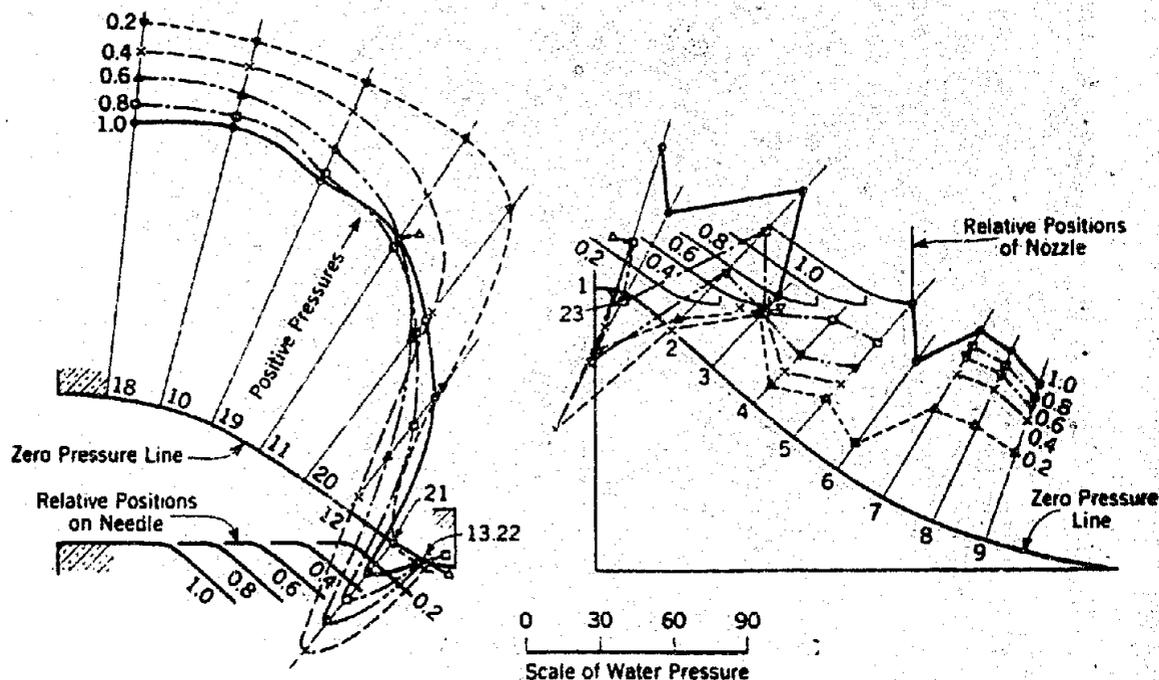
Boulder Dam. The pressure distribution on the needle and nozzle is shown in Fig. 34 for various openings of the valve under a constant head of 150 ft.

FIG. 34.—DETAIL DATA FROM EXTENSIVE TESTS OF A 5-IN. SCALE-MODEL NEEDLE VALVE FURTHER CONFIRM THE PRESSURE MEASUREMENTS AND PITTING OBSERVED ON THE PROTOTYPE

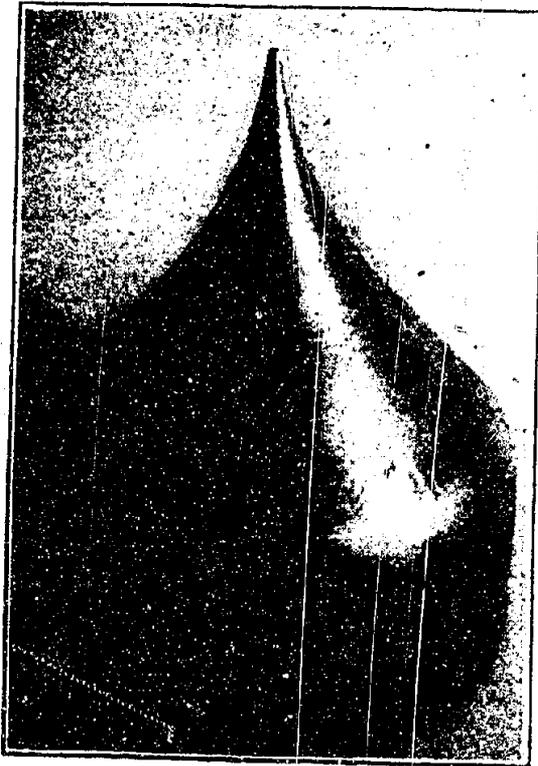
In general, the pressure conditions were most critical at a valve opening of approximately 40%. The results of a wear test (Fig. 35) are shown after six

days of operation under a total head on the valve of 460 ft with the valve opening of 40%—the severest condition.

FIG. 35.—PITTING ON THE NEEDLE OF A 5-IN. VALVE, ACCORDING TO THE ORIGINAL DESIGN, AFTER SIX DAYS OF OPERATION (40% OPENING AND $H = 460$ FT)

The original design of nozzle had an expanding water passage which tended to lower the velocity and cause a regain of velocity head. This yielded a higher discharge but created low-pressure areas in the valve. When forces in the low-pressure areas were of sufficient intensity, they produced cavitation with the accompanying pitting.

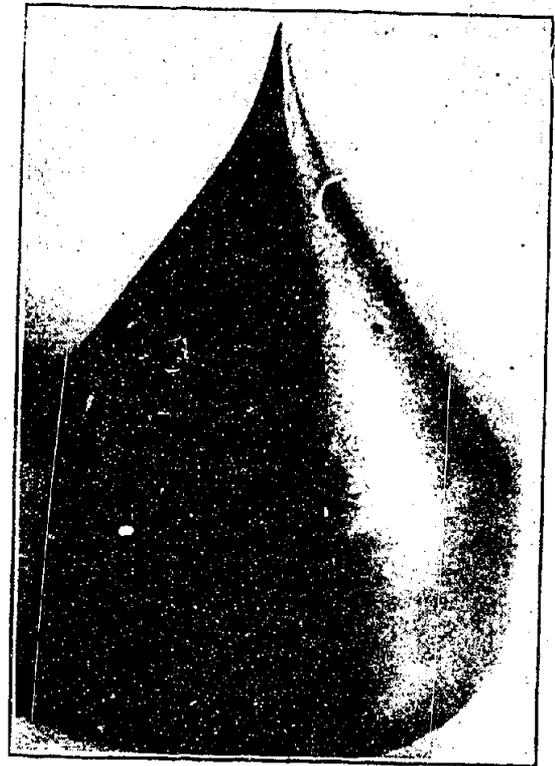
FIG. 36.—ABSENCE OF PITTING ON THE NEEDLE OF A 5-IN. VALVE, ACCORDING TO THE IMPROVED DESIGN, AFTER 84 DAYS OF OPERATION (20% OPENING AND $H = 460$ FT)

A number of designs were studied in the laboratory using the same 5-in. valve and a design was developed which produced positive pressures at all valve openings and at all heads. This design, when subjected to a wear test, under the same conditions as the original design (except at an opening of 20%, the opening at which the severest conditions occurred), showed no sign of pitting on the needle after eighty-four days of operation (Fig. 36).

From the high-head studies of the 5-in. valve, certain specifications were developed to maintain positive pressures on the needle and nozzle of the valve at all openings. The angle between the needle and the nozzle must not be divergent in the direction of flow. The needle and nozzle profiles may be parallel and still maintain positive pressures, but a convergence of one to three degrees is preferable. The seat must be on the tangent portion of the needle; that is, the base diameter of the needle cone must be slightly larger than the outlet diameter of the nozzle. The valve nozzle should have no point of inflection; it should have a sharp edge to maintain the minimum section at

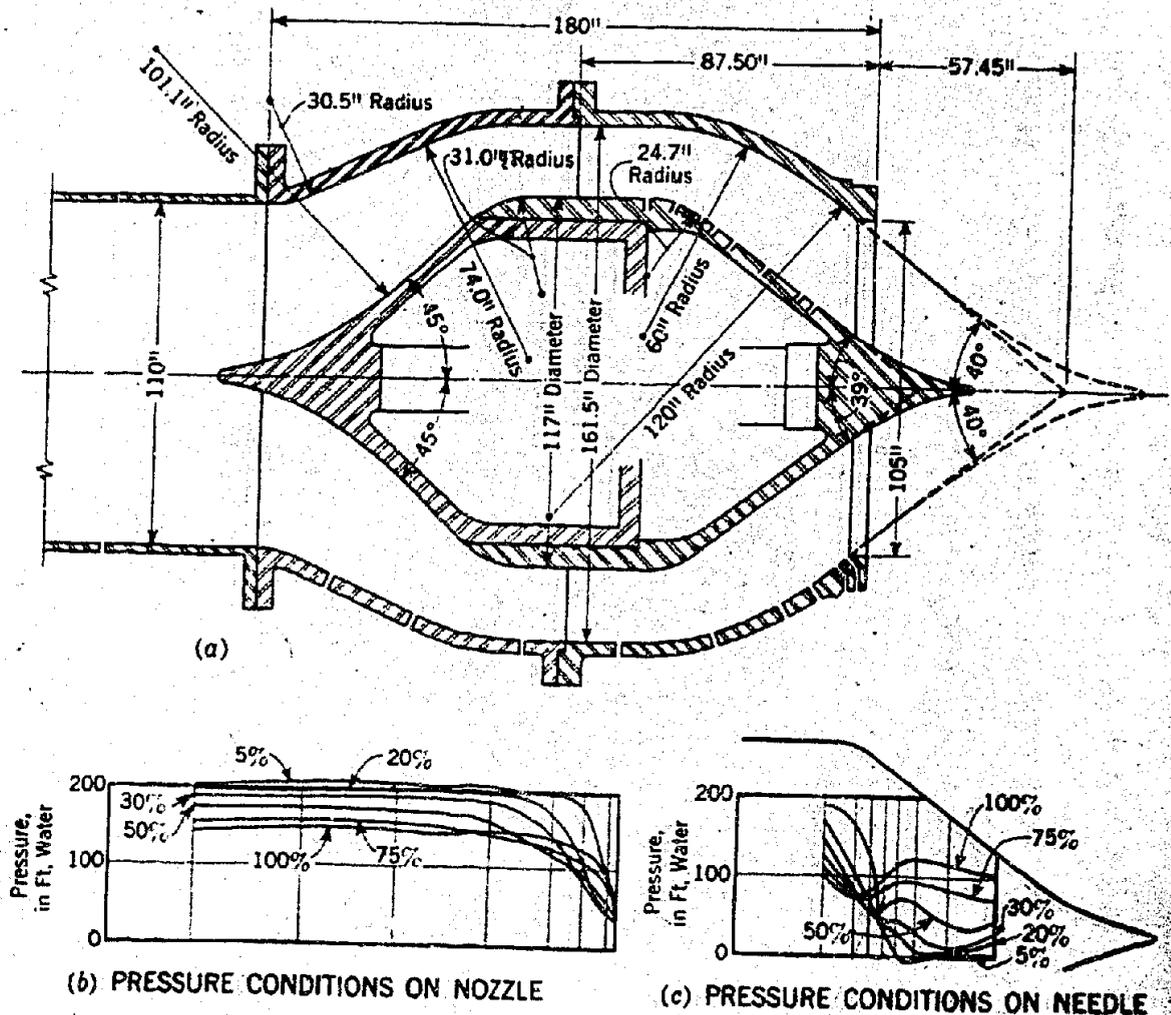
FIG. 37.—COMPLETE ABSENCE OF CAVITATING PRESSURES ON THE NEEDLE AND THE NOZZLE OF A NEW DESIGN OF NEEDLE VALVE, AS DETERMINED FROM A 6-IN. MODEL

Using a 6-in. valve equipped with piezometric taps throughout the profile of the needle and the nozzle, the design was altered further by increasing the outlet and equatorial diameter and the needle travel until a combination was found in which the cavitating pressures were absent over the entire range of valve opening (Fig. 37) and the discharge capacity was comparable to that of the original valve.

Although the new design has not been used in a field structure, the satisfactory operation of the 5-in. valve with positive pressures throughout, under a head of 460 ft for eighty-four days, indicates similar satisfactory operation in a larger valve of the new design. As designed for Friant Dam in California, the

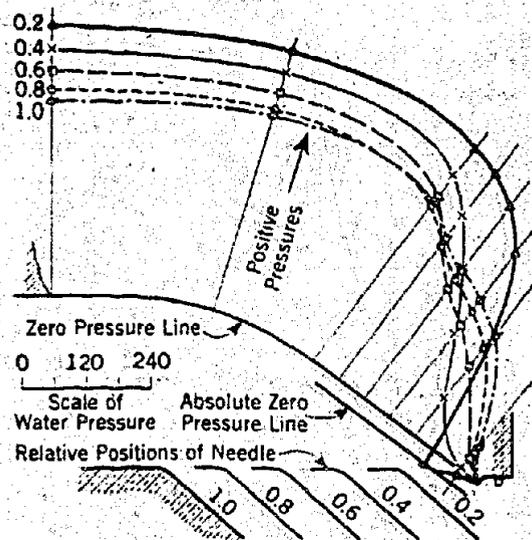
FIG. 38.—PRESSURE DISTRIBUTION ON THE NOZZLE OF THE 72-IN. NEEDLE VALVES AT BOULDER DAM, WITH REVISED PROFILE OF NOZZLE

Subsequently, sharp-edged nozzles were installed on certain valves at Boulder Dam and the pressure results show a marked improvement in distribution (Fig. 38). Field reports indicate a minimizing of pitting on those valves so equipped. Operation of the valves with the original nozzle shape at openings where the subatmospheric pressures were less severe, as indicated by model tests, has also tended to reduce the amount of pitting.

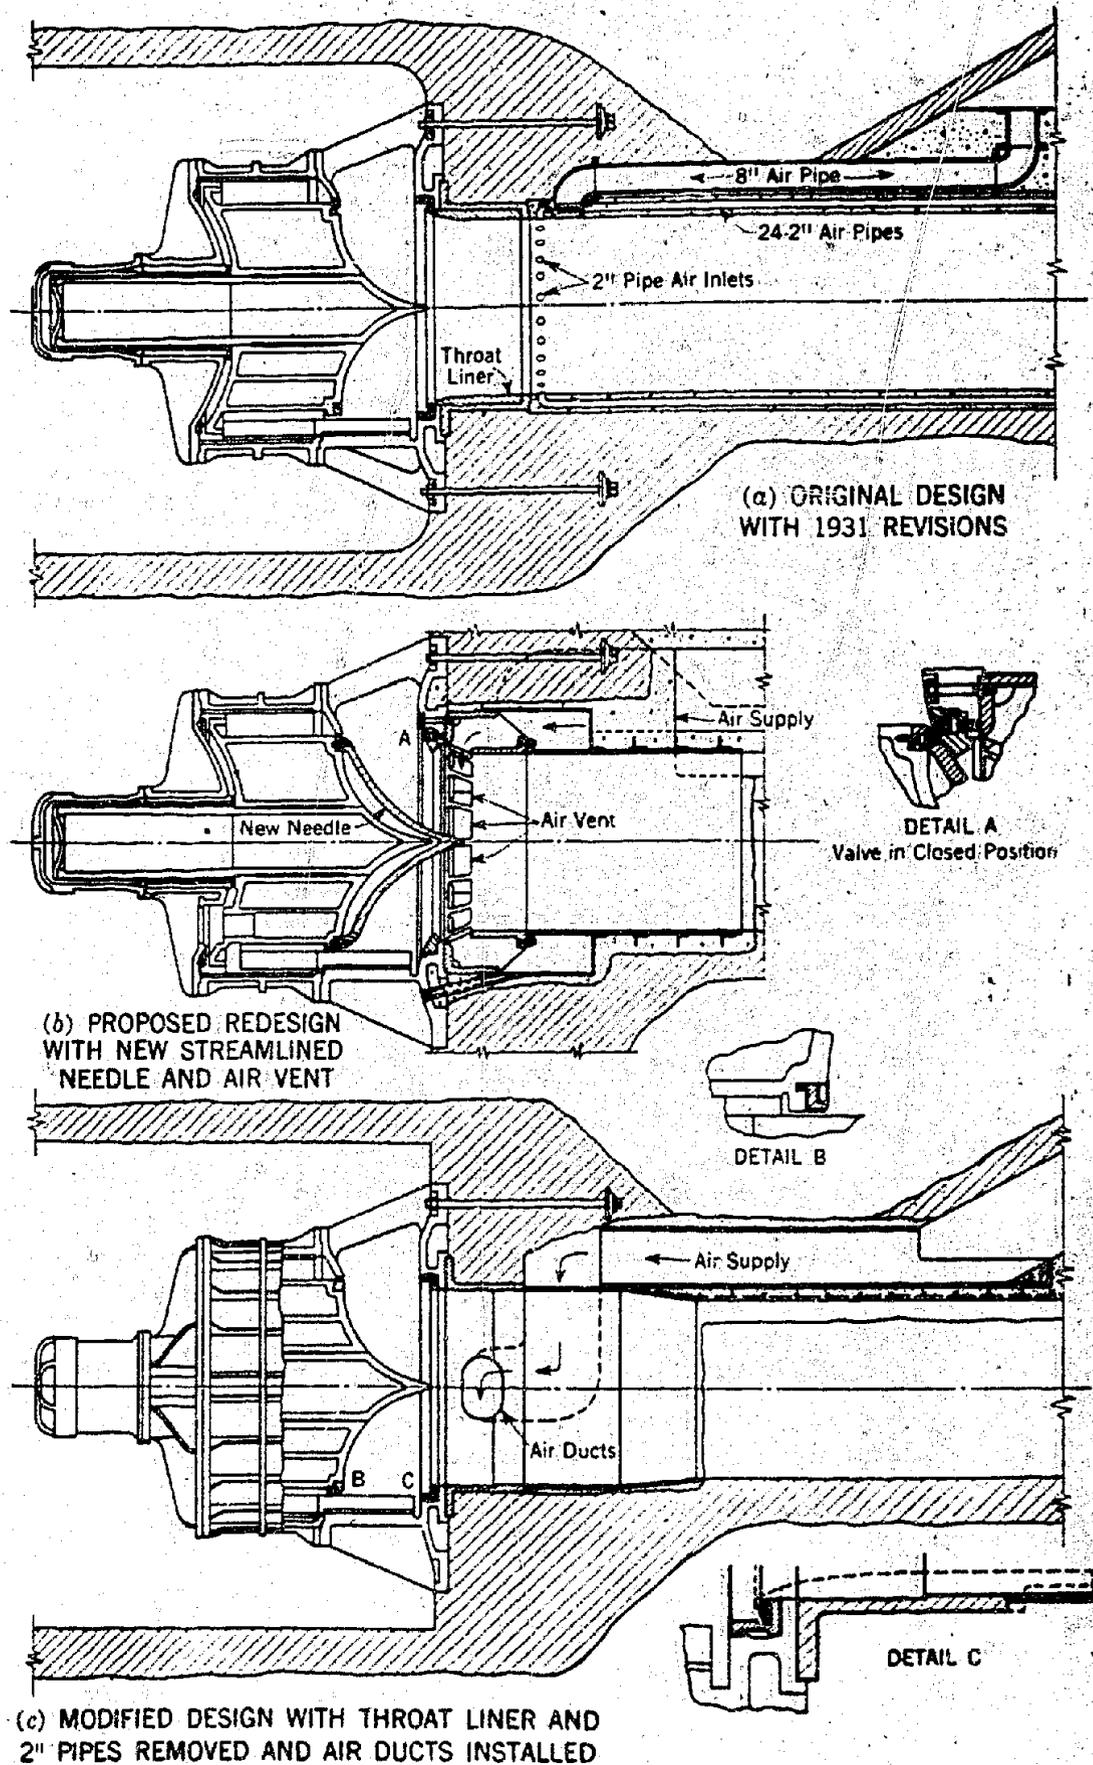
FIG. 39.—BALANCED VALVES IN THE LOWER OUTLETS AT SHOSHONE DAM

In 1930-1931, an attempt was made to relieve the Shoshone situation by installing twenty-four 2-in. pipes and an 8-in. air duct below each valve (Fig. 39(a)). A marked increase in the intensity of the noise accompanying the discharging water resulted, and the experiment was considered unsuccessful. Because of the failure of the vent system, resort was made to the original method of maintenance and the valves were used as little as possible. The pitting was serious and the repairs inadequate, but a more practical method of repair was not apparent.

The model tests showed that the present prototype vent system is inadequate to prevent cavitation for all except a very small range of valve openings. Insufficient air is supplied between 23% and 70% openings, and some of the 2-in. vent pipes on the invert and crown become ineffective at openings above 85%, due to eddies forming immediately downstream from the V-guides. These conditions precluded safe operation of the present installation at ranges of valve opening other than 70% to 85%. Studies of the present installation indicated that the pitting on the valve needles was most severe between openings of 14% and 25%, and that damage to the conduits resulted between 23% and 70% valve opening. The damage to the conduit at these openings probably rendered the air-supply system ineffective and aggravated the destructive action for larger valve openings.

Three alternatives were developed: (a) The range of valve opening was determined in which damage would be minimized until materials, unobtainable due to wartime restrictions, become available; (b) a redesign (Fig. 39(b)) was developed in which adverse pressure conditions were eliminated over the entire range of operation, but at some sacrifice in the discharge capacity; and (c) a modification of the present installation (Fig. 39(c)) was developed in which pressure conditions were acceptable over a range of valve opening from 25% to 100% with no reduction in the discharge capacity.

Damage by cavitation and pitting on the valve needles and discharge conduits can be eliminated entirely by a major revision (Fig. 39(b)) of the needle tip, the valve seat, the conduit throat, and the aeration system. This solution will reduce maintenance costs to a minimum and the valves can be operated at any opening without fear of damage due to subatmospheric pressures; but it will reduce the discharge capacity by approximately 20%, a factor to be considered in future revisions.

Minor alterations of the present structure (Fig. 39(c)) will involve: (a) Streamlining of the sealing edge of the plunger; (b) removal of a part of the bronze sealing ring by chipping and grinding; (c) removal of the throat liner; and (d) revamping of the air-supply system. Aeration equivalent to three 12-in. ducts would be adequate in this arrangement, but slightly more area was recommended as information on air requirements in high-velocity flow is limited. Operation of this modified design at openings smaller than 23% will have to be avoided to prevent damage to the needle. The discharge capacity is not affected noticeably by the modification.

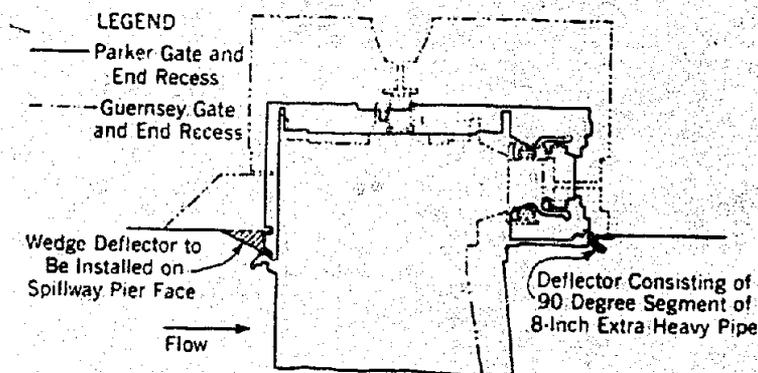
The gate slot at Guernsey Dam is considerably larger (Fig. 42) in horizontal cross section than the gate slot at Parker Dam. As a result, the vortex in the

FIG. 42.—COMPARISON OF THE GATE RECESSES OF GUERNSEY DAM AND PARKER DAM, SHOWING THE LOCATION OF THE DEFLECTORS PROPOSED AS REMEDIAL MEASURES AT PARKER DAM

gate slot at Guernsey Dam was large and slow in rotation with no appreciable reduction in pressure at the core, whereas with the smaller cross section of the gate slot at Parker Dam, the angular velocity was high with a very small core and very low pressures in the core. As in the case of the cavitation zone downstream from a venturi throat, the flow condition was unstable and low-pressure pockets broke away from the bottom of the vortex. Some of the pockets collapsed against the boundary surface, resulting in the destruction of the concrete and metal.

According to the present conception of the condition, the solution appears to be the elimination of the vortex. This can be done in a number of ways, none of which is universally applicable. In the case of Parker Dam, it is proposed to install a wedge-shaped deflector (Fig. 42) upstream from the gate sufficient in extent to deflect the flow of water under the gate away from the

downstream corner of the gate slot, thus negating the formation of the vortex. An additional curved deflector consisting of a 90° segment of an 8-in. extra heavy pipe fastened to the metal at the downstream side of the gate slot will further deflect the flow away from the pier face and provide aeration down to the spillway crest. Another solution, practicable where the spillway crest is sufficiently far above the tailwater to provide drainage, is the extension of the end beams of the gates down into wells in the spillway crest, thus making them continuations of the gate slots. These gate-beam extensions will then serve as followers and will fill the gate slot as the gate is raised, providing continuity of the spillway pier face. In the case of a gate 50 ft high, the follower is considered structurally feasible in lengths to 6 ft. The model studies indicated that a follower length of from 2 ft to 3 ft is all that is necessary, since the occasion and duration of operation at the larger openings are infrequent and short.
