HYDRAULIC LABORATORY REPORT NO. 189
TESTS ON 24-INCH
HOLLOW-JET VALVE AT BOULDER
DAI

Denver, Colorado,
Nov. 29, 1945

Subject: Tests on 24-inch hollow-jet valve at Boulder Dam.

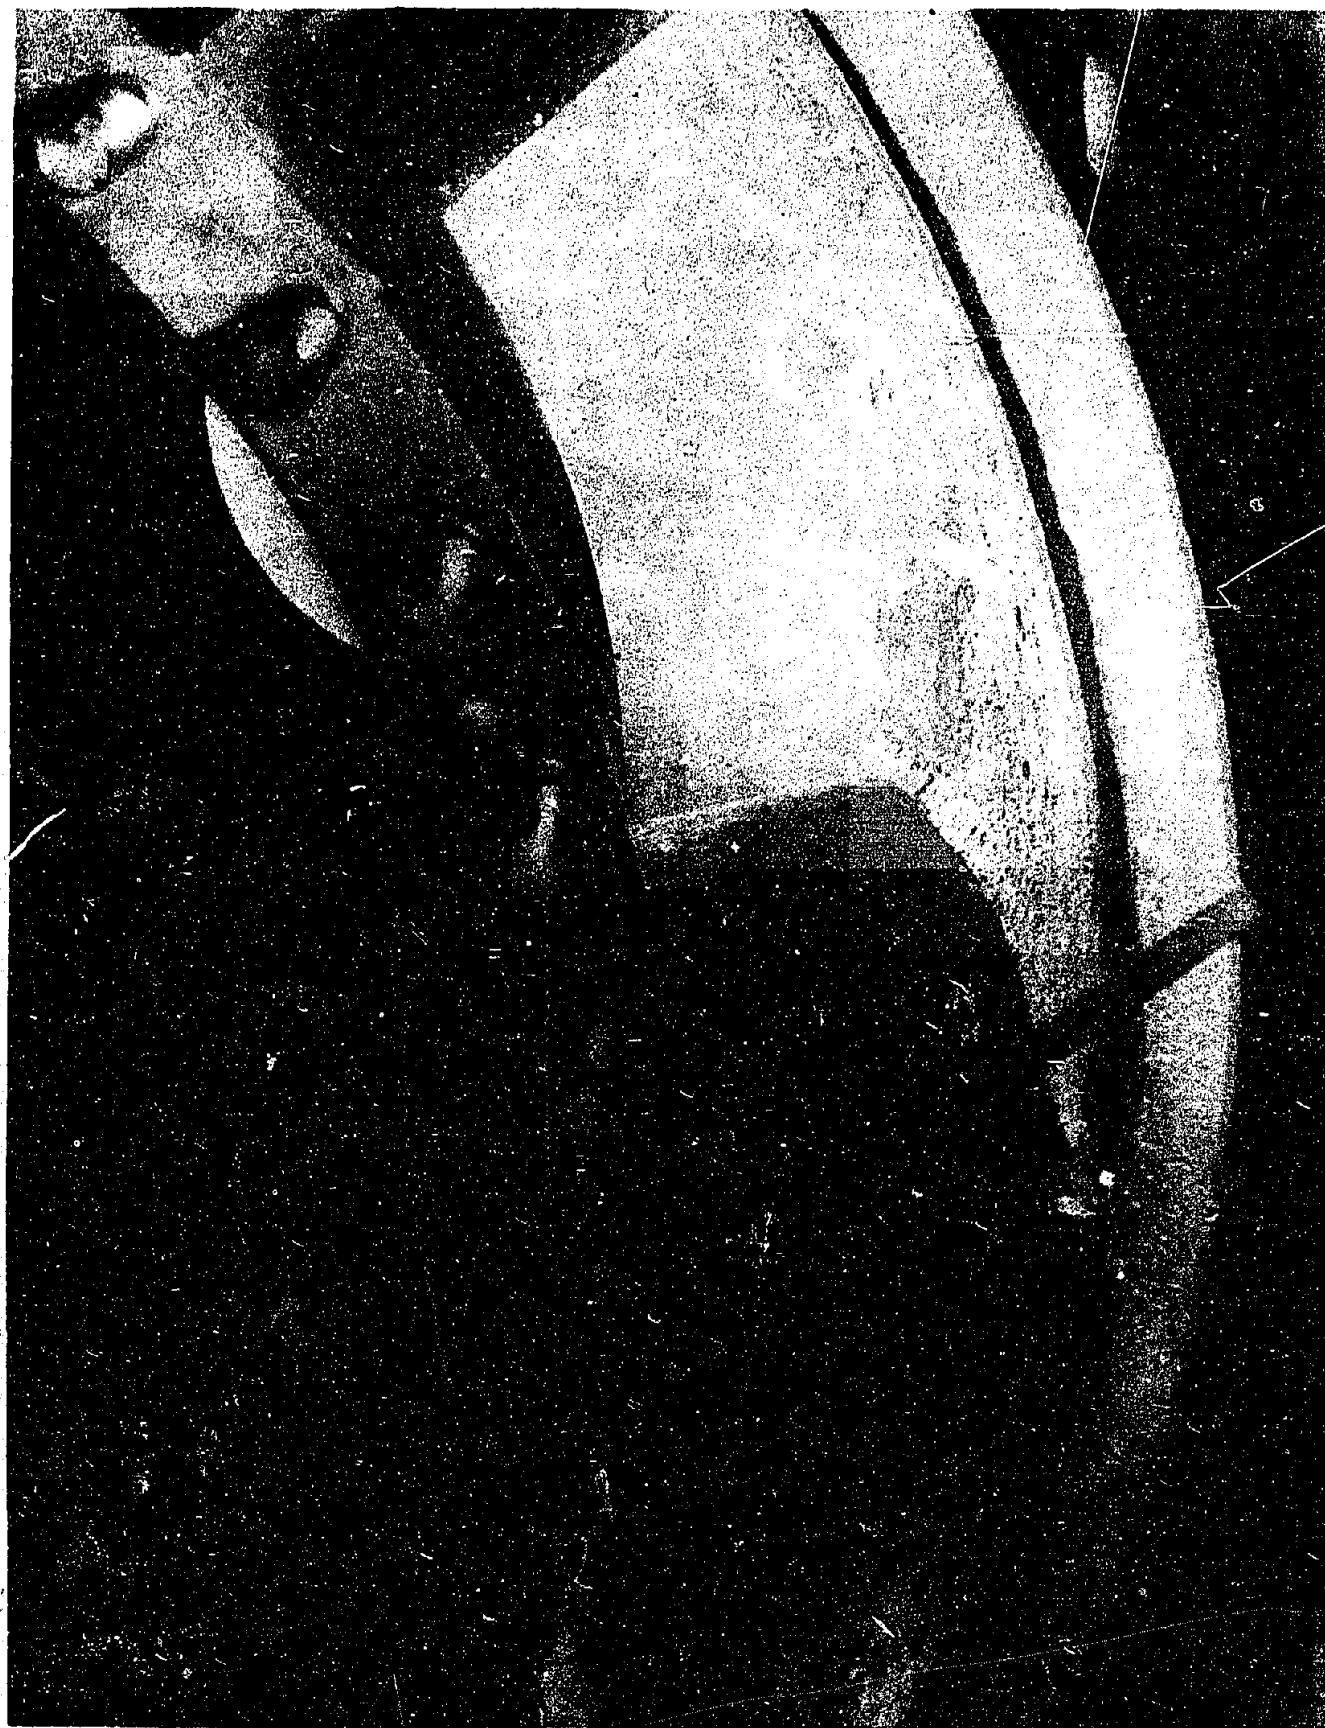
FIGURE 2

The cast surfaces of the valve body were quite rough. There were numerous slag pockets and evidence of wash in the mold due to pouring of the metal (figures 2 and 3). Other areas of the casting showed roughness due to careless handling of the molds. In the unmachined areas of the casting, a certain amount of the roughness was eliminated by hand grinding. However, it was not possible to obtain a smooth surface without excessive grinding and destroying the designed contour of the valve. The machined surfaces of the valve body finished down to sound metal except the region at the upstream flange where the slag pockets were quite deep (figure 4). Figures 5 and 6 show the character of the junction of the vanes with the valve body before and after grinding. The abrupt shoulder at the upstream end of the splitter was the result of machining. This condition (figure 4) may be expected in future valves, and it should be specified that this part should be feathered to the valve contour as shown in figure 6.

DOWNTSTREAM END OF VALVE BEFORE TESTING-CHARACTER OF UNMACHINED SURFACES

- f. There was no evidence of cavitation in the valve nor was there any appreciable amount of vibration.
- g. Care must be exercised in obtaining smooth surfaces in the water passages of the unmechanized portion of the hollow-jet valve. This will be necessary to prevent the possibility of local cavitation when the valve is used with heads higher than the test heads at Boulder.

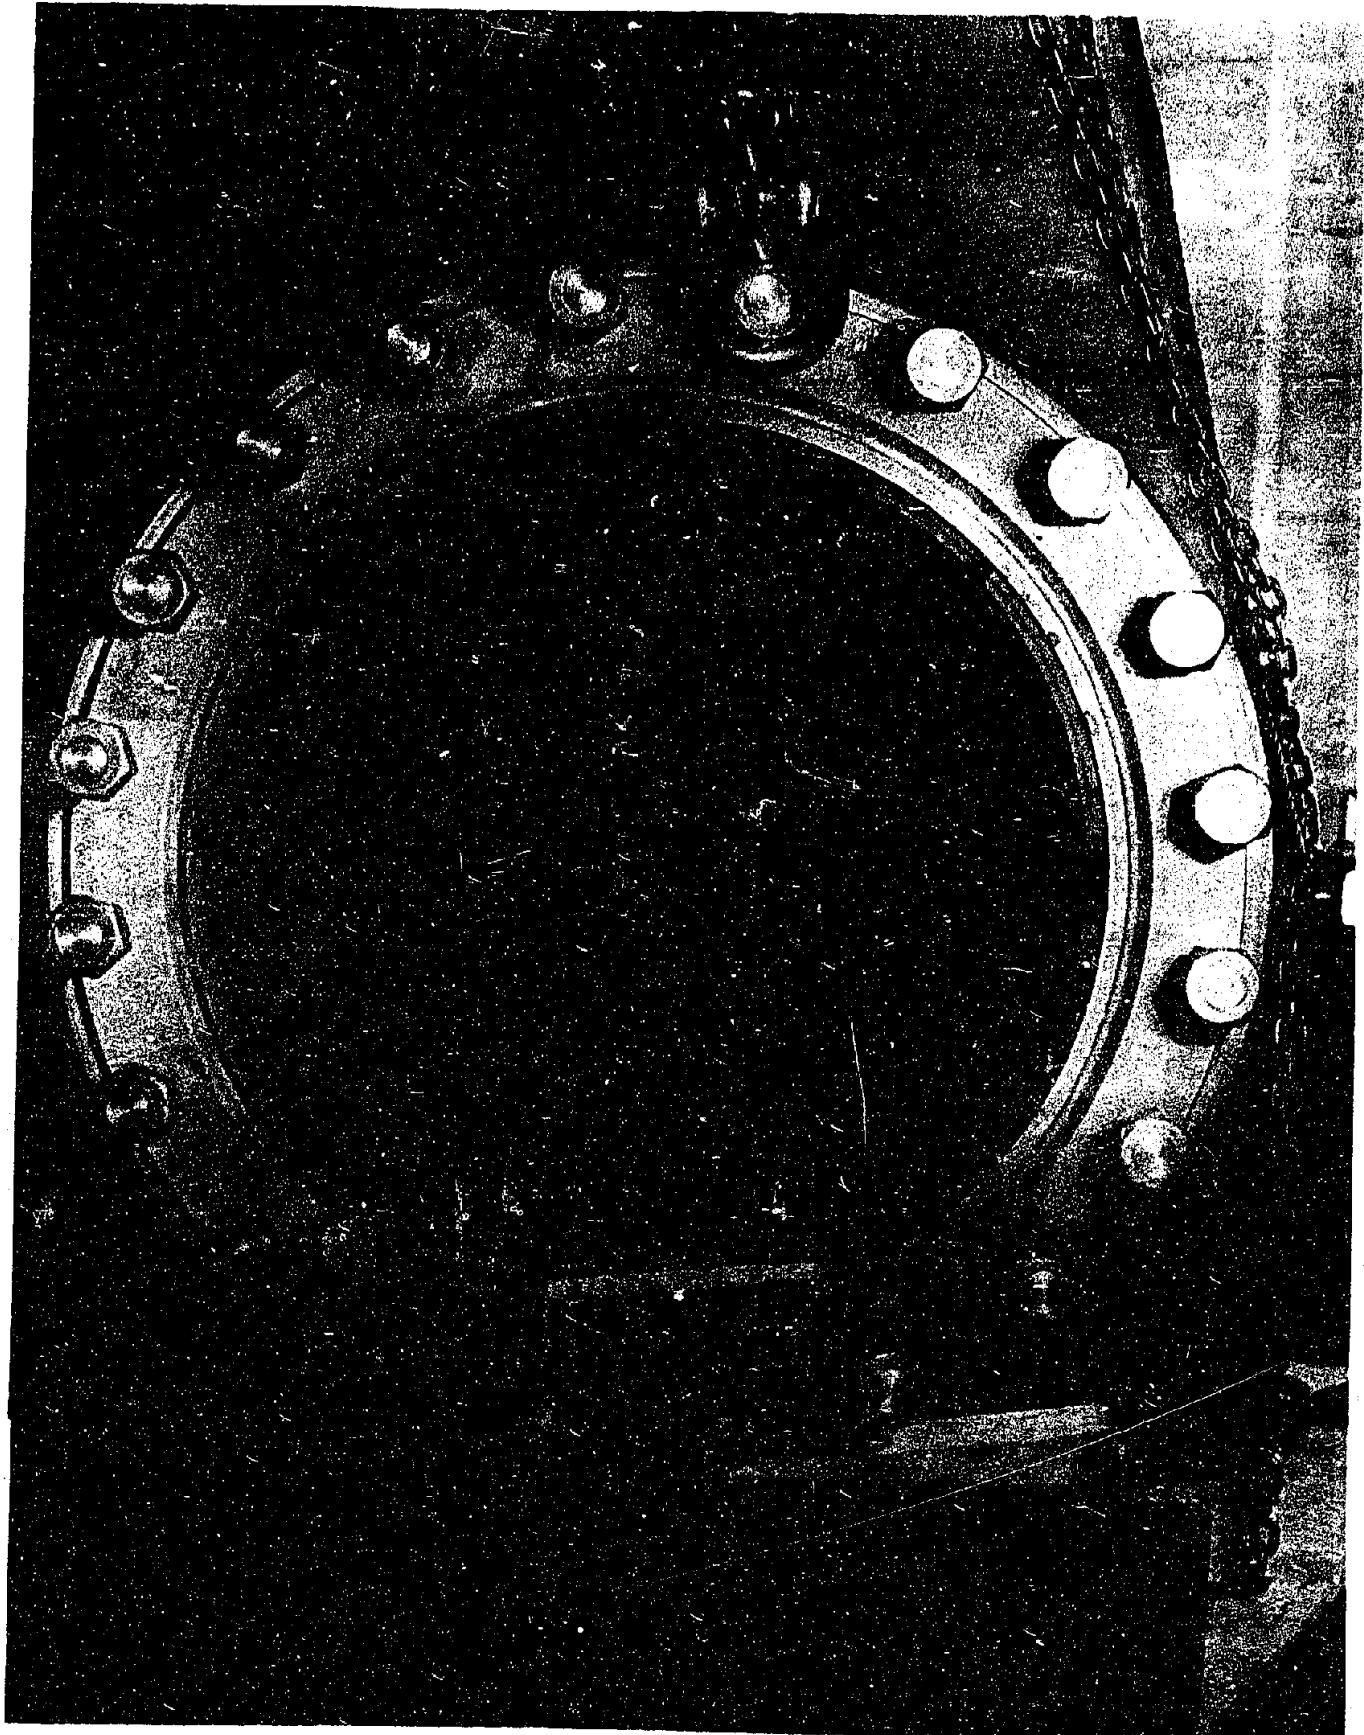
FIGURE 4

UPSTREAM END OF VALVE SHOWING SLAG POCKETS
IN FINISHED SURFACE OF FLANGE

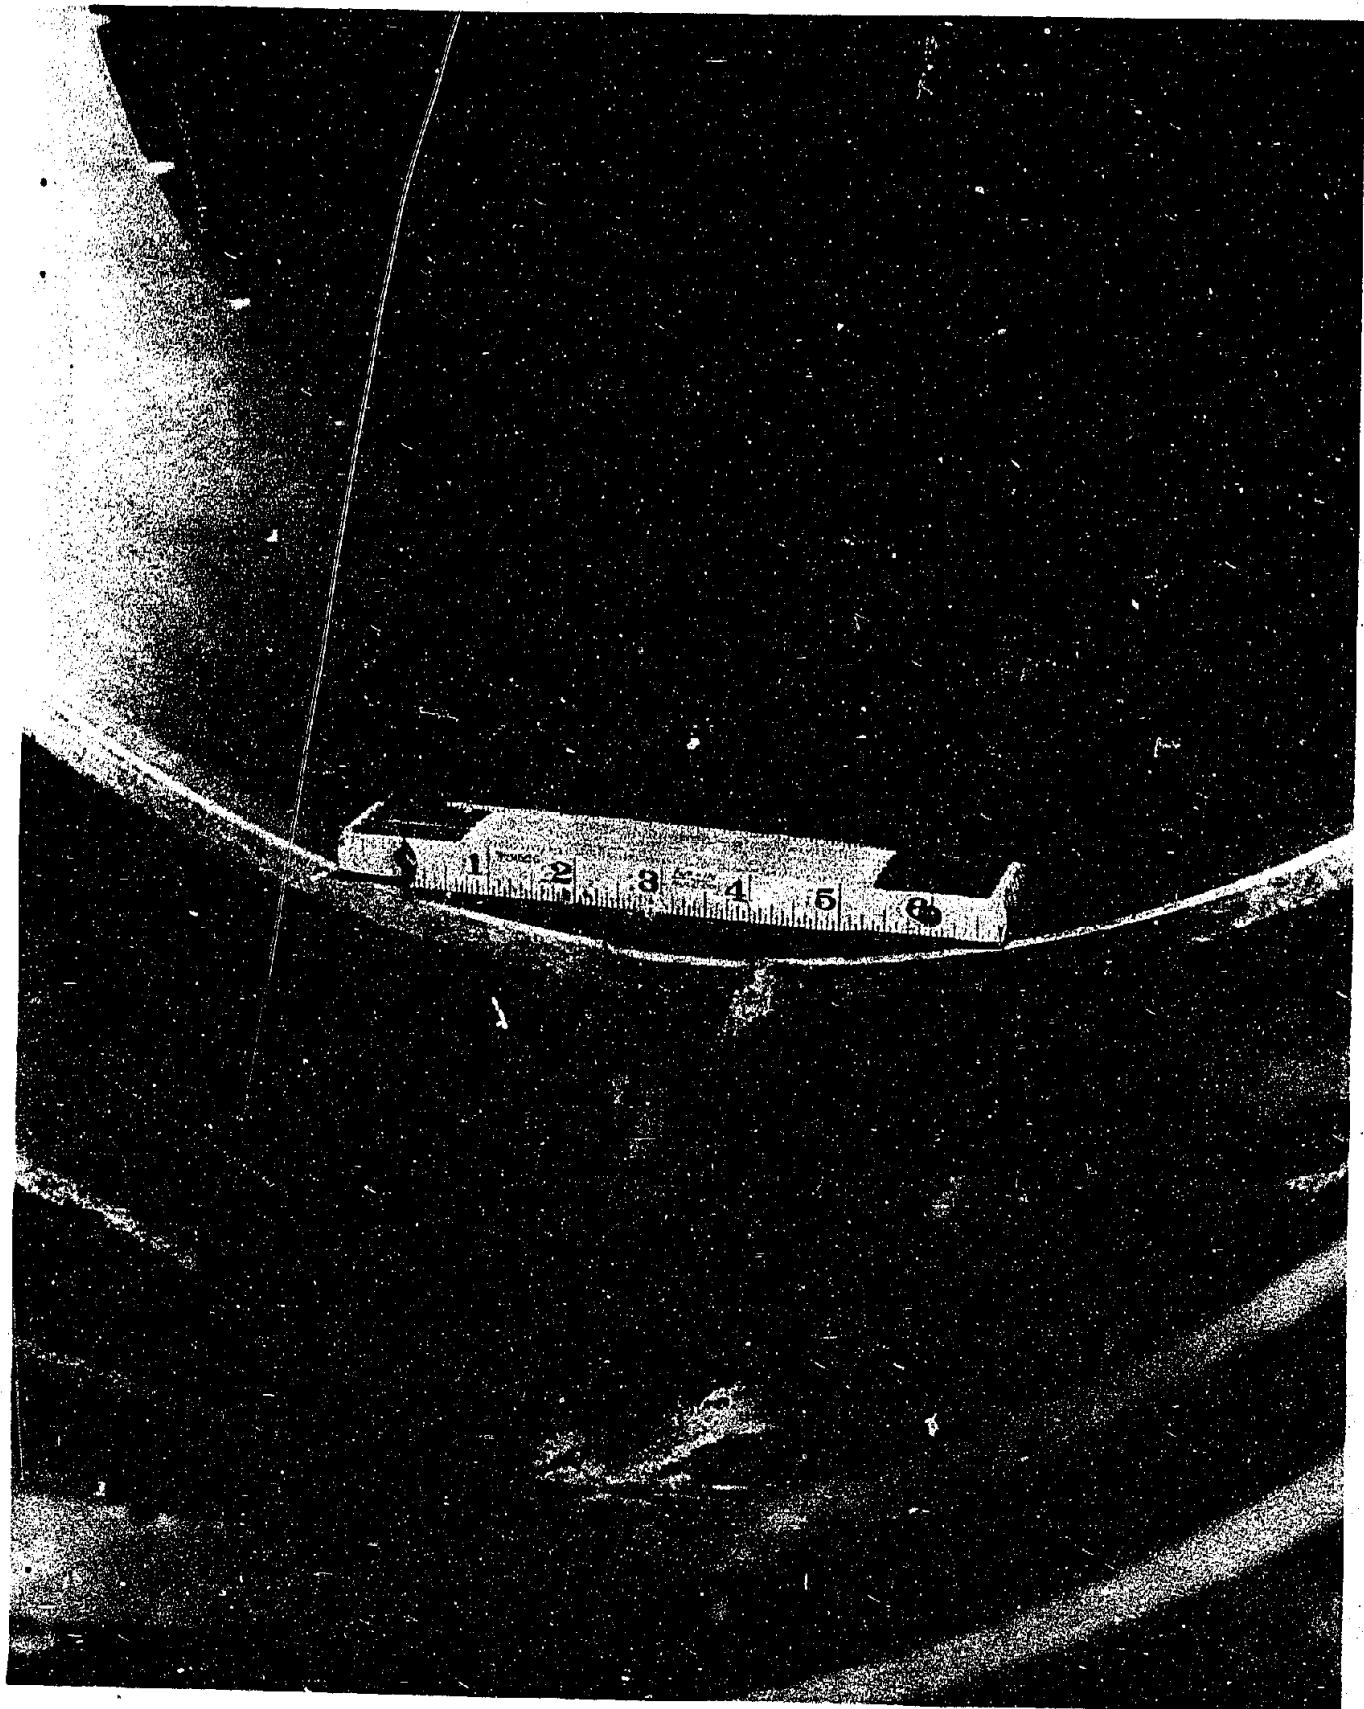
FIGURE 5

UPSTREAM END OF LARGE SPLITTER SHOWING JUNCTION OF
SPLITTER WITH BODY BEFORE HAND FINISHING

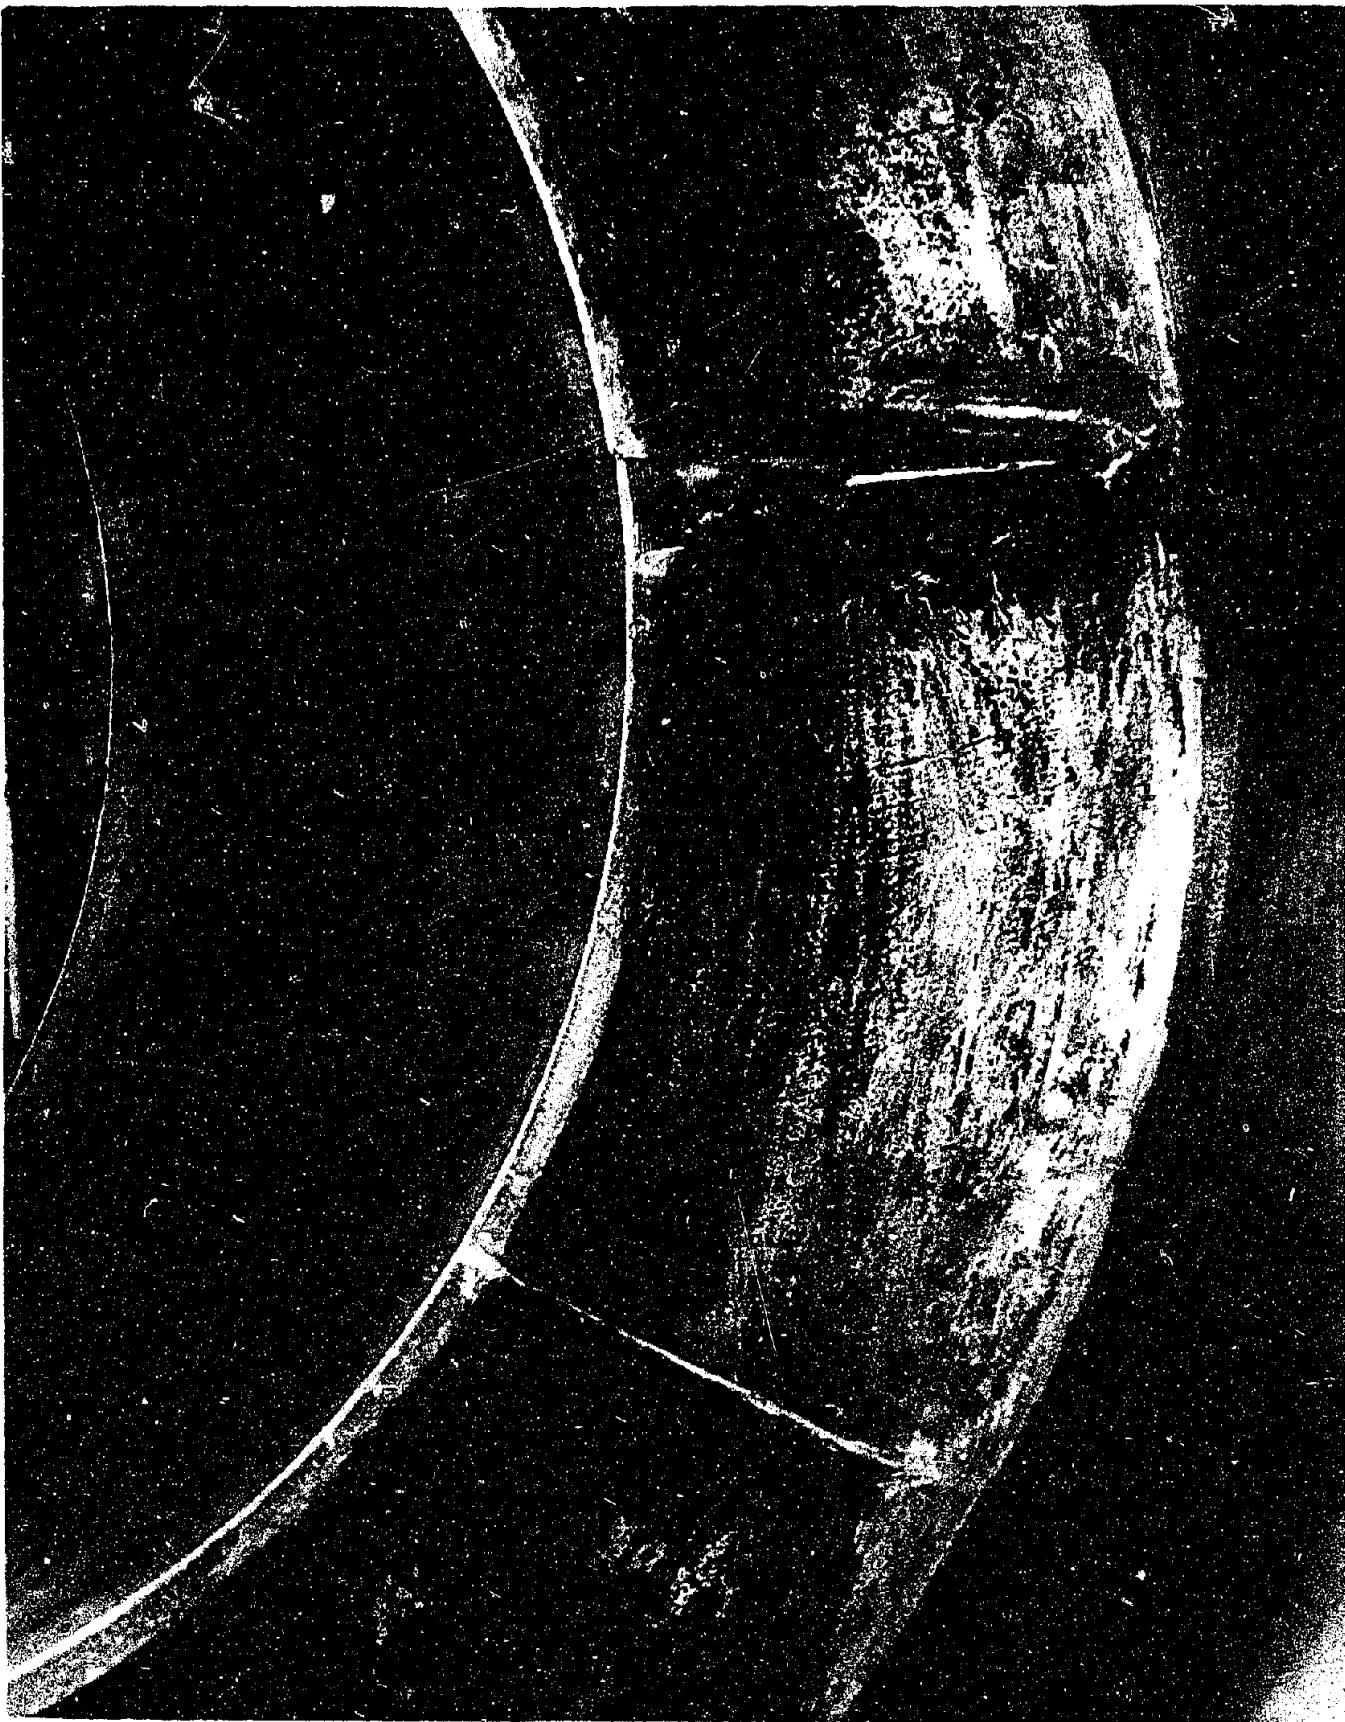
FIGURE 6

JUNCTION OF SPLITTERS WITH VALVE BODY AFTER HAND FINISHING

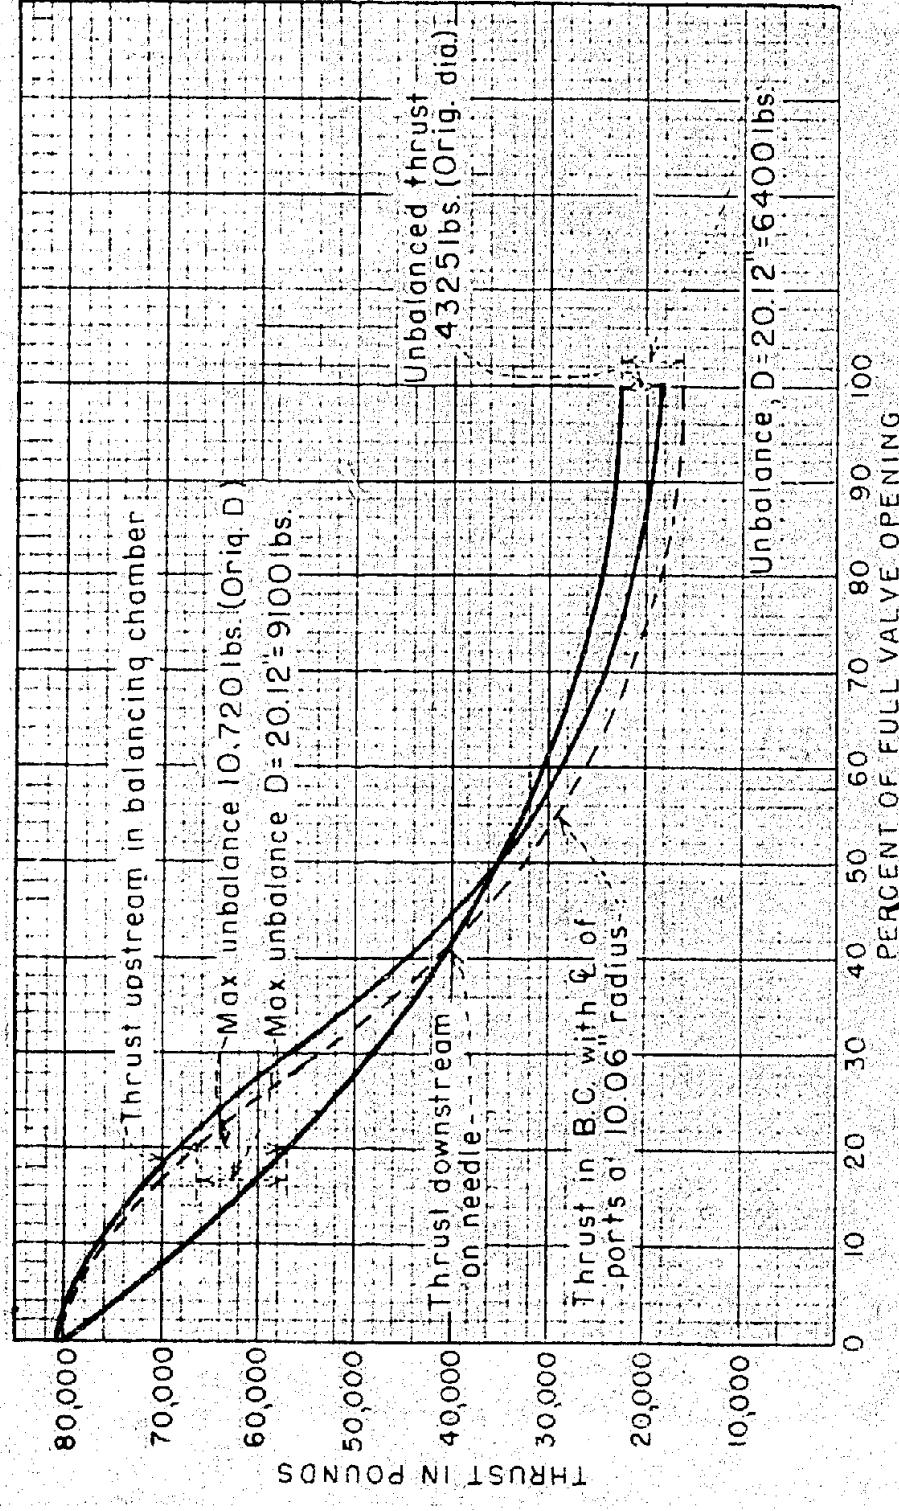
The significance of this was that, while the thrust on the needle was essentially the same as was determined from the six-inch model, the balancing force had increased considerably, with the result that instead of obtaining a maximum unbalanced thrust of 9,000 pounds as anticipated in the design, the force was actually 10,700 pounds (figure 7).

UNBALANCED THRUST
24 INCH HOLLOW JET VALVE TESTS
BOULDER DAM INSTALLATION

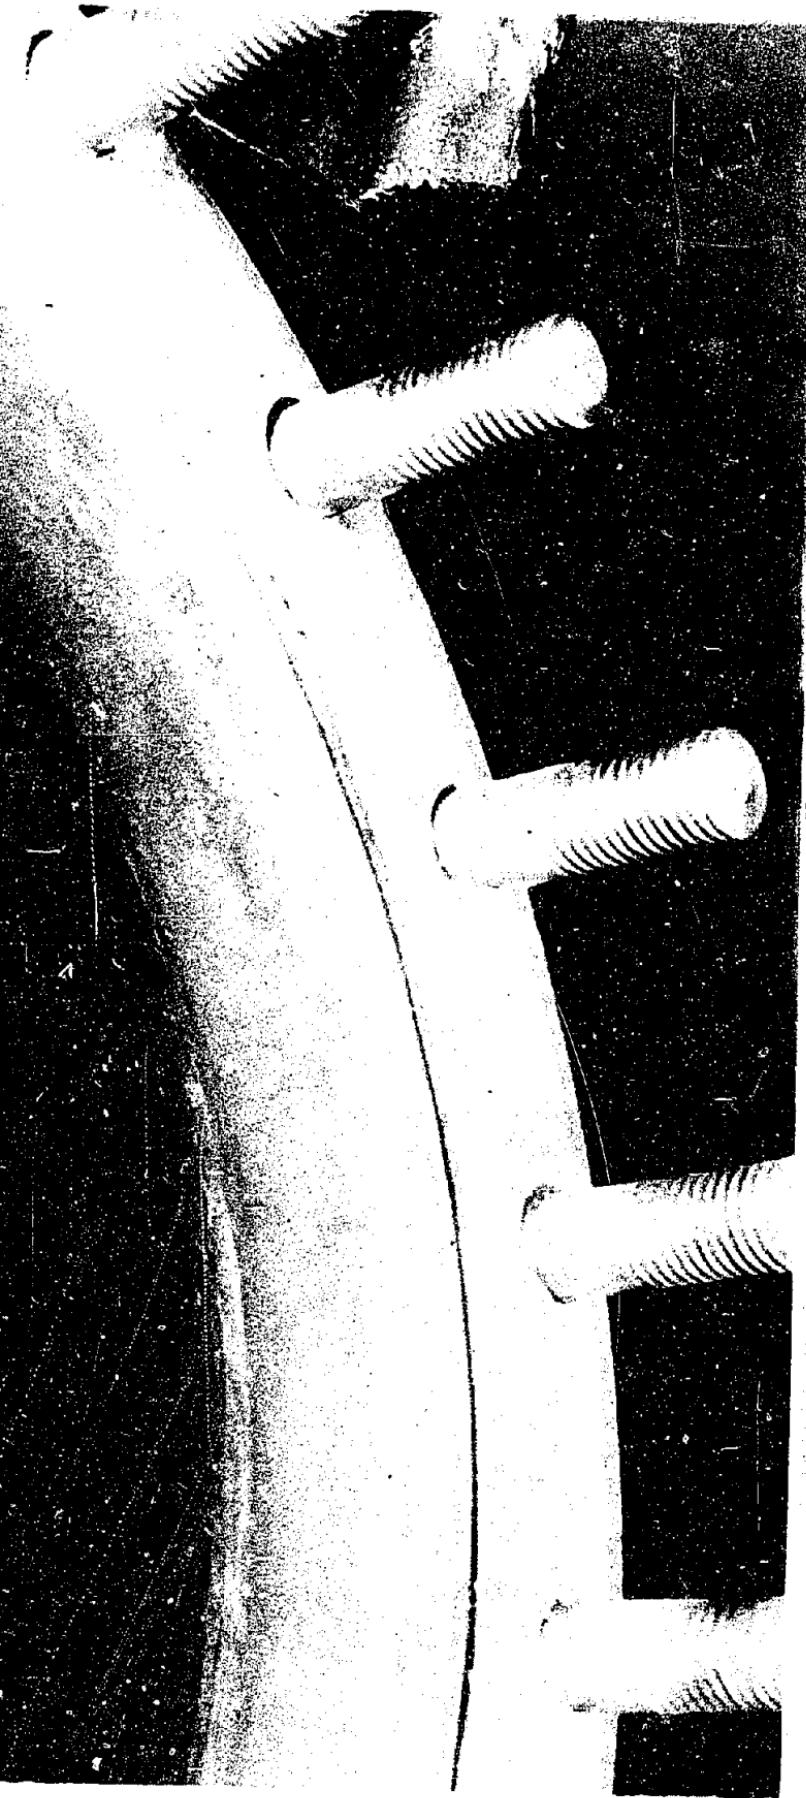
FIGURE 12

As has been mentioned previously, the shortage of water prevented an extended period of operation to determine if cavitation was present in the so-called mild form, so an accelerated test was made whereby the surfaces of the water passages were given a coat of glyptal and the valve operated an additional 16 hours. During this time the valve setting was changed, and the head on the valve varied with the friction losses in the conduit. At the conclusion of the test the valve was dismantled and examined closely for any evidence of erosion of the paint. The examination did not disclose any eroded or worn spots (figures 12 and 13). From this it was concluded that local cavitation due to surface irregularities was not present in the valve under the heads available for the test, for had there been cavitational erosion present, it would have damaged the paint within a few hours of operation.

UNDAMAGED PAINT SURFACE INDICATING THE ABSENCE OF CAVITATION

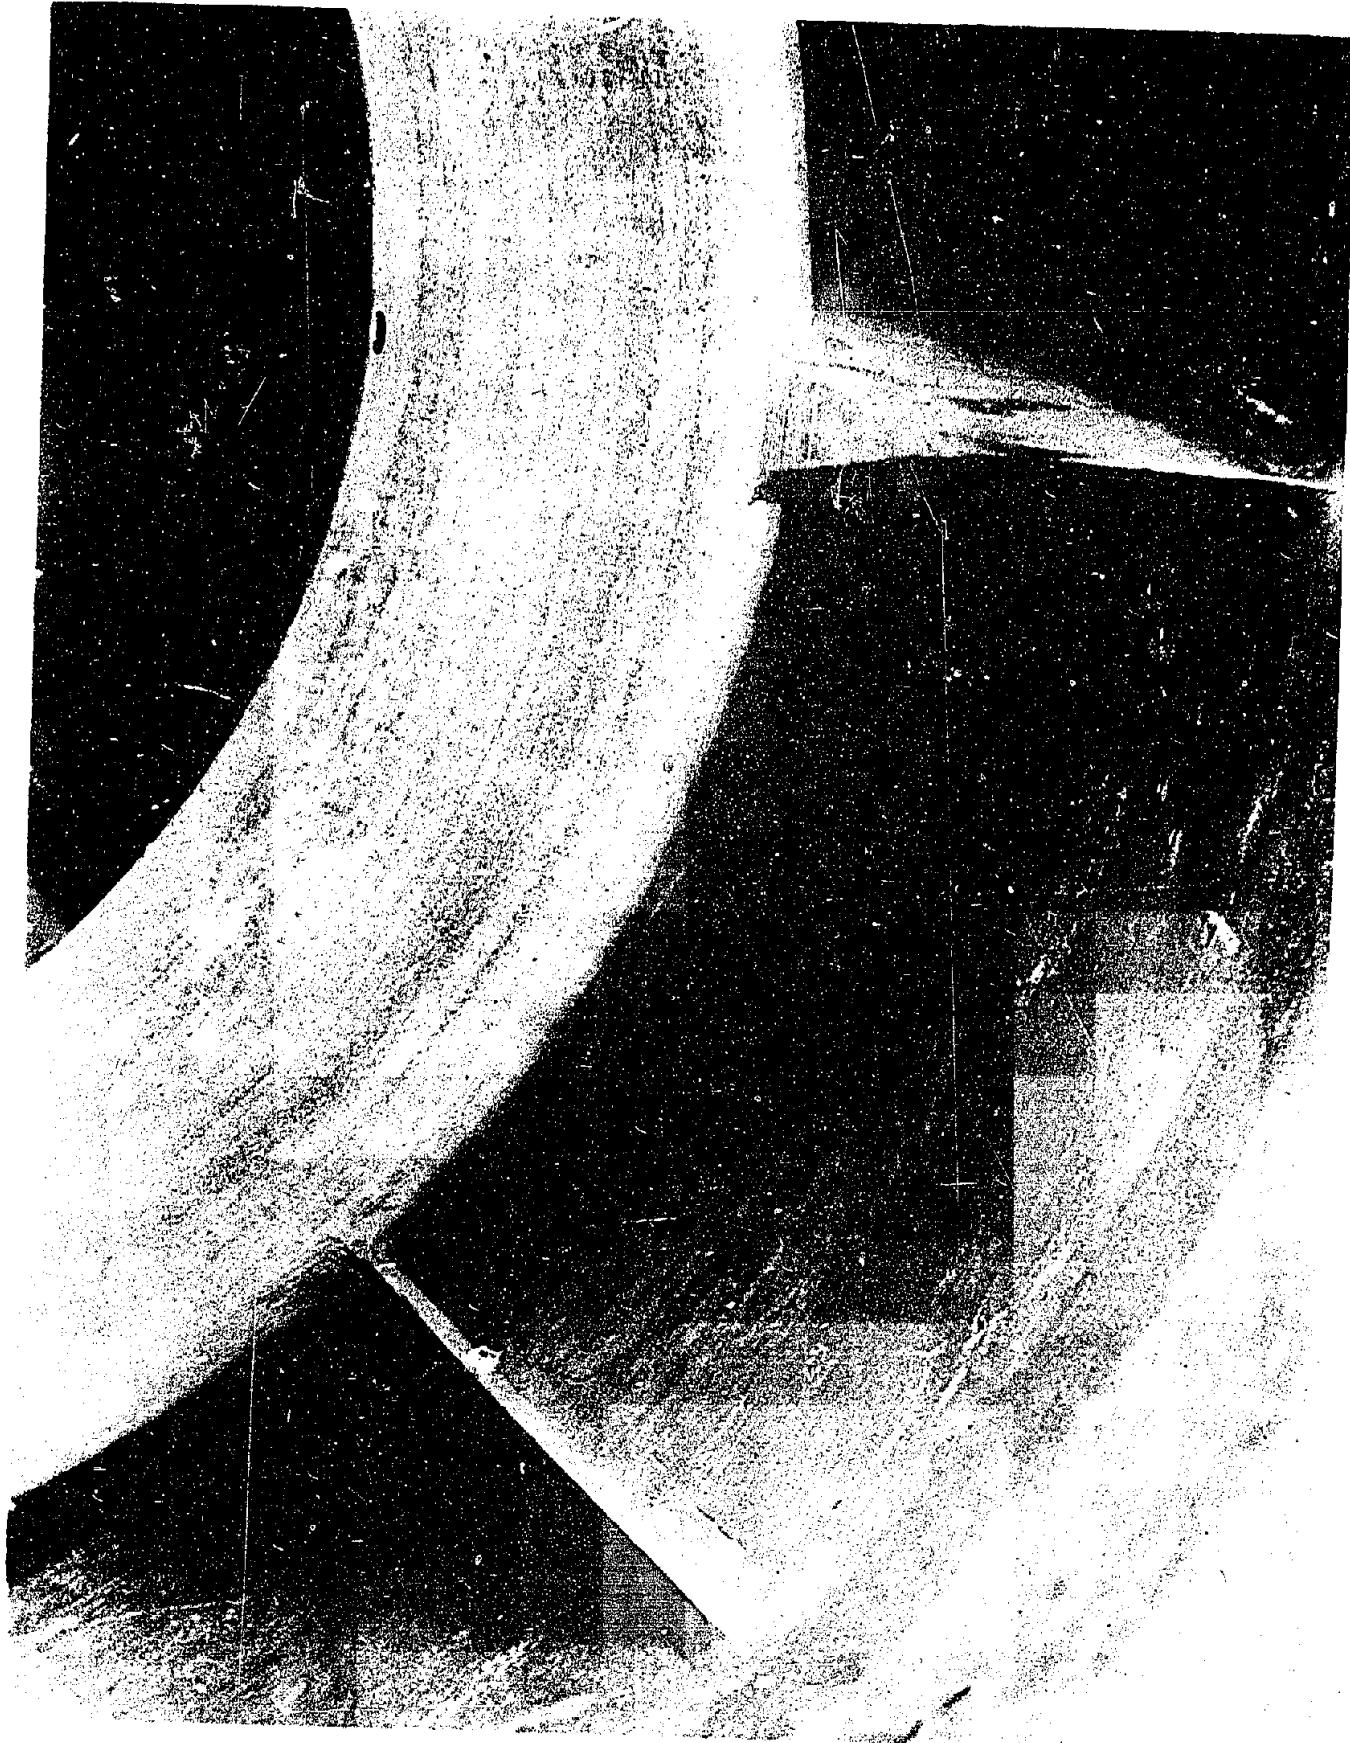
FIGURE 13

UNDAMAGED PAINT SURFACE

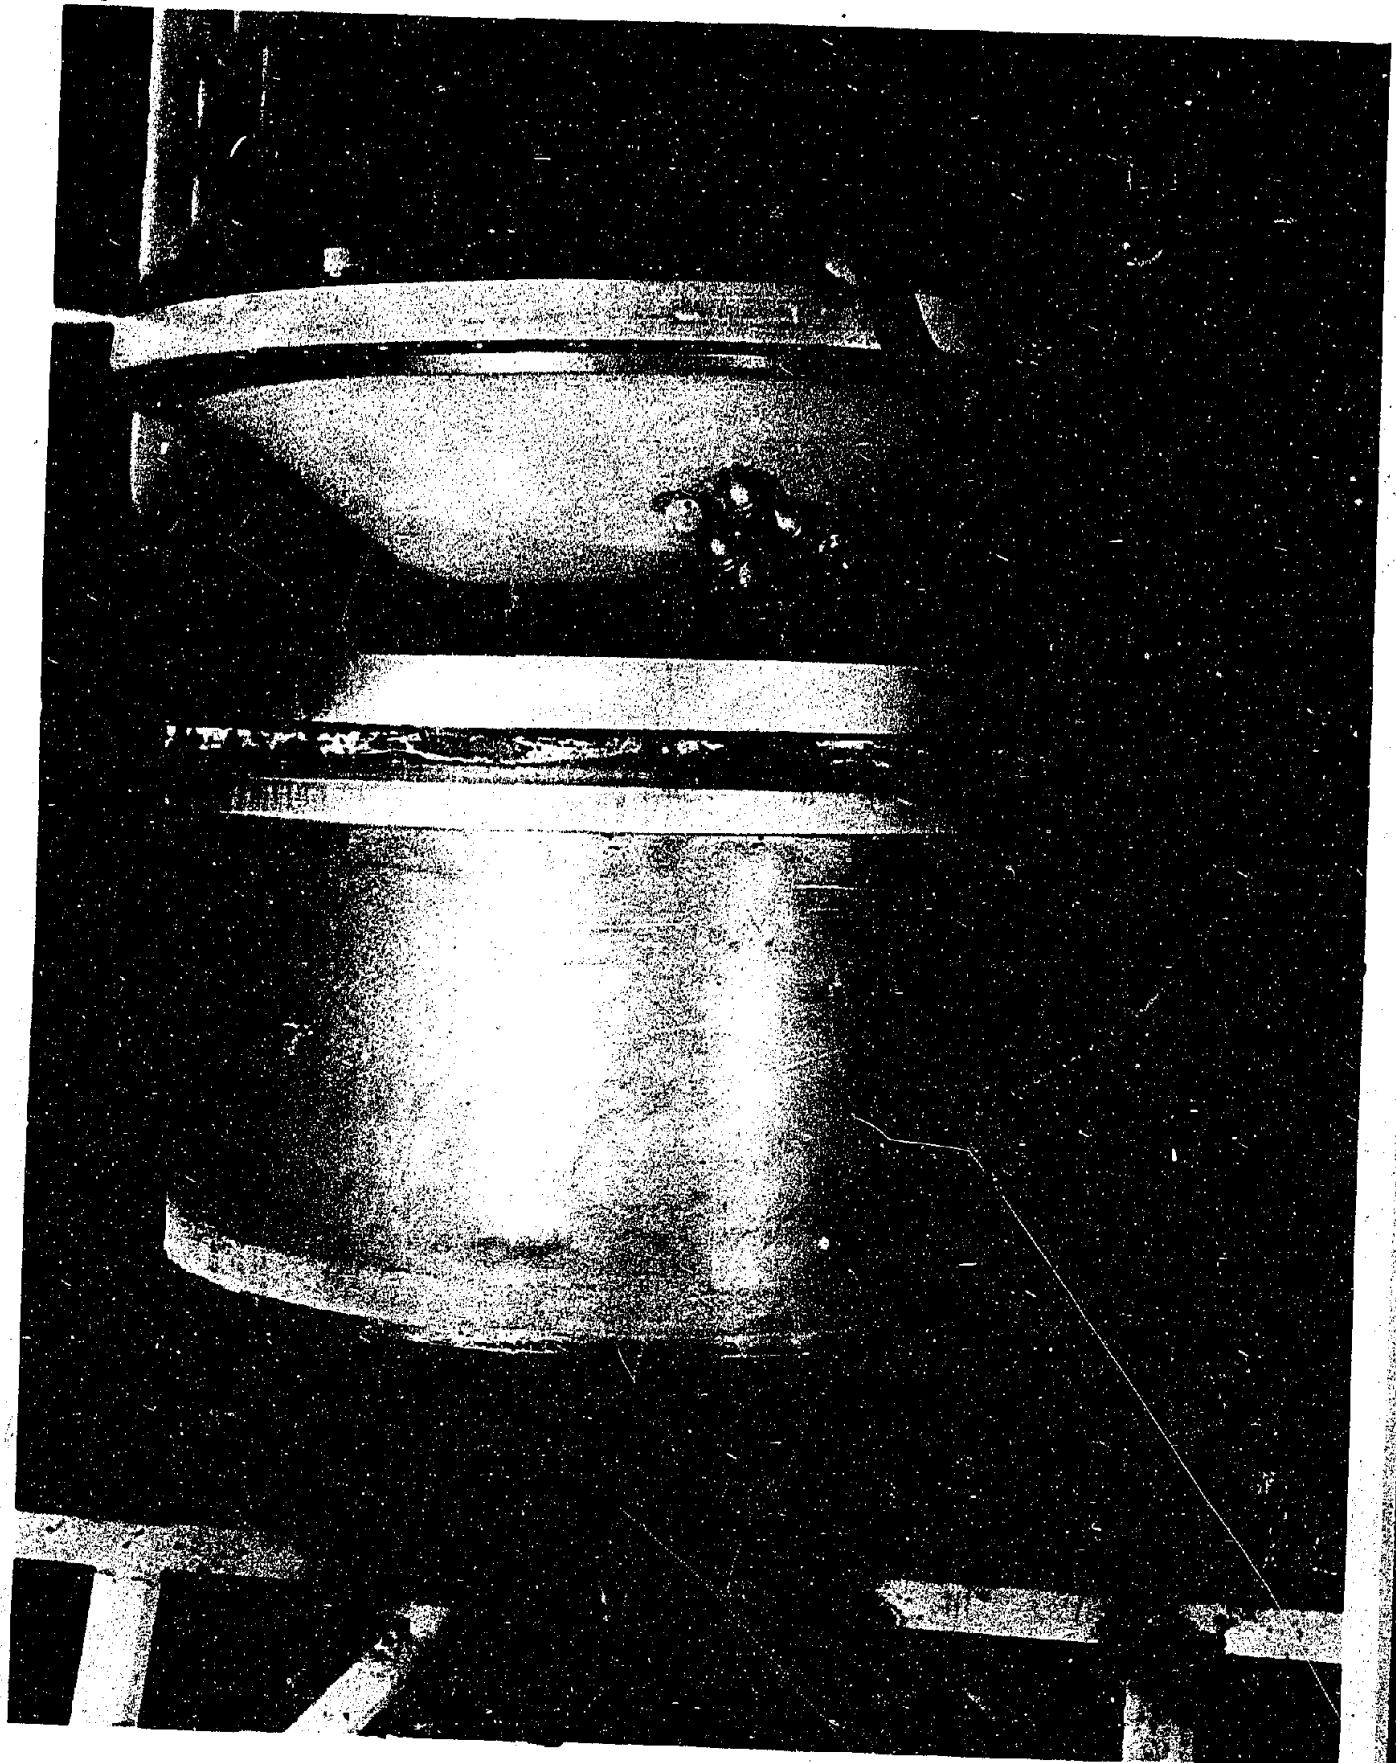
FIGURE 18

Figures 18 and 19 show the condition of the needle before and after testing. A considerable amount of corrosion due to a chemical action has occurred. It is believed that this surface as well as other exposed iron surfaces should be painted and kept painted with a good grade of wear-resisting paint to preserve the valve.

NEEDLE ASSEMBLY

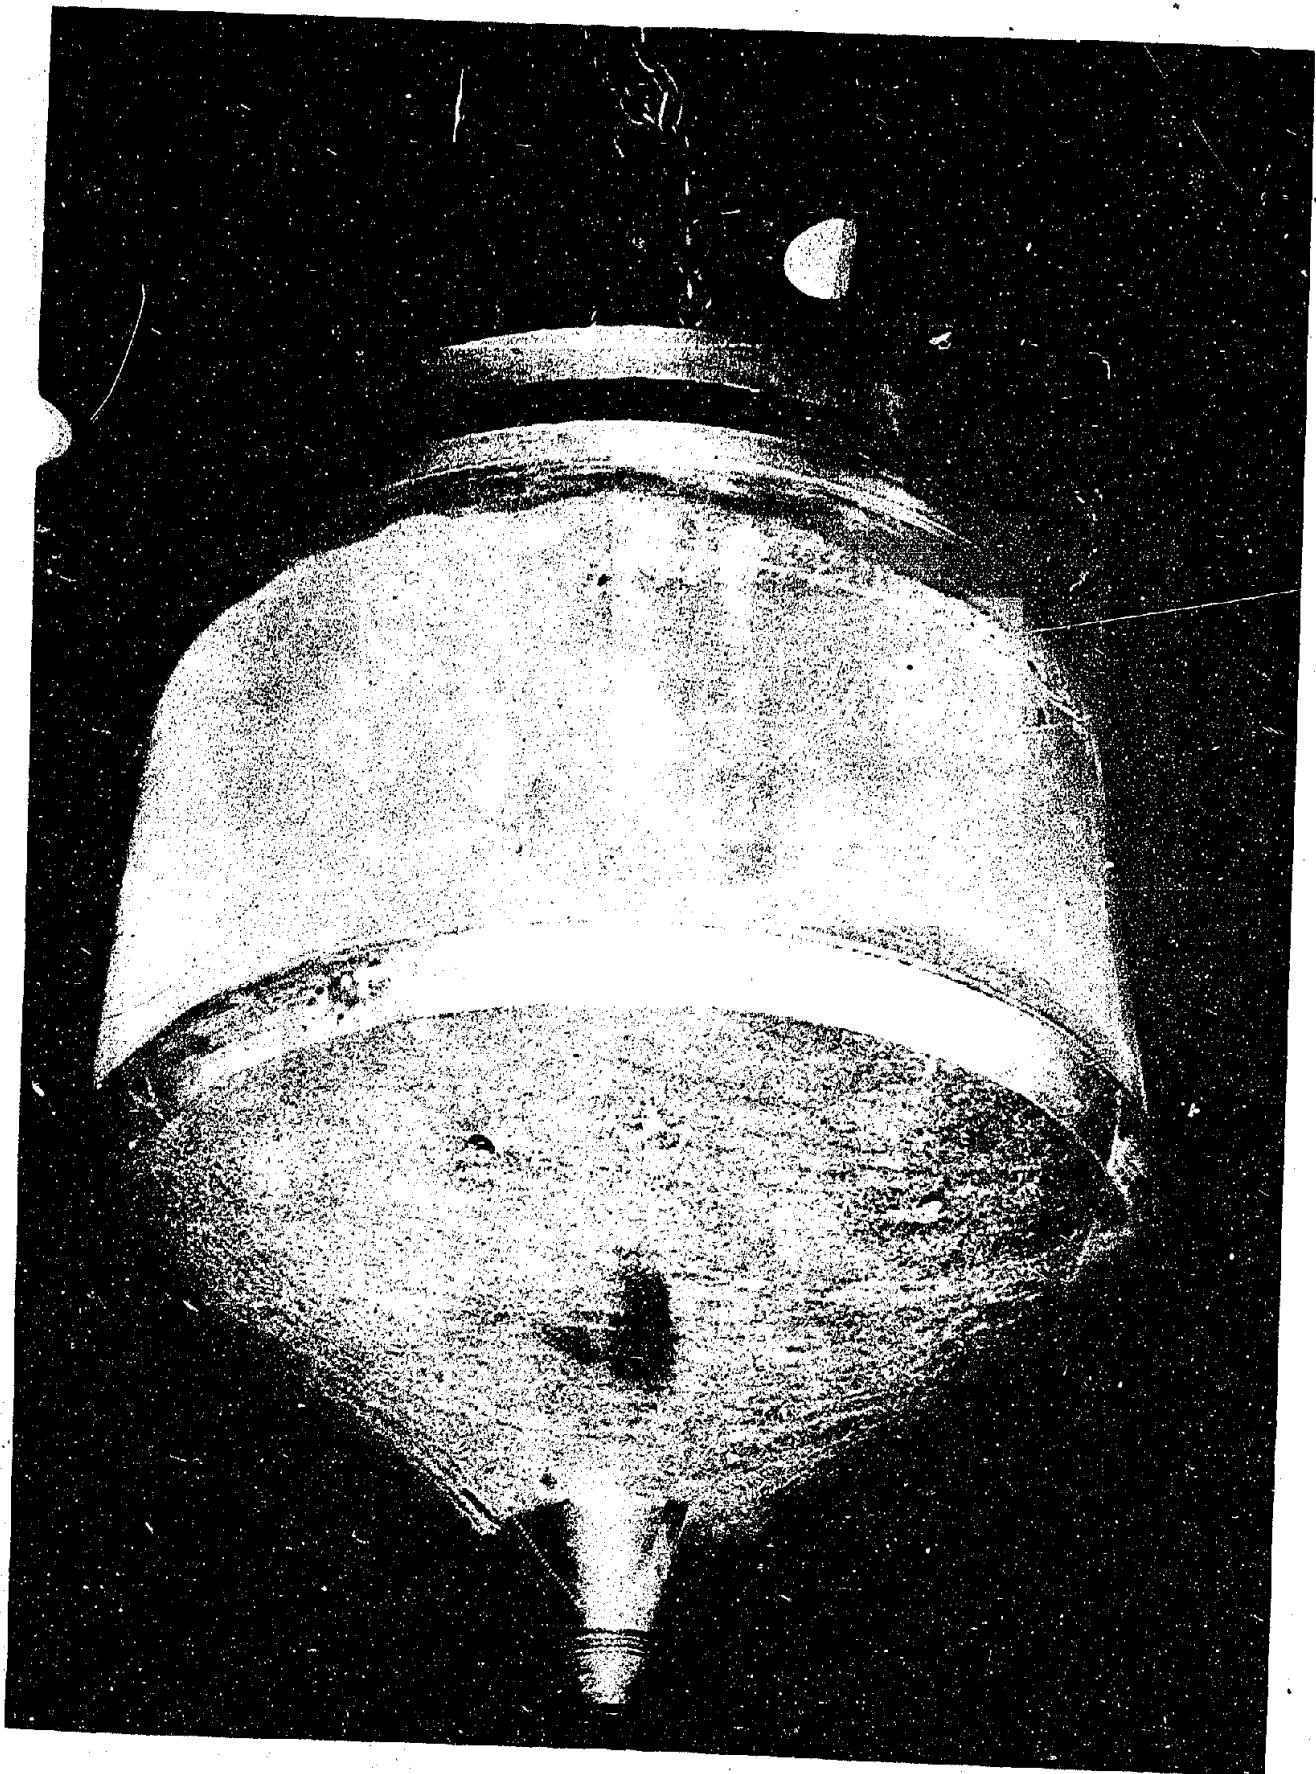
FIGURE 19

CORROSION OF CAST IRON SURFACE OF NEEDLE

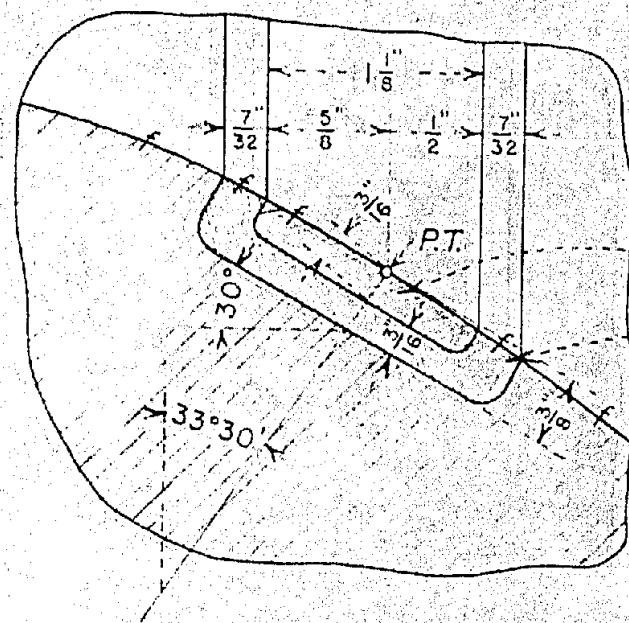
FIGURE 20

Other changes recommended on the 24-inch valve involve (1) replacing the bronze seat ring and (2) replacing and revising the body seat from that shown on figure 1 to that of figure 20. The bronze seat ring was porous and leakage through the metal occurred.

SEAT REVISION
OF
24" HOLLOW-JET VALVE

9. Tests after Mechanical Revisions. In accordance with the recommendations of this report, the valve seat was altered as shown on figure 20, the Metco process liner was replaced with a cast bronze liner, and the diameter of the balancing port circle was increased to 20-1/8 inches. This additional work was completed about September 16, 1945, and the valve was placed on the test line to determine the suitability of the corrective measures.

The combination ferro-weld and stainless steel valve body seat was used in the 24-inch valve, because the initial groove for the bronze seat was 3/8 inch deep and would have required an excessive amount of stainless steel to fill the groove. It was also felt that the ferro-weld would reduce the amount of flame hardening in the cast iron. The body seats on future valves are to be constructed of K monel 3/16-inch thick and welded in place. Recent tests have shown no appreciable hardening of the cast iron at the weld, and it is believed that this type of seat will be machinable and provide a satisfactory seating area.
