HYDRAULIC LABORATORY REPORT NO. 190

**HYDRAULIC MODEL STUDIES ON
REPAIRS TO THE CALIFORNIA WASTEWAY
YUMA PROJECT
ARIZONA-CALIFORNIA**

Subject: Hydraulic model studies on repairs to the California
Wasteway - Yuma Project, Arizona-California.

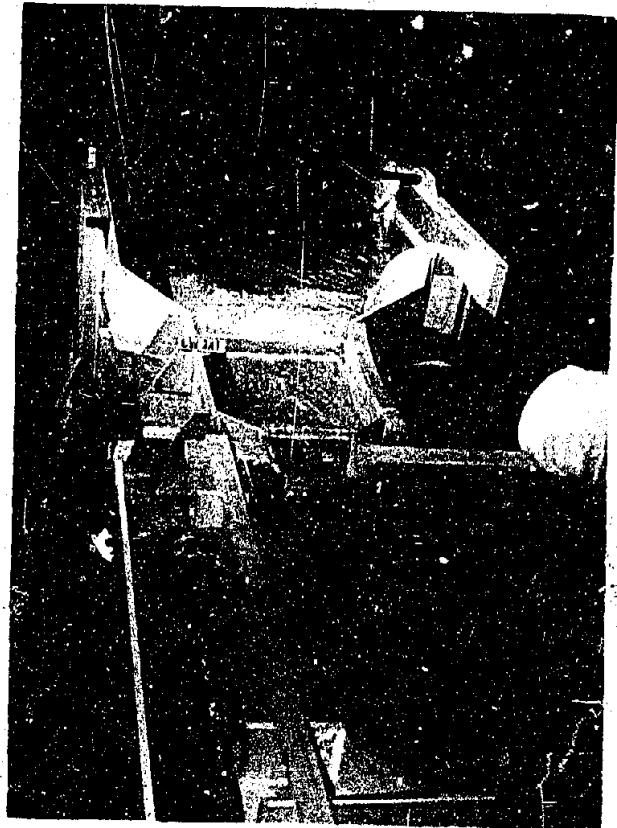
Test Procedure. The operation of the wasteway showed various objectionable features (figure 3). Flow through the wasteway gate structure was undesirable as the two downstream (with relation to the canal) gates were running full while the upstream gate flowed half full. Several types of vanes were tried at the entrance to correct this condition. Vanes proved

B. Flow of 1000 second-feet
through Wasteway.

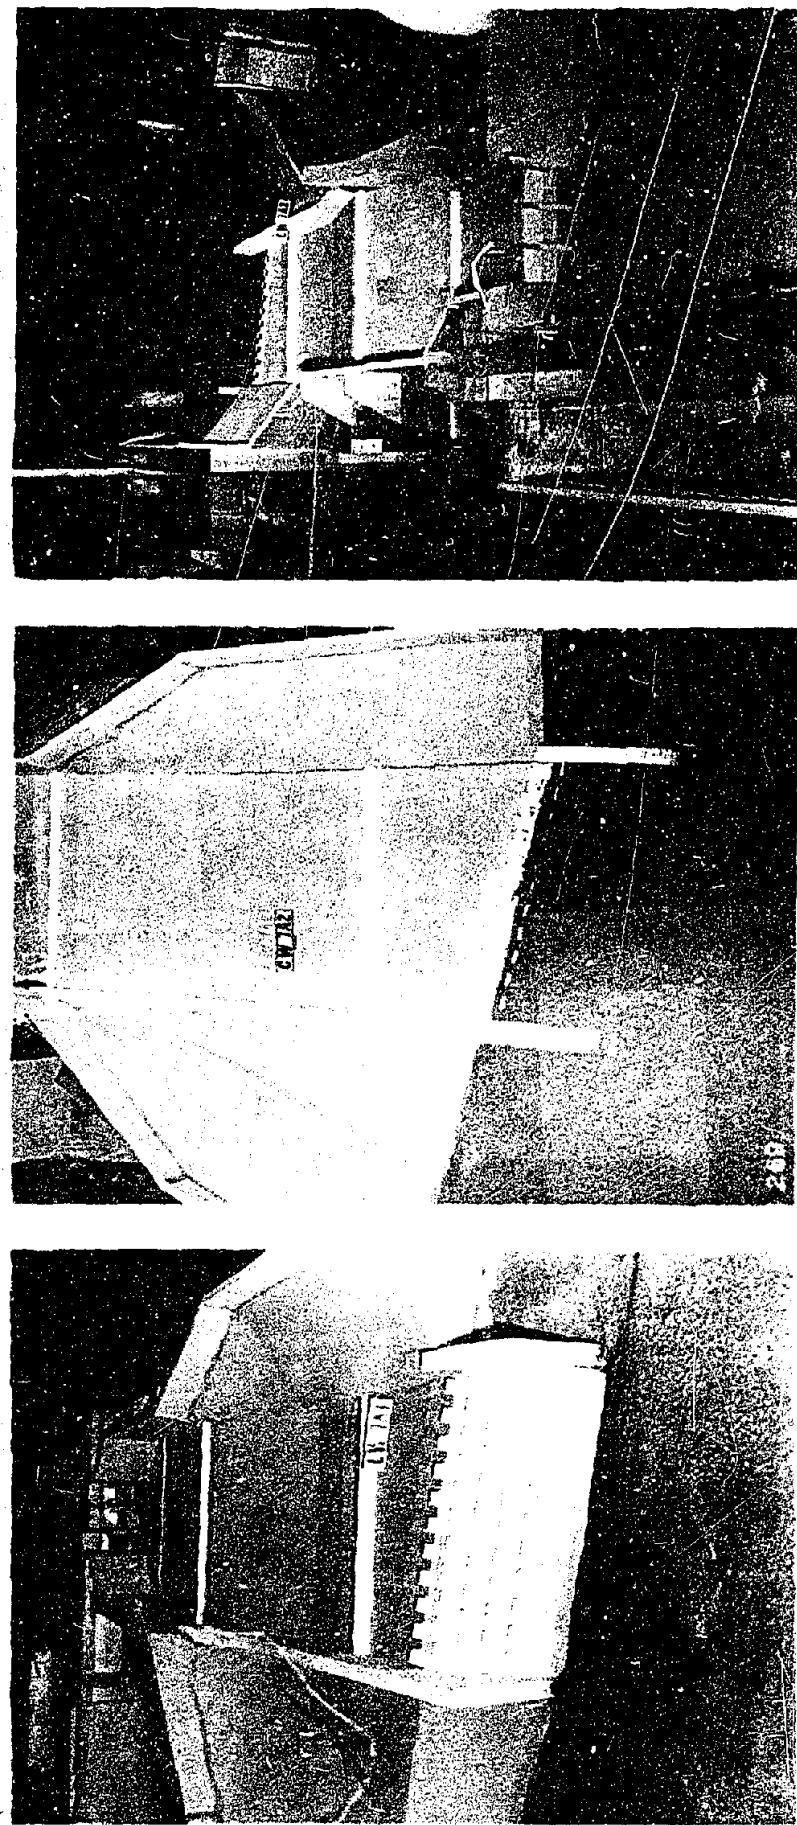
FIGURE 5

A. Looking upstream apron uncovered.

B. Looking upstream apron covered.

C. Looking downstream.

5. Recommended design. The hydraulic laboratory recommends that a sill two feet high be placed above the 3:1 slope, that a vertical training wall be constructed in the stilling pool to provide more symmetrical flow, that a sill three feet high be placed in the stilling pool, and that the 2:1 sloping apron with teeth be placed downstream from the end of the stilling pool apron (figure 5A). Figure 5B shows the river bed in place for the recommended design.

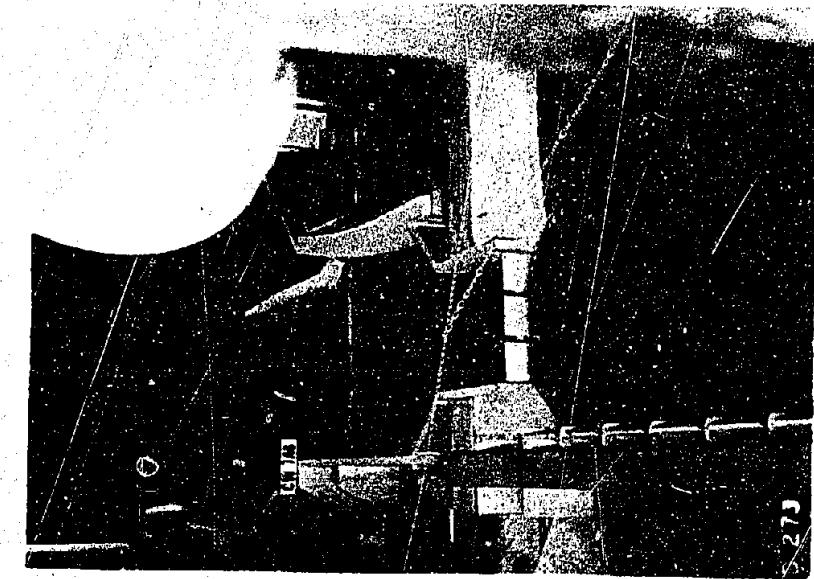
- A. Flow of 1000 second-feet.
High tail water.
Low tail water.

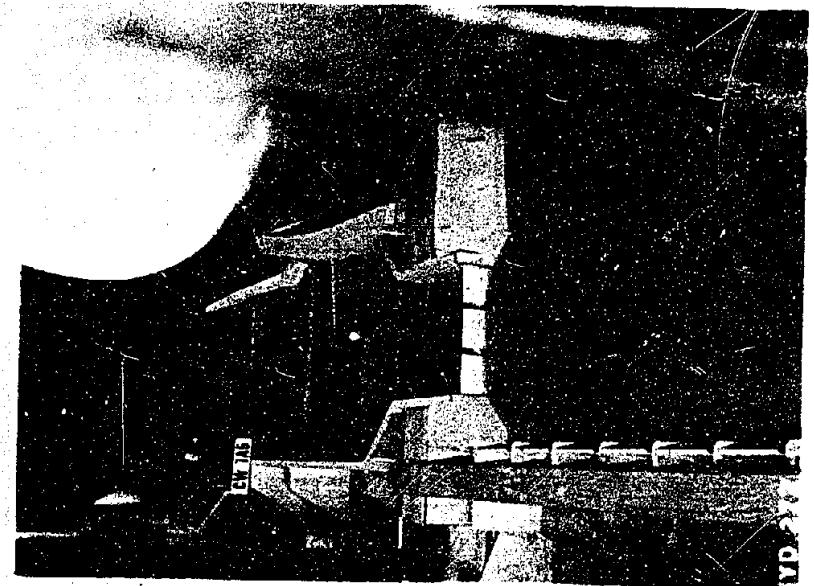
- B. Flow of 1000 second-feet.
Low tail water.

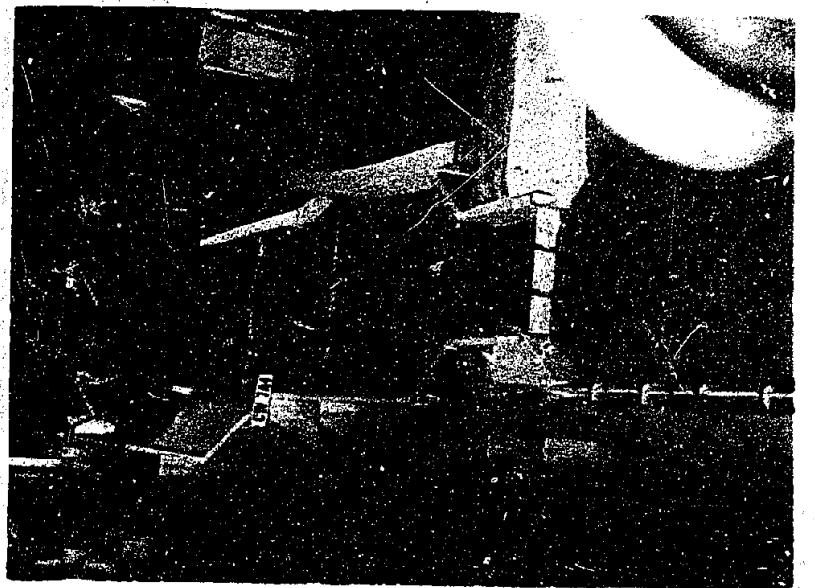
- C. Flow of 1000 second-feet.
No tail water.

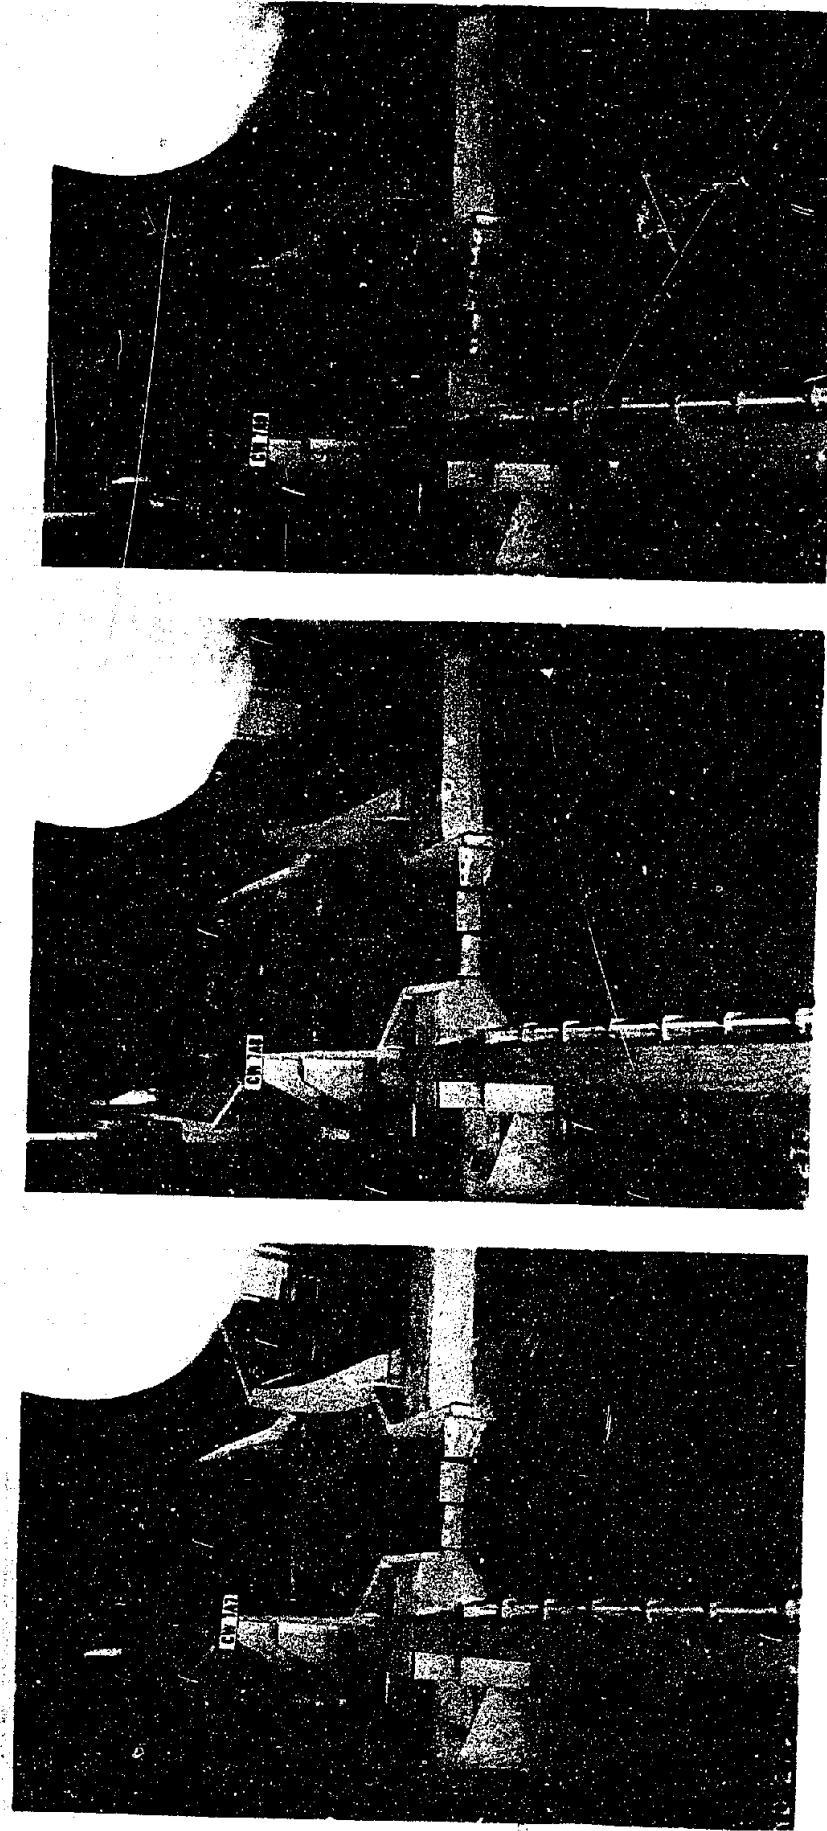
FIGURE 7

The recommended design of the wasteway was tested with different quantities of water from 500 second-feet to 2000 second-feet. Figures 6 and 7 show flows of 1000 and 2000 second-feet for various tailwater elevations. At all times the operation was satisfactory. Figure 8A and B show the scour pattern after a flow of 2000 second-feet for a period of 1½ hours. This flow uncovered the tops of the second row of teeth on the 2:1 sloping apron.

A. Flow of 2000 second-feet.
High tail water.

B. Flow of 2000 second-feet.
Low tail water.

C. Flow of 2000 second-feet.
No tail water.

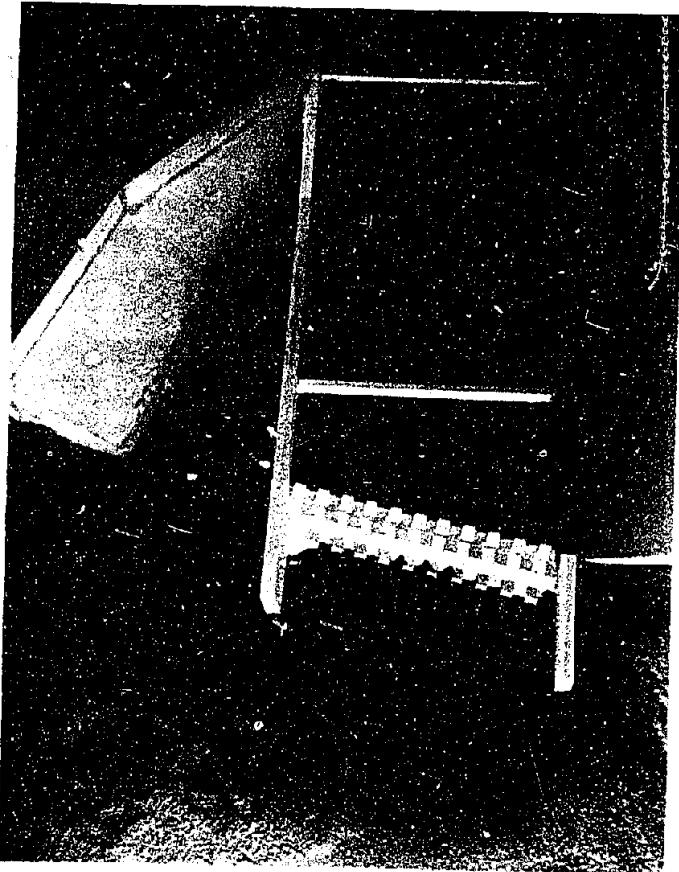
A. Looking upstream. Erosion after 1½ hours 2000 second-feet flowing.

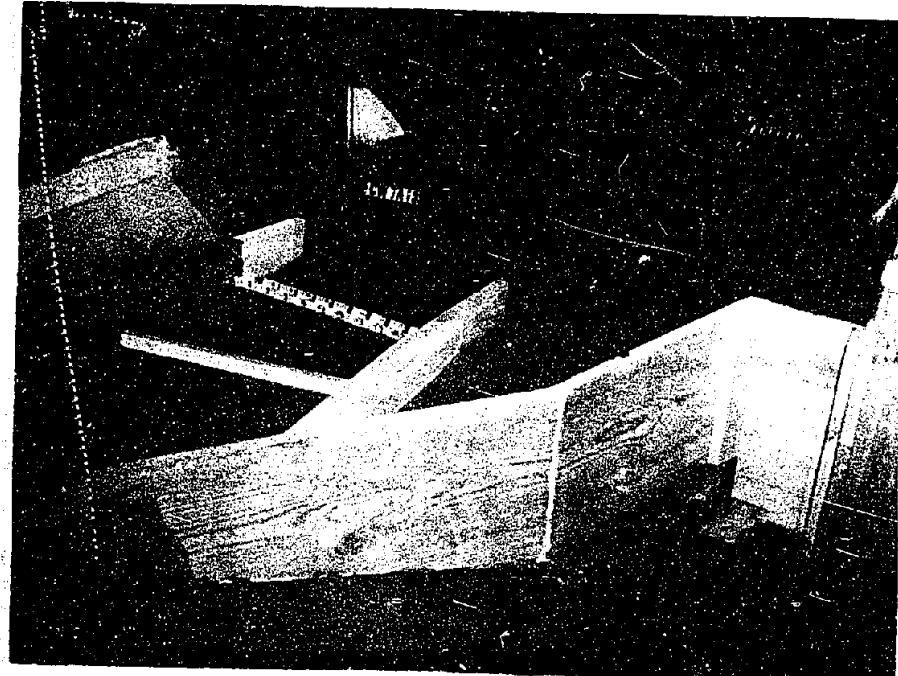
B. Looking downstream. Erosion after 1½ hours 2000 second-feet flowing.
