IMPORTANCE OF SMOOTH SURFACES ON FLOW  
BOUNDARIES DOWNSTREAM FROM OUTLET  
WORKS CONTROL GATES

Hydraulic Laboratory Report No. Hyd-448

July 15, 1958

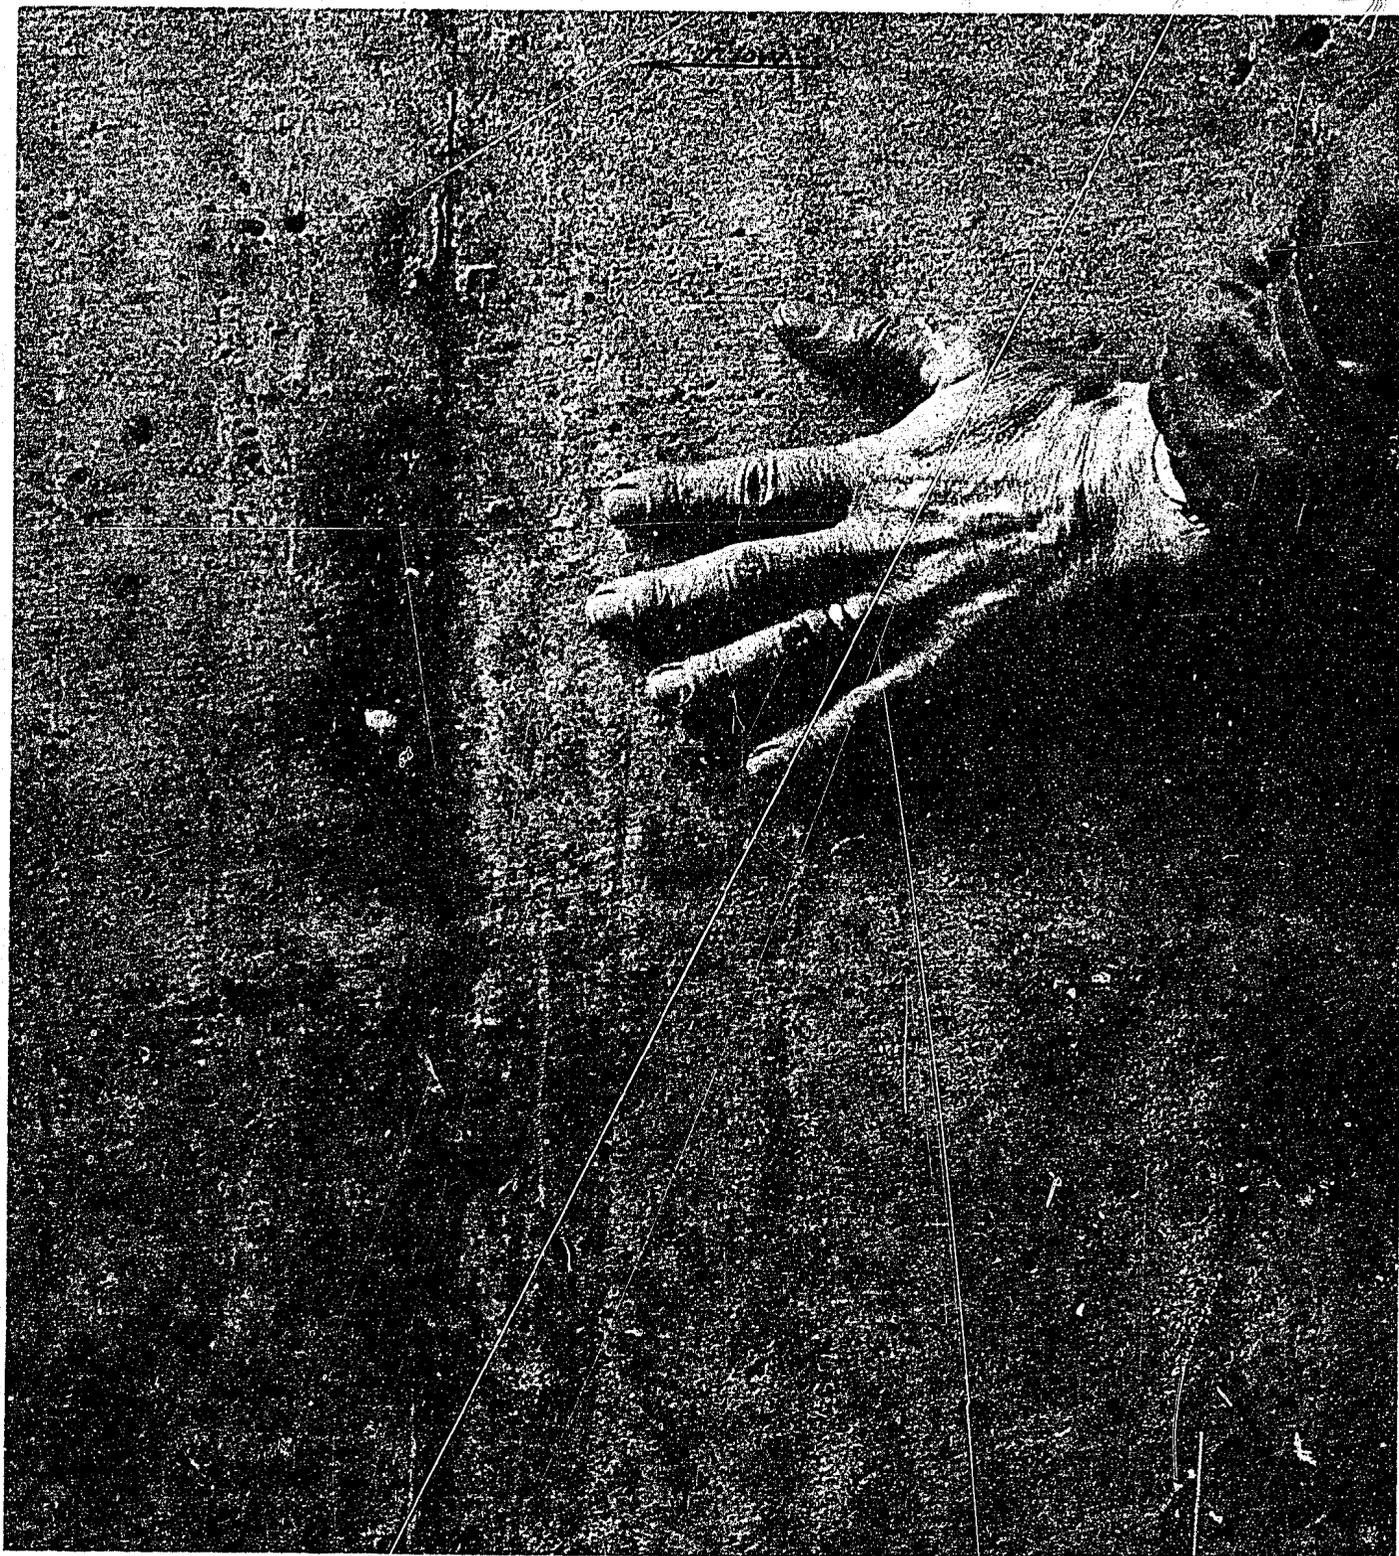
Figure 3

At Palisades Dam, where velocities just downstream from the gates were in the range of 100 to 115 feet per second, cavitation pitting occurred downstream of an abrupt offset of 1/8 inch (Figure 3). Similar offsets in the left passage below the Wanship outlet gates, where the velocities were about 93 feet per second, caused severe damage (Figure 4). Apparently, these offsets produced local cavitation that in turn increased the roughness of the surface so that damage progressed to that shown in the photograph. There was no cavitation damage below the right gate where no offsets into the flow were reported.

Palisades Project--Outlet No. 7  
Cavitation-erosion at 1/8 inch,  
abrupt, into-the-flow-offset  
H-1340-38 February 1958

In view of the laboratory tests and the field information from Palisades and Wanship Dams, it is considered imperative that specifications for outlet works include instructions that permit no abrupt into-the-flow offsets not parallel to the direction of flow for finite distances downstream of control gates where velocities exceed about 40 feet per second.

It is suggested that some provision be made to eliminate such offsets when they do occur. This might be accomplished by requiring the offsets to be ground on bevels of 20:1, 50:1, or 100:1, depending on whether the velocities exceed about 40, 90, or 120 feet per second. These treatments would be similar to those now specified for tunnel spillways. Surfaces downstream from the 15, 30, and 50-foot distances could have the same finishes and tolerances now specified for tunnel spillways.

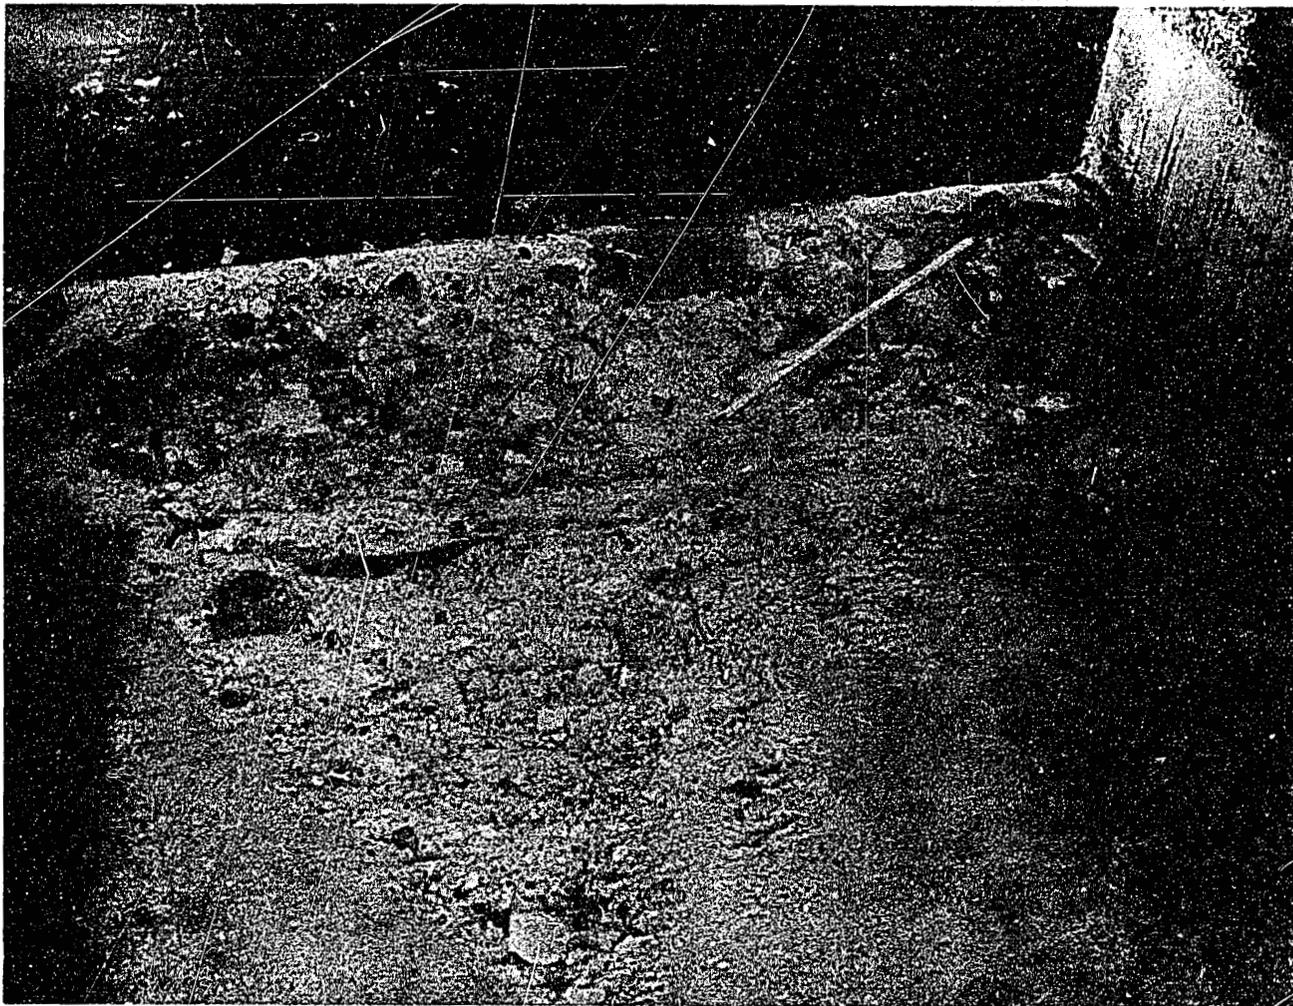
Weber Basin Project, Utah--Photograph No. P-526-400-4477  
Wanship Dam. This view shows cavitation of the concrete  
floor just downstream from the left control gate of the outlet  
works. The dark area in the background is the downstream  
frame of the 3' - 6" x 3' - 6" gate. The maximum depth of  
cavitation was about 0.3 feet.

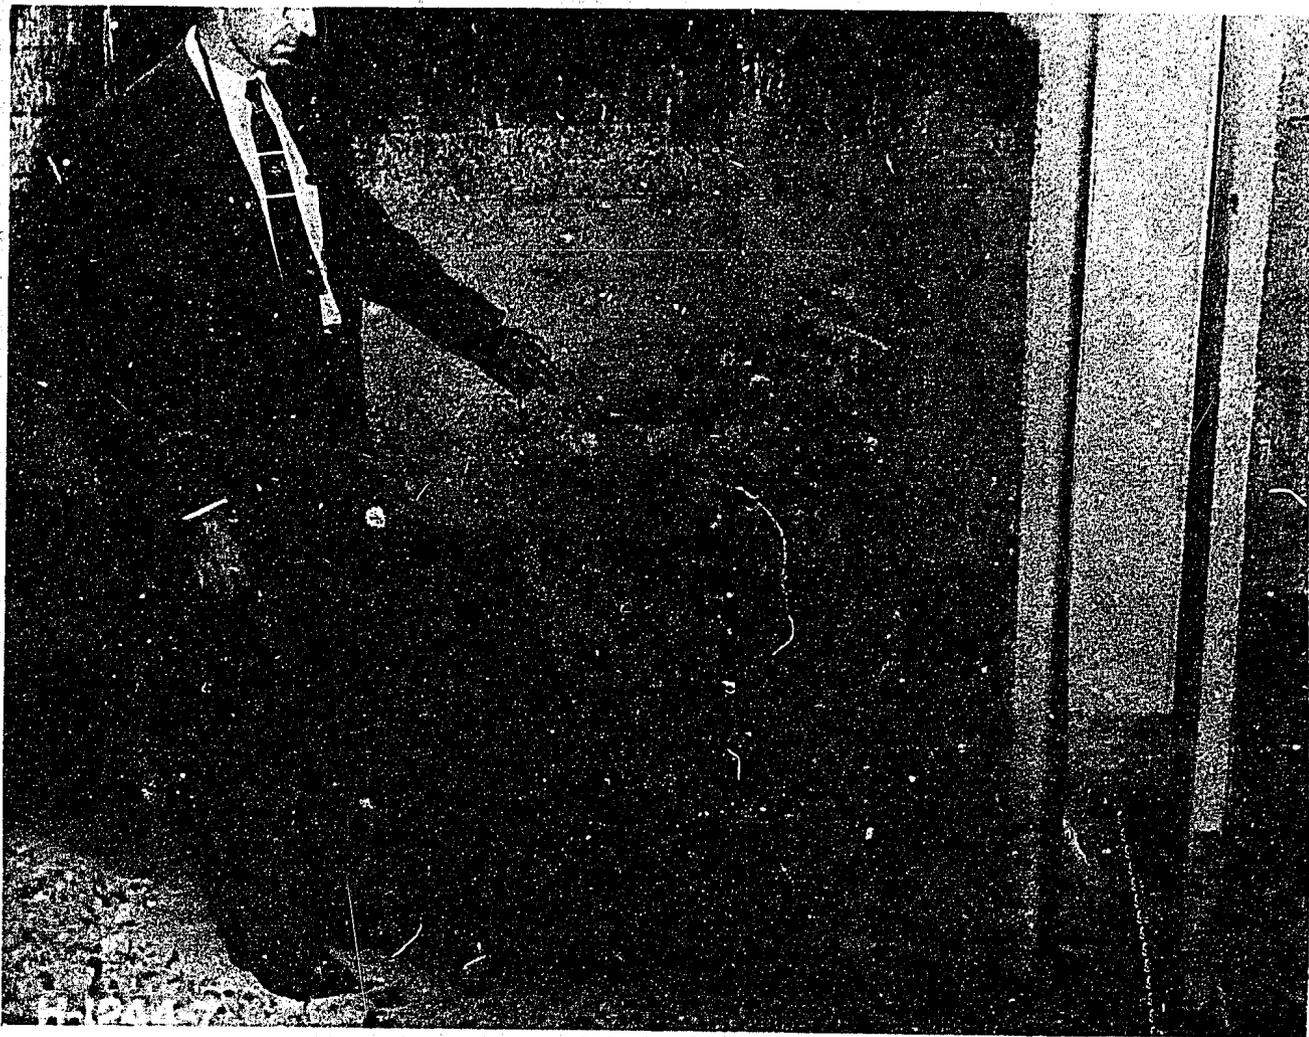
Figure 7

Pitting was also noted at the downstream end of a bevel of about 10:1 which had been formed by grinding an into-the-flow offset at the end of the Palisades gate frame (Figure 5). The probability of this damage has been indicated in model tests which show that low pressures form downstream of lines of intersection for bevels of 12:1 and 24:1 (Figure 6). When high velocity flows pass the abrupt changes in alignment of these surfaces, the pressures are reduced to vapor pressure and cavitation and cavitation pitting takes place. Typical pitting downstream of a 12:1 bevel at a stop log slot is shown in Figure 7.

Lucky Peak Dam, Outlet No. 4--Corps of Engineers  
Erosion at end of 1:12 bevel at stop log slot.

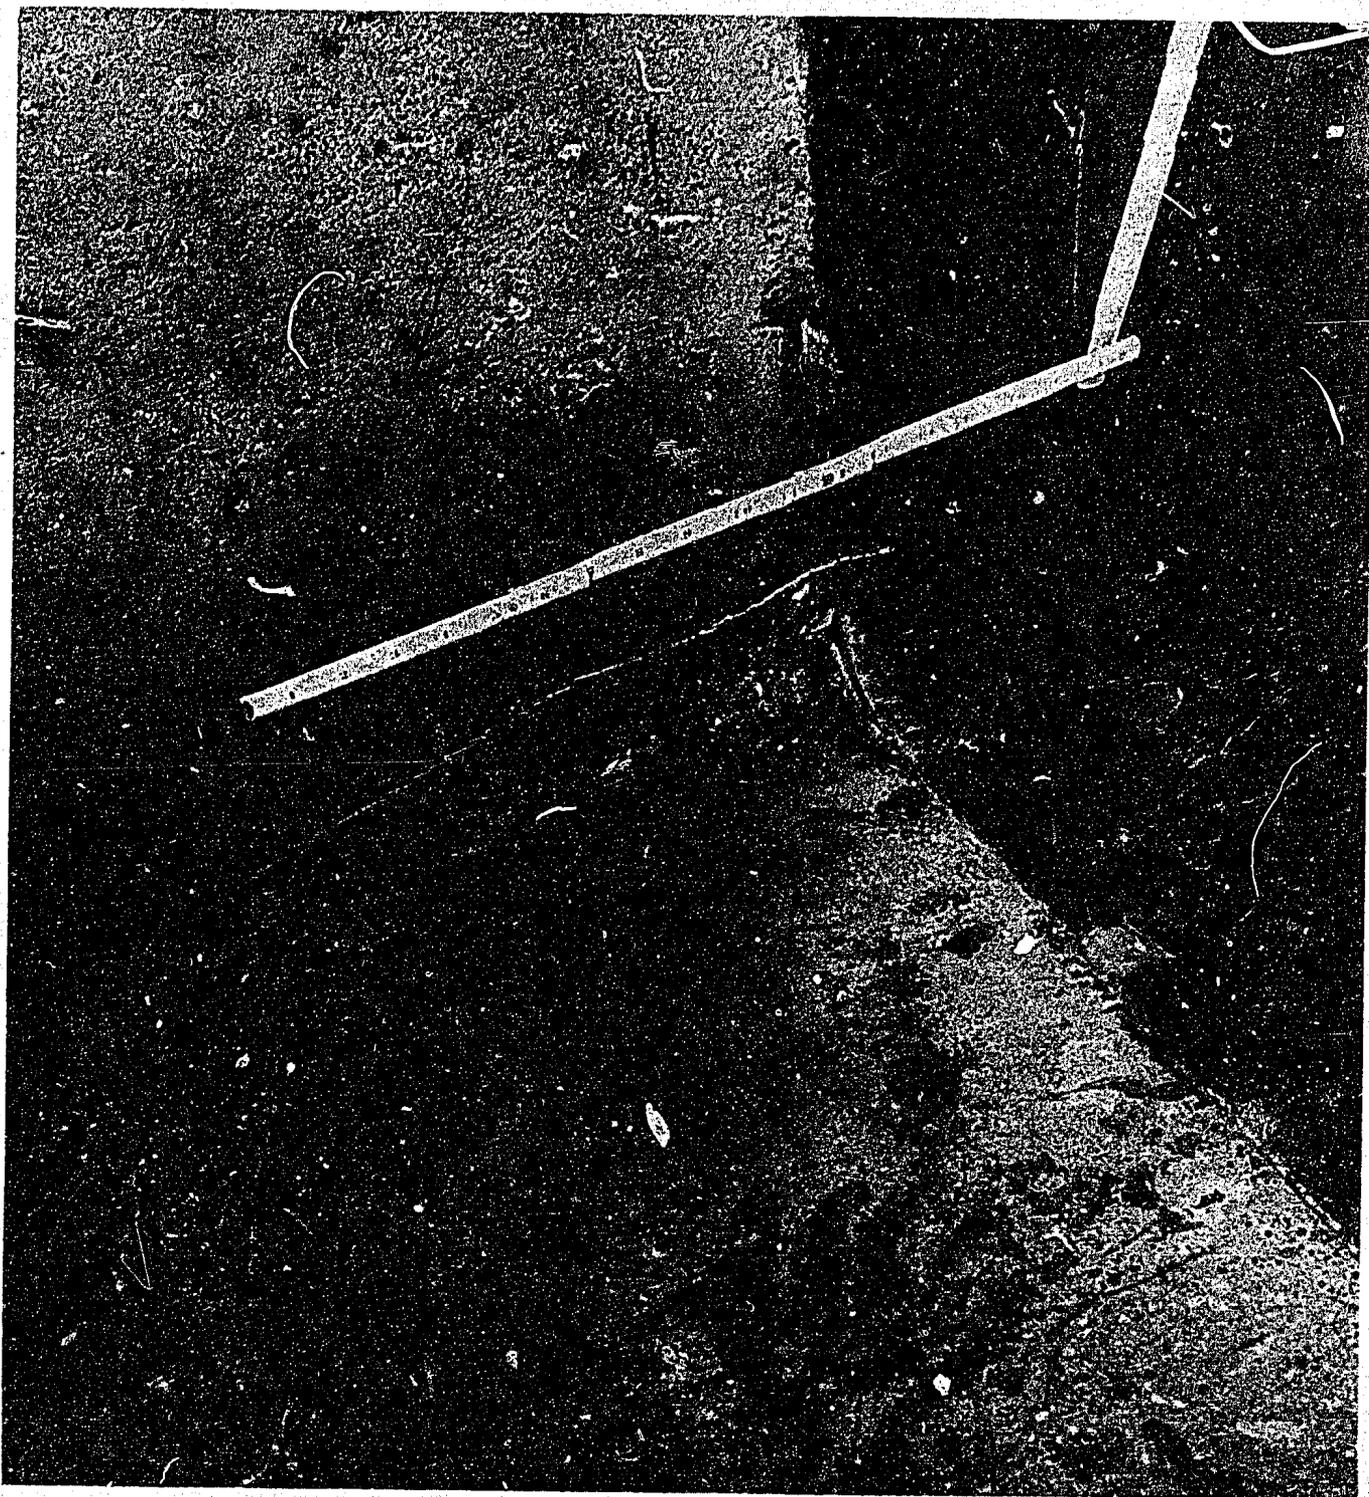
Figure 8

Offsets away from the flow do not appear critical if the offsets are small. This is not true of large offsets as evidenced by the erosion shown in Figures 8 and 9. The offset of about 1-1/4 inches, in this case, occurred between the curved corner of the gate frame and the square corner of the downstream flow channel. Actually, a fillet about 10 inches long was placed in the corner at the end of the gate frame. The damage at this offset on August 15, 1957, is shown in Figure 8. The increase in damage incurred during a month's operation at small openings is shown in Figure 9.

Palisades Project--Photograph No. P-456-108-4358  
Right Bottom corner of concrete-steel joint in Outlet  
No. 8. 8-15-57

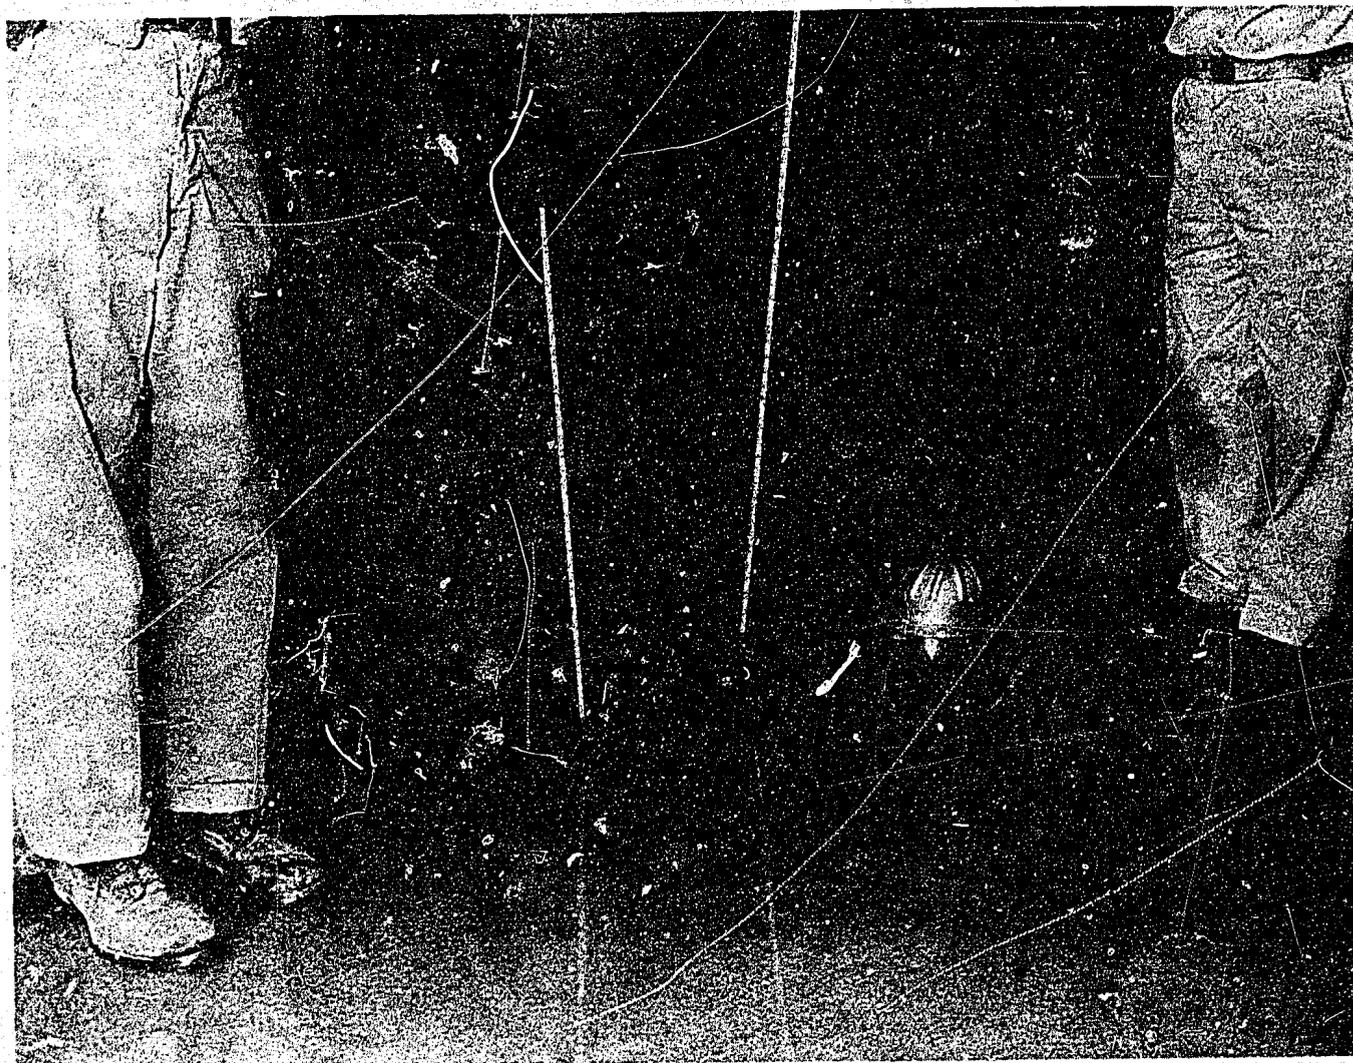
Figure 9

Palisades Project--Photograph No. P-456-108-4411  
Cavitation in floor on right side of outlet gate No. 8.  
Eroded area is about 9 feet long, 20 inches wide, and  
a maximum of 6 inches deep. Note reinforcing steel.  
9-17-57
