UNITED STATES  
DEPARTMENT OF THE INTERIOR  
BUREAU OF RECLAMATION

Laboratory Report No. HM-12  
Glendive Pumping Plant  
Buffalo Rapids Project  
Test Conducted by: G. J. Hornsby  
Checked by: D. J. Hebert  
Submitted by: G. J. Hornsby

Subject: Field acceptance test on pumping units Nos. 1 and 2 of the Glendive pumping plant - Buffalo Rapids project, Glendive, Montana - Specifications No. 1018-D.

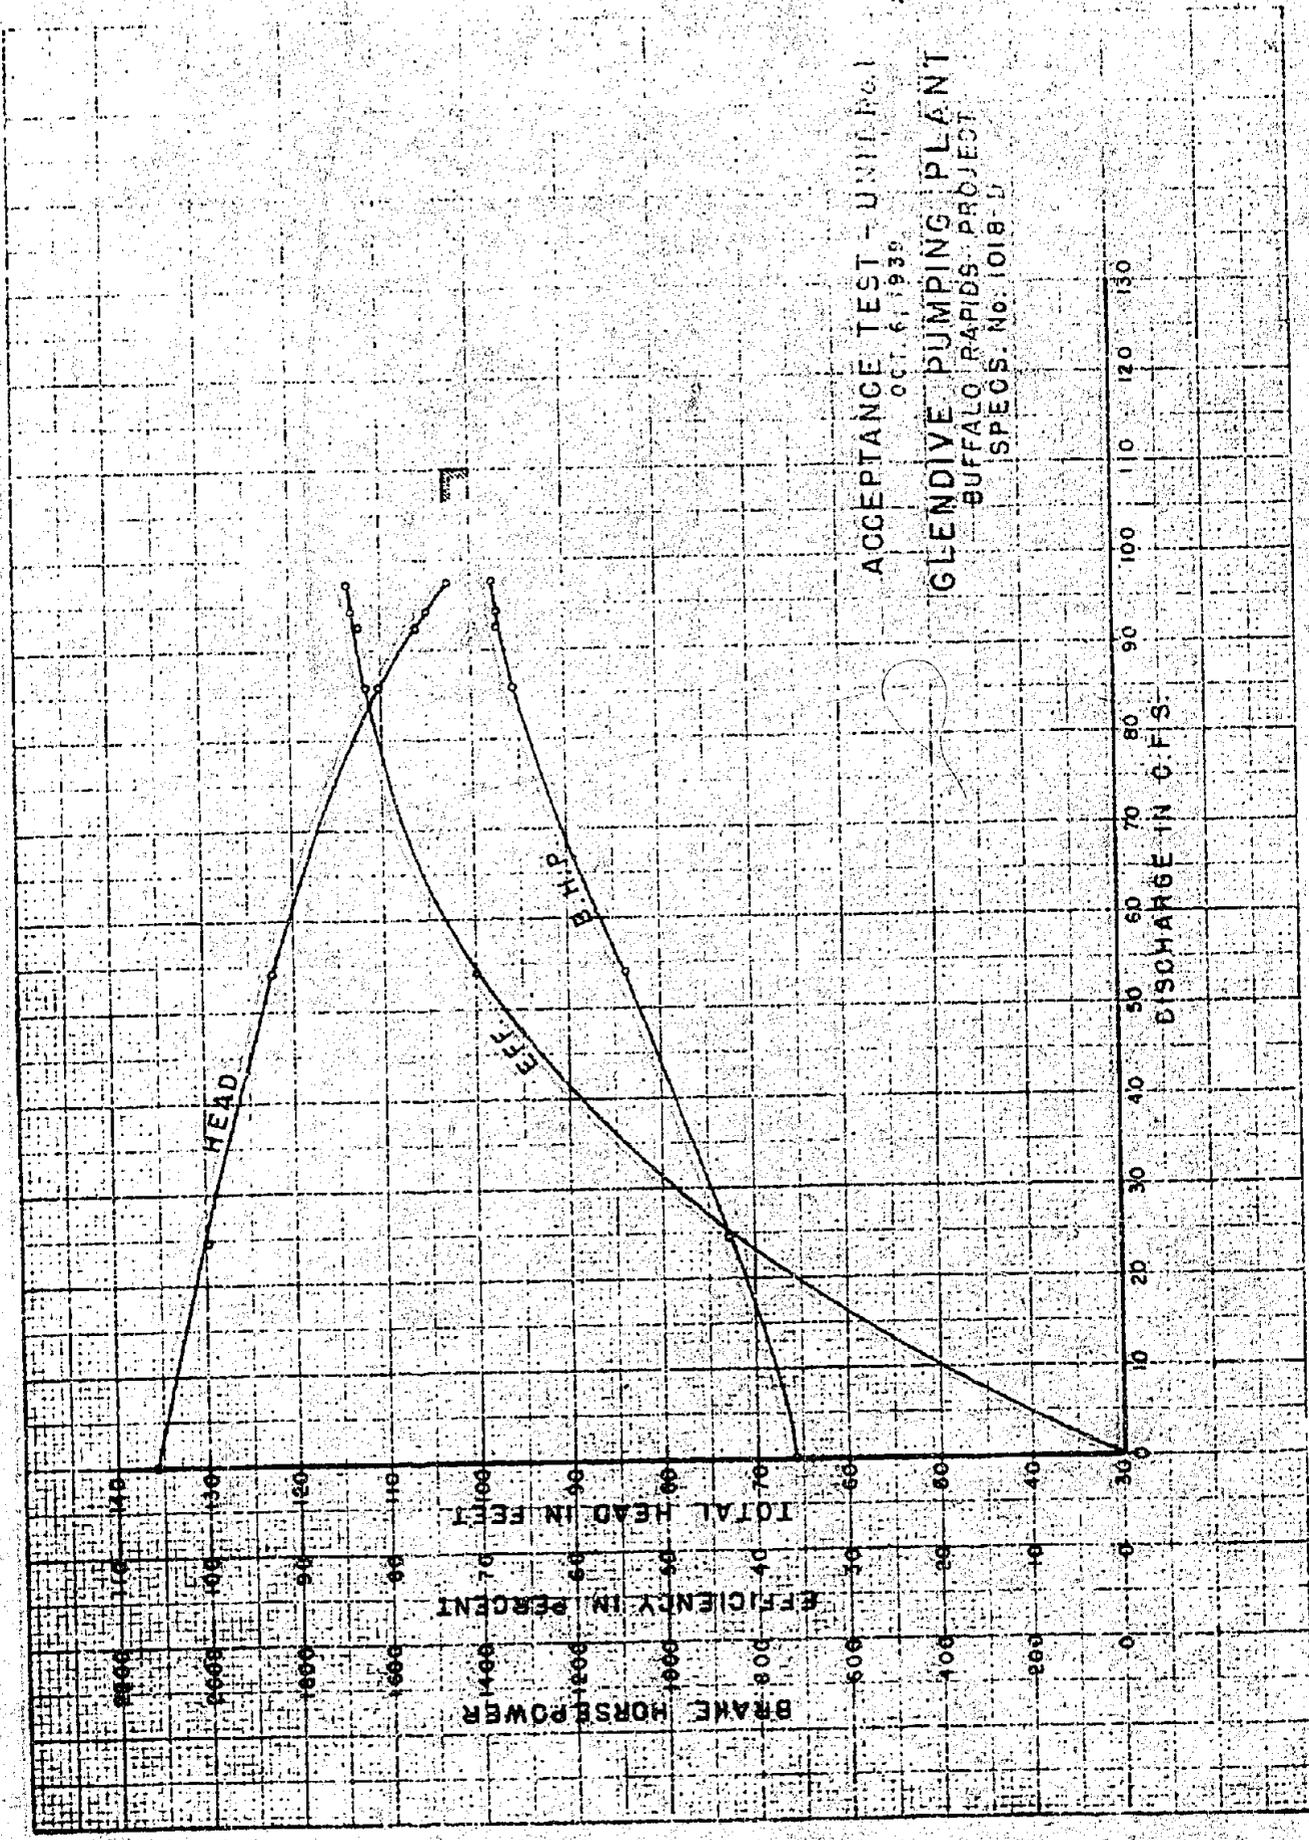
ACCEPTANCE TEST - UNIT No. 1  
 OCT. 6, 1939  
 GLENDIVE PUMPING PLANT  
 BUFFALO RAPIDS PROJECT  
 SPECS. No. 1018 D

4. Results of tests. The first, or trial test, on unit No. 1 was interrupted by a break in the canal at the discharge transition. The results of this test are, therefore, not plotted. Test No. 2, unit No. 1, was complete and the results are tabulated in table No. 1, and plotted on performance curve, figure 5. The results of test No. 1, unit No. 2, are tabulated in table No. 2, and plotted on performance curve, figure 6. The water temperature for all tests was between 10 and 11 degrees centigrade.
