# DOCUMENTATION OF OPERATION, DAMAGE, REPAIR, AND TESTING OF YELLOWTAIL DAM SPILLWAY

R. C. Borden  
D. Colgate  
James Legas  
C. E. Selander  
Engineering and Research Center  
Bureau of Reclamation

May 1971

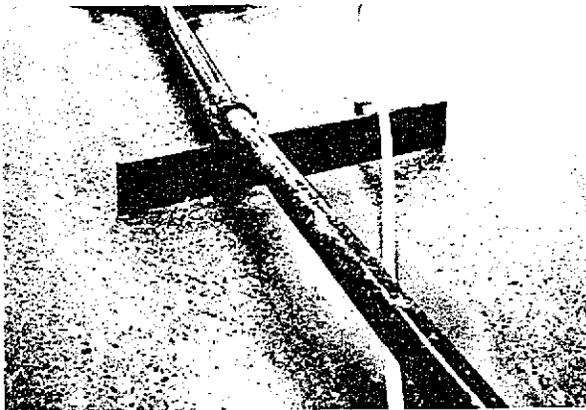
The condition of the stilling basin invert was excellent considering the amount of silt-laden materials passed during diversion. The surface was sufficiently eroded to expose aggregate, see Figure 1-3, but the texture of the eroded surfaces was generally smoother than similarly affected areas in the spillway tunnel. The depth of

Figure 1-3. Typical erosion pattern in invert of stilling basin. Photo P459-D-55582 NA

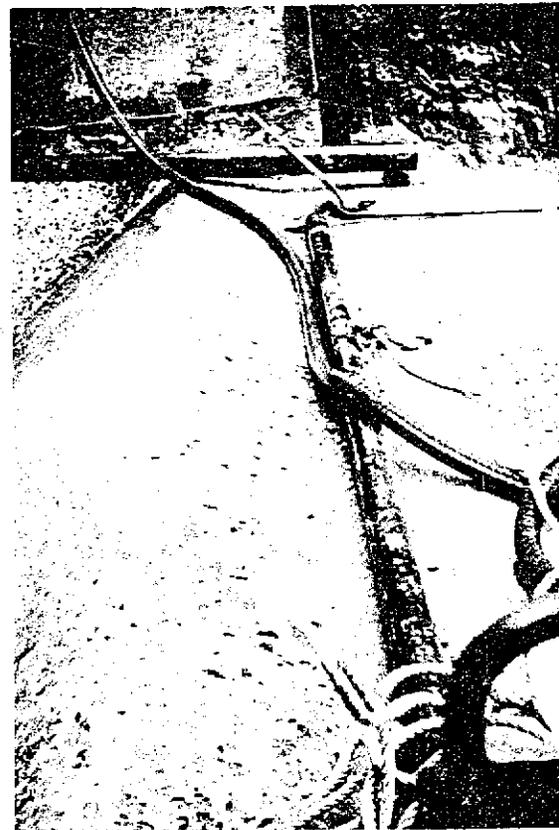
erosion was greatest at the basin centerline and decreased uniformly to the original surface in a distance of 6 to 8 feet from the centerline. All construction joints were in good condition and free of spalling or excessive erosion except for a small pocket of spalled concrete at a joint between the curved flip bucket and the right sidewall of the basin. Several small nicks in the lip of the flip bucket had occurred, and erosion had exposed aggregate the full width of the basin, but both nicks and erosion were insignificant. Refer to Figures 1-4 and 1-5 for the lip erosion and a general view of the stilling basin.

Figure 1-4. Eroded concrete surfaces downstream of bucket lip. Stoplog seal plate is undamaged. Photo P459-D-55583 NA

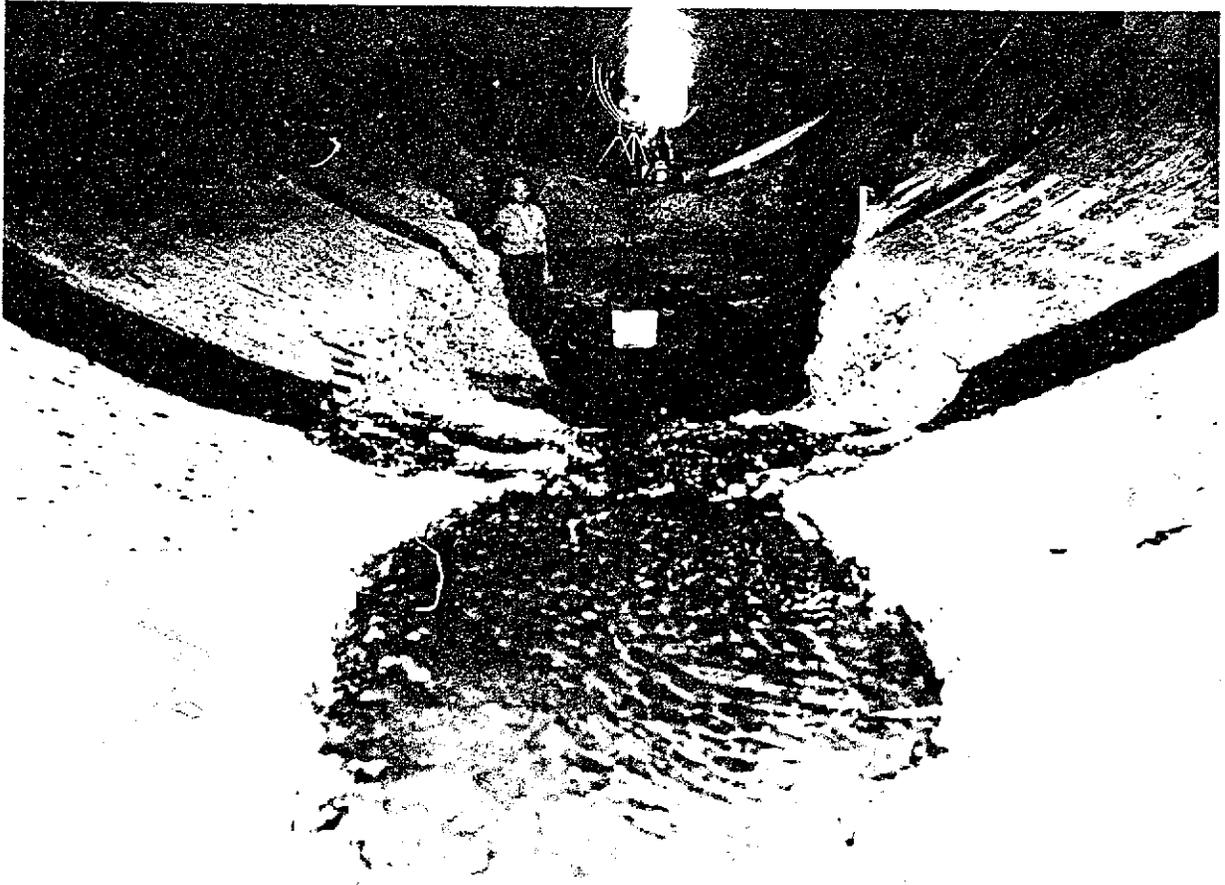
Figure 1-7. Looking downstream in major damaged area in horizontal reach of tunnel. Photo P459-640-4042

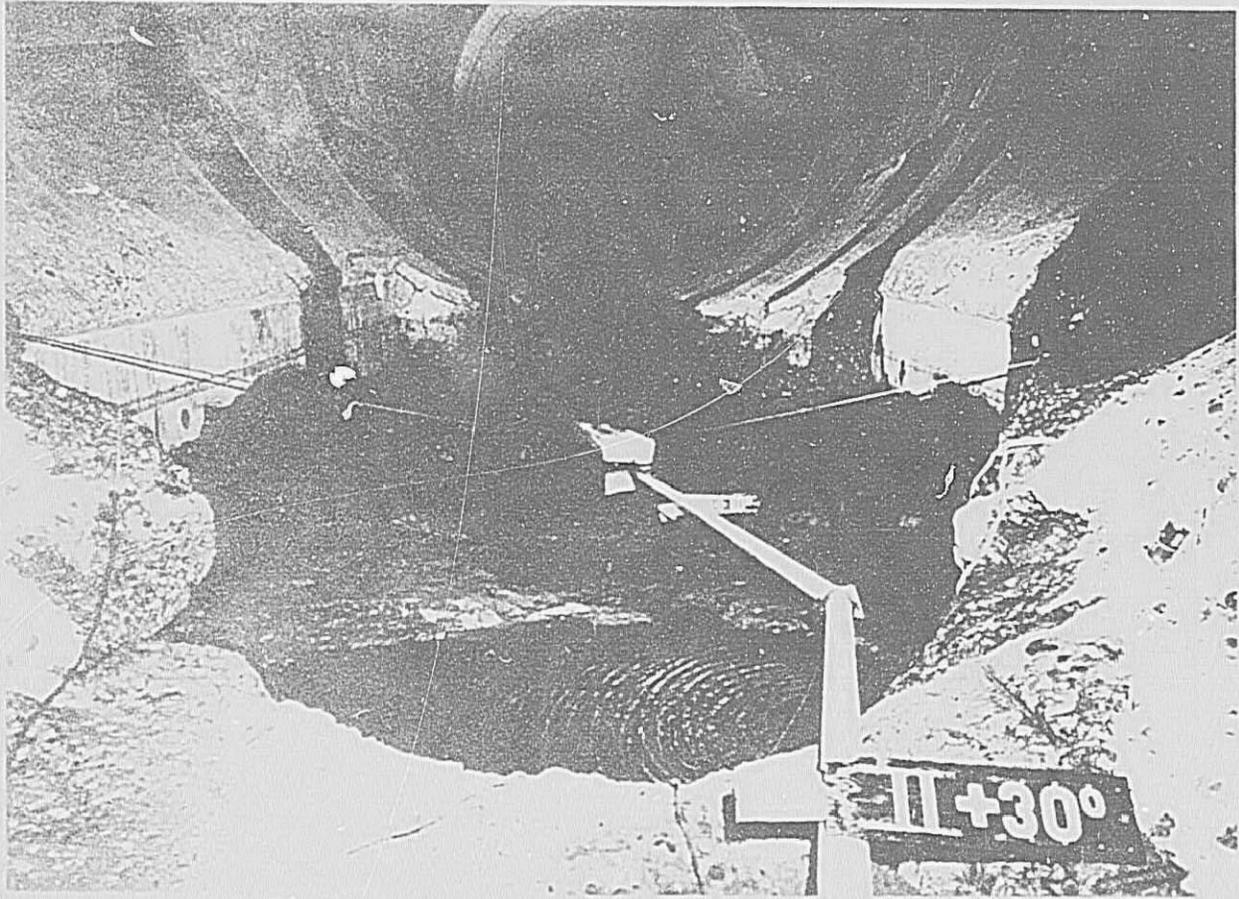
Figure 1-8. Major damaged area in horizontal reach of tunnel. Photo P459 640 4169

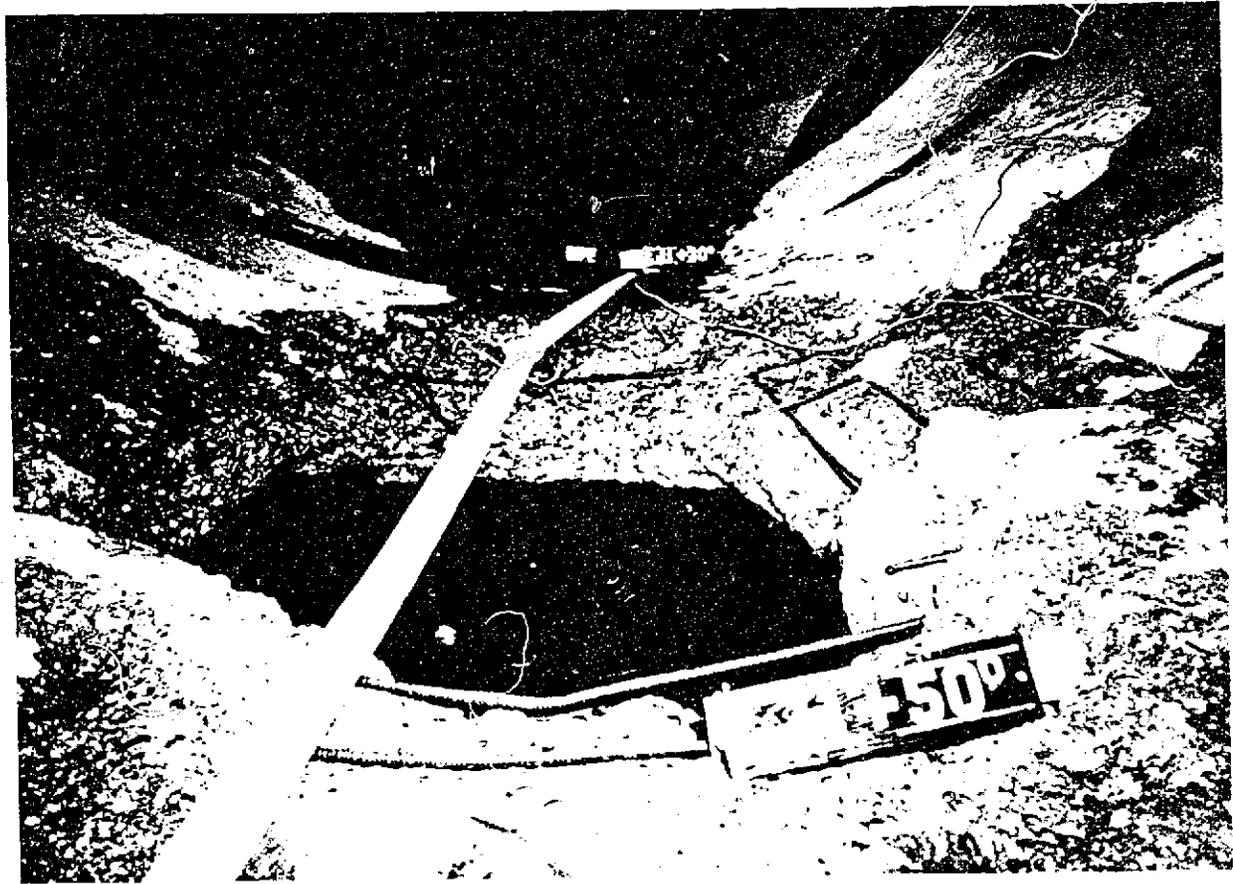
Figure 1-9. Major damaged area in horizontal reach of tunnel. Photo P459-640-4170

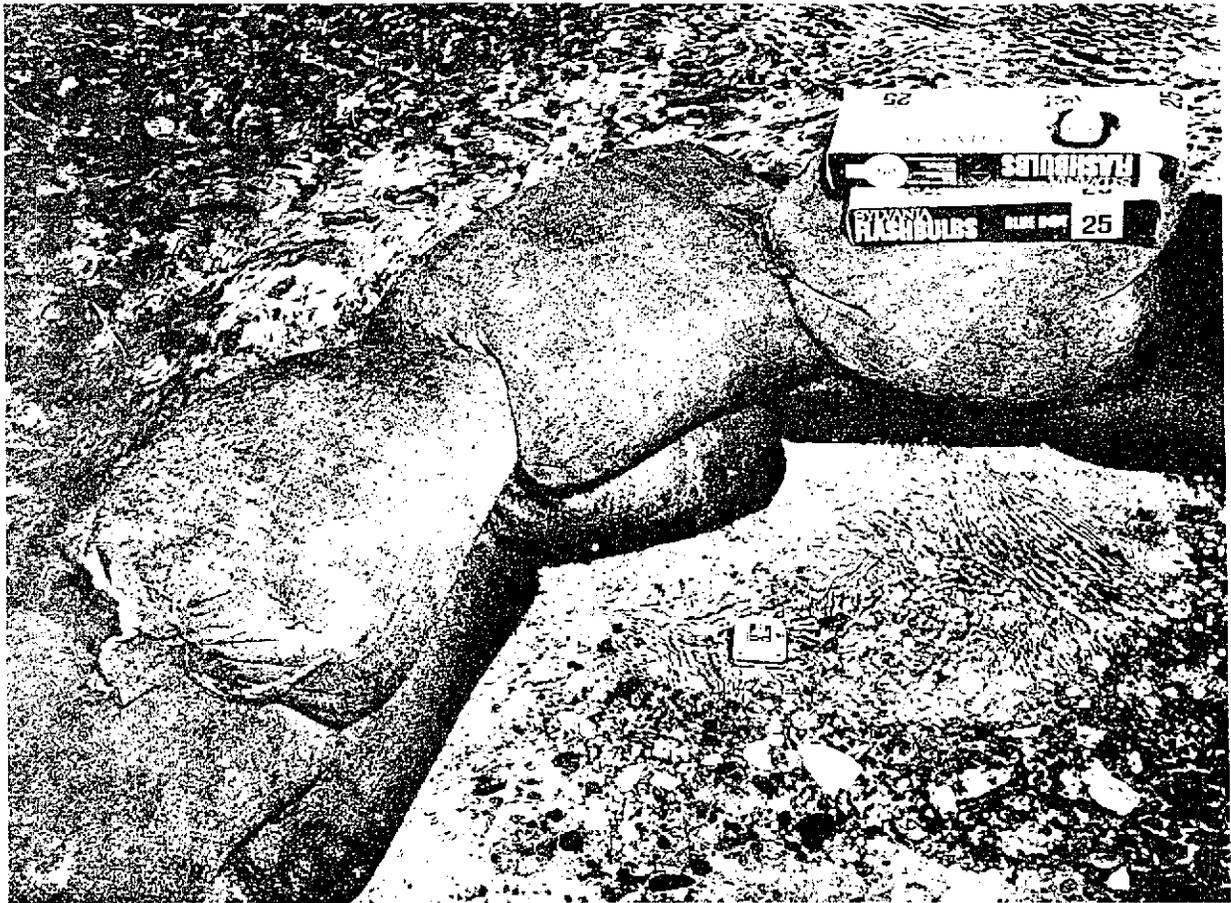
Figure 1-10. Depression that initiated the damage in horizontal reach of tunnel. Photo P459-640-4051 NA

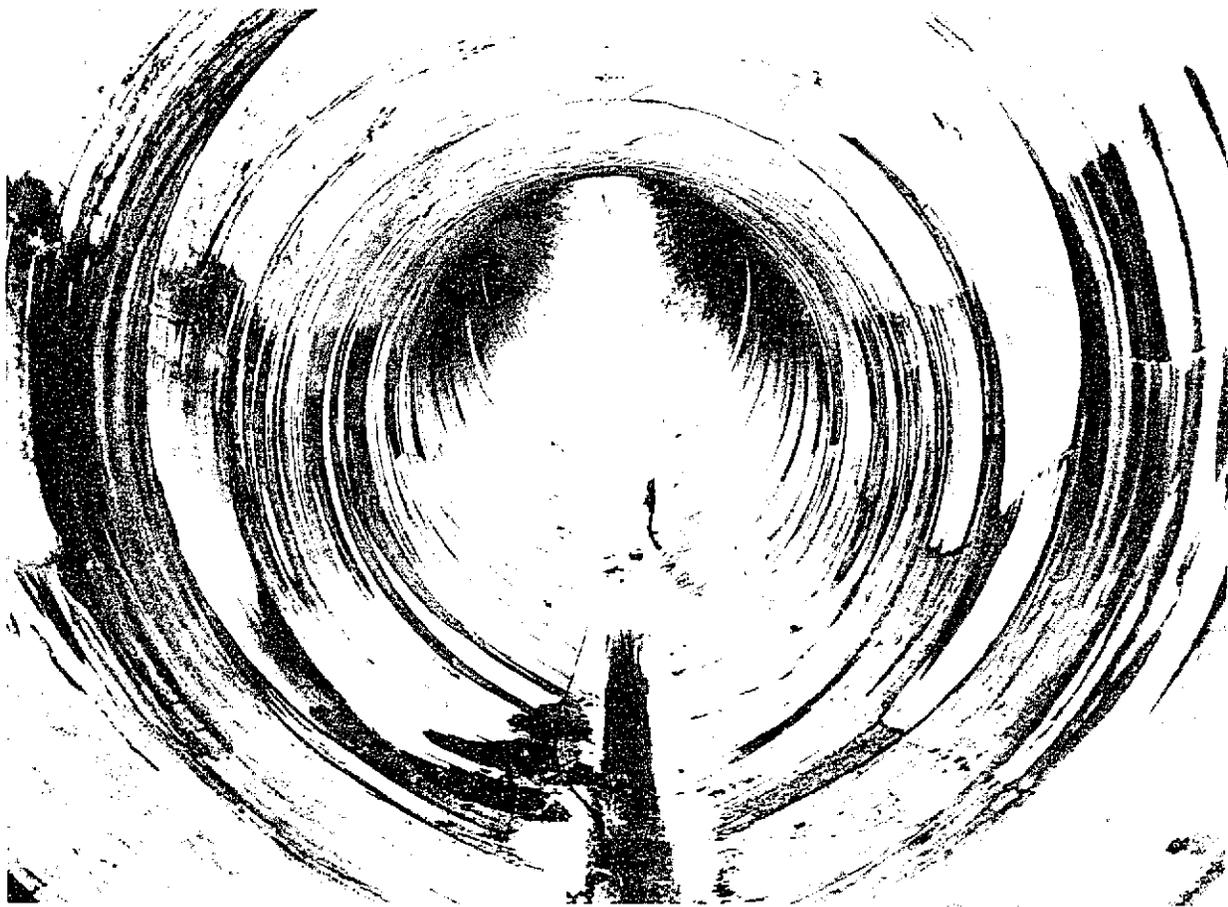
Figure 1-11. Looking upstream at damaged areas in tunnel elbow. Photo P459-640-4028 NA

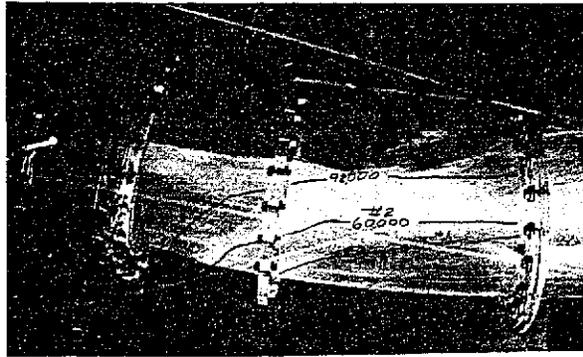
Figure 2-17. Aeration slot in the bend—Station 9+57.67— $Q = 60,000$  cfs—Side fins choking the tunnel downstream. Photo P459-D-68811

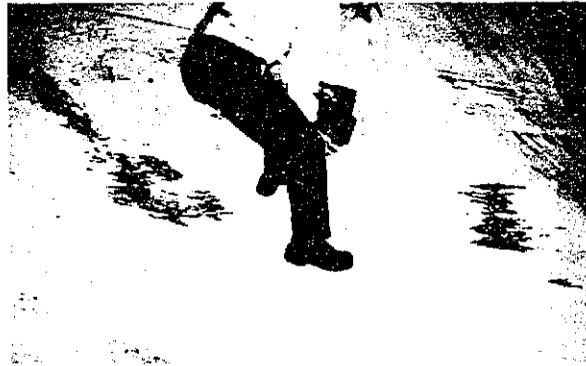
Figure 4-2. Paint failure in tunnel elbow at Station 9+56±. Photo C459-D-68459 NA.
