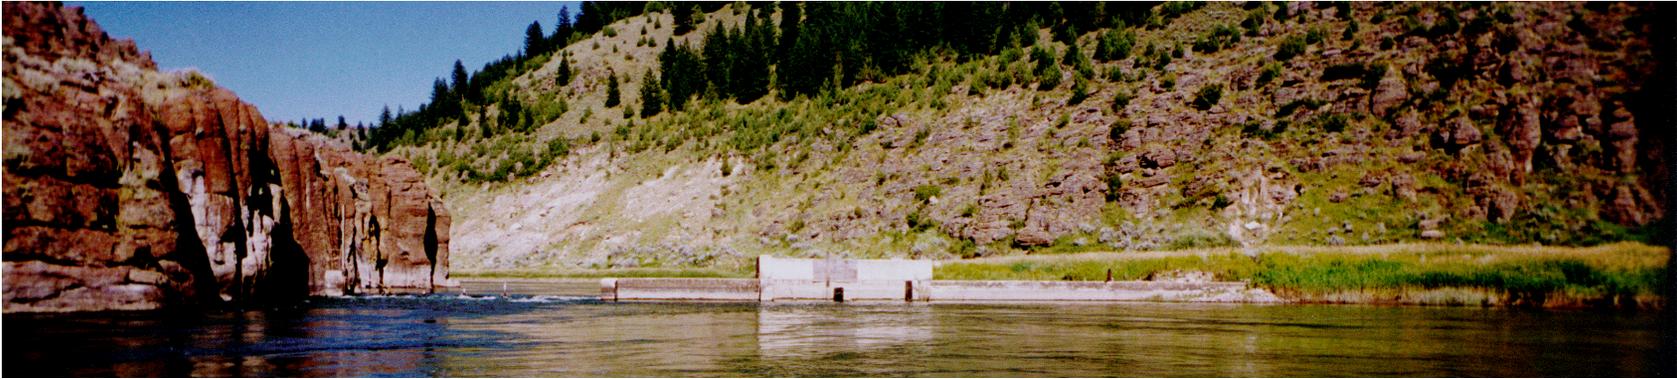
*Photograph A- 31. Looking upstream at Linderman Dam, located about 10 miles upstream of Teton Dam at the confluence with Milk Creek. This dam was in operation in 1972, creating a 10- foot drop in water surface and backing up a pool of water over 3,600 feet long. During the construction of Teton Dam, Linderman Dam was partially removed, leaving remnants that create only a 2- foot drop in water surface. USBR photograph by Tim Randle, 1998.*

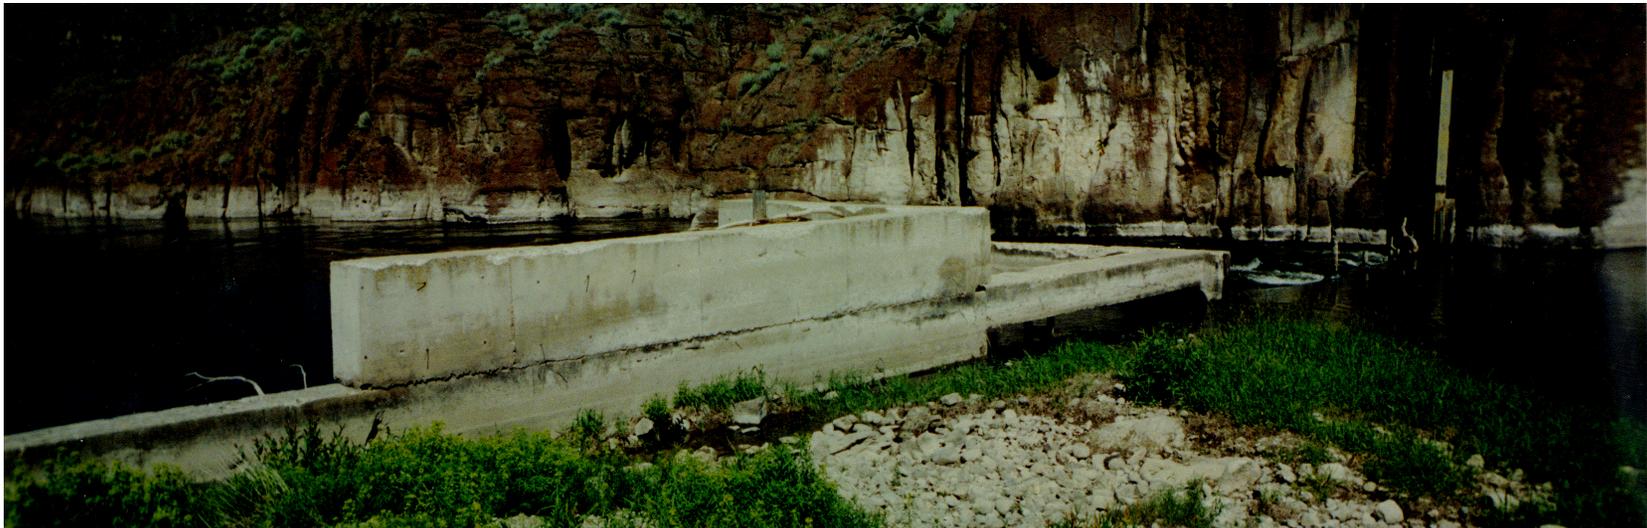
*Photograph A- 32. Looking downstream at Linderman Dam. A portion of the dam has a dangerous underflow current not visible to boaters at higher flows. In addition, pieces of the old structure stick vertically out of the water in the main channel flow. USBR photograph by Tim Randle, 1997.*

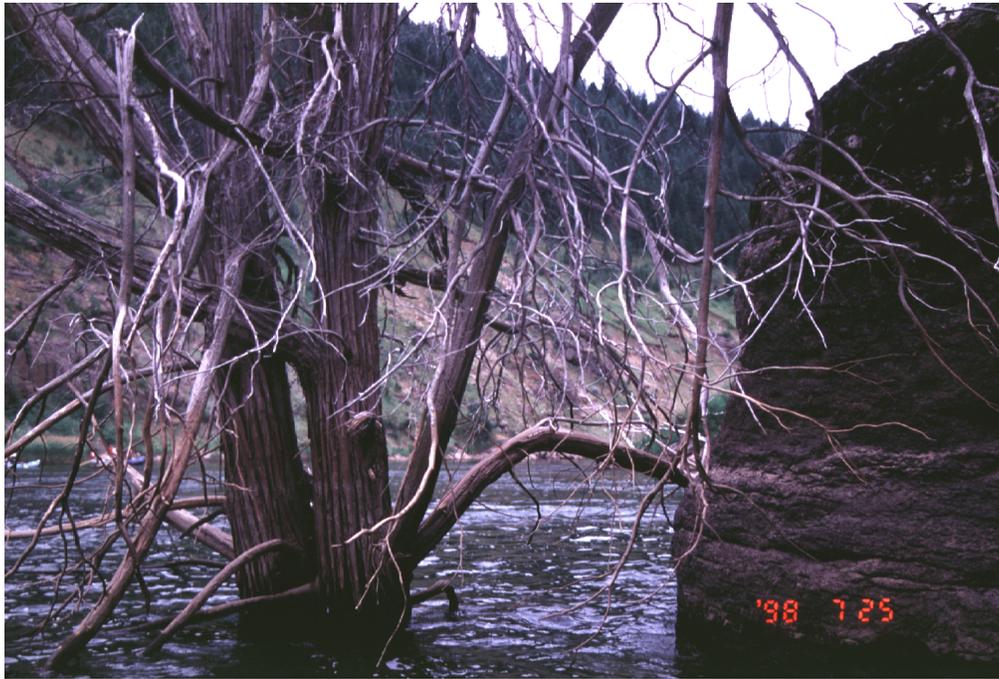
*Photograph A- 33. In pool 15, about 10 river miles upstream of Teton Dam, a drowned juniper tree provides evidence for the extent of inundation in this pool caused by landslides downstream. USBR photograph by Ralph Klinger, 1998.*

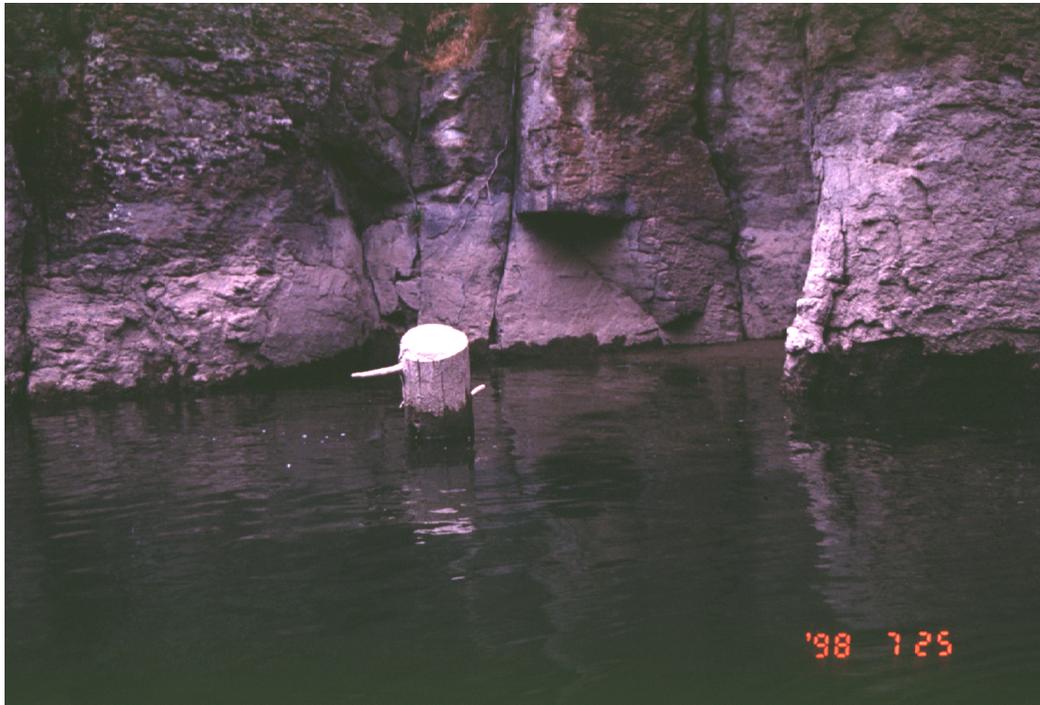
*Photograph A- 34. Stump of drowned tree in growth position on inundated terrace in pool 15. USBR photograph by Ralph Klinger, 1998.*

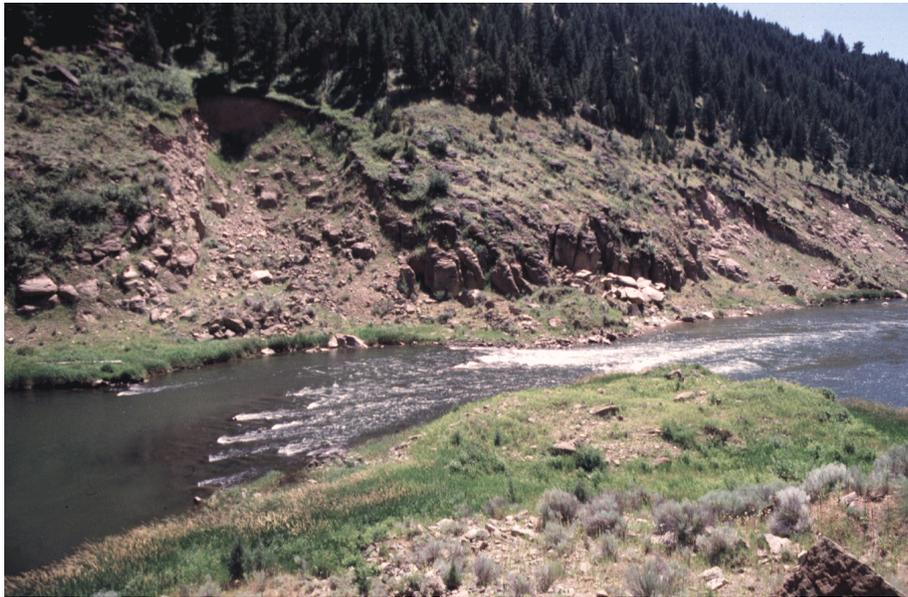
*Photograph A- 35. Landslide on left canyon wall at rapid 12. Note the extent of modification to the slide debris forming the rapid. USBR photograph by Ralph Klinger, 1998.*

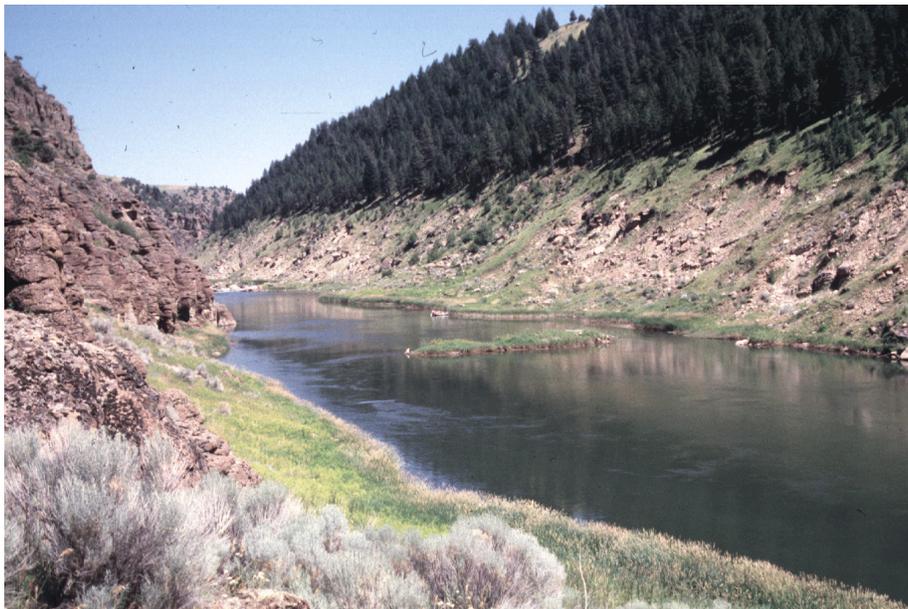
*Photograph A- 36. Island in pool 12 formed of slide debris derived from the left canyon wall. USBR photograph by Ralph Klinger, 1998.*

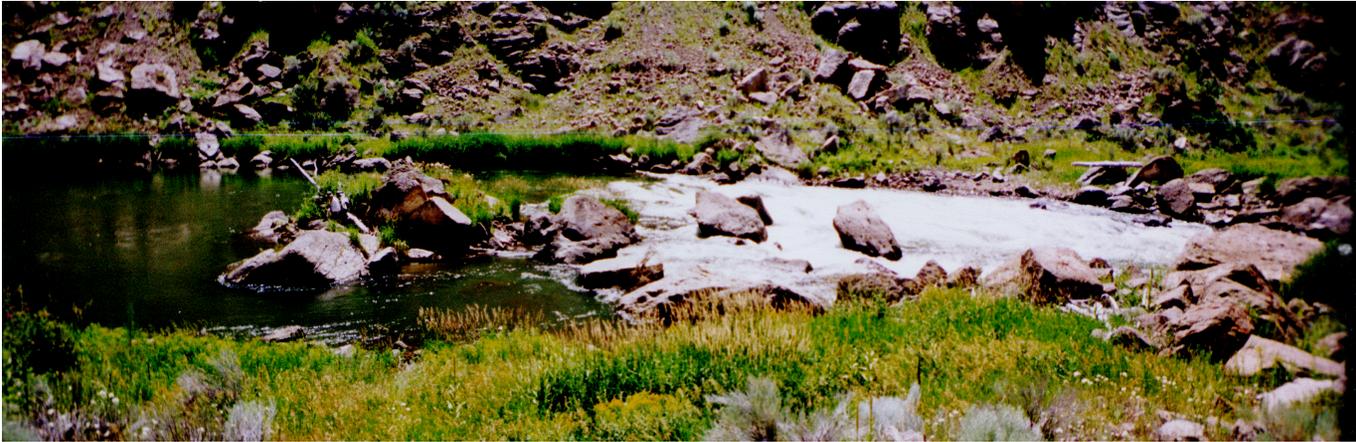
*Photograph A- 37. Rapid 11, about 11½ river miles upstream of Teton Dam, has a drop of 5 feet in water surface elevation. A riffle existed at this location prior to the dam failure and was enlarged by the 1976 landslides. USBR photograph by Tim Randle, 1998.*

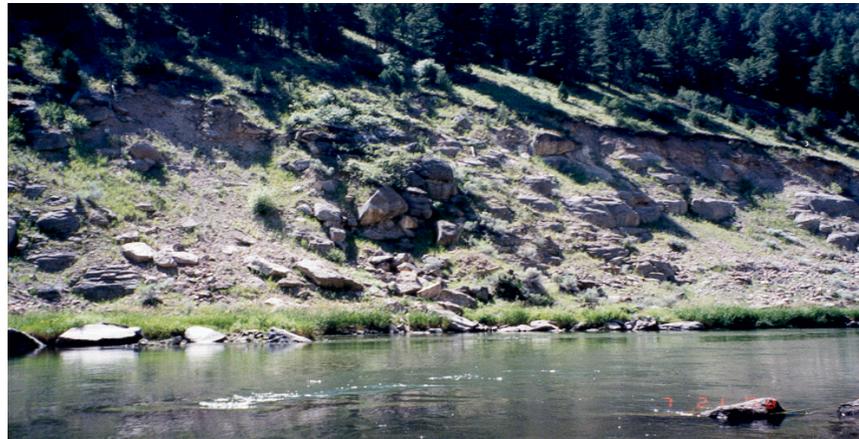
*Photograph A- 38. View of landslides on the south canyon wall below Spring Hollow. The landslides are slumps in the colluvium. Note the larger rock on the headscarps. Also note that only a small percentage of the slide material reached the river. USBR photograph by A.C. Lockhart, July 21, 1998.*

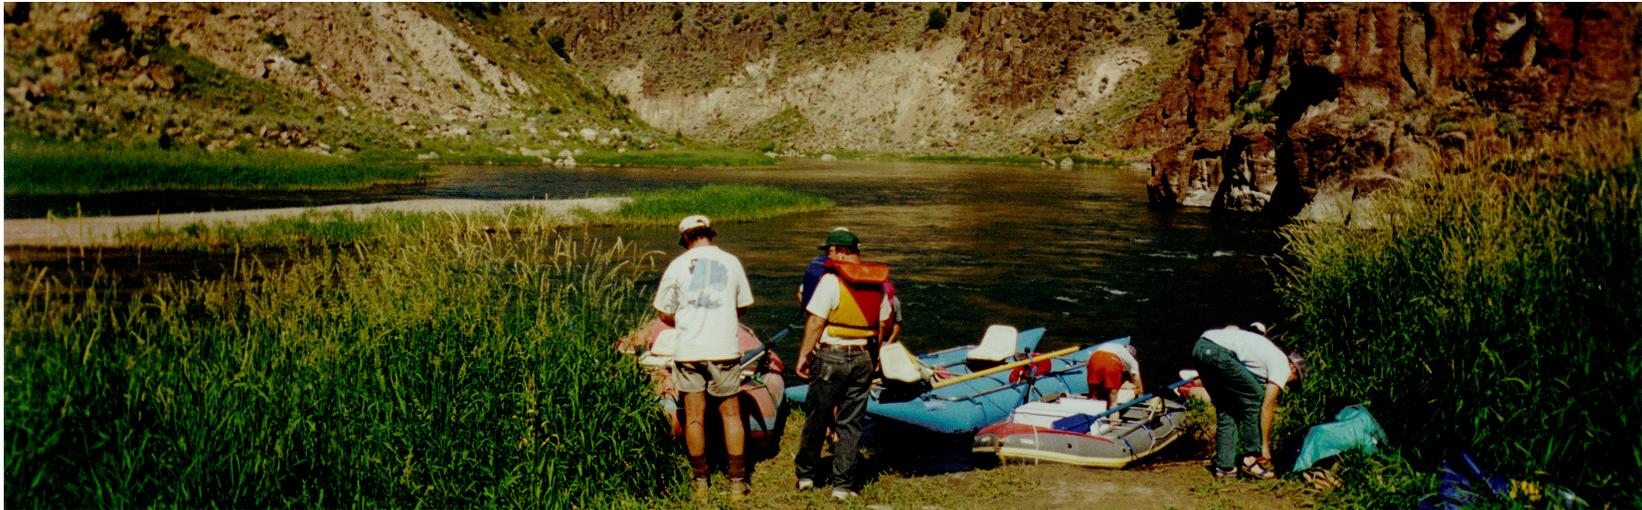
*Photograph A- 39. Spring Hollow is a boat launch site about 12 river miles upstream from Teton Dam. A midchannel sand bar was formed, in part, from landslide debris. USBR photograph by Tim Randle, 1997.*

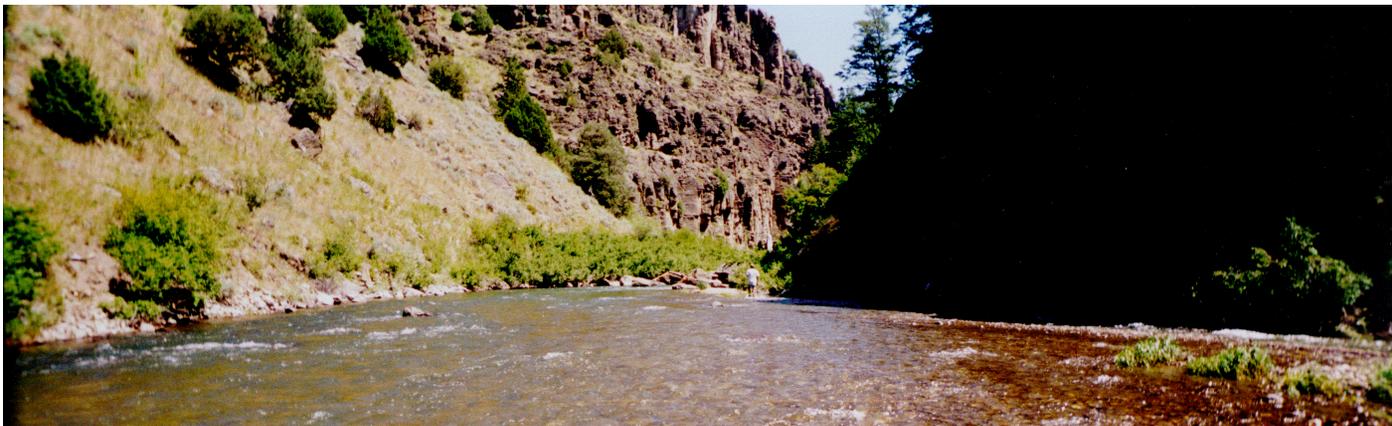
*Photograph A- 40. Looking upstream from the mouth of Bitch Creek, about 17 river miles upstream of Teton Dam, at its confluence with the Teton River. Just downstream of this confluence marks the upstream extent of the former reservoir inundation area. USBR photograph by Tim Randle, 1998.*
