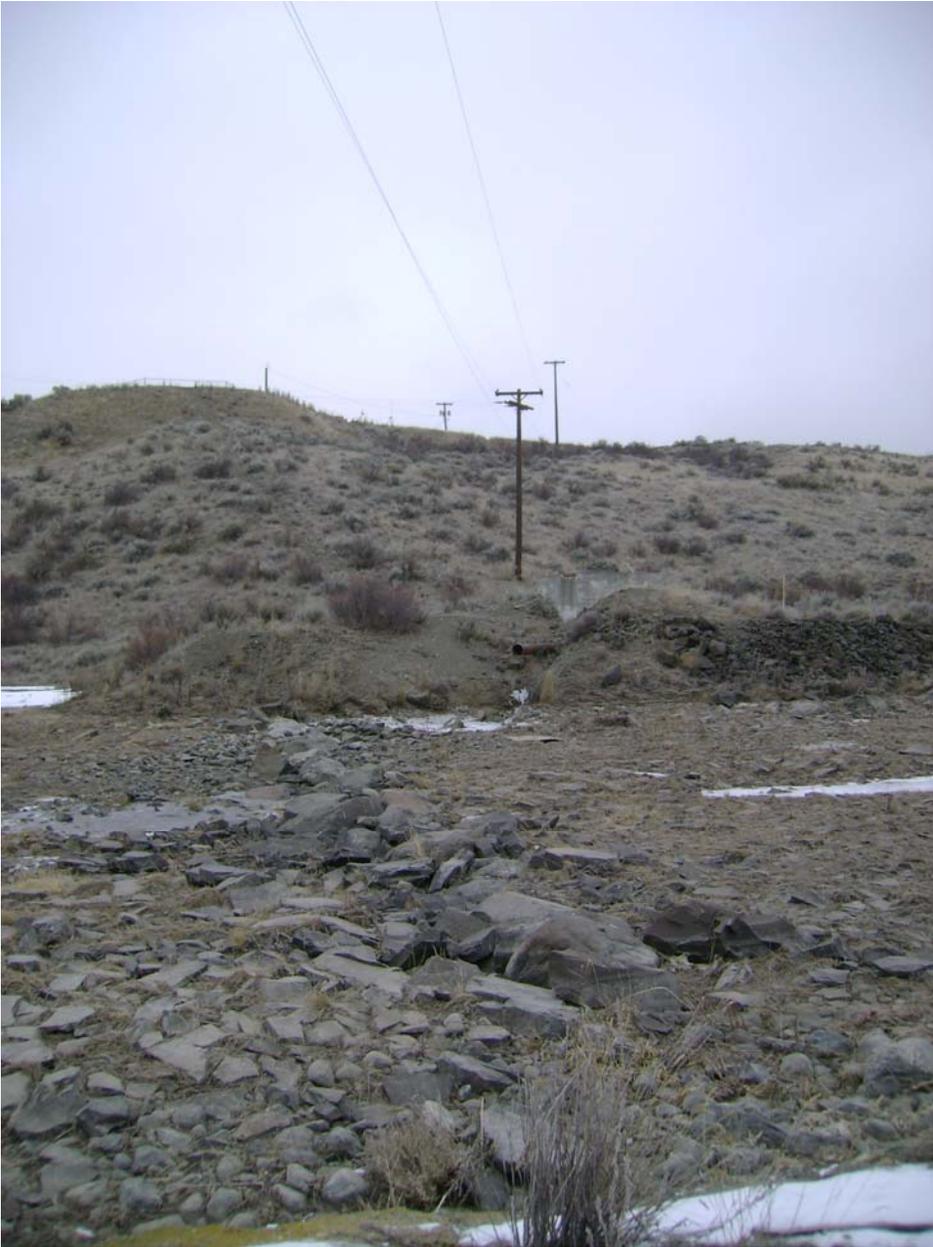
FIGURE E-1
Riprap covering the East-Low Siphon

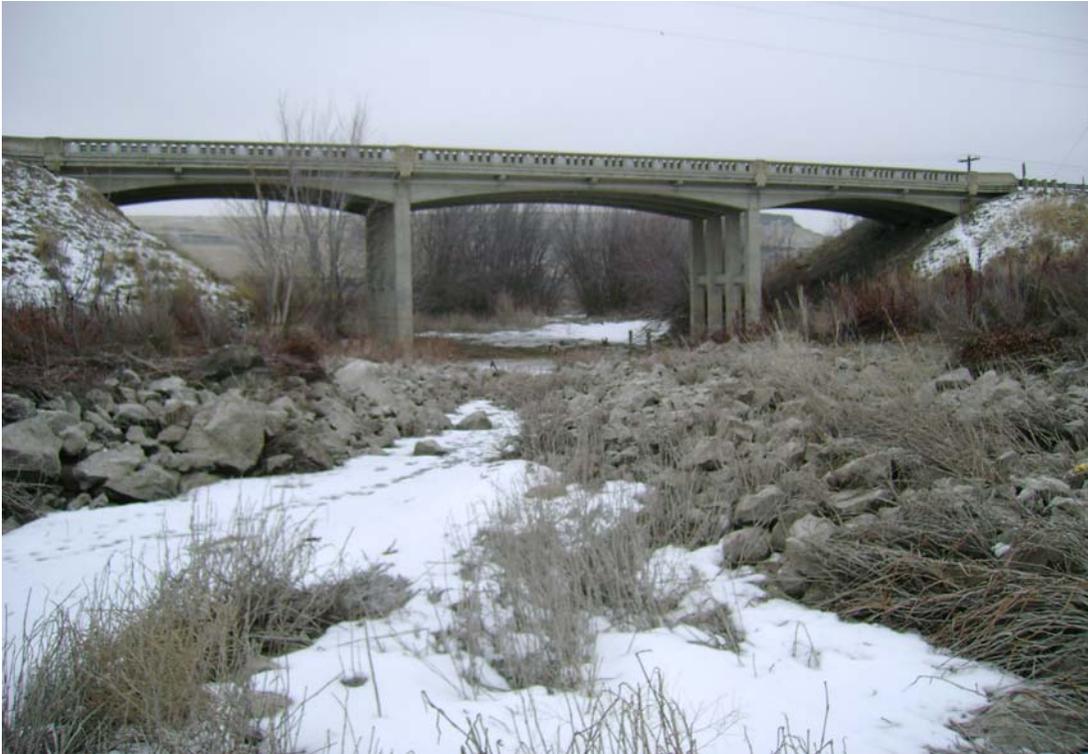
FIGURE E-2
From the outlet of Brook Lake looking downstream at HWY 26

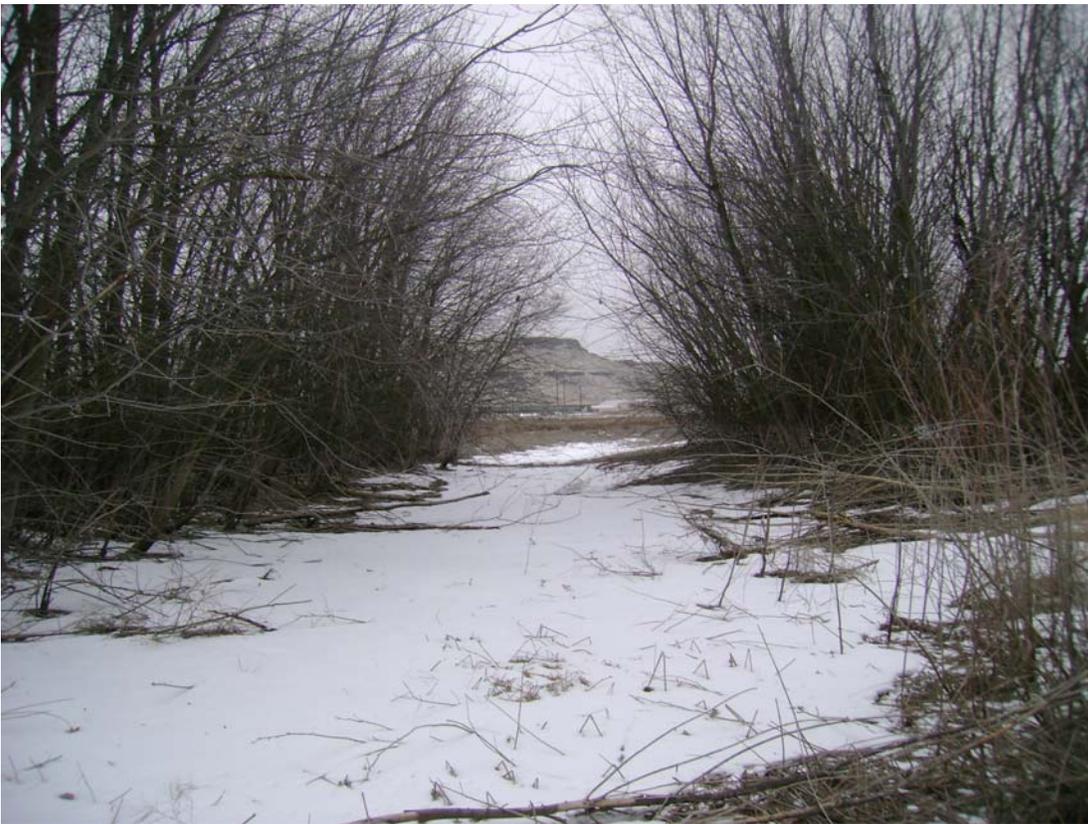
FIGURE E-3
Sample photo of the channel and bank conditions just downstream of HWY 26 in Subreach 1A

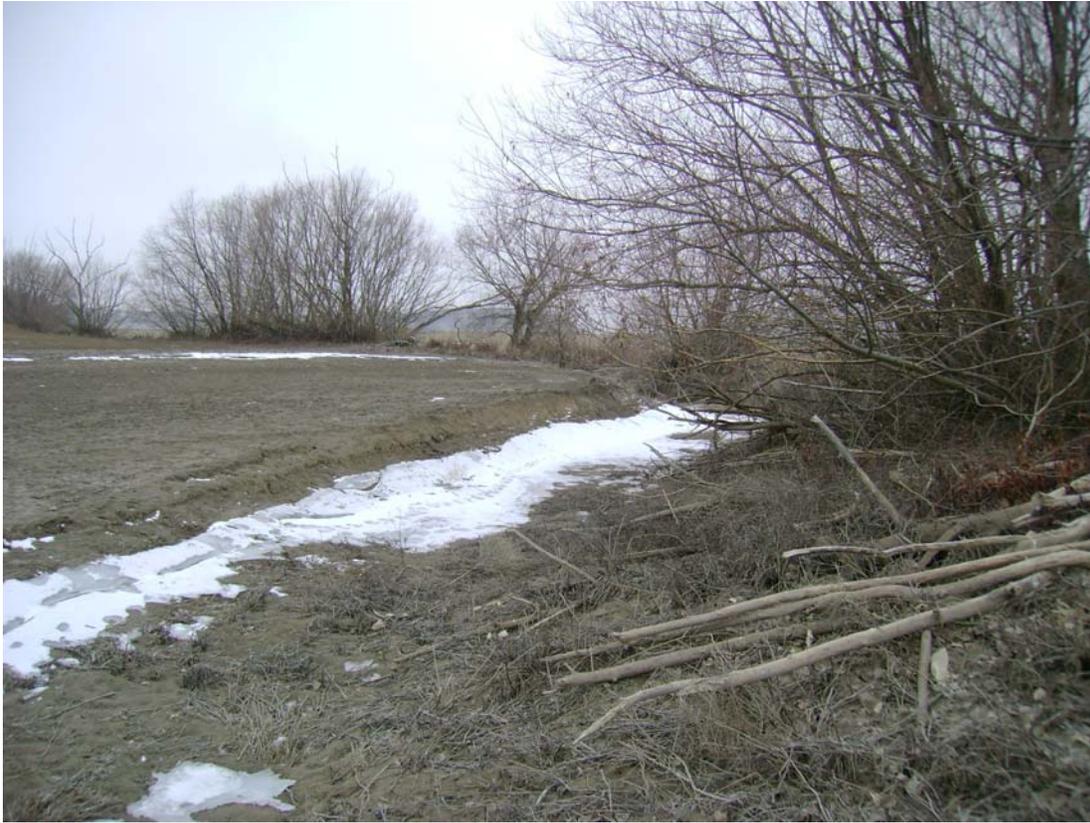
FIGURE E-4
Sample photo documentation of channel and bank condition at transition from Subreach 1A to 1B

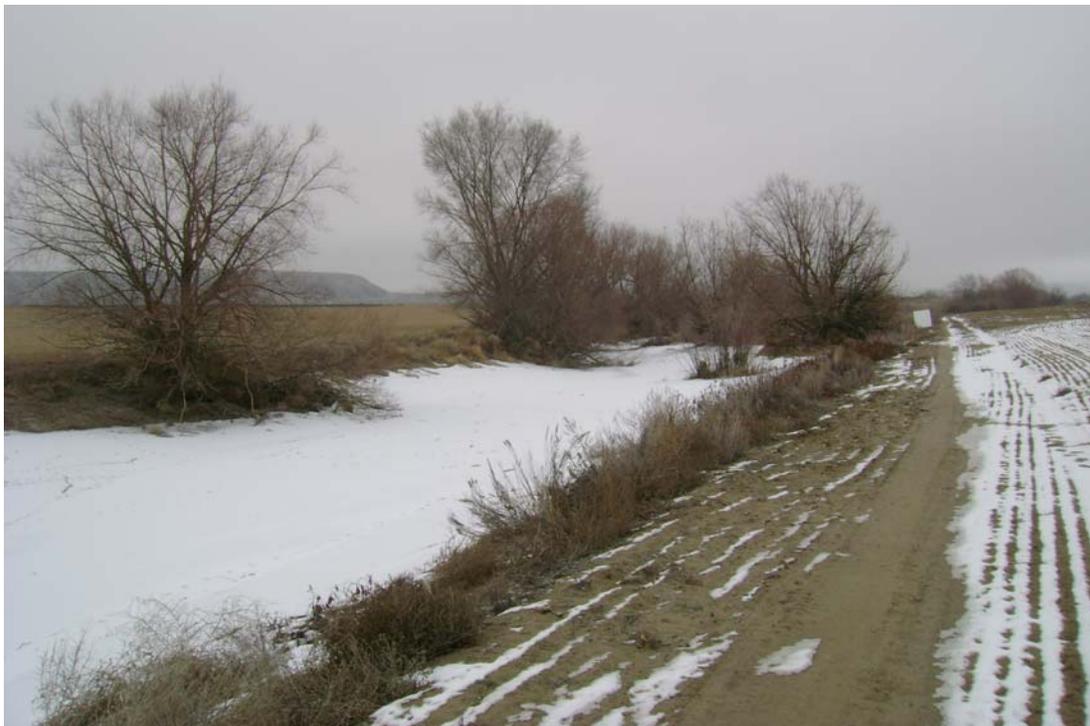
FIGURE E-5
Sample photo of channel and bank condition in Reach 1C

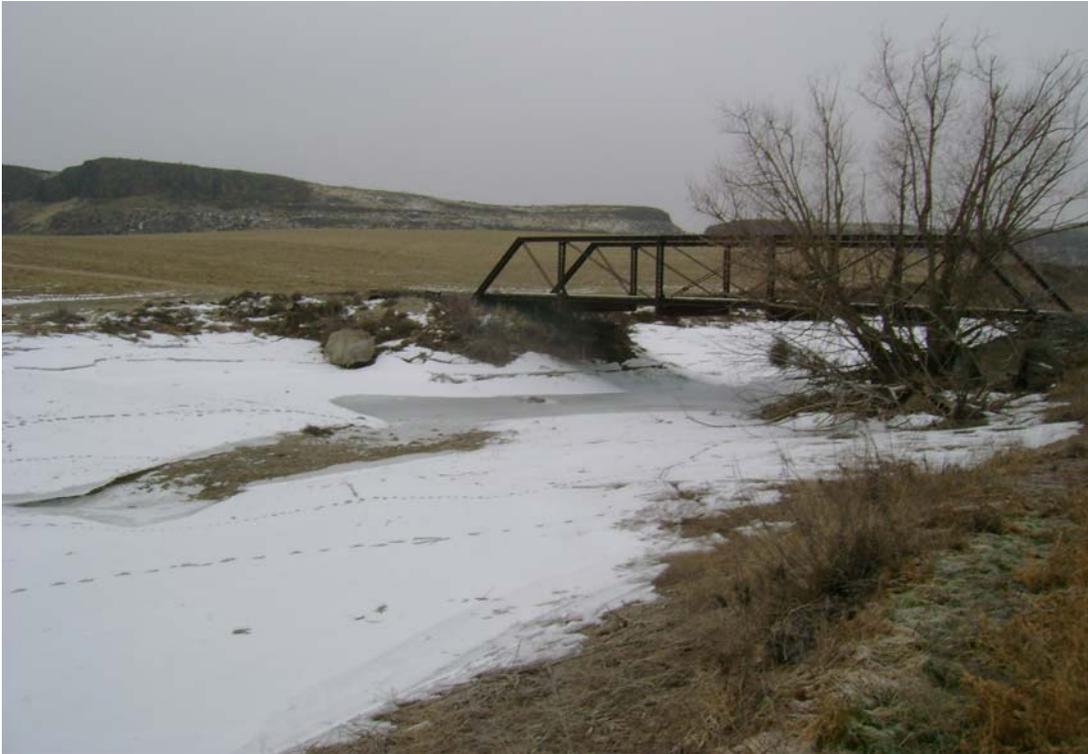
FIGURE E-6
Sample photo documentation of bridge features and high water marks

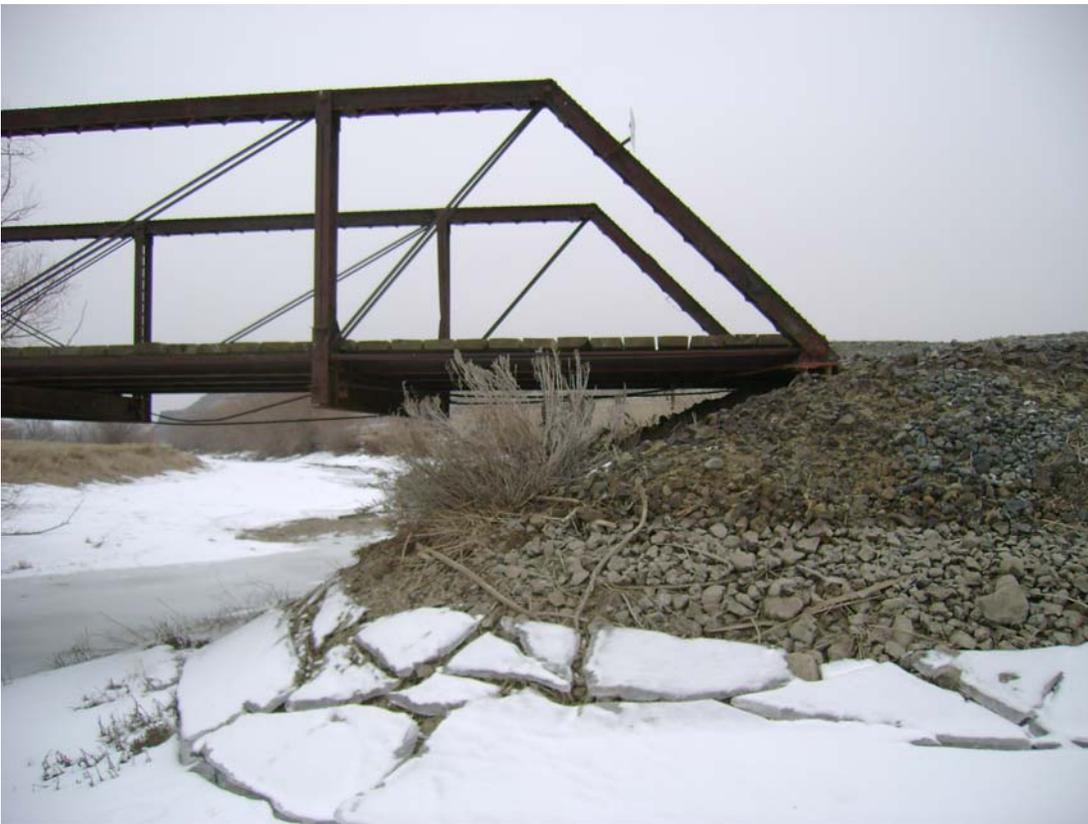
FIGURE E-7
High water mark at the "Private Bridge"

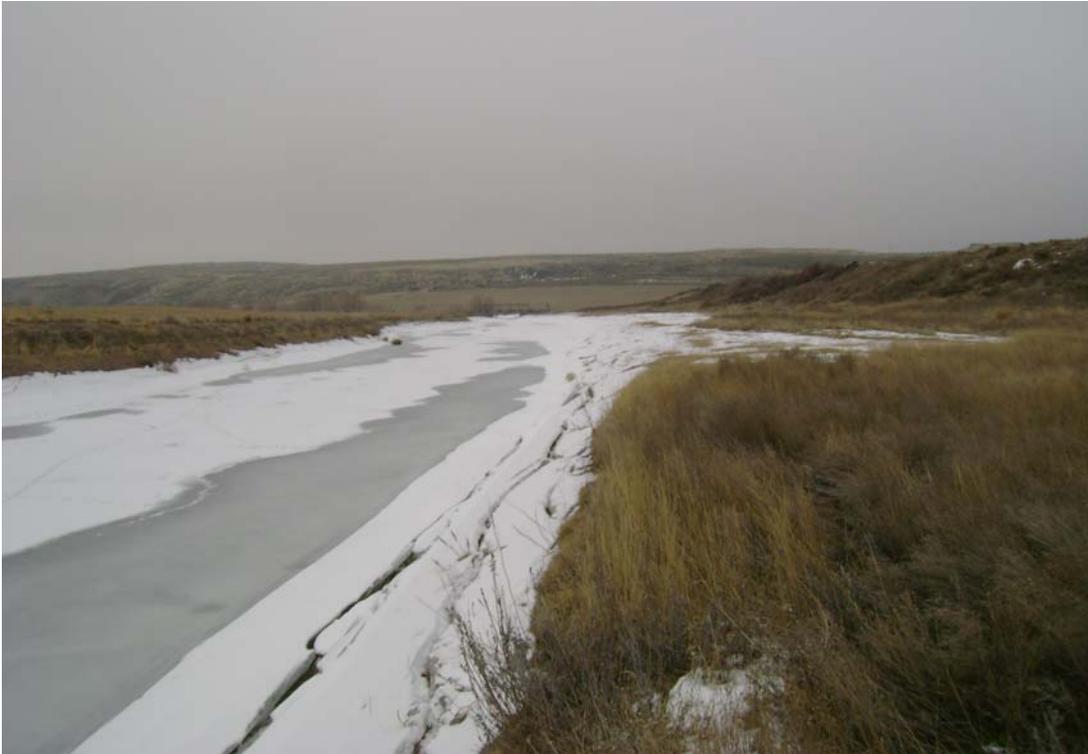
FIGURE E-8
Example photo documenting bank and channel conditions in Reach 1C

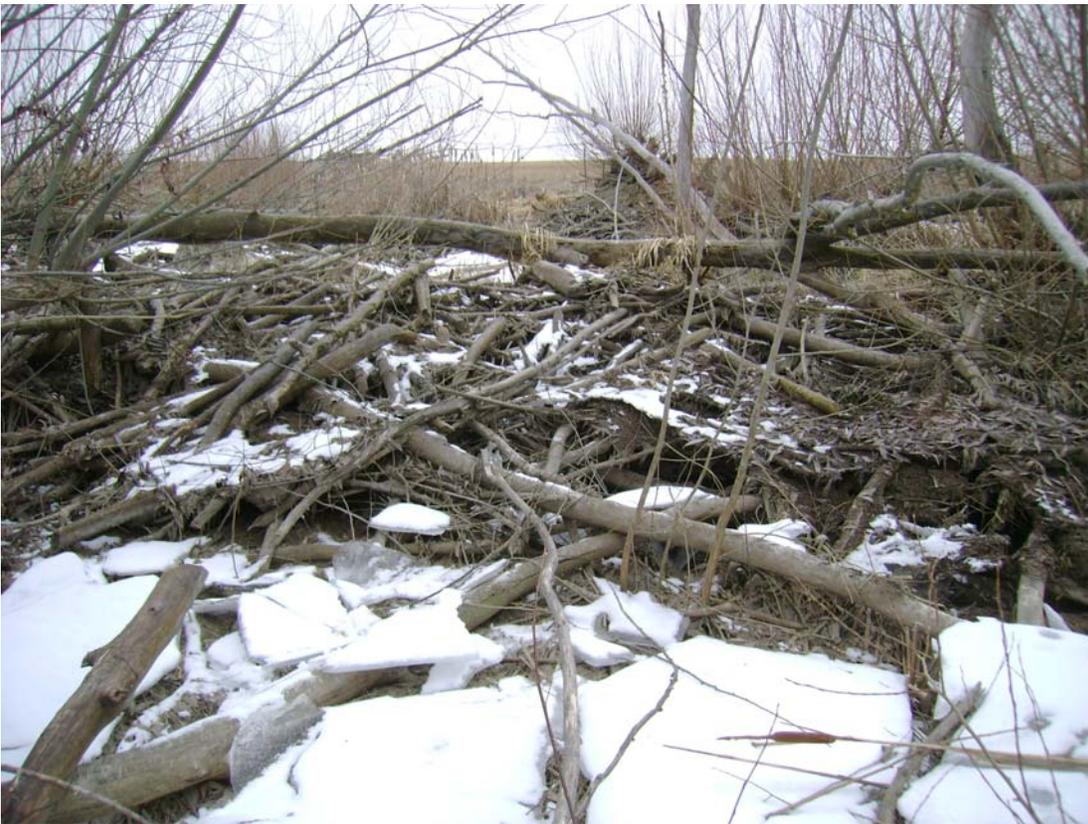
FIGURE E-9
One of three beaver dams located in Subreach 1D

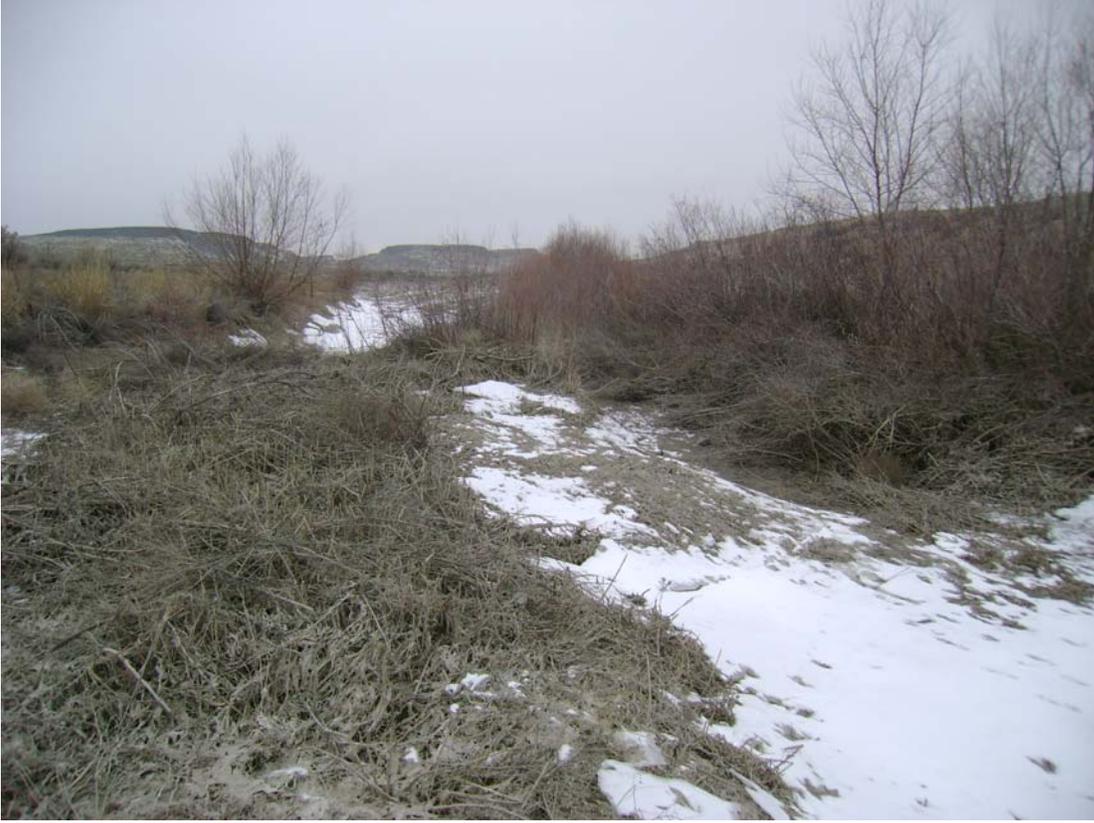
FIGURE E-10
Heavy debris in the channel located in Subreach 1D

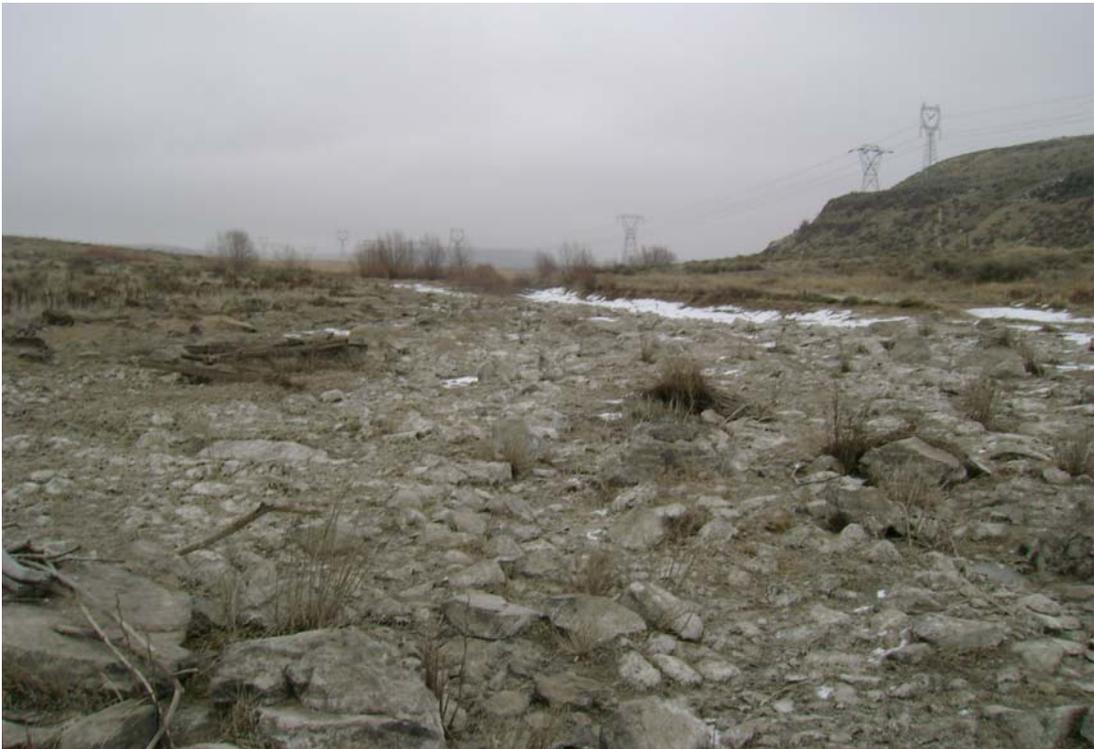
FIGURE E-11
Bedrock encountered in Subreach 1E

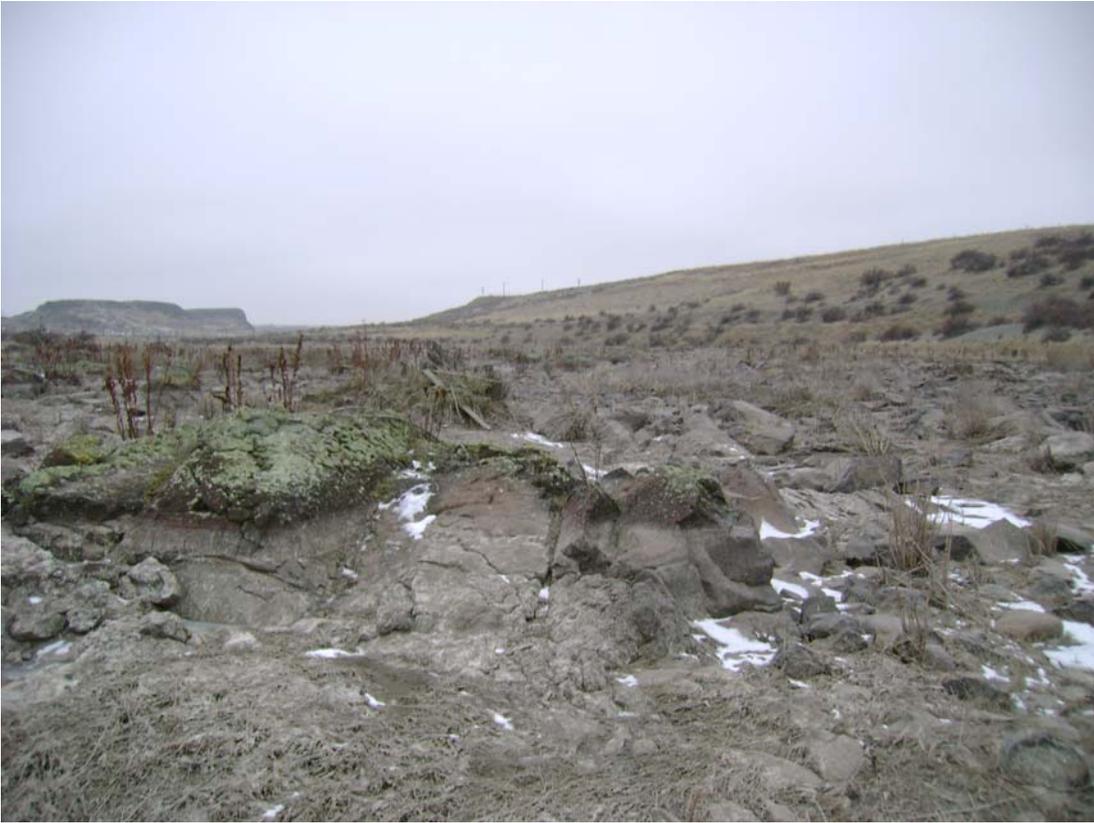
FIGURE E-12
Bedrock outcrop in Subreach 1E
