Oxbow Conservation Area Reach Assessment Middle Fork John Day River

Grant County, Oregon

U.S. Department of the Interior
Bureau of Reclamation
Pacific Northwest Region
Pacific Northwest Regional Office, Boise, Idaho

March 2010

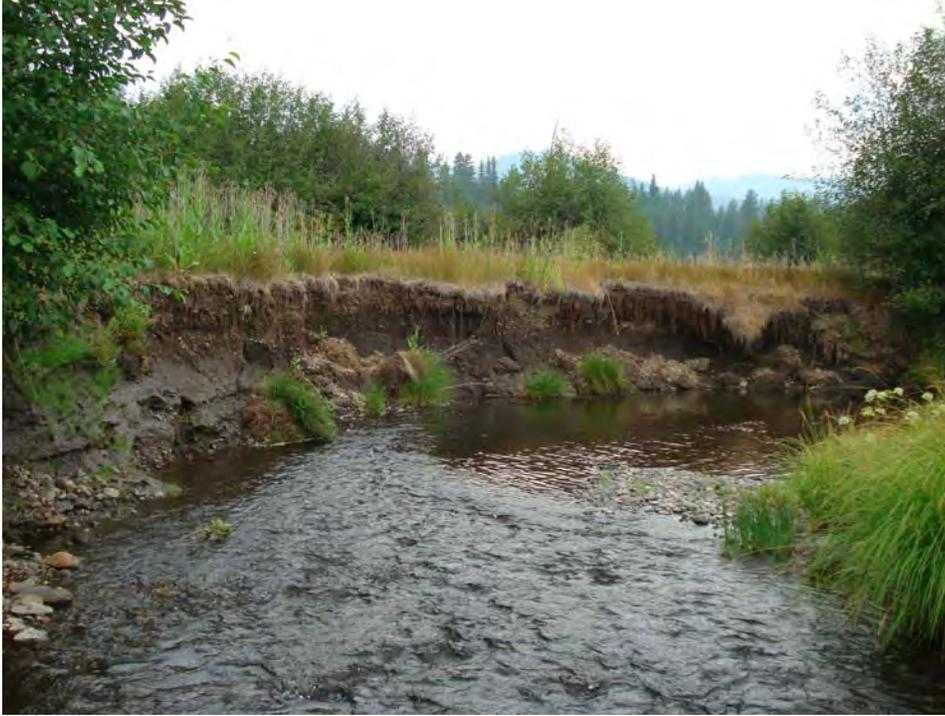
Figure 12. View is to the west looking downstream at bank erosion along river left. Oxbow Reach – Middle Fork John Day River – John Day Subbasin, Oregon – Reclamation photograph by R. McAfee, July 17, 2007.

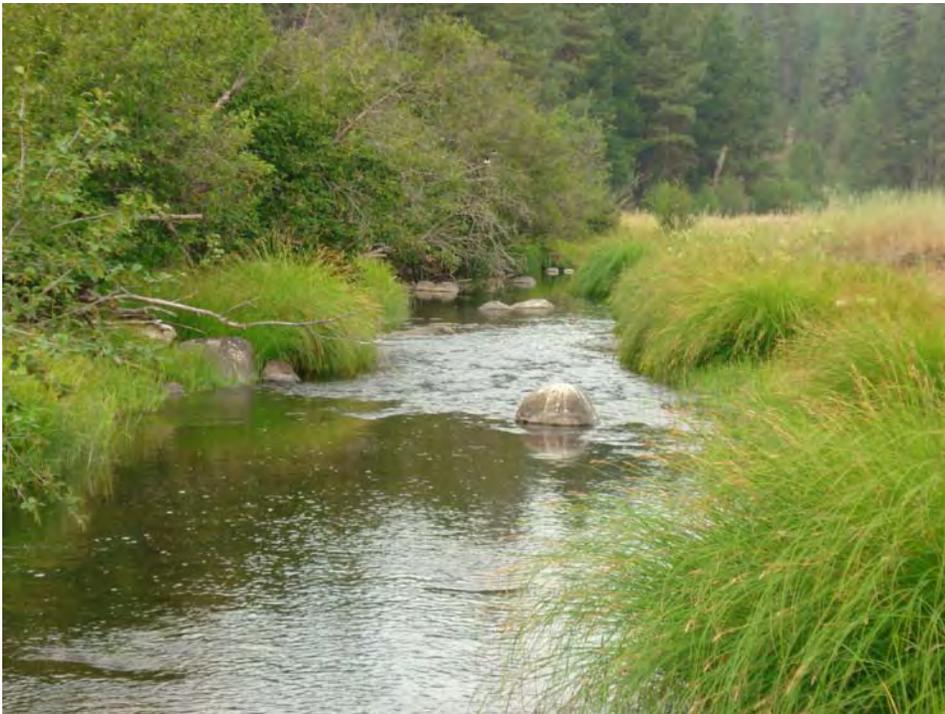
Figure 13. View is to the northeast looking at “pocket-pools” along the South Channel. Oxbow Reach – Middle Fork John Day River, Oregon – Bureau of Reclamation photograph by R. McAfee, July 17, 2007.

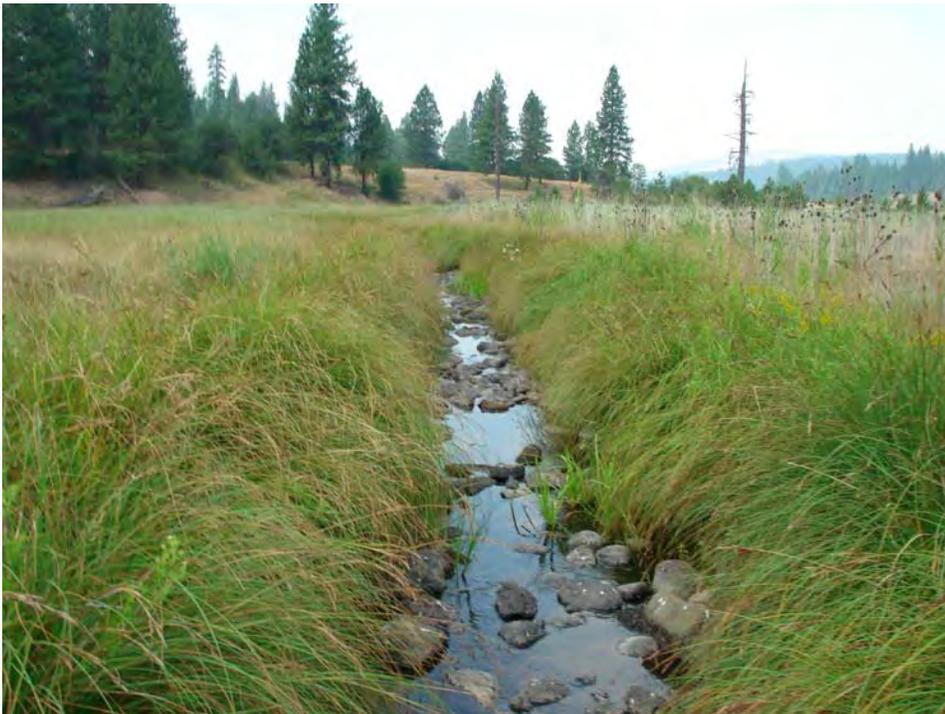
Figure 15. View is to the west looking at a small continuation of the South Channel (irrigation ditch). Oxbow Reach – Middle Fork John Day River, Oregon – Bureau of Reclamation photograph by R. McAfee, July 17, 2007.

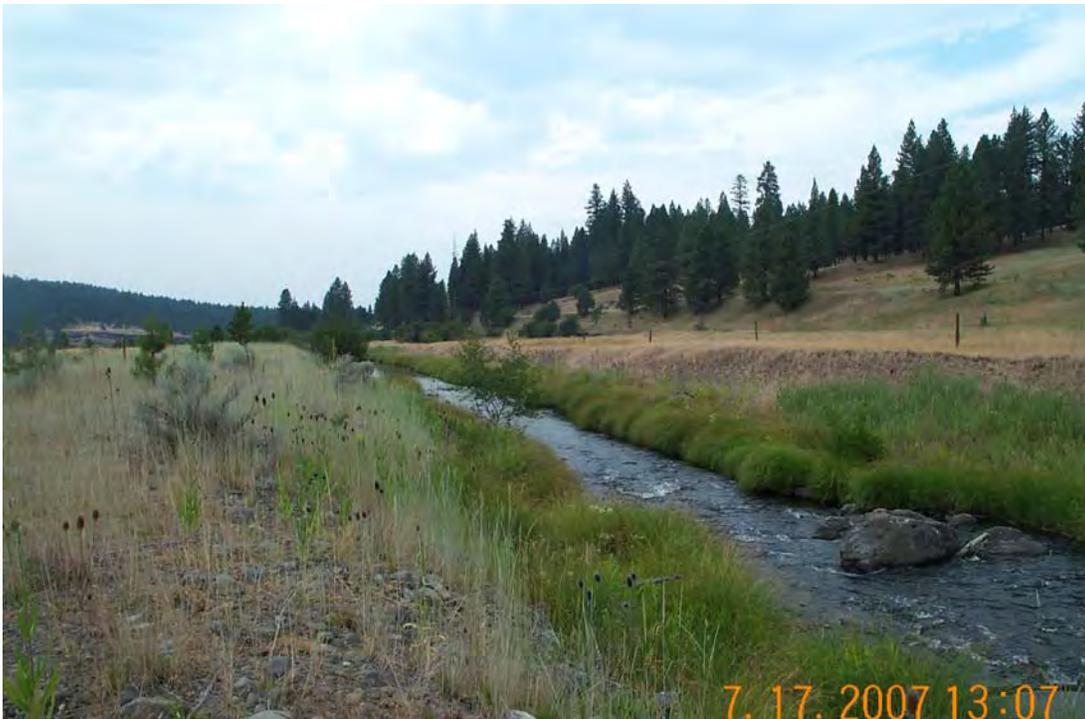
Figure 18. View is to the west looking at the mine tailings along river left where the river has been channelized. Oxbow Reach – Middle Fork John Day River, Oregon – Bureau of Reclamation photograph by E. Lyon, July 17, 2007.

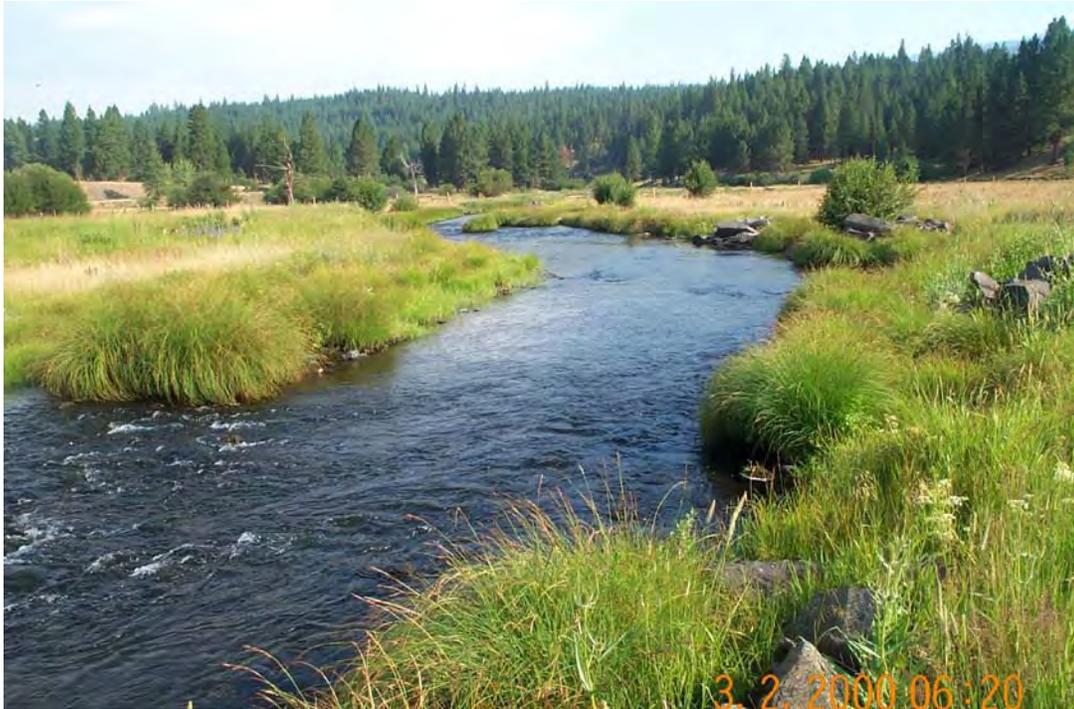
Figure 20. View is to the north looking downstream at rock spurs placed along river right. Oxbow Reach – Middle Fork John Day River, Oregon – Bureau of Reclamation photograph by E. Lyon, July 18, 2007.

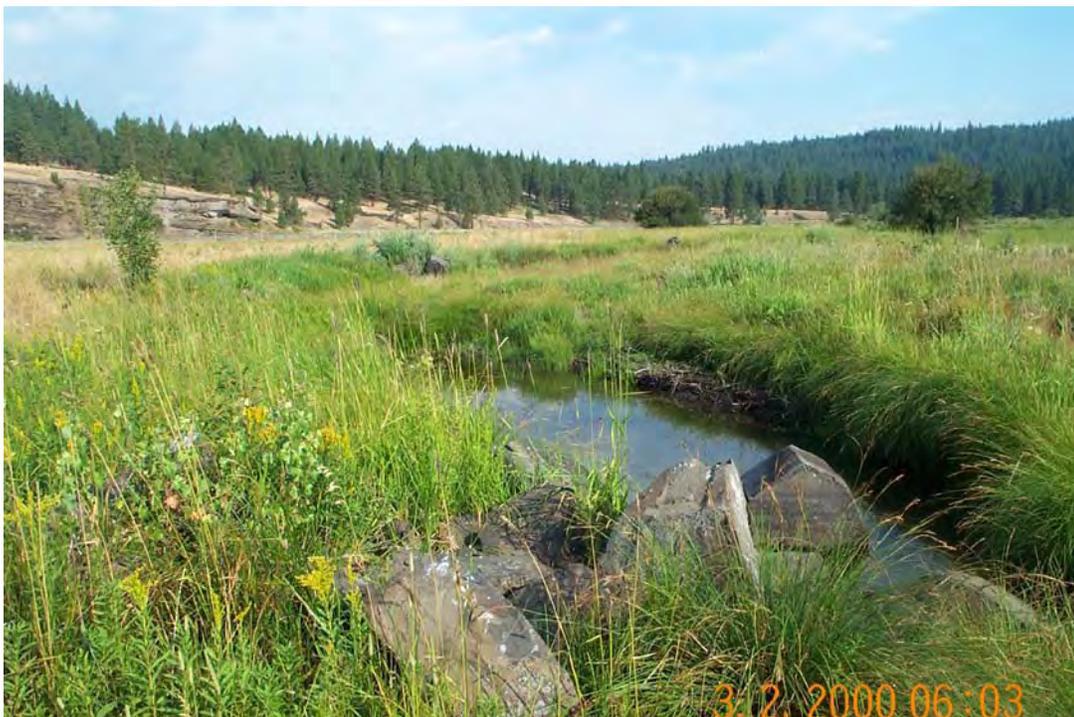
Figure 21. View is to the northwest looking downstream at rock spurs placed along the left bank of the side channel. Oxbow Reach – Middle Fork John Day River, Oregon – Bureau of Reclamation photograph by E. Lyon, July 18, 2007.

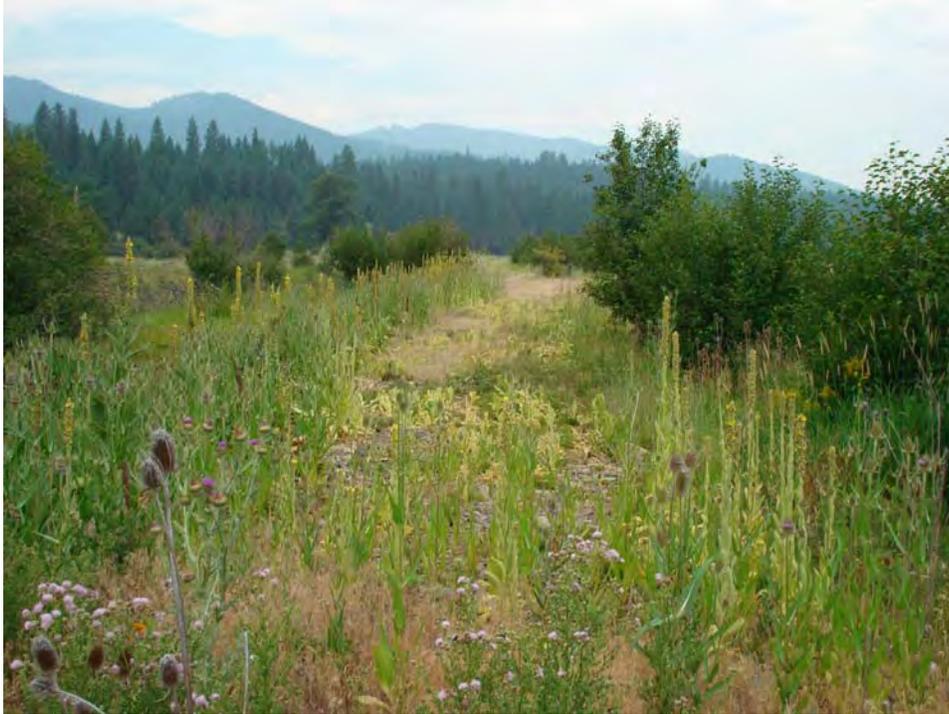
Figure 25. View is to the west looking at an embankment that bisects the floodplain between the North and South Channels. Oxbow Reach – Middle Fork John Day River, Oregon – Bureau of Reclamation photograph by R. McAfee, July 17, 2007.

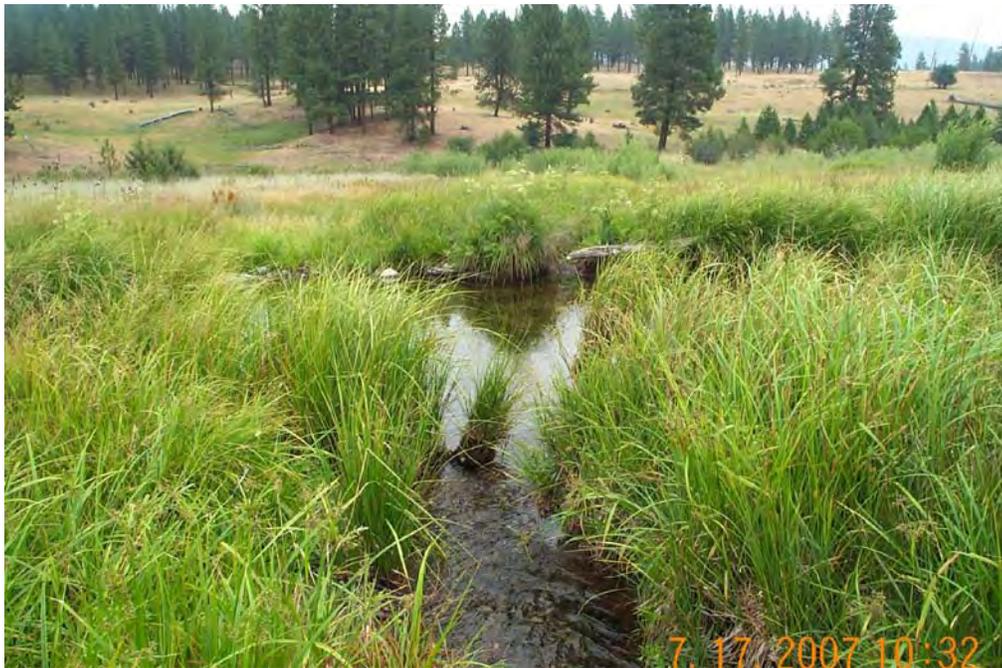
Photograph No. 66. View is to the east looking at Ruby Creek where it is diverted into an irrigation ditch. Oxbow Reach – Middle Fork John Day River – John Day Subbasin, Oregon – Bureau of Reclamation Photograph by E. Lyon, July 17, 2007.

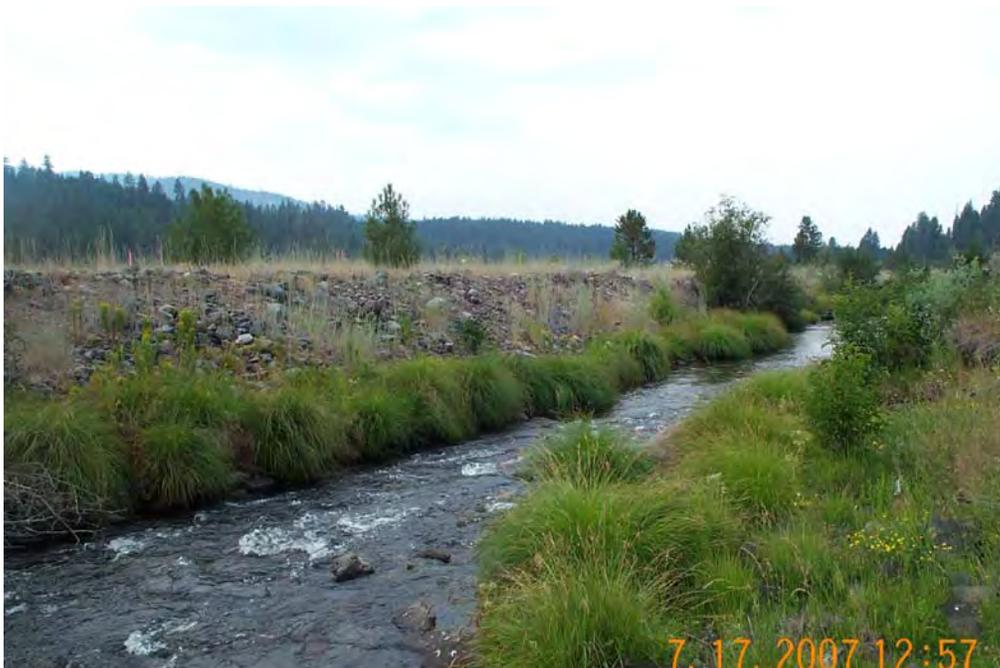
Photograph No. 68. View is to the west looking at the mine tailings (about 12-feet in height) along river left where the river has been channelized. Oxbow Reach – Middle Fork John Day River – John Day Subbasin, Oregon – Bureau of Reclamation Photograph by E. Lyon, July 17, 2007.

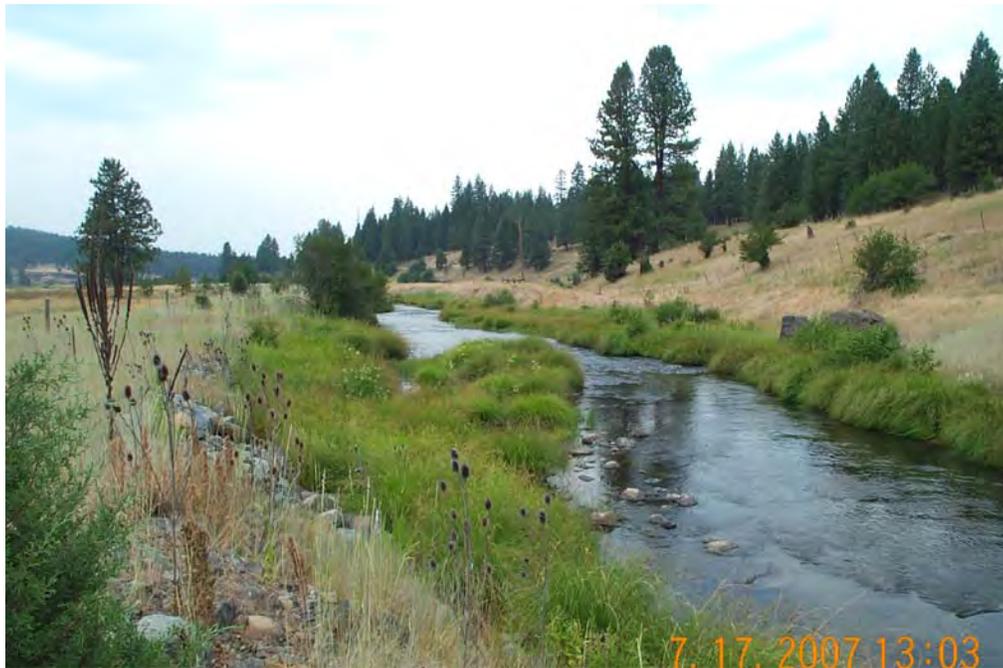
Photograph No. 70. View is to the west looking at the mine tailings along river left where the river has been channelized. Oxbow Reach – Middle Fork John Day River – John Day Subbasin, Oregon – Bureau of Reclamation Photograph by E. Lyon, July 17, 2007.

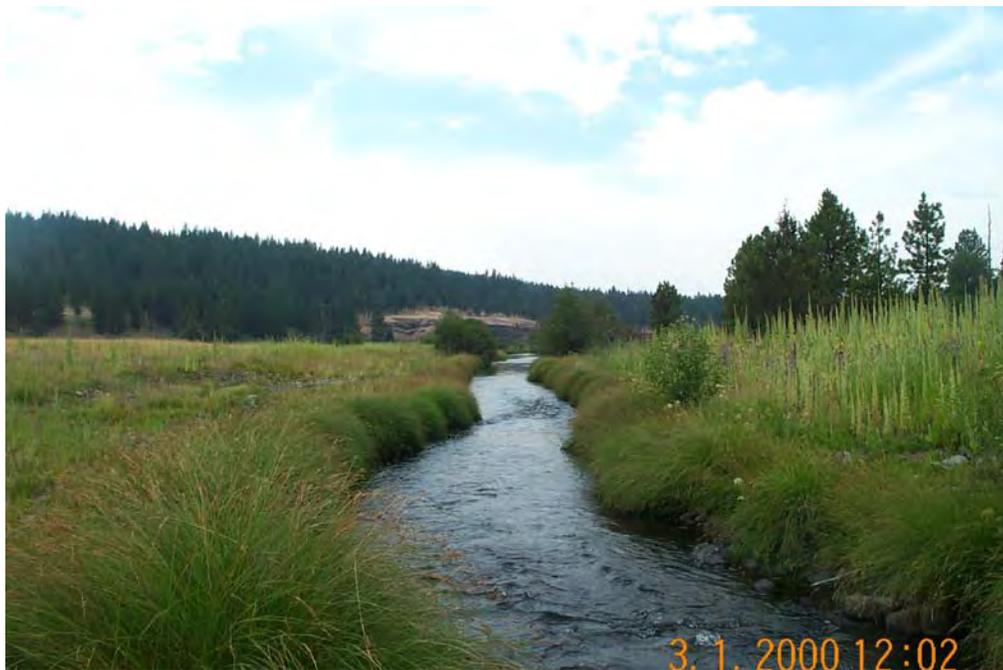
Photograph No. 74. View is to the west looking at the mine tailings (about 12-feet in height) along river left where the river has been channelized. Oxbow Reach – Middle Fork John Day River – John Day Subbasin, Oregon – Bureau of Reclamation Photograph by E. Lyon, July 17, 2007.

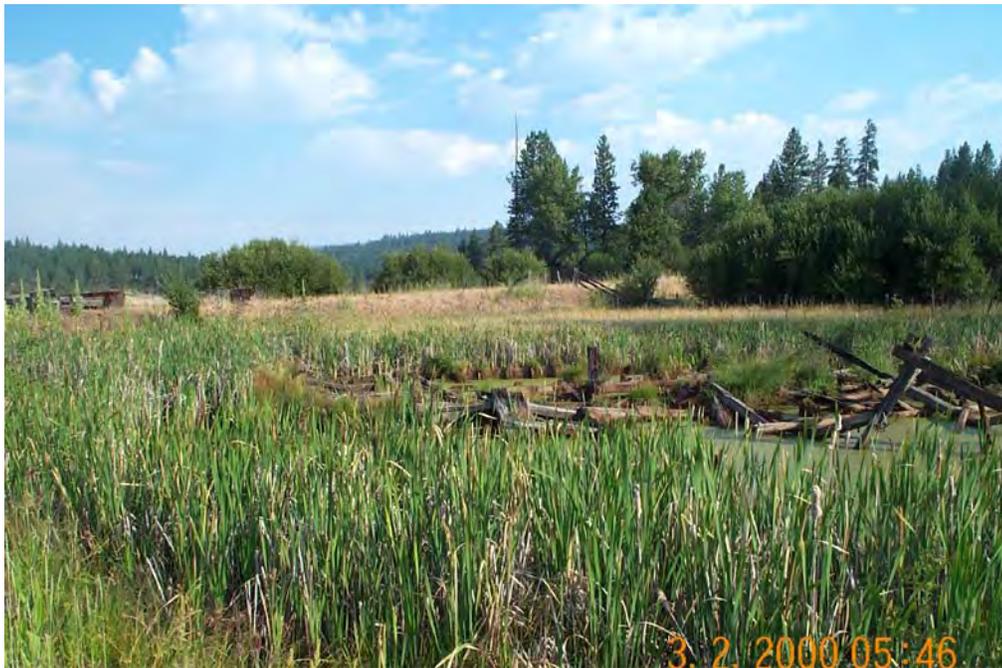
Photograph No. 82. View is to the northwest looking at remains of dredge left in the wetland area. Oxbow Reach – Middle Fork John Day River – John Day Subbasin, Oregon – Bureau of Reclamation Photograph by E. Lyon, July 18, 2007.

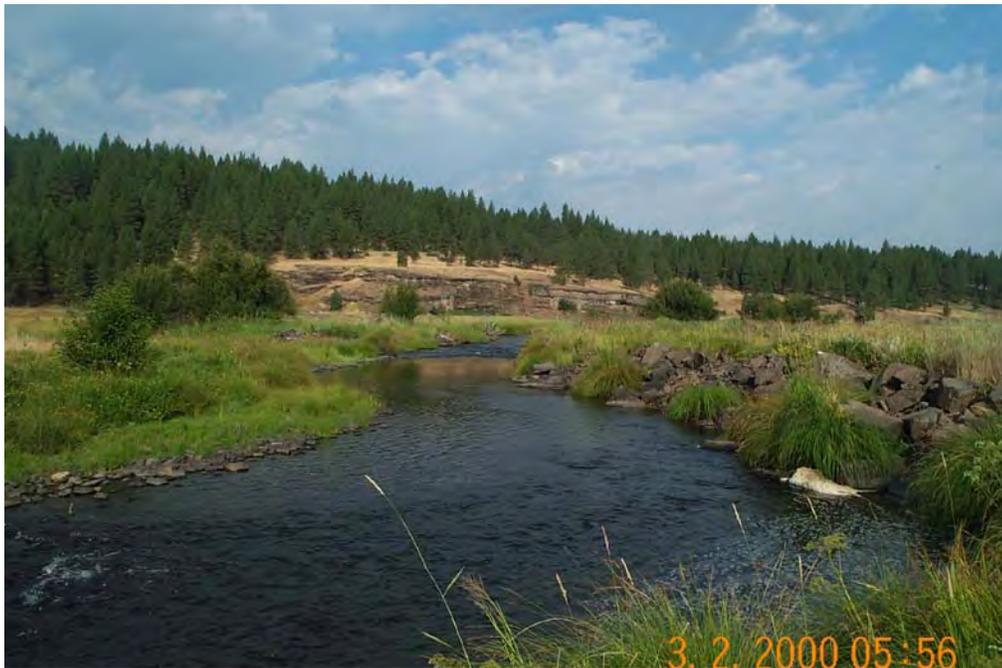
Photograph No. 86. View is to the west looking downstream at riprap placed along river right. Oxbow Reach – Middle Fork John Day River – John Day Subbasin, Oregon – Bureau of Reclamation Photograph by E. Lyon, July 18, 2007.

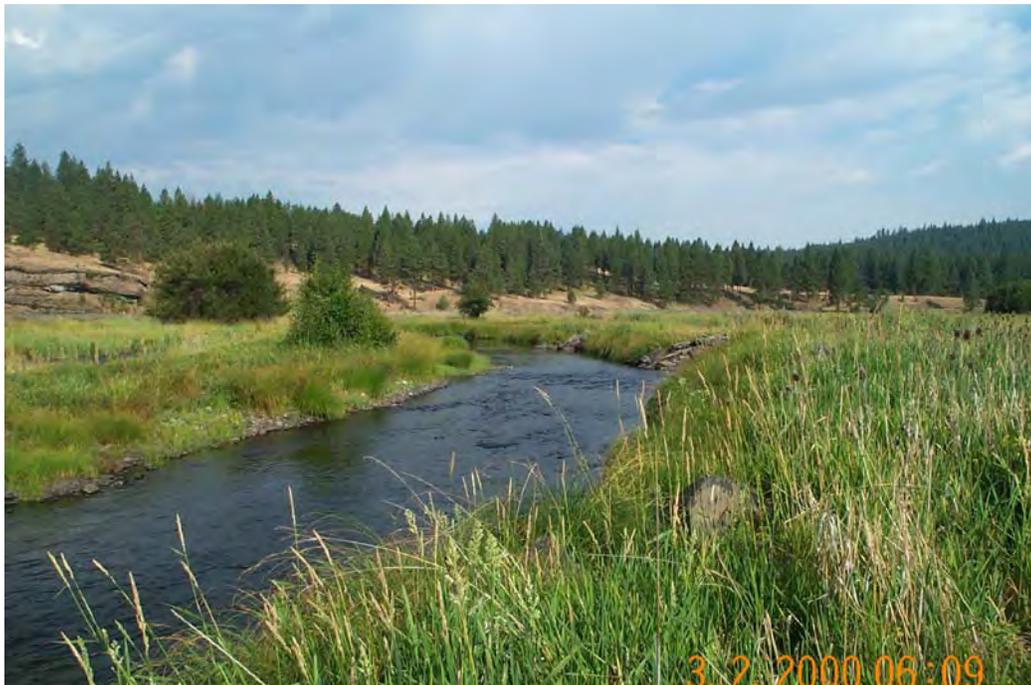
Photograph No. 90. View is to the northwest looking downstream at rock spurs placed along river right. Oxbow Reach – Middle Fork John Day River – John Day Subbasin, Oregon – Bureau of Reclamation Photograph by E. Lyon, July 18, 2007.
