**CANAL-LINING DEMONSTRATION PROJECT
YEAR 7 DURABILITY REPORT**

September 1999

**U.S. DEPARTMENT OF THE INTERIOR
Bureau of Reclamation**

**Pacific Northwest Region
Water Conservation Center**

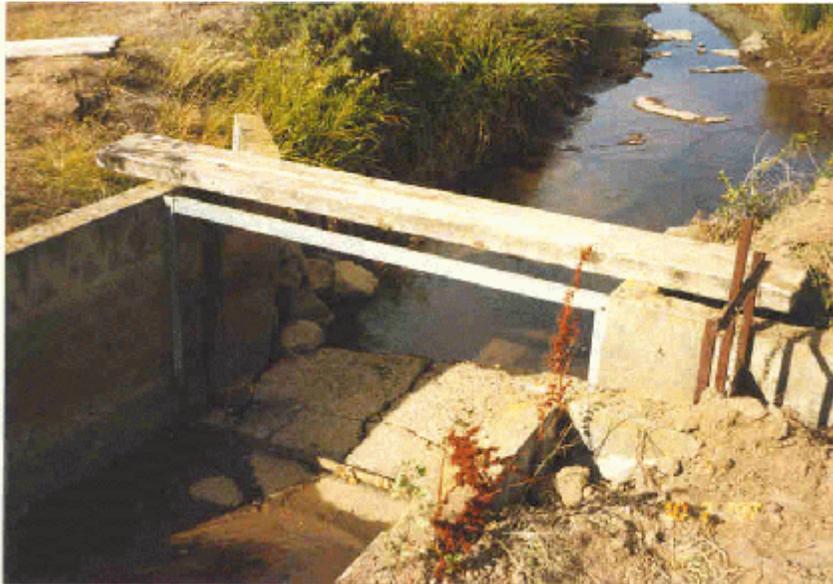
Photograph 20.—Canal has been dewatered, and the trees have been removed from the canal banks. Cracks in the canal invert show the poor condition of the concrete turnout structure.

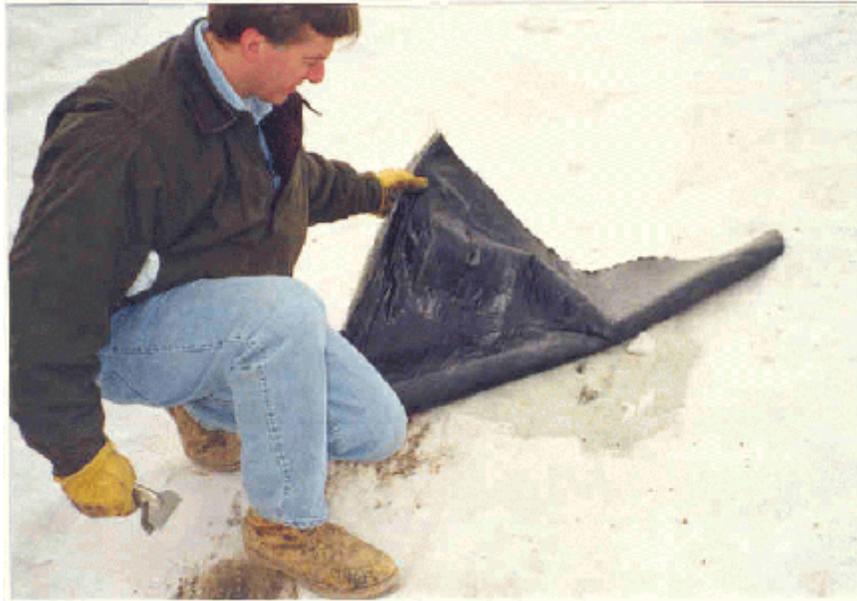
Difficulties: The forklift operator tore several rolls of GCL picking them off the ground. The tears often damaged 2-3 layers per roll. Damaged GCL was either discarded or patched by covering with additional GCL. Patches covered the damaged area for at least 1 foot in all directions, and granular Bentonite was sprinkled into the seams.

Photograph 34.—Damaged GCL repaired with granular Bentonite and GCL patch.

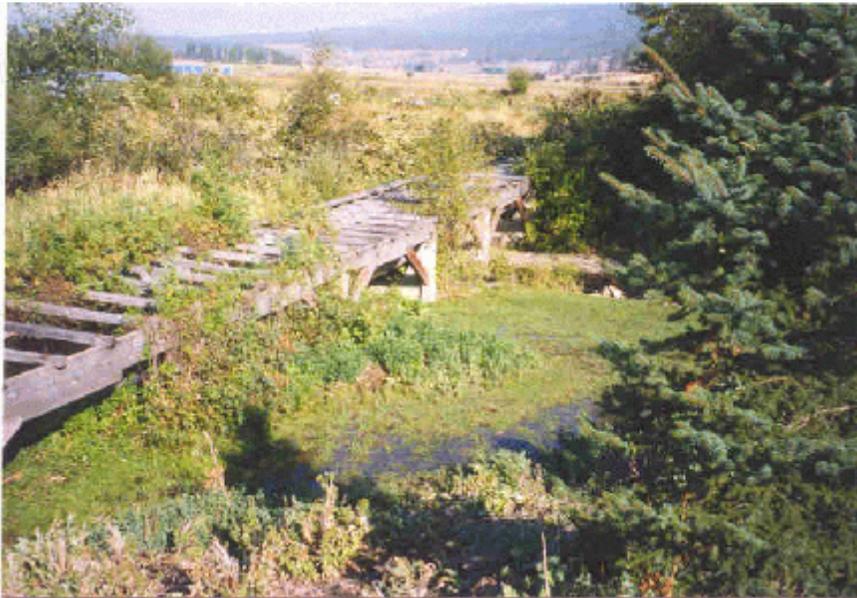
Photograph 43.—Swamp had developed from seepage through joints in 3-foot steel panels.

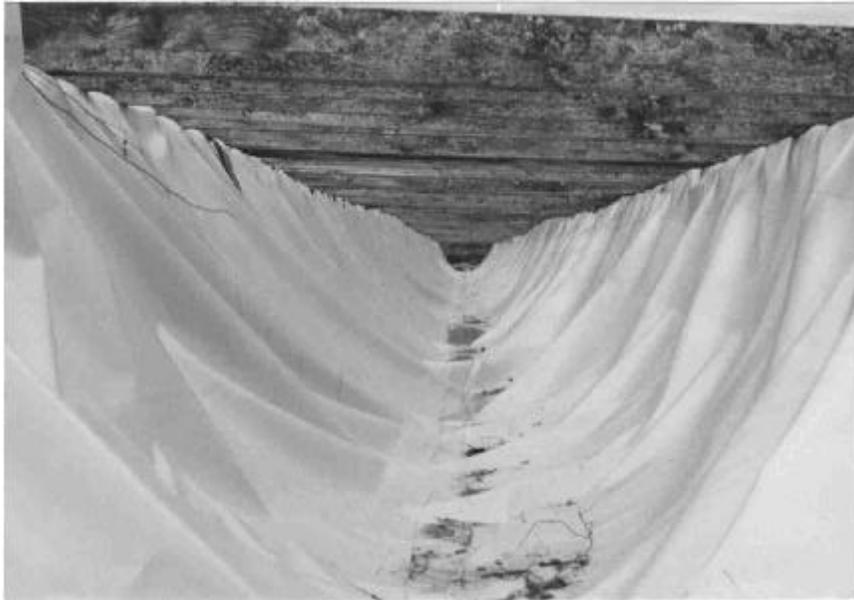
Photograph 56.—Wrinkles indicate that the liner was installed in a slack condition.

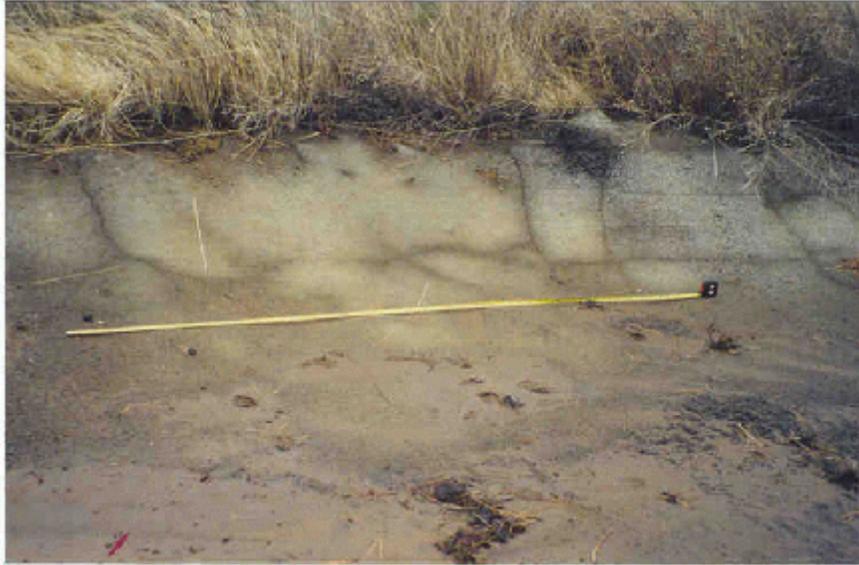
Photograph 81.—Random cracks are visible in the invert as well as in the sidewalls.

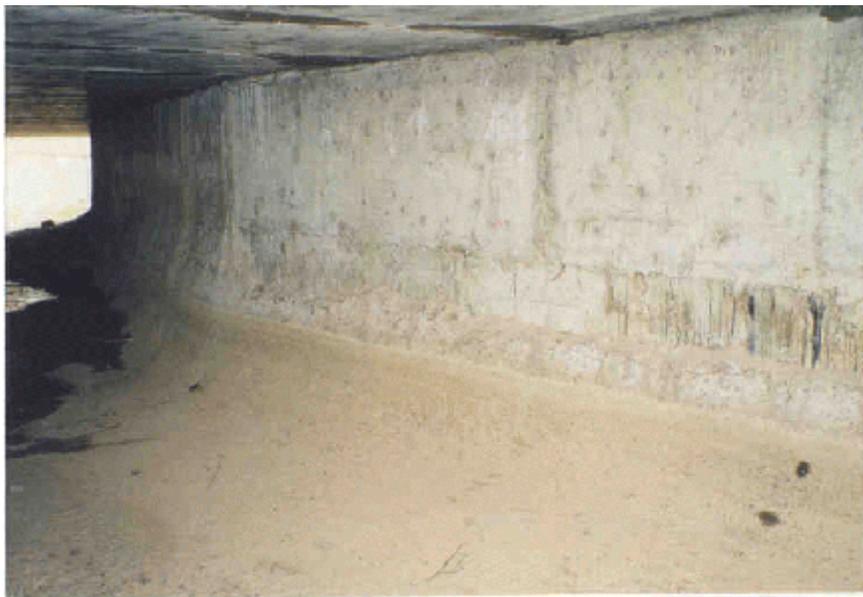
Photograph 82.—Shotcrete lining in tunnel beneath the new bridge has spalled in some locations, but spall is not progressing.

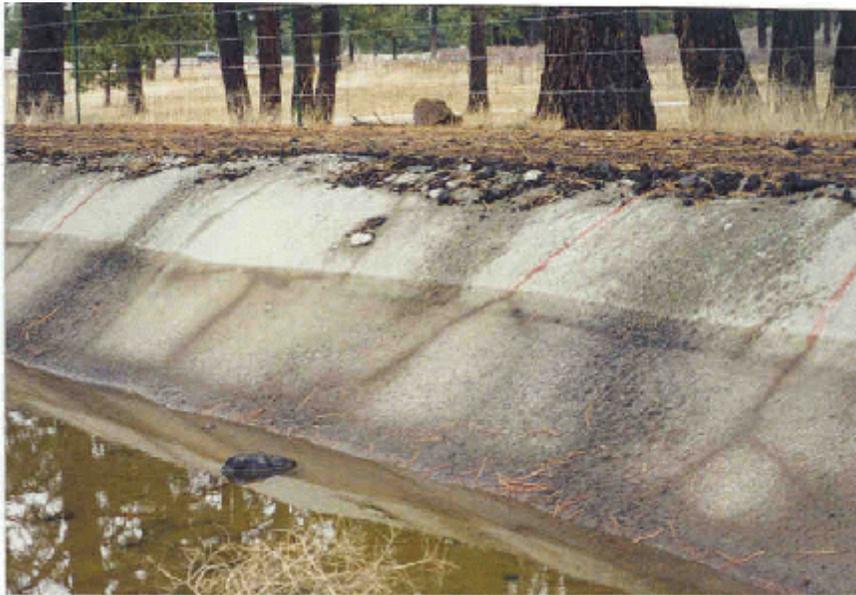
Photograph 84.—Transverse contraction cracks are visible on the sidewalls.
Red spray paint from 1996 inspection shows that number and length of cracks have increased.

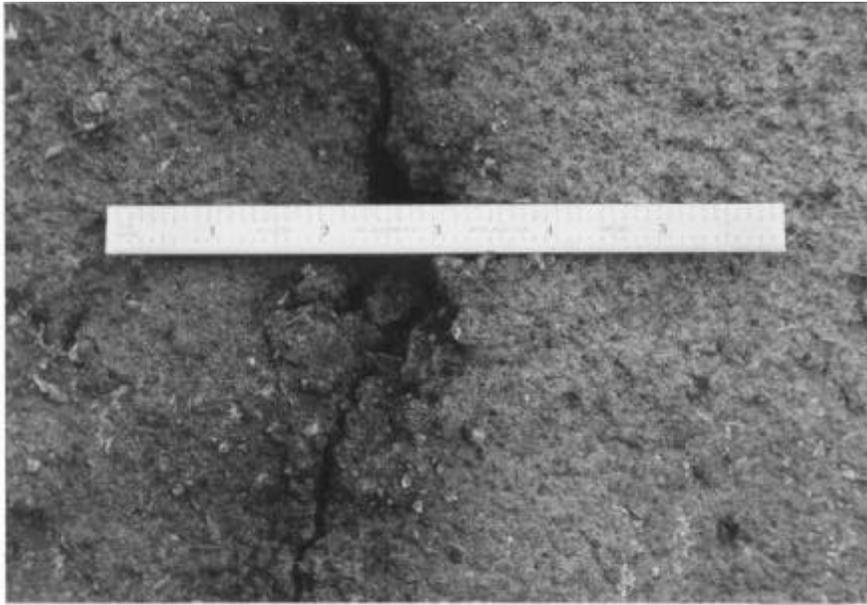
Photograph 85.—Largest cracks measure up to 3/16 inch wide.

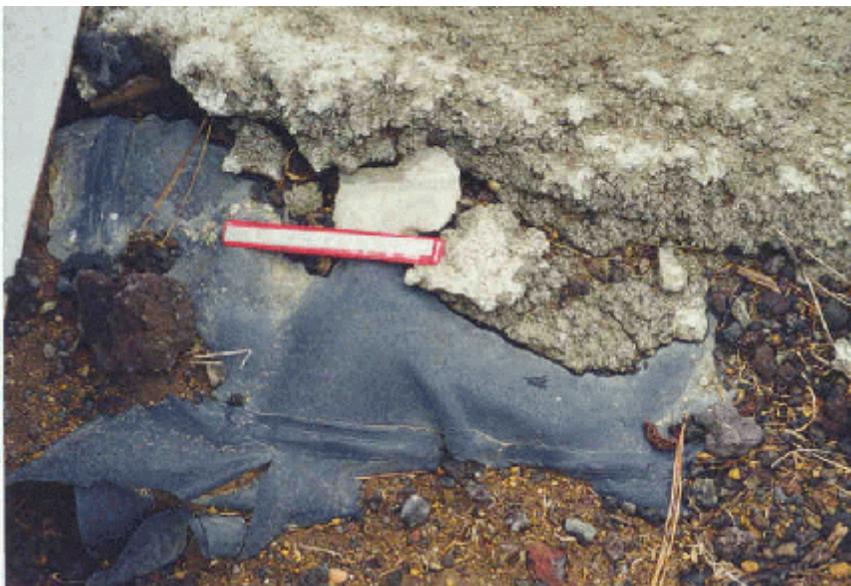
Photograph 86.—Thin shotcrete over anchor trench is less than 1 inch thick and severely cracked.

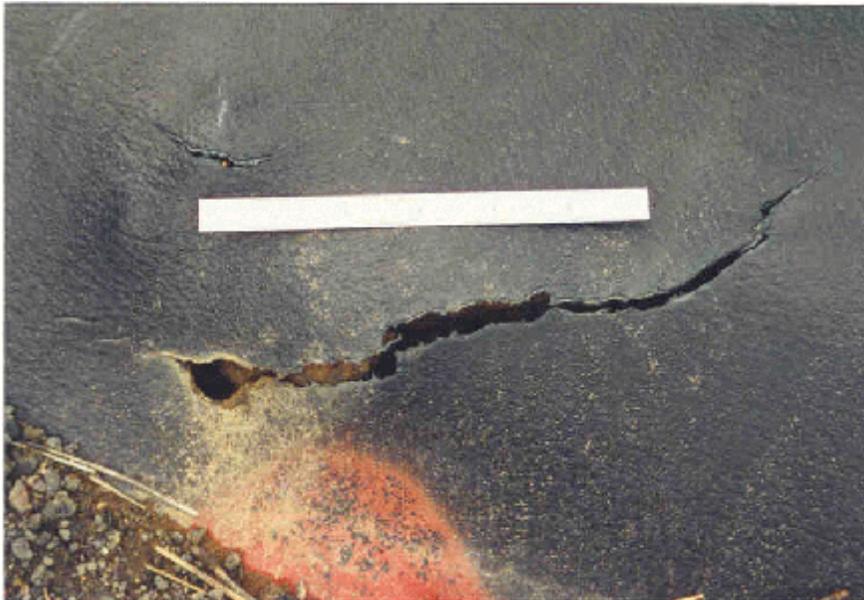
Photograph 88.—Tears in the liner at station 16+00.

Needed: Patch half a dozen small tears in the liner. District needs a small hand-held extrusion welder to perform repairs.

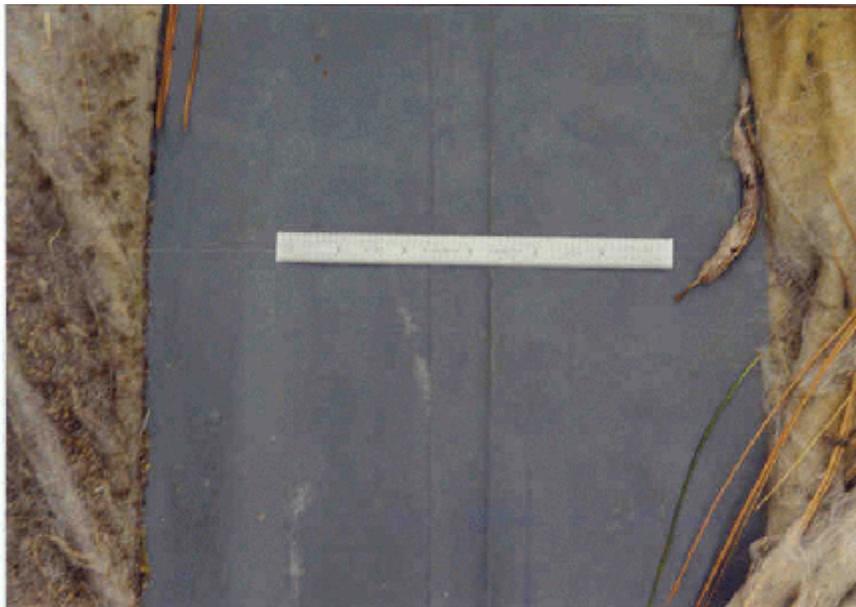
Photograph 90.—Exposed PVC geomembrane where the geotextile seam needs repair.

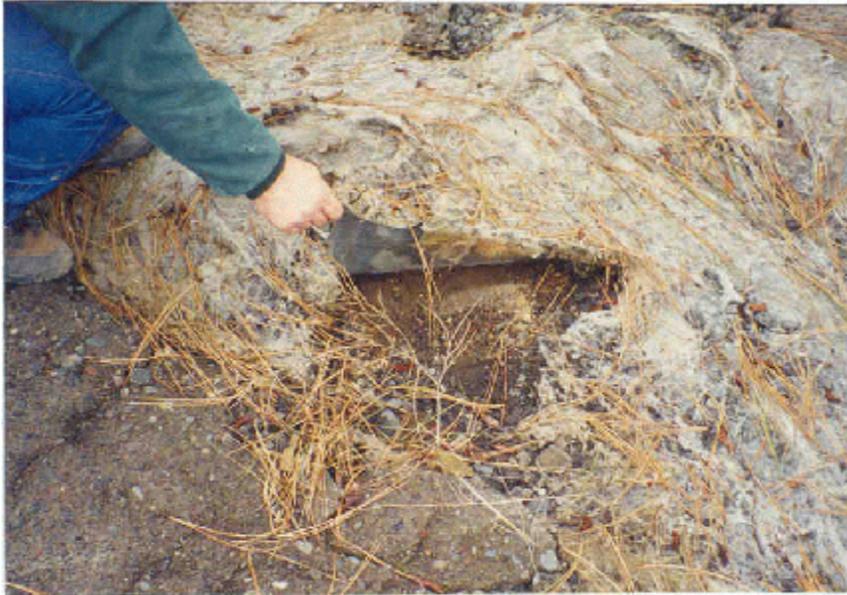
Photograph 91.—Tear in geomembrane (from falling tree) at station 20+20 needs repair.

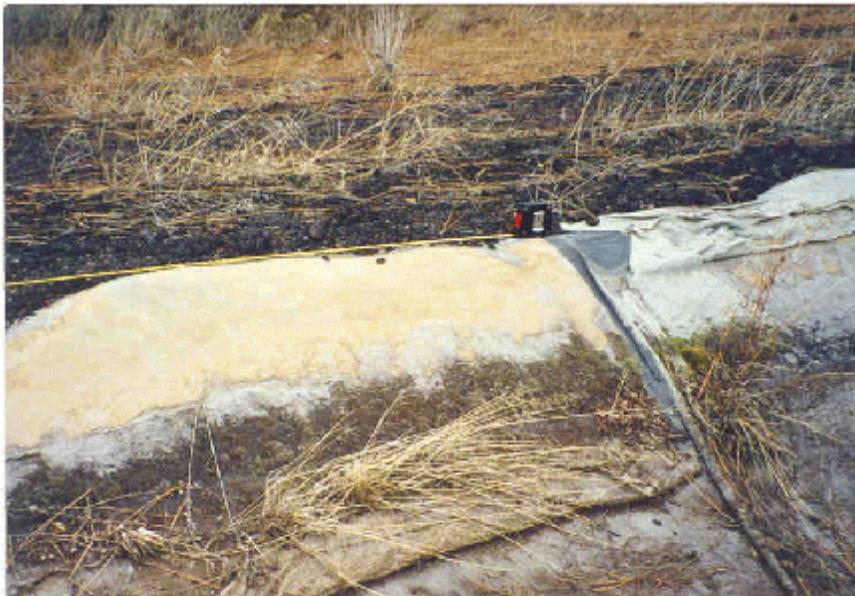
Photograph 92.—At the top of the canal bank, the geotextile is deteriorating from UV exposure.

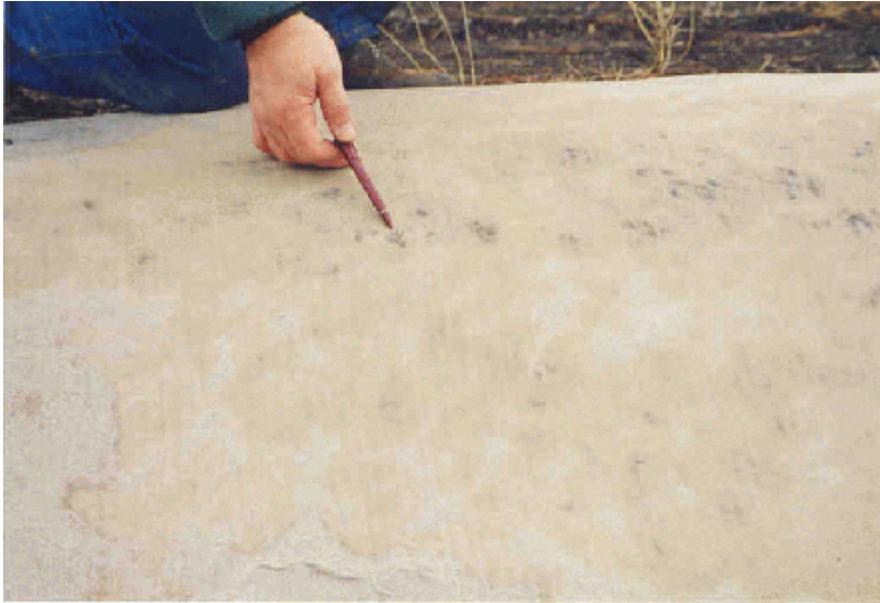
Photograph 93.—Closeup of deteriorating geotextile above the waterline.
PVC geomembrane is visible beneath deteriorating geotextile.

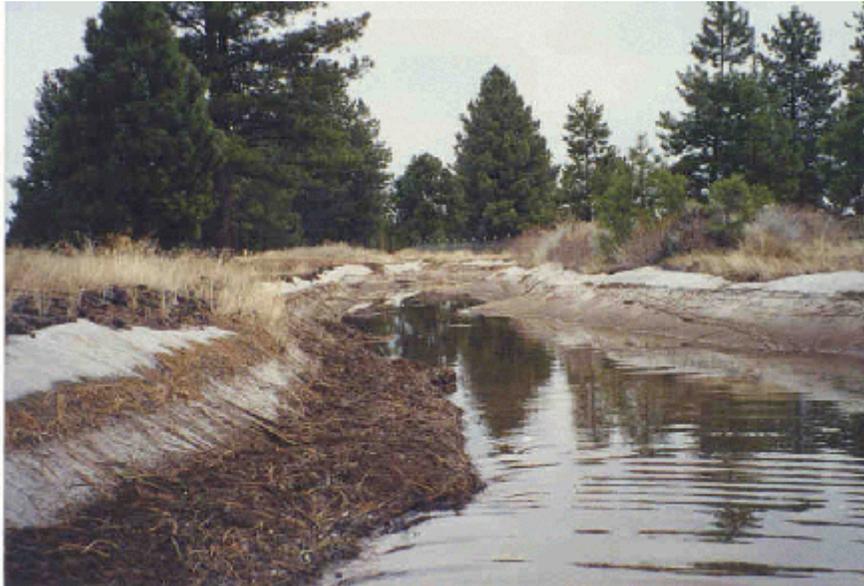
Sediment Cover.—Many of the exposed geomembranes are collecting sediment in the invert. This sediment may act as ballast against uplift, and may provide protection from UV and mechanical damage. Unknown if this sediment will improve design life.

Photograph 94.—A great deal of sediment has collected in the canal around
this bend between stations 23+00 and 27+00.

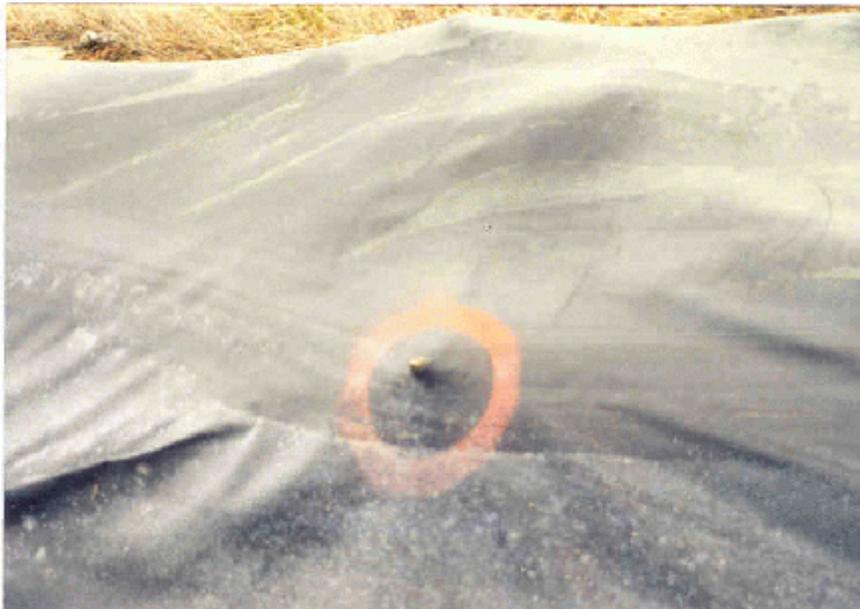
Photograph 96.—Sharp subgrade rock (or stick) has punctured the liner at station 33+20. The puncture has not progressed over the last 4 years.

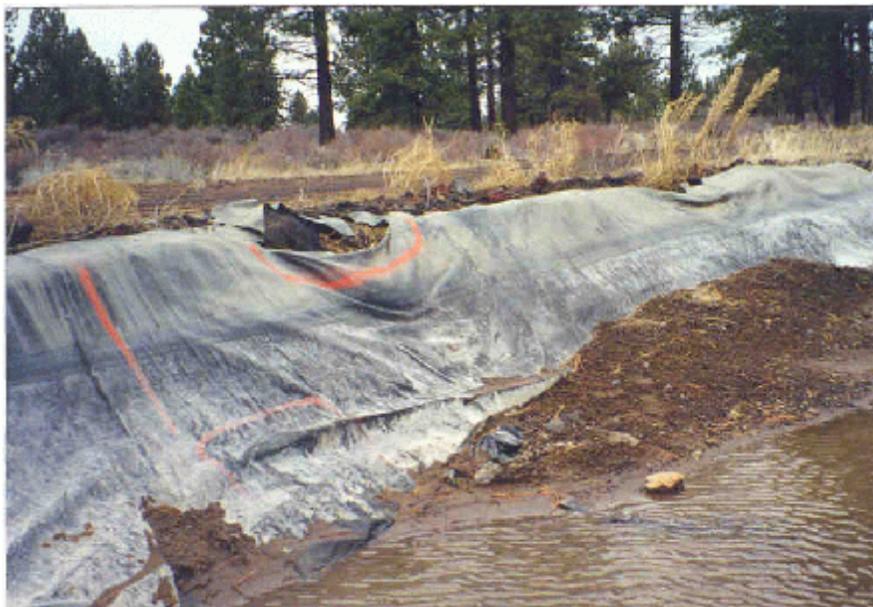
Photograph 100.—Several tears at the downstream end (station 40+00) need to be repaired.
Test Section A-7—

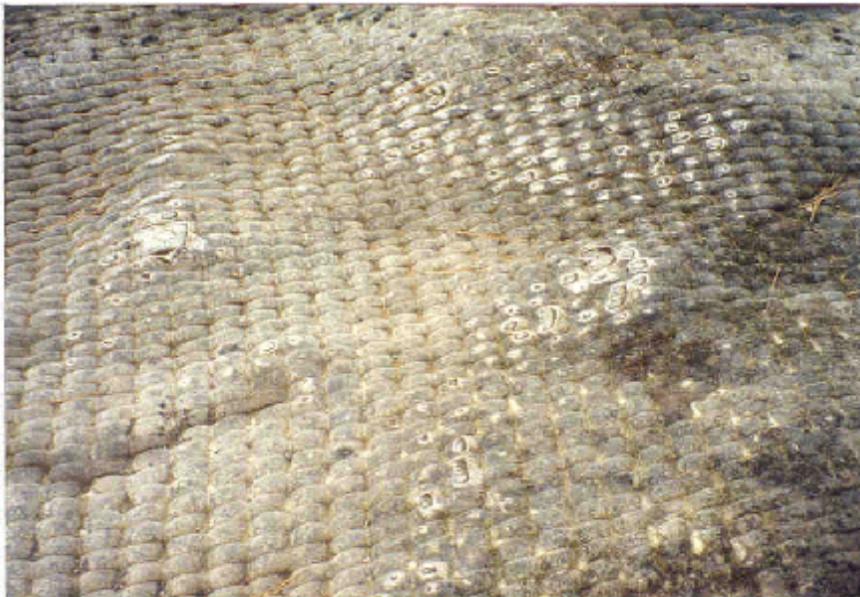
Photograph 102.—Geotextile is deteriorating and is abraded completely in some areas.

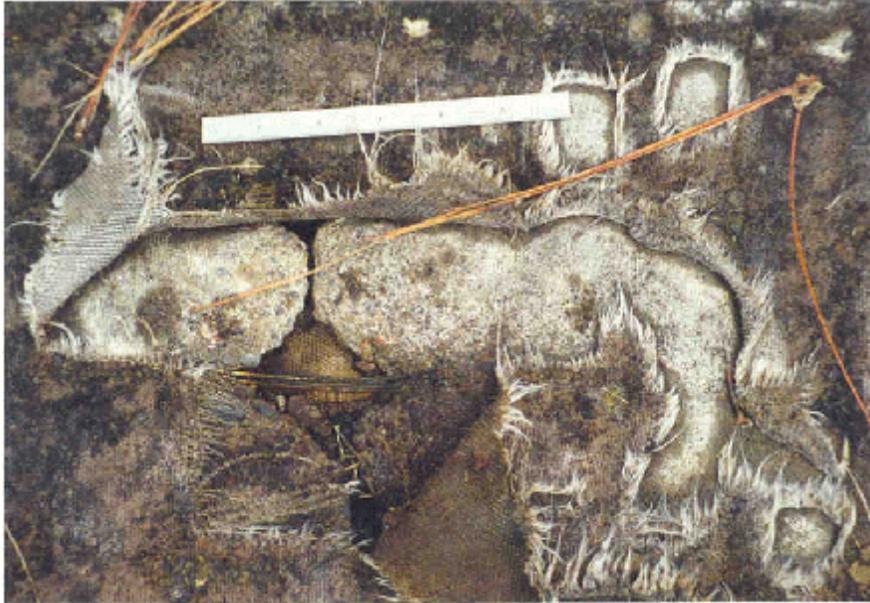
Photograph 103.—Closeup of area with deteriorated geotextile.
Note that some of the grout bricks are also missing in this area.

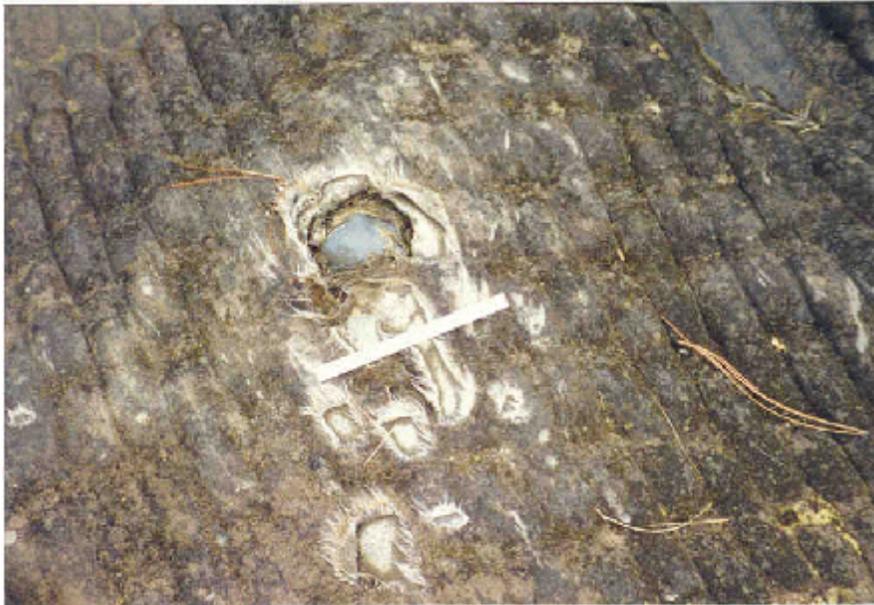
Photograph 104.—PVC membrane visible beneath grout mattress.
Grout was only about ½ inch thick in this location.

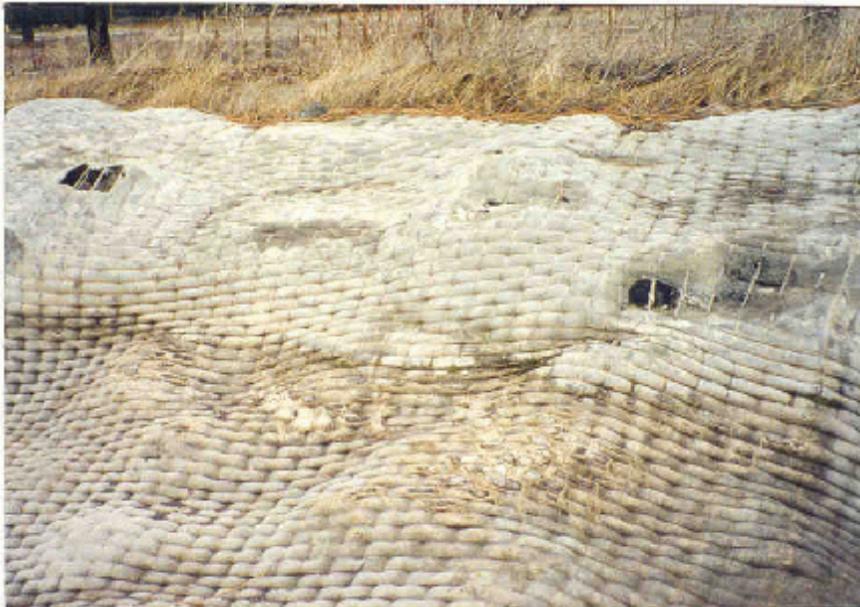
Photograph 106.—The grout-filled mattress is missing several bricks at station 54+50.

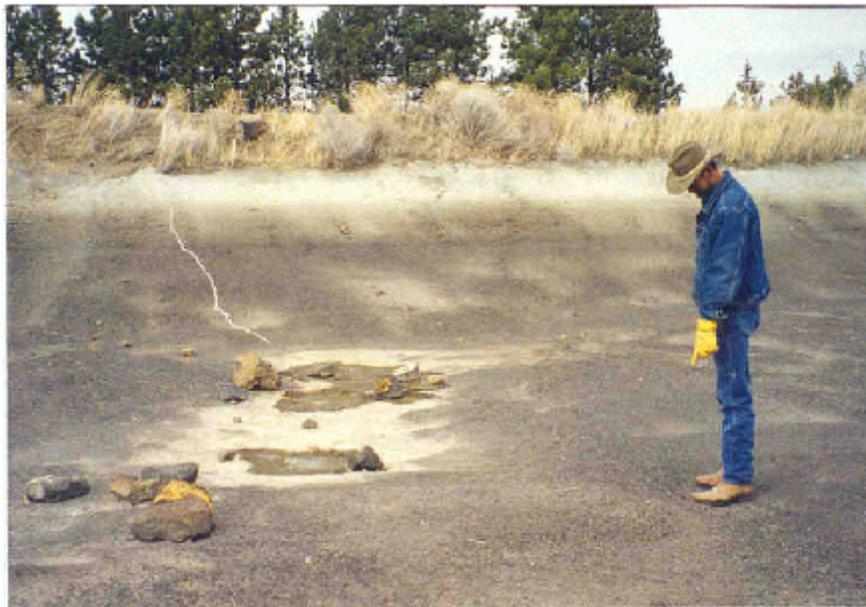
Photograph 109.—Transverse crack on side slope now extends into the invert for a total length of about 30 feet. Ditchrider pointing at end of crack in the invert.

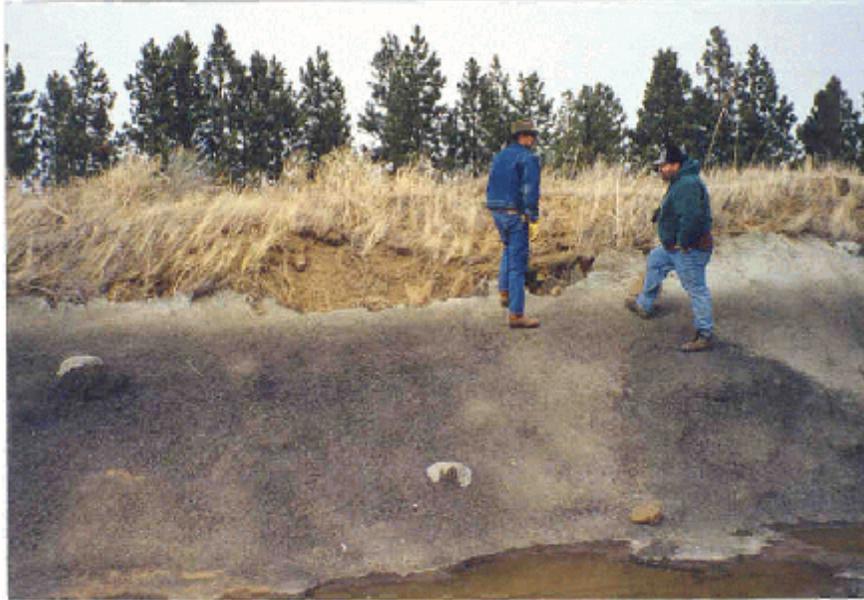
Photograph 110.—Area at top of canal lining where subgrade is washing out behind lining.

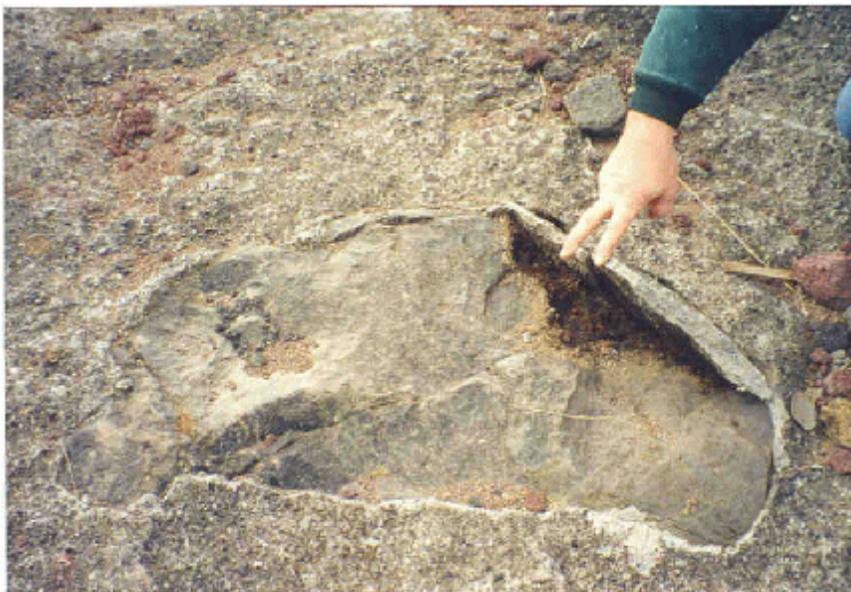
Photograph 115.—Two-ft diameter hole in shotcrete lining.
Note that the shotcrete is only about $\frac{1}{2}$ inch thick in this location.

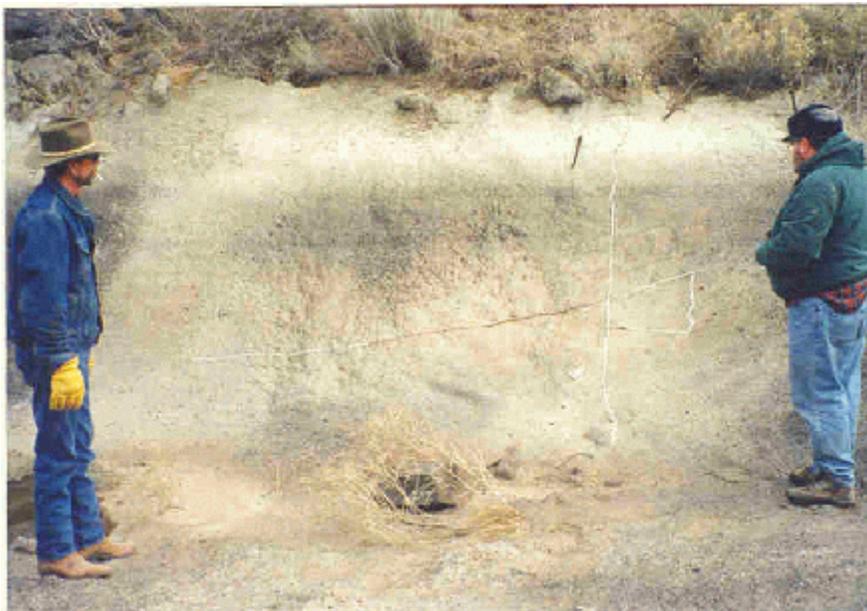
Photograph 118.—Extent of random cracking at this location has not increased over the last few years.

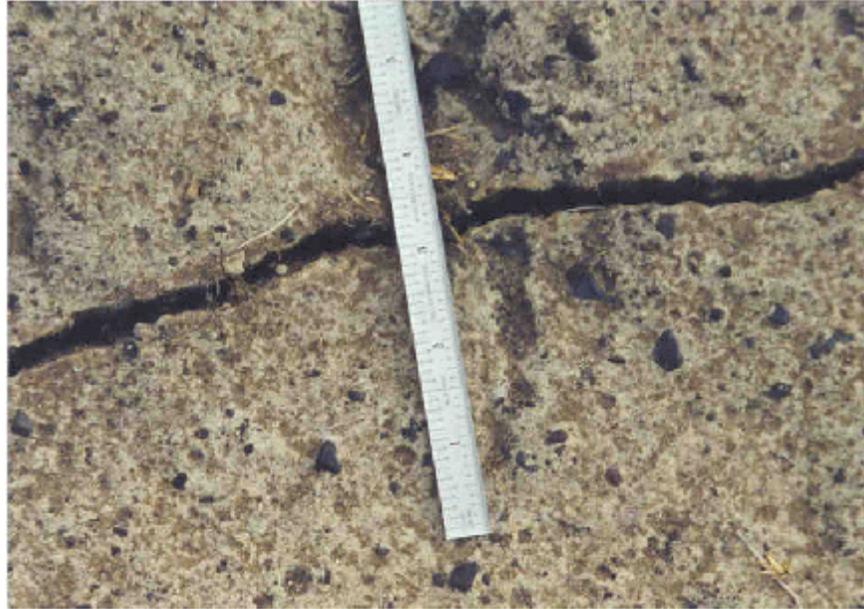
Photograph 119.—Largest crack measures about ¼ inch wide.

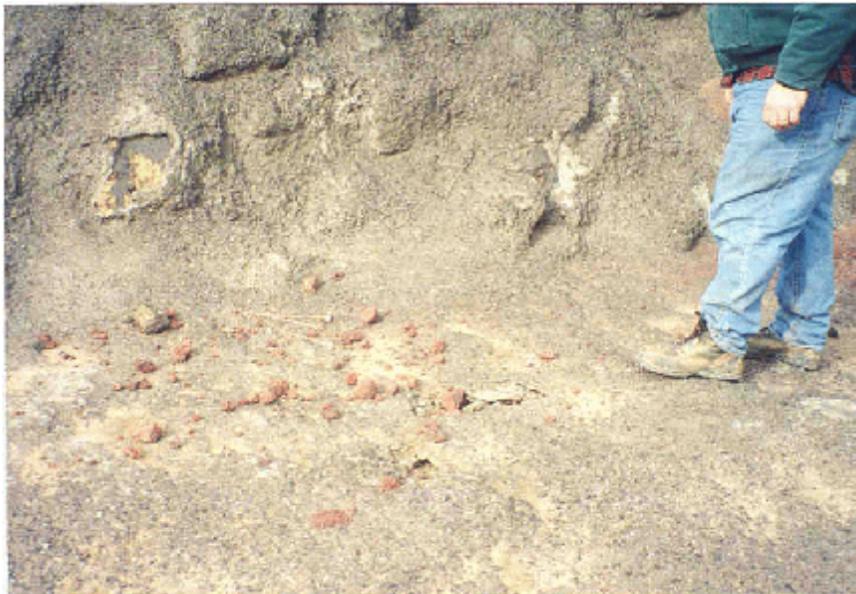
Photograph 121.—Several holes in shotcrete, exposing subgrade rocks on sidewall.

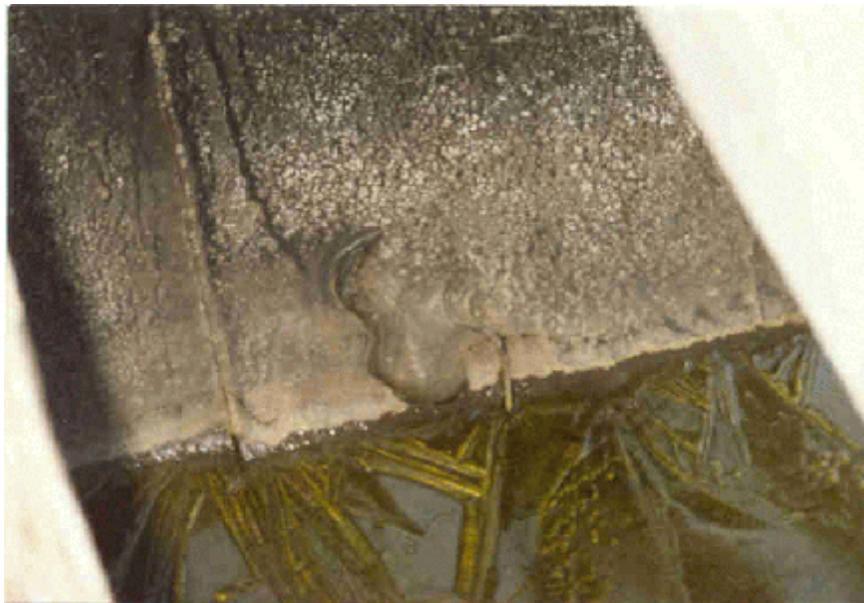
Liquid Boot - Excellent effectiveness (90 percent). Problems with blistering below the waterline raise questions about durability. Can be repaired with hand-mix version.

Photograph 128.—Closeup of 6-inch blister on the sidewall.

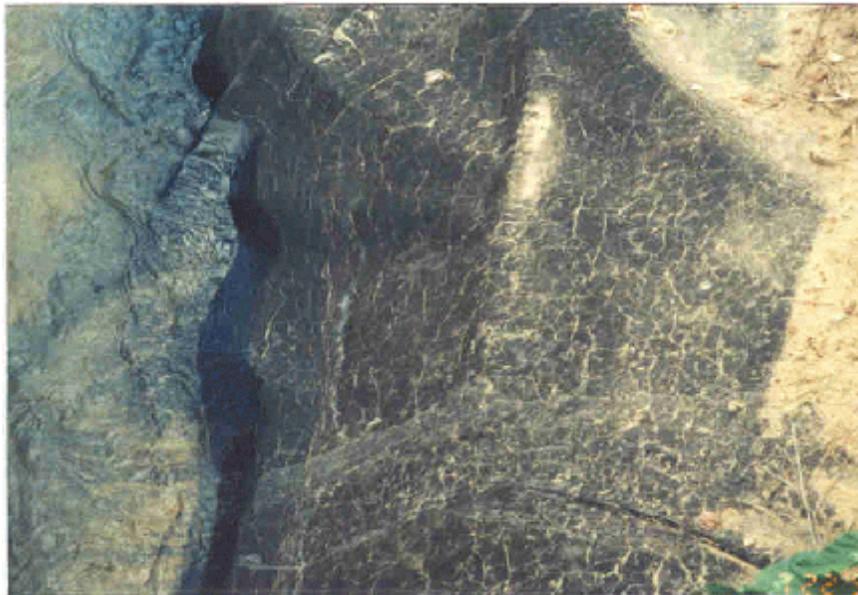
Photograph 130.—After 5 years, the Teranap shows some surface cracking (alligator cracking), which is normal for this product.
(Photograph courtesy of Lugert-Altus Irrigation District).

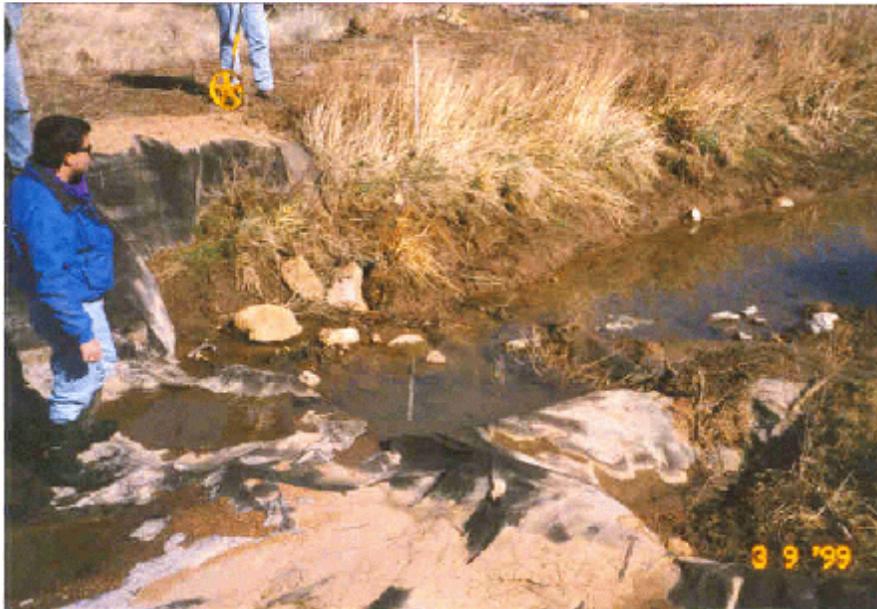
Photograph 132.—Downstream cutoff trench is washing out.
Needs to be buried deeper or cover with 3-inch concrete cap.
