**BUREAU OF RECLAMATION
FACILITIES INSTRUCTIONS, STANDARDS & TECHNIQUES
Volume 5-11**

**POTENTIAL HAZARD FROM
MESSWANDLER-BAU INSTRUMENT
TRANSFORMERS**

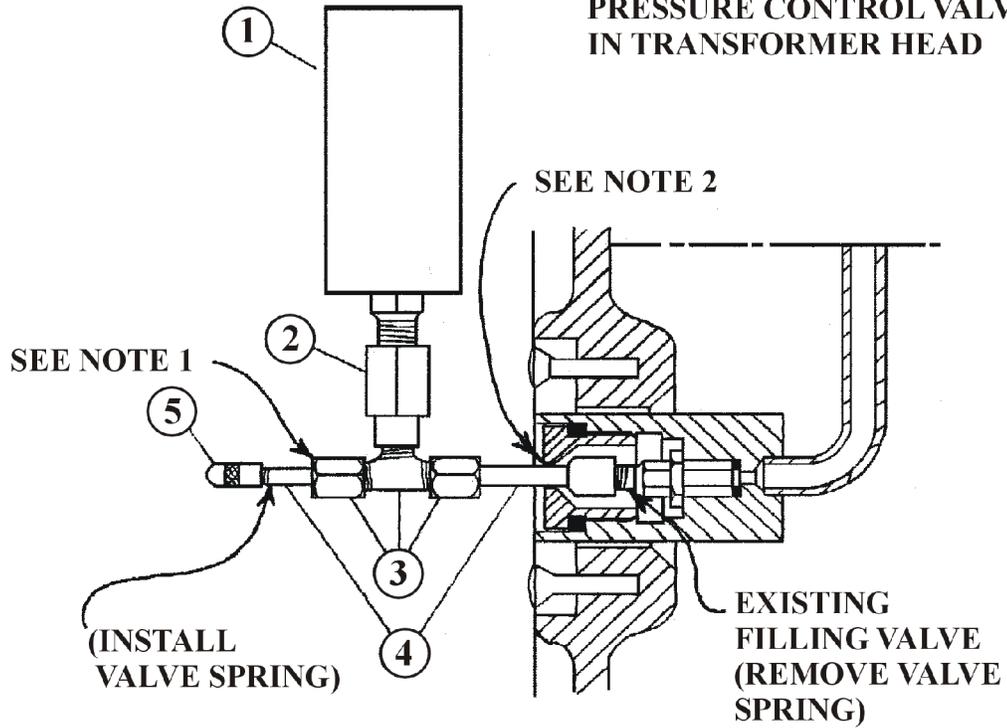
**NITROGEN FILLING AND
PRESSURE CONTROL VALVE
IN TRANSFORMER HEAD**

During a four year period in the late 1960's and early 1970's, Reclamation experienced five destructive explosions of Messwandler-Bau (MWB) 230-kV and 345-kV current transformers. MWB agreed to rebuild 42 JK-196 units because of a high percent of combustible gas (ranging from 4 to 32 percent), high gas pressure (ranging from 8 to over 30 psi-g), and high power factor (ranging from 0.5 percent to 3.41 percent). This experience leads us to be concerned over future explosive failures affecting the safety of our personnel and the security of nearby power equipment.

Types JK-196 and JTS-345 MWB current transformers manufactured after 1964 are the units that are most prone to failure. It is suspected that the explosive failures are the result of internal corona action which causes buildup of excessive Internal gas pressure or leakage paths and ultimate flashover across major insulation.

1. Install a pressure gage as shown on the attached Drawing No. 1046-ES-131 to provide for convenient periodic monitoring and

recording of the internal gas pressure during routine inspections. Gas pressure in excess of that shown in table 1 should be considered as indication that the instrument transformer may be abnormal and should be tested more frequently or removed from service; however, if the pressure exceeds 15 psi-g, the transformer shall be removed from service Immediately.
