WATER OPERATION AND MAINTENANCE

BULLETIN NO. 153

September 1990

**UNITED STATES DEPARTMENT OF THE INTERIOR
Bureau of Reclamation**

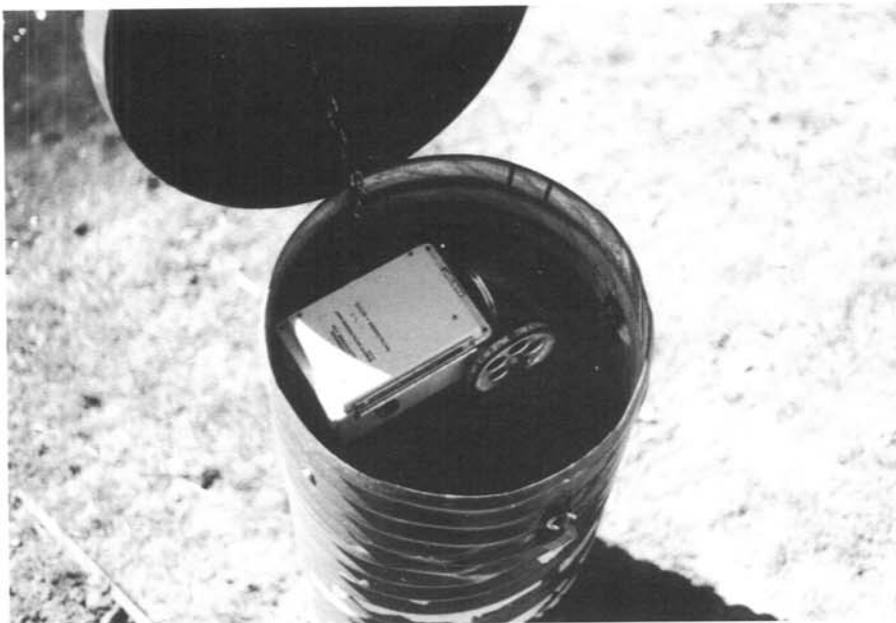
During the summer of 1989, the staff of the irrigation branch of Alberta Agriculture noticed the repeated failure of their electronic dataloggers installed in corrugated metal pipe (CMP) and steel recording wells. Replacement instruments would record data for about 2 weeks and then fail again.

Brian Cook, an electronics technologist with the branch, believes "the problem occurred when the CMP or any other metal in contact with moist soil becomes a primitive battery or galvanic cell generating between 0.7 to 1.1 volts." This voltage, he says, along with the high humidity found in recording wells and manholes is enough to destroy most micro chip based instruments and computers. Where possible, he suggests electronic equipment should be installed in PVC, fiberglass, concrete, or other nonconductive recording wells and manholes.

Alberta Agriculture has discontinued use of corrugated metal pipe and steel recording wells to house their electronic dataloggers.

If, however, electronic equipment must be installed in a buried metal structure, he recommends using a desiccant product such as Silica-Gel in a tightly closed instrument box which is electrically insulated from all other metal.

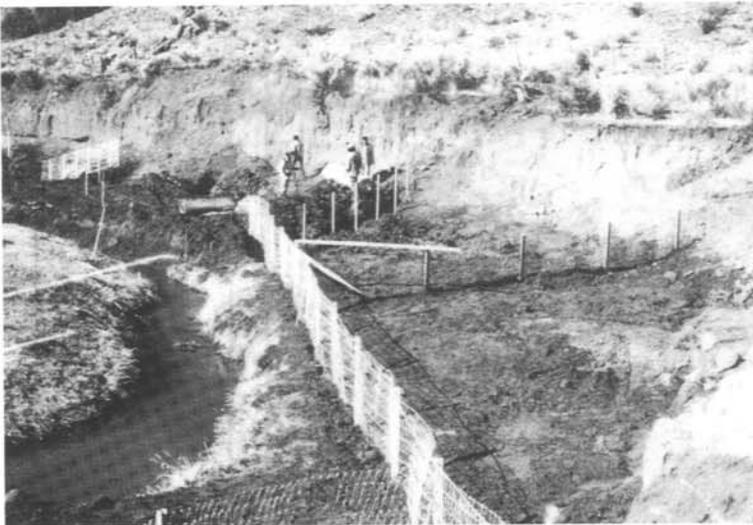
Construction view of revetment shows main baffle segment parallel to flow, one perpendicular baffle, and posts in place for a second. At right, bank slumping along the main stem of Bluewater Creek prior to the project.

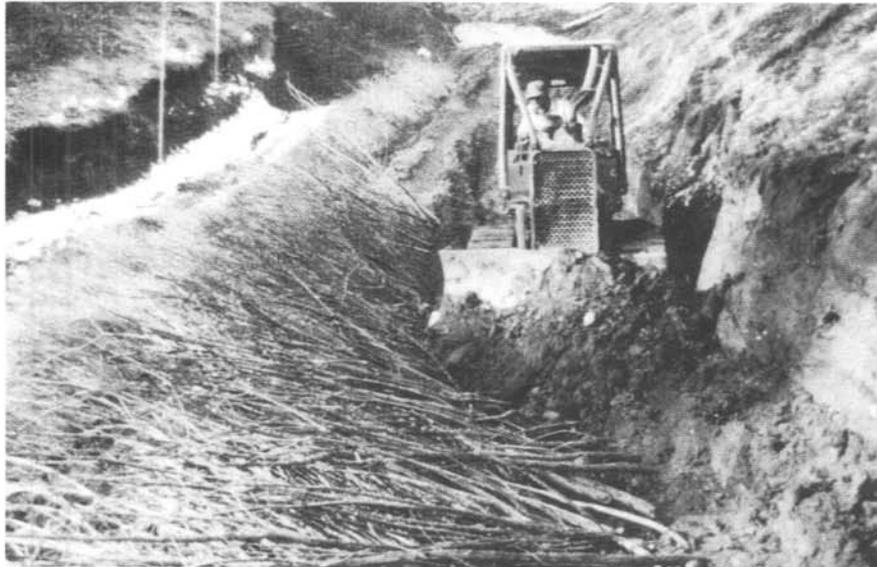
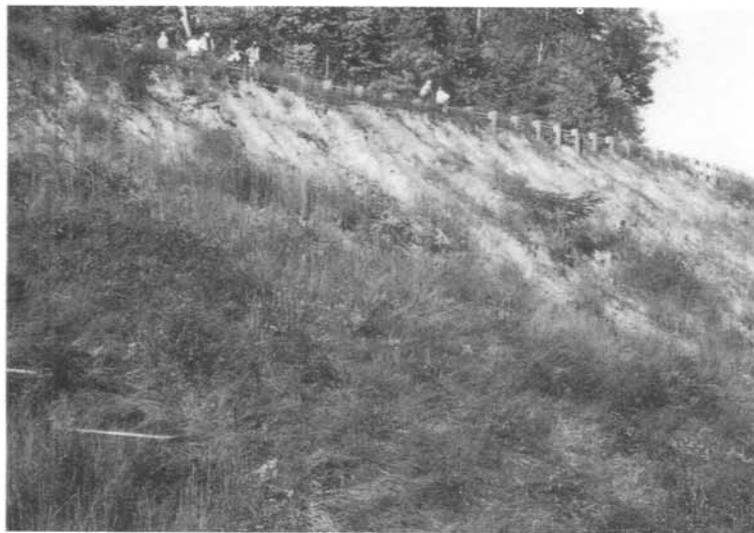
height of 60 feet with a slope face ranging from 100 to 200 feet long. This fill section was constructed in 1980-81 with the slope varying from 1.5:1 to 2:1. The slope began to fail and erode shortly after construction and was repaired several times using conventional treatments. When the decision was made to repair the slope with soil bioengineering systems, face sliding and erosion had started to undermine the guard rail posts at several locations and encroach on the pavement structure.

Installation of fill brushlayer during North Carolina embankment stabilization project, top; and a view of the slope before repairs began.

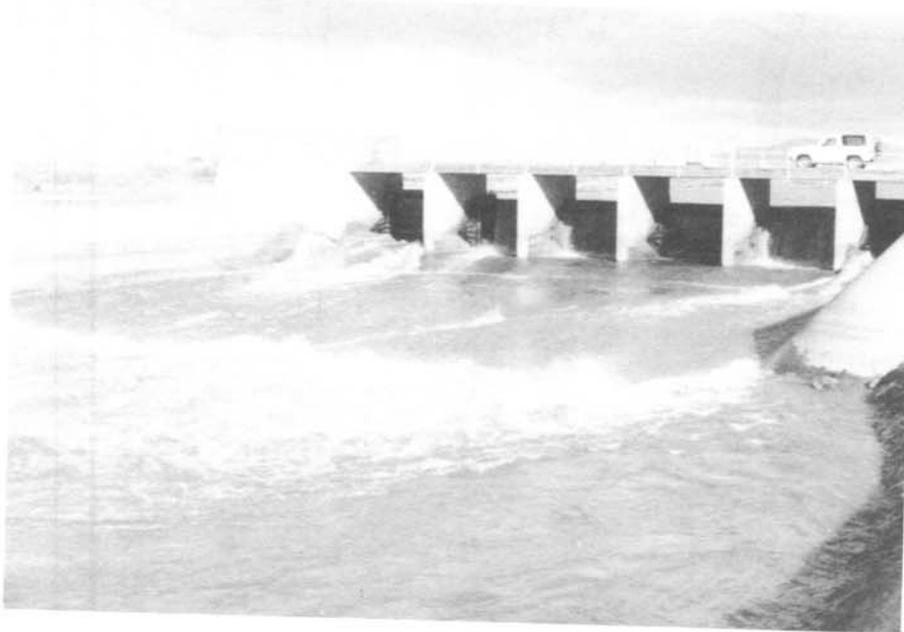
Photograph 1. - Riverside Diversion Dam. Sluiceway stilling basin. 3/17/87

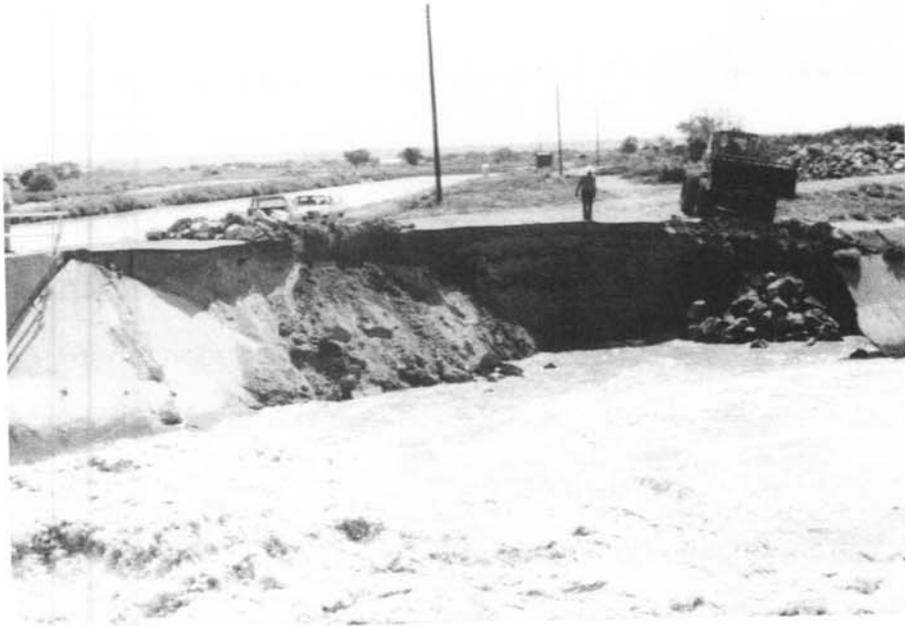
1. Another sinkhole developed near the right abutment of headworks.
2. Right downstream abutment of sluiceway failed.
3. Sluiceway gates were raised and diversions were stopped.
4. Excess riverflows were reduced.

Photograph 2. - Riverside Diversion Dam. Left abutment of sluiceway stilling basin. 6/9/87

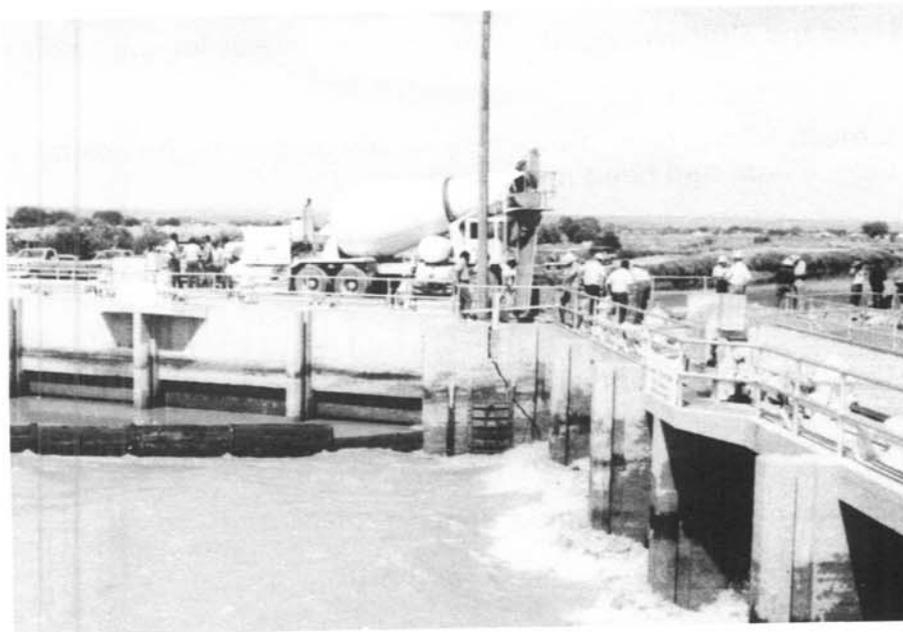
Photograph 3. - Riverside Diversion Dam. Notice crack in left upstream abutment wall of sluiceway. 6/9/87

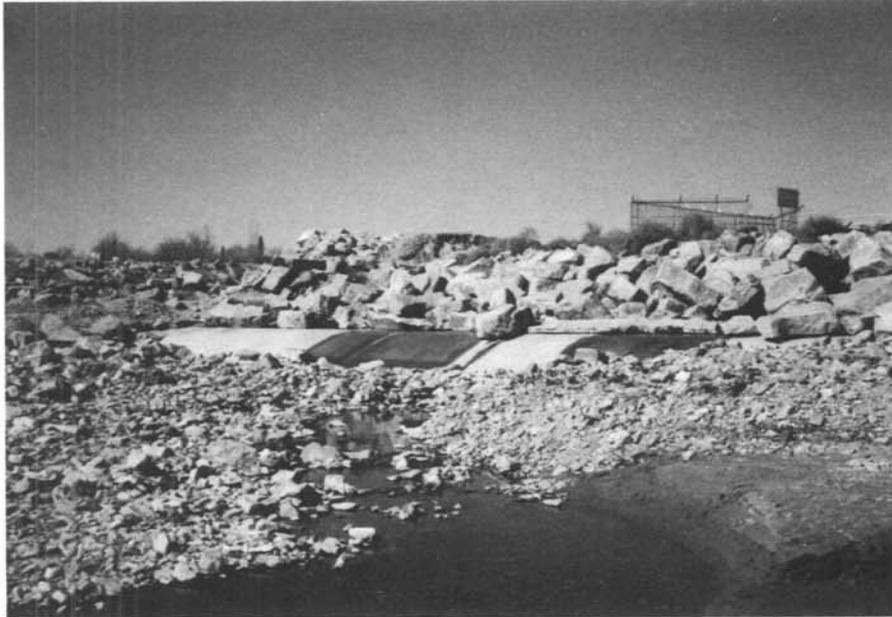
In addition to the above, it was noticed the floor of the sluiceway was destroyed and much of the area where the floor used to be was undercut. Photograph 4 shows the concrete drop, constructed in 1943 at the downstream end of the stilling basin, which remained in place.

Photograph 4. – Riverside Diversion Dam. Concrete drop at downstream end of sluiceway stilling basin. 2/11/88

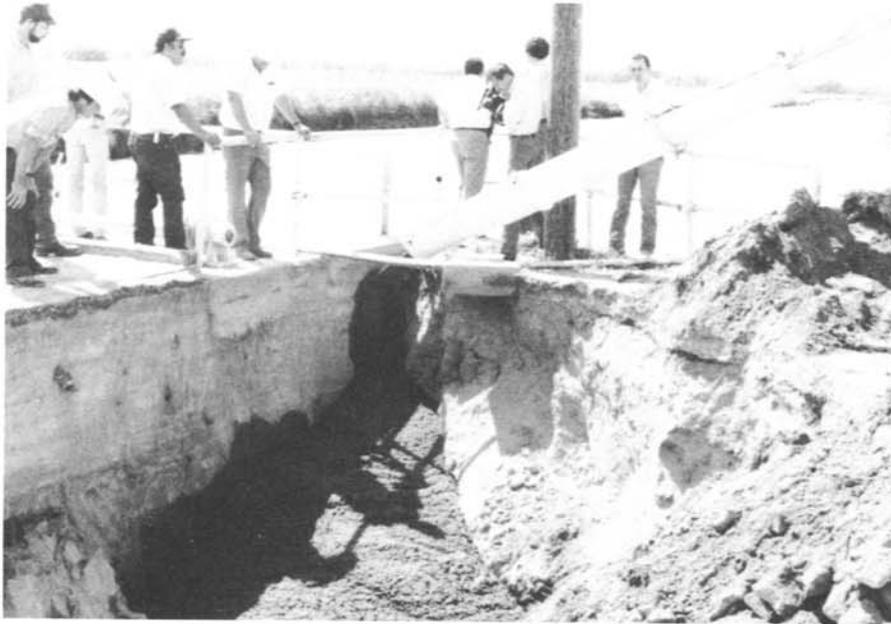
Photograph 5. - Riverside Diversion Dam. Filling sinkhole at left side of sluiceway. 6/9/87

1. Filled sinkhole near headworks with concrete. Concrete had polymer fibers (photograph 5).
2. Rebuilt right downstream abutment of sluiceway with rock, which was then covered with concrete.
3. Constructed a rock cofferdam across downstream concrete apron of sluiceway. Covered upstream face and crest with concrete. Top of crest is at elevation of top of concrete weir.
4. Placed rock in sediment cover on upstream concrete apron of concrete weir.
5. Placed rock on downstream concrete apron of concrete weir. This rock was subsequently washed away.
6. Added rock protection to right bank of concrete weir.

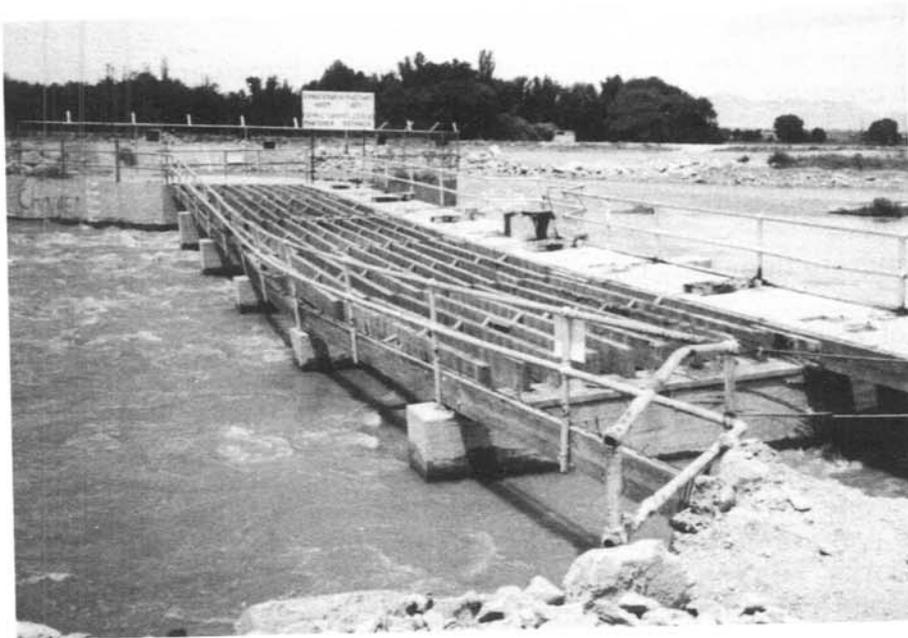
Photograph 6. - Riverside Diversion Dam. Dismantled sluiceway structure from left abutment after the failure.
7/15/87

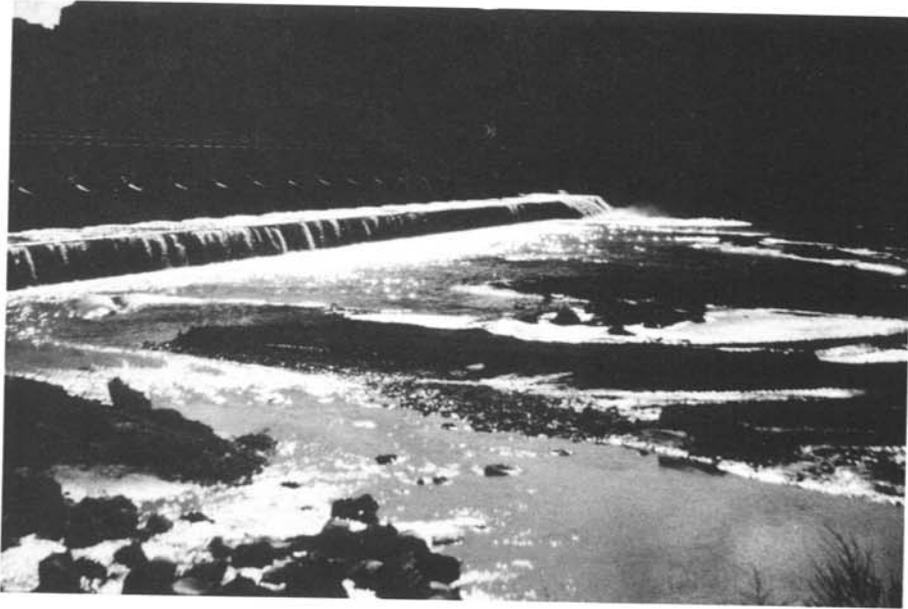
Figure 2. - Downstream view of San Acacia Diversion Dam showing depth of scour prior to rehabilitation. 11/88
