# WATER OPERATION AND MAINTENANCE BULLETIN

No. 198

December 2001

## LIQUEFACTION MITIGATION OF A SILTY DAM FOUNDATION USING VIBRO-STONE COLUMNS AND DRAINAGE WICKS: A CASE HISTORY AT SALMON LAKE DAM

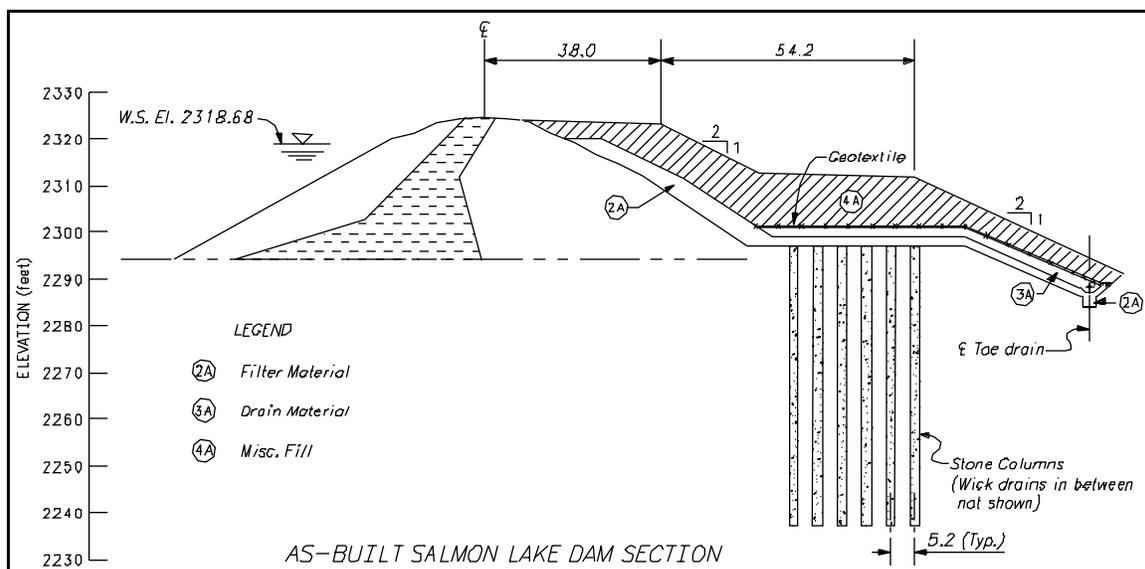
Figure 2.—SOD modifications post-construction section.

In addition to treating the foundation using the dry bottom-feed vibro-stone columns method of construction, the structural SOD modification included a 29-foot-high buttress and a 19-foot-high stability berm "sandwiching" a two-stage filter and toe drain system on the downstream excavated slope (figure 2). The downstream buttress was constructed to address upstream slope stability.

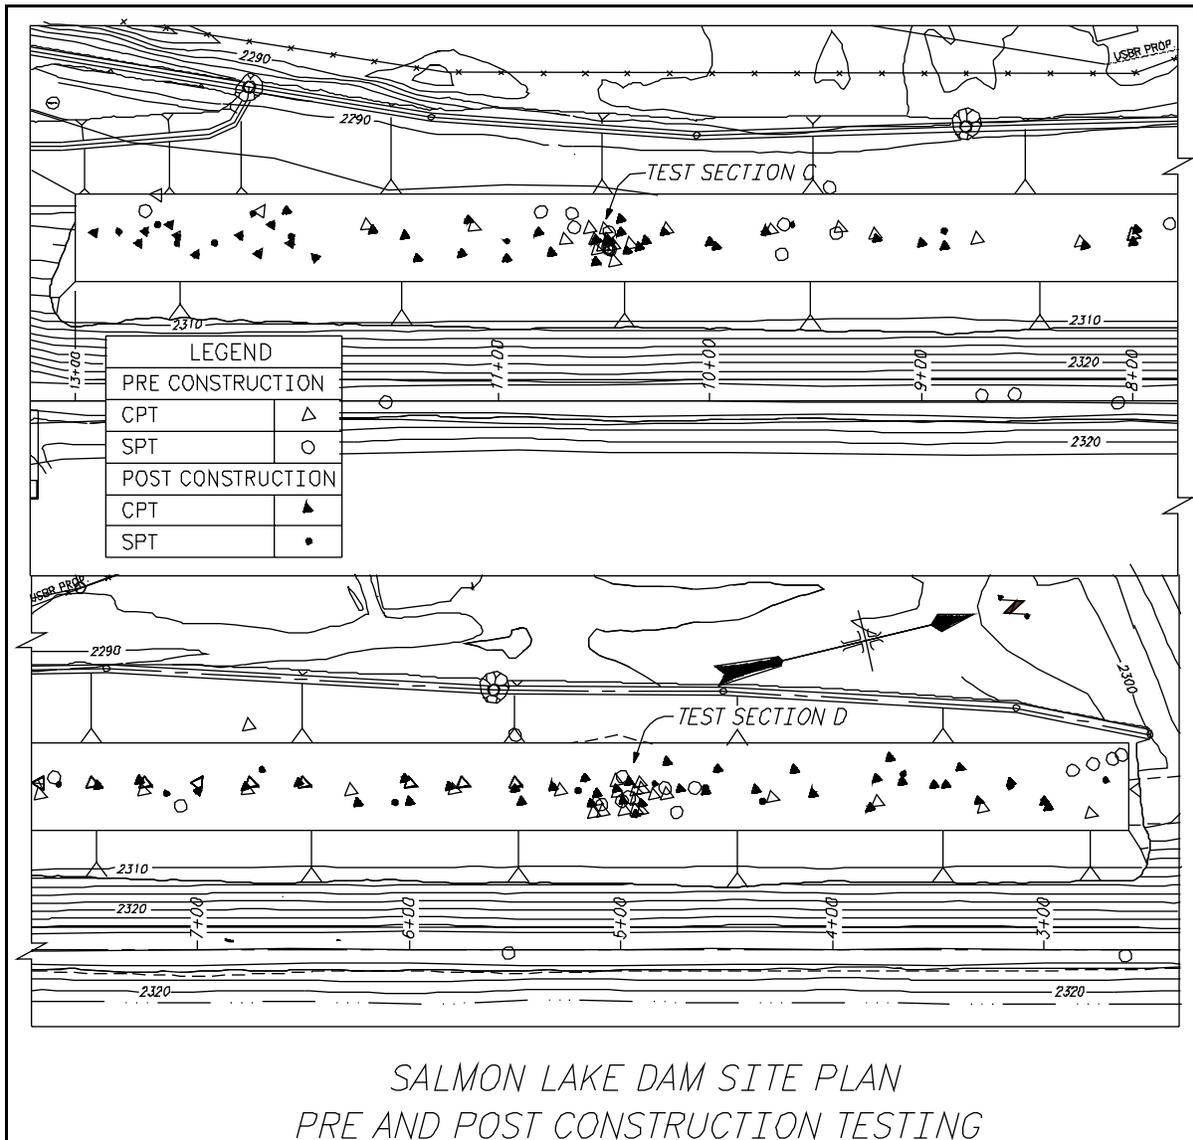
Figure 4.—Distribution of pre- and post-construction verification testing.

Because of the silty nature of the foundation soils, verification testing to characterize foundation improvement after stone column construction of "designated treated areas" was conducted a minimum of 2 weeks after the construction of the last stone columns at each site in an effort to allow pore pressures to dissipate before testing. Verification testing included 17 SPT borings and 93 CPT soundings (18 post-test section CPT soundings, 12 CPT soundings investigating the "aging" affect before construction, and 63 post-construction soundings) (figure 4).

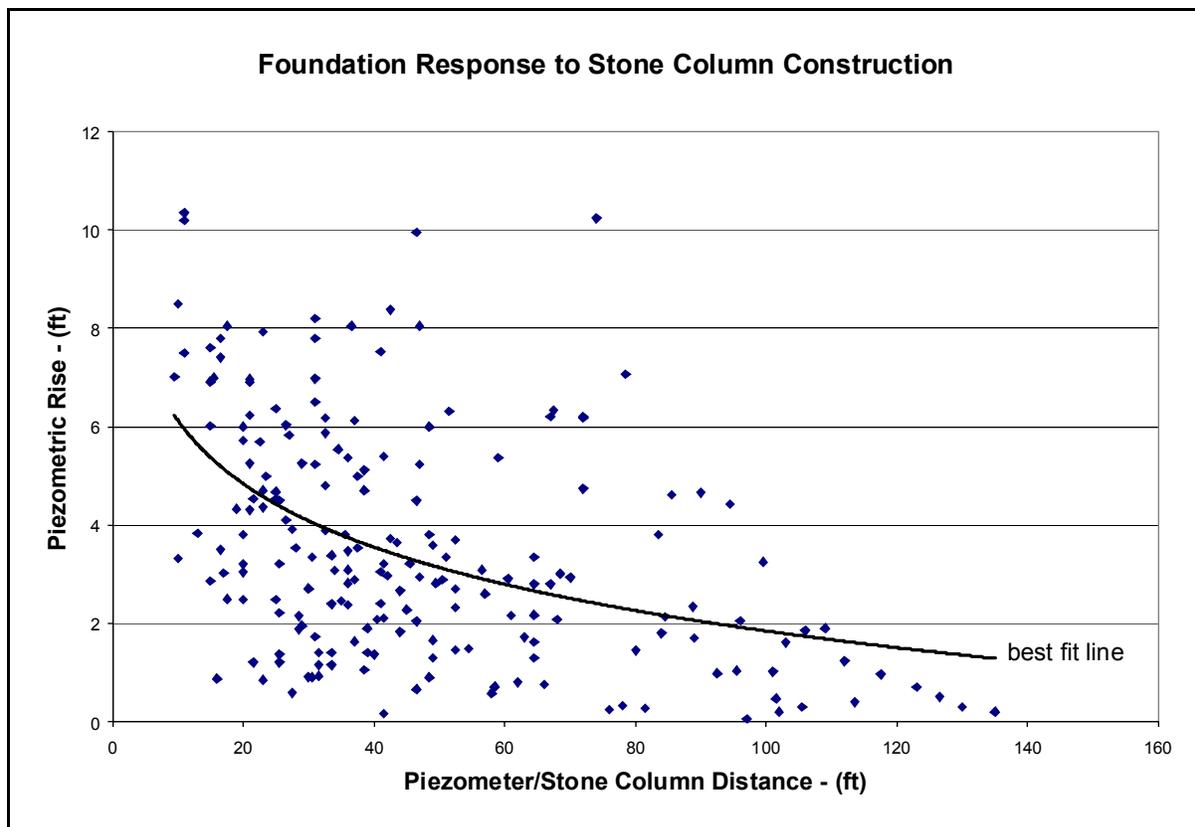
Figure 5.—Piezometric rise with piezometer/stone column distance.

The piezometric response during the construction of any given stone column is the maximum pore pressure rise observed at various distances. Pore pressure rise exceeding 10 feet was observed within wick drains closest to the stone column being constructed and up to a 2-foot rise over a distance of 100 feet. Foundation response to probe penetration and stone column construction is practically instantaneous, and pore pressure dissipation occurs concurrently with the completion of the stone column. Piezometer tip elevations are between 50 and 60 feet, which coincide with the depth of the stone column. An additional 25,300 lineal feet (466 wicks) of drainage wicks (two "lines") were installed downstream of the last row before adjusting the stone column pattern downstream one row.

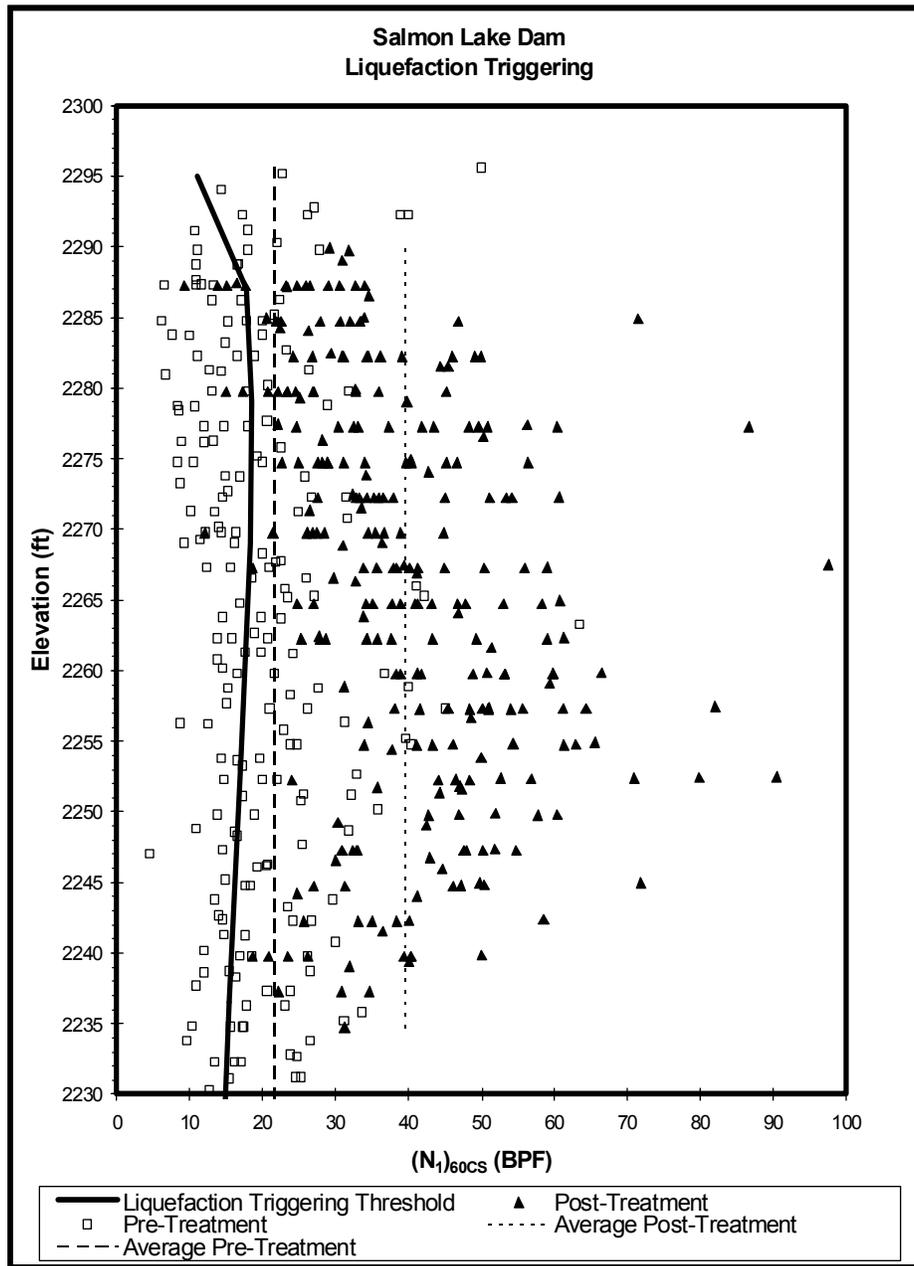
Figure 6.—Comparisons of pre- and post-construction SPT data.

Figure 6 compares representative pre- and post-construction SPT blowcount data  $N_{1(60)m,(cs)}$  against required  $N_{1(60)r,(cs)}$  (liquefaction triggering threshold). Measured  $N_{1(60)m,(cs)}$  values that fall to the left of the required  $N_{1(60)r,(cs)}$  line indicate potential for triggering of liquefaction. The majority of hollow shapes (or pre-treatment data) lie near or to the left of the liquefaction triggering threshold line. The post-treatment data, represented by solid shapes, show significantly higher blowcounts and indicate foundation improvement by measured densification increase.

An area of significant fines (silts and silty sands) is present between elevations 2275 and 2260, whereas sandy lenses are apparent between elevations 2283 and 2280 and between elevations 2260 and 2248. The effectiveness of treatment of these areas is influenced by the fines content and is readily apparent.

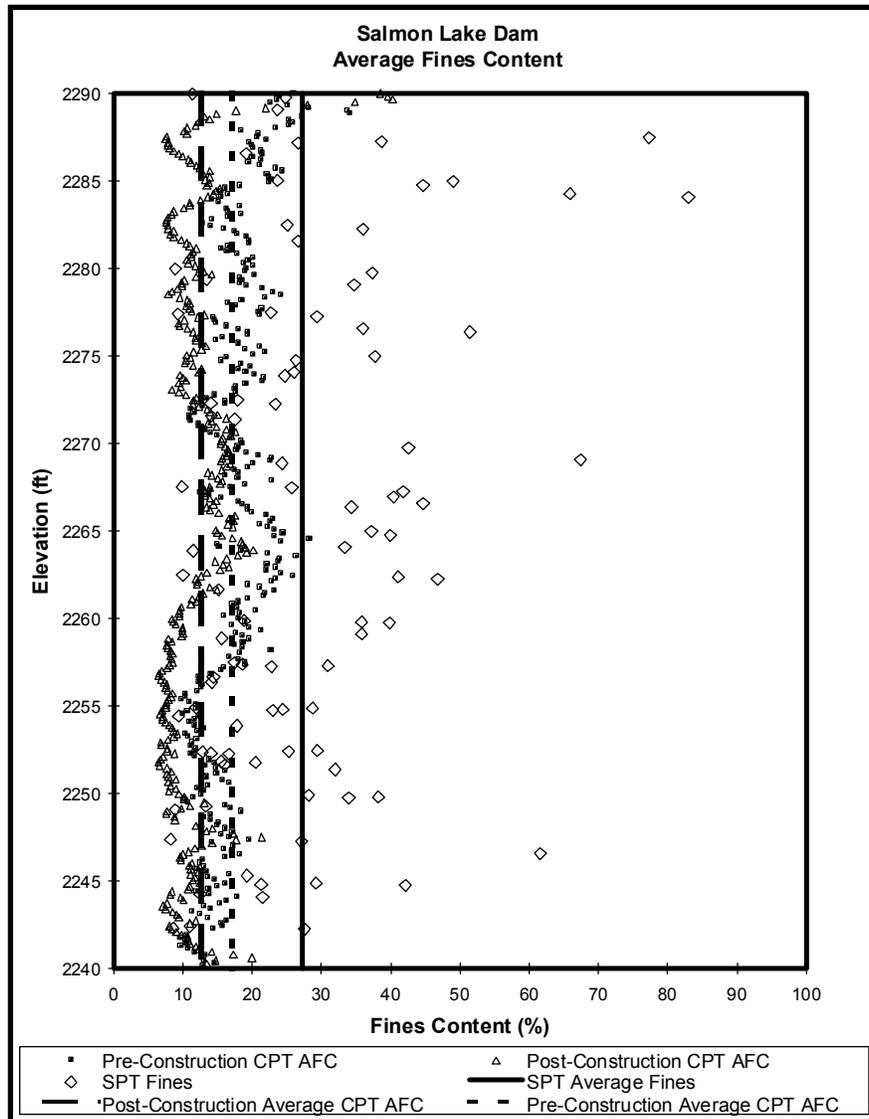
Figure 7.—CPT apparent/SPT laboratory fines content with elevation.

According to Robertson and Wride [9], it is possible to correct the measured CPT penetration resistance to an equivalent clean sand value by estimating grain characteristics (apparent fines content [AFC]) directly from the CPT. However, it should be noted that estimates of the AFC from the CPT can be unreliable for determining the actual fines content in some cases and probably should not be used rigorously for this purpose. At this site, the method generally underestimates the laboratory measured fines content (figure 7).

Comparisons of AFC on companion CPT holes (pre- versus post-construction) generally show a decrease in fines after stone column construction, which would imply the foundation has become coarser. Since the actual fines content of the materials is unlikely to have changed significantly during treatment, the change in AFC must be associated with changes in the treated foundation differing stress conditions and is clearly artificial [10]. This points out the difficulties in predicting the fines content from these CPT parameters.

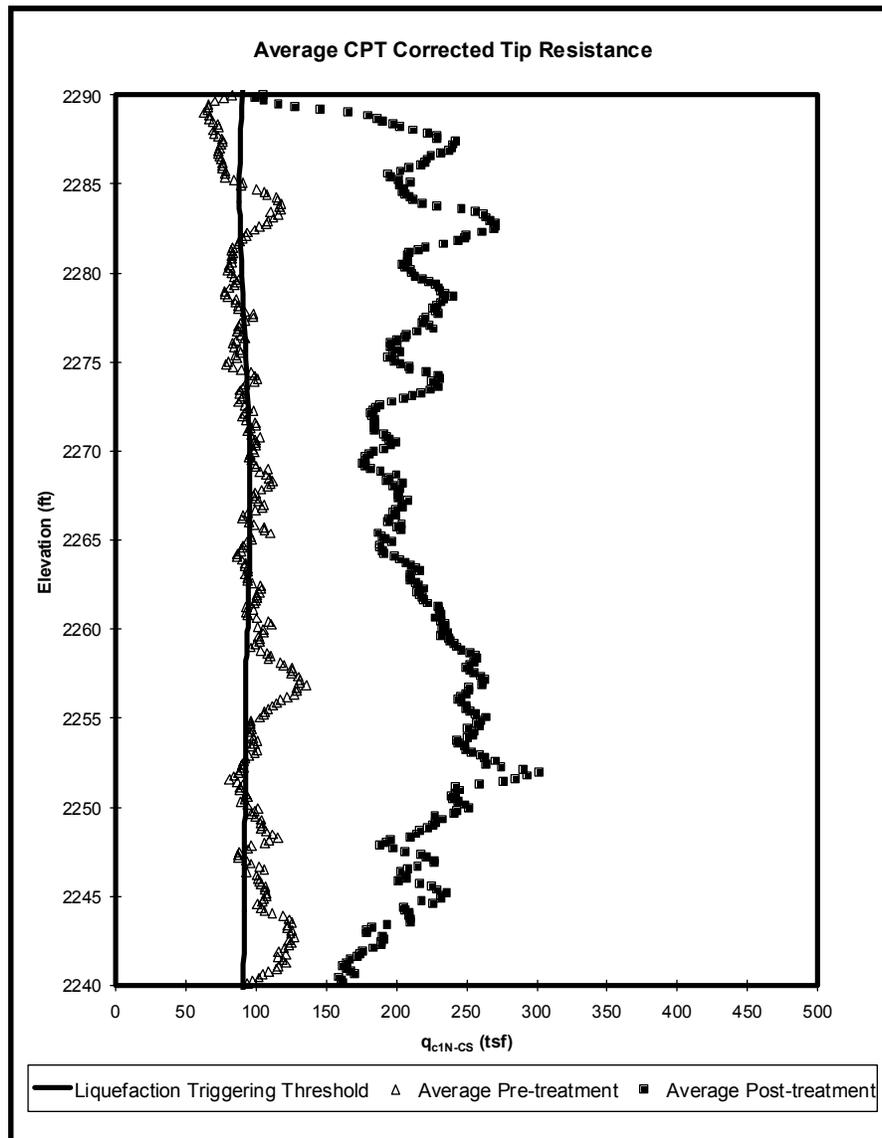
Figure 8.—Clean sand equivalent tip resistance ( $q_{c1N-cs}$ ) with elevation.

Since the calculated AFC after treatment was used to correct the post-construction CPT tip resistance to equivalent clean-sand values, and the AFC decreased after treatment (average 5 percent), the corrected post-treatment CPT resistance values,  $q_{c1Ncs}$ , are on a relative basis biased on the conservative side. Thus, the actual level of foundation improvement is likely to be slightly higher than that inferred by comparing the pre- and post-treatment values of corrected equivalent clean-sand CPT tip resistance.

It is fortunate that the foundation improvement observed has been so significant that a difference in the measured stress condition (as reflected in the AFC) does not impact the conclusions on the adequacy of treatment (figure 8).

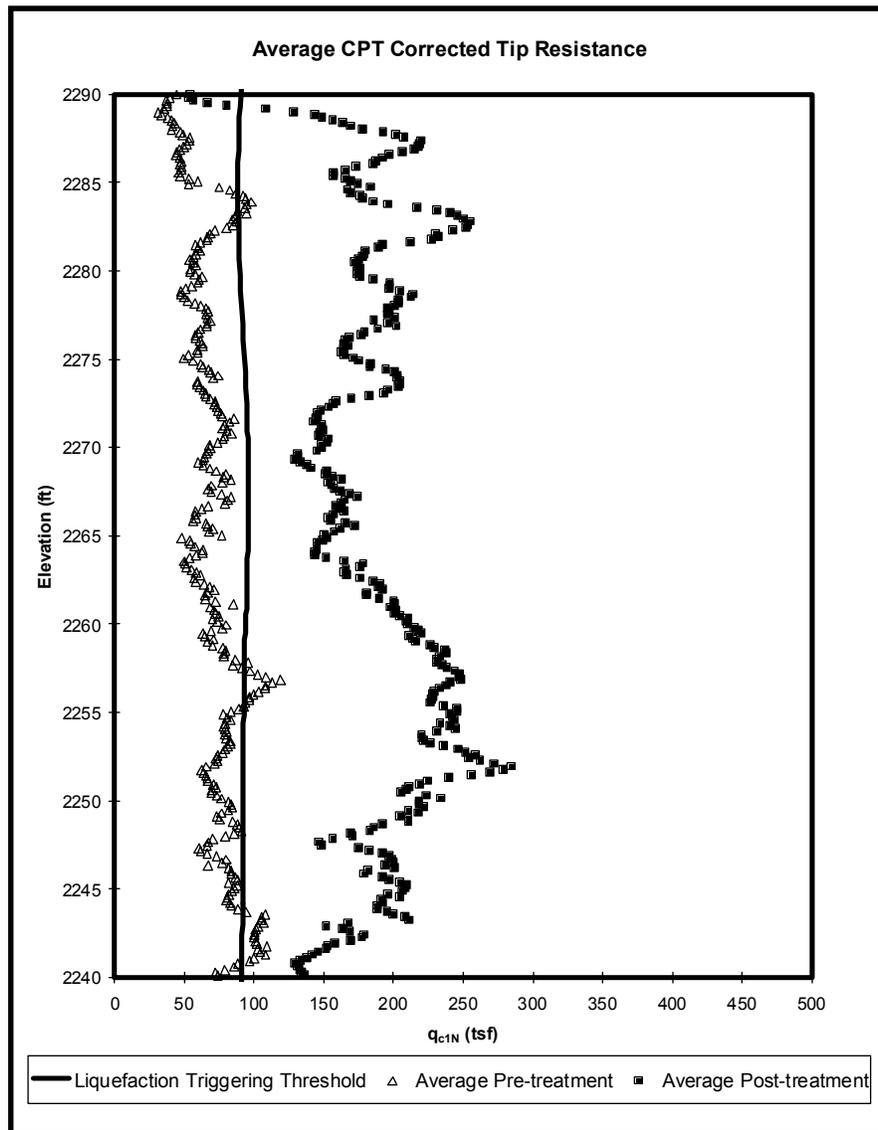
Figure 9.—Average corrected tip resistance ( $q_{c1N}$ ) with elevation.

The level of foundation improvement can also be depicted by a comparison between average pre- and post-treatment values of normalized CPT tip resistance,  $q_{c1N}$  [10] (figure 9). Data shown is the average (at each elevation) of all applicable pre- and post-construction CPT data.

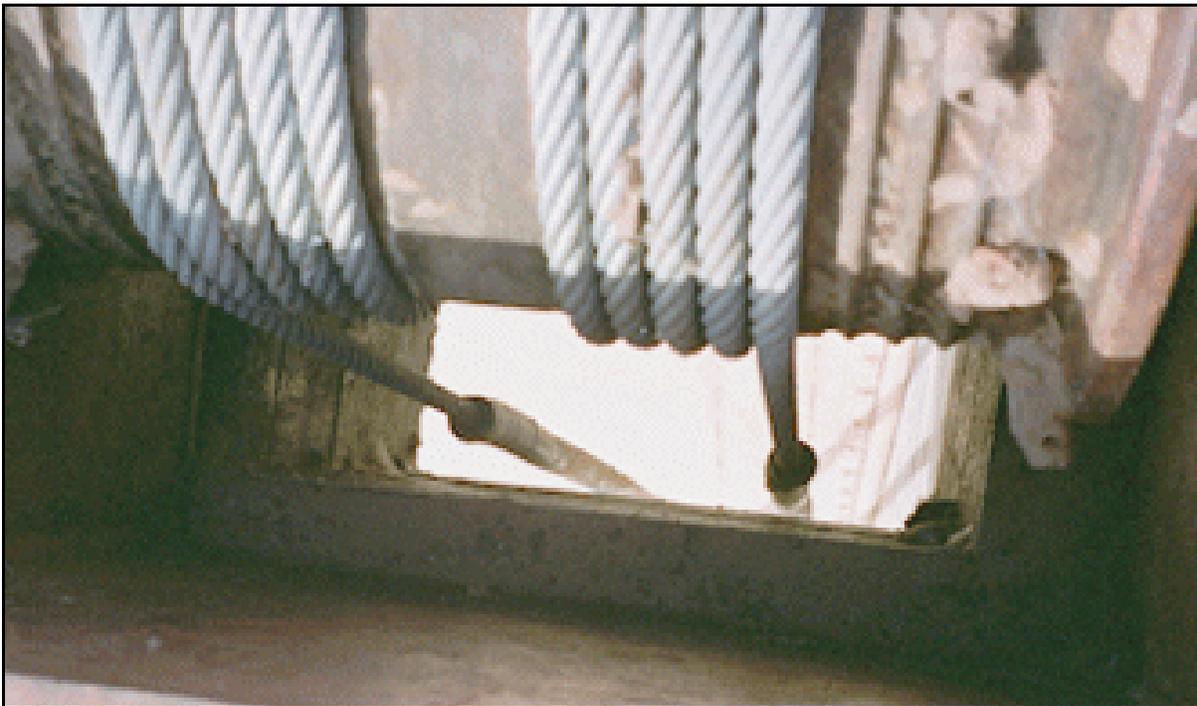
In 1999, the Lugert-Altus Irrigation District in Altus, Oklahoma, replaced the wire ropes of the spillway radial gates at Altus Dam. When the stainless steel wire ropes were installed, they were encased to not only maintain the lubricant but also to prevent the radial gate steel skinplates from corroding as rapidly as they would if they were in direct contact with the wire ropes. The installation was made by spirally cutting a rubber water hose, which was then wrapped as an encasement around the lubricated cable. The encased cable and lubricant, which has been in place for over 2 years, is expected to increase the life of the protected parts far beyond what would normally be expected if left unprotected.

The gates can be raised up to an opening of 8 feet before the hoses come into contact with the hoist drums. During extreme flood events, the hoses can be removed from the wire ropes to allow the gates to be raised as required for flood operations.
