Water Operation and Maintenance Bulletin

No. 215

Otter Lake Dam Drilling and Chemical Grouting

March 2006

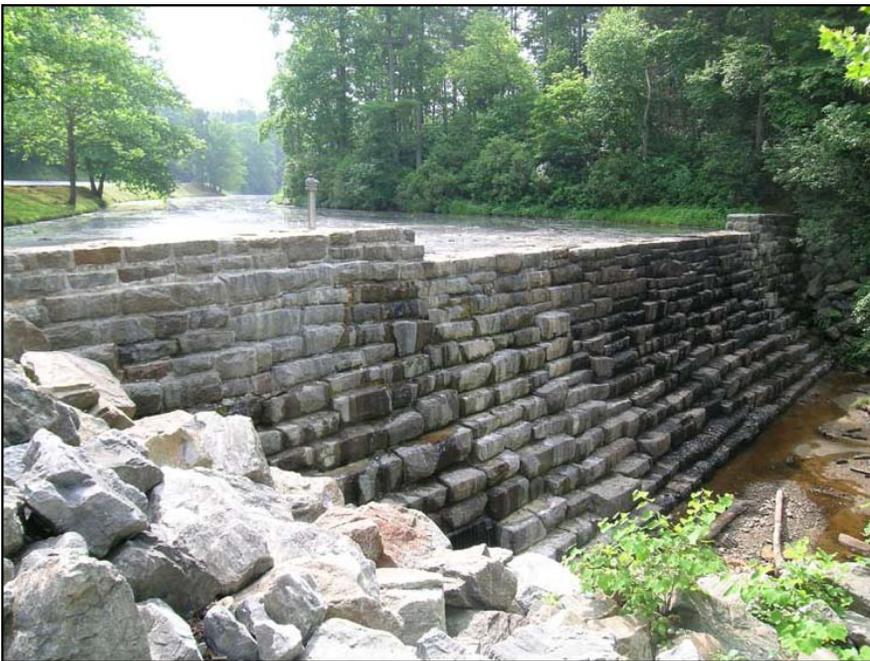
*Cover photograph – Outlet works slide gate closed with the lake
just starting to pass over the spillway crest.*

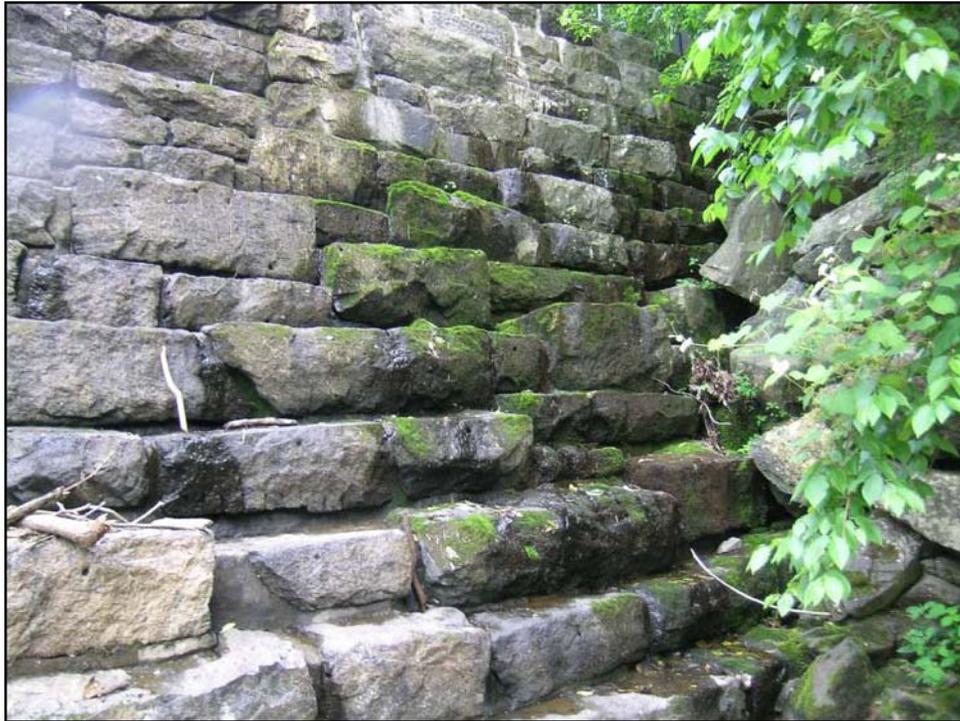
Figure 1.—Left abutment before grouting (June 2, 2005).

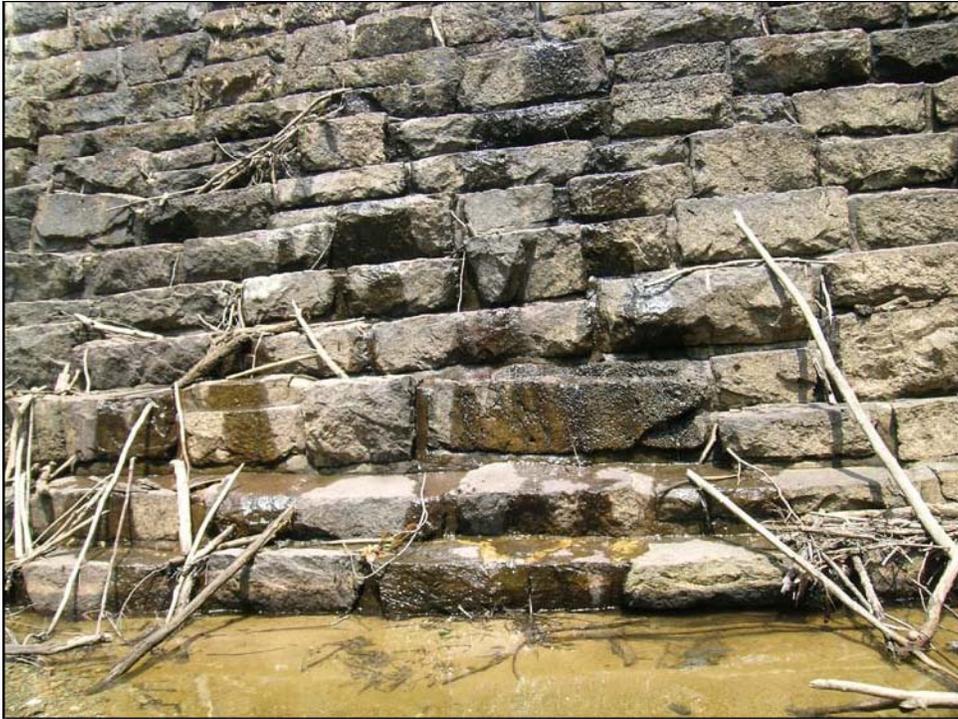
Figure 2.—Downstream face (near right abutment) before grouting (June 2, 2005).

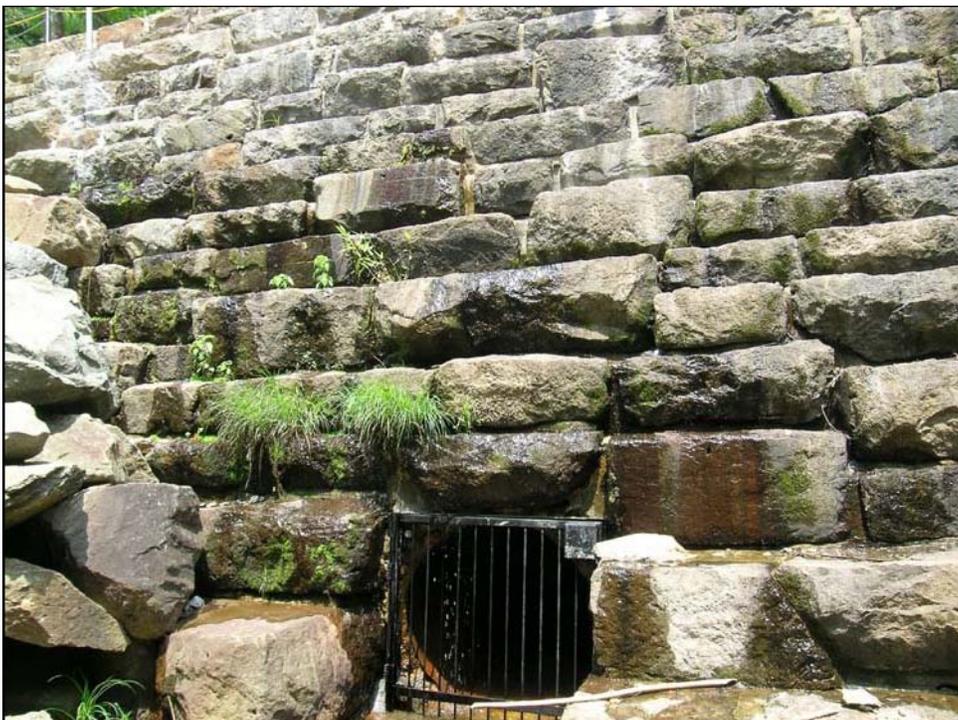
Figure 3.—Right abutment and outlet works before grouting (June 2, 2005).

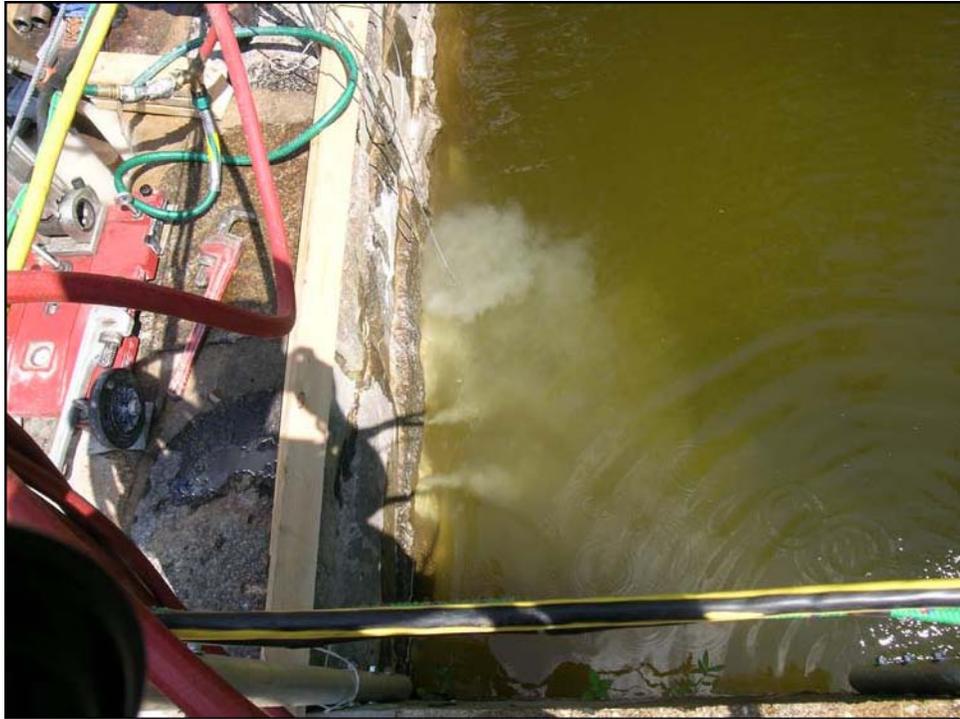
Figure 14.—Drill water exiting through upstream cracks (June 10, 2005).

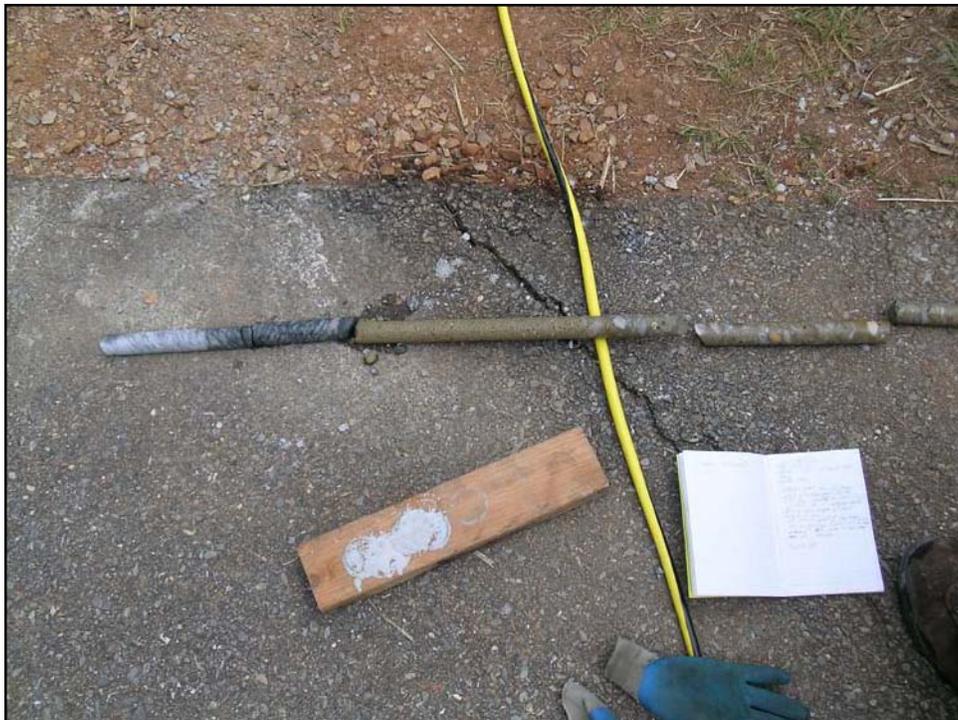
The concrete varied throughout the structure in strength, quality, and drillability. Areas near the slide gate appeared somewhat softer than other areas. In general, the dam-to-rock contact was good, but there was a weak bond from approximately 65 feet in from the left abutment through to 90 feet.

Figure 19.—Drill core. Note foundation rock (far left), dental concrete (center), and concrete with larger aggregate (far right) (June 15, 2005).

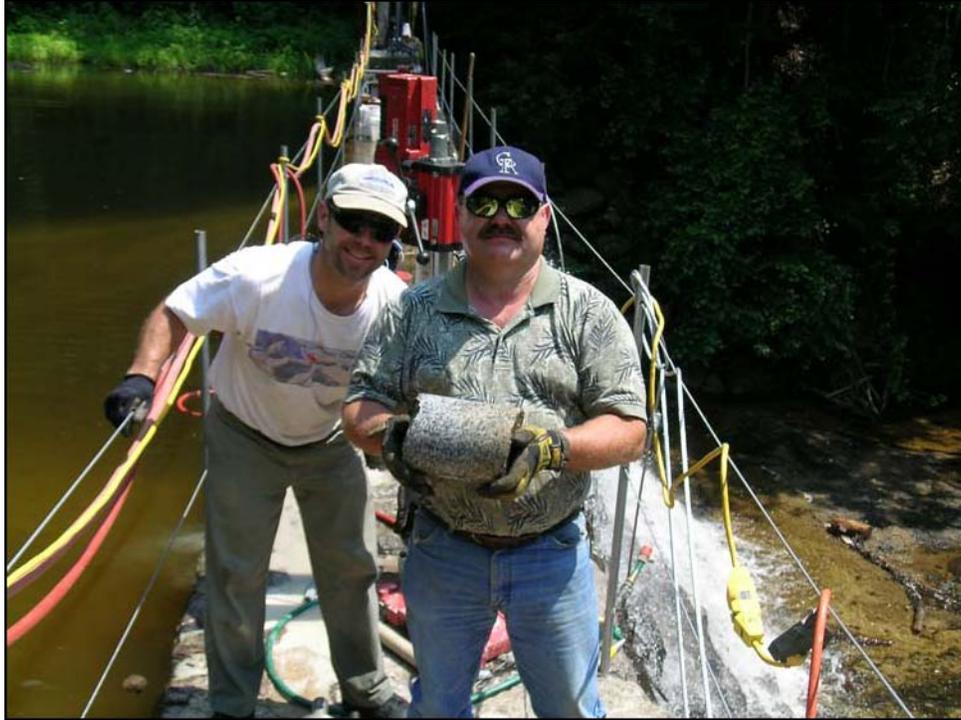
Several 6-inch-diameter cores were drilled in an attempt to provide mass concrete samples for compression testing in Denver, Colorado; however, it was difficult to provide representative pieces that were long enough to meet test criteria. Most, or all of, the entire concrete core taken appeared to be surface mortar into which the granitic stone facing on the top of the dam was set. It was not representative of the concrete core of the dam.

Figure 20.—Six-inch cap rock core (June 22, 2005).

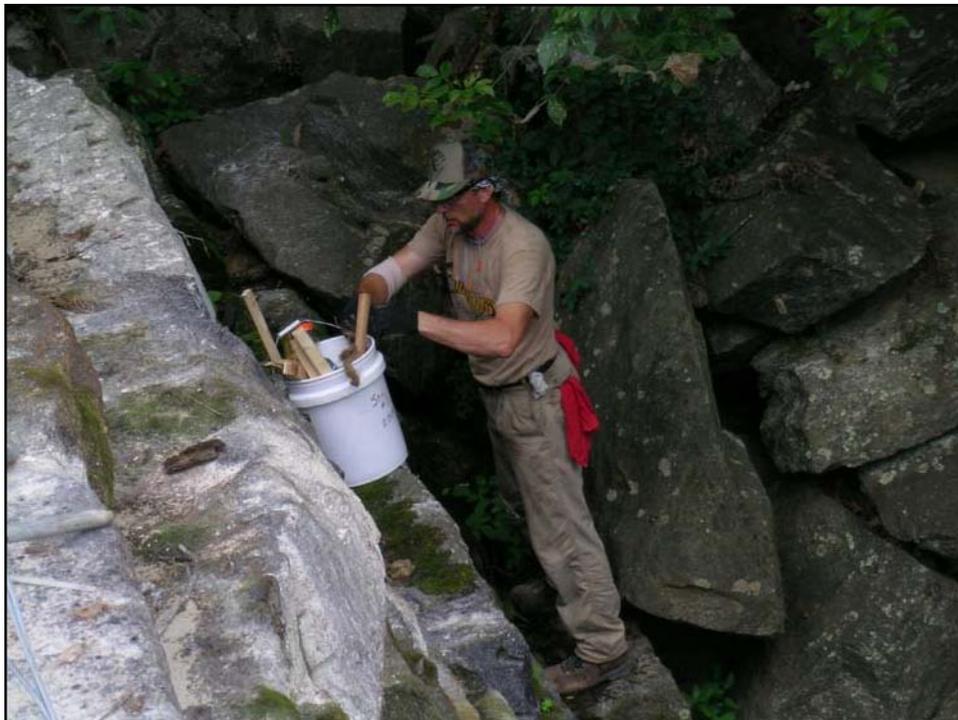
Grout takes were generally high and particularly high in the holes near the abutments. Leakage of grout was observed at the upstream and downstream faces and 5 to 10 feet down from the top of the dam at several locations. These leaks were controlled by intermittent grouting and extensive caulking using oakum, which was pounded into cracks and holes on the downstream rock face. The total amount of chemical grout pumped at a 1:1 ratio was 80 gallons, combined with 80 gallons of water to equal a total of 160 gallons of material pumped to refusal at 15 lb/in².

Figure 27.—Caulking leaks during grouting on the left abutment with oakum and wood wedges (June 27, 2005).

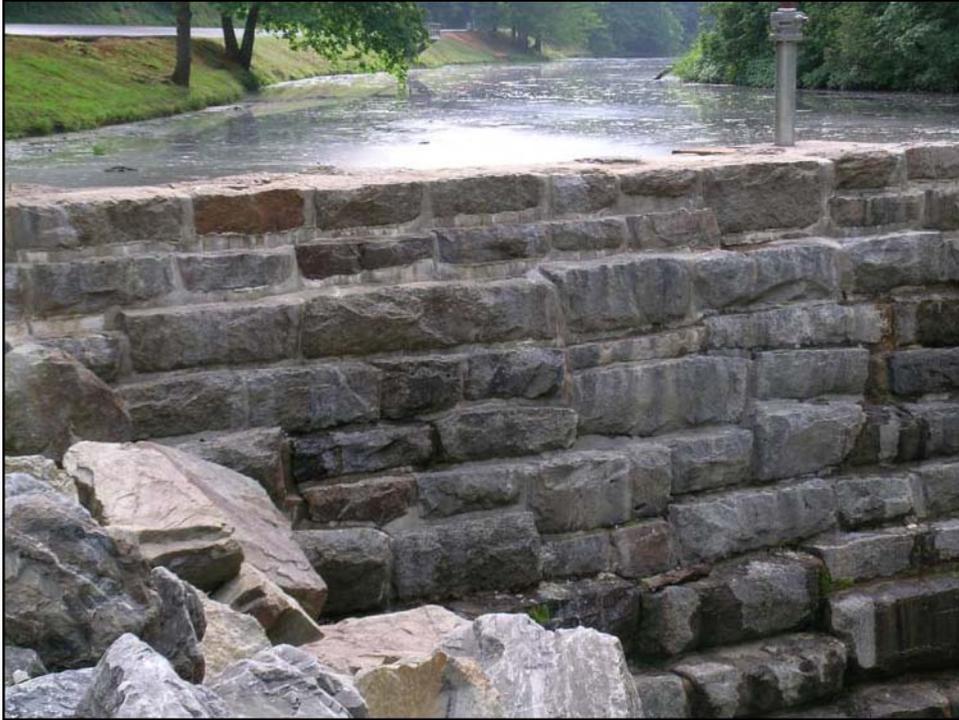
Prior to grouting, water could be heard traveling around the ends of the dam, but after injecting the abutment fan patterns, all downstream leaks ceased, and running water was not discernible. **Most notable by everyone on site was the immediate rise in the lake level upon completion of the right abutment fan holes.**

Figure 28.—Grouting completed, face drying up, gate closed, and the lake is beginning to fill more rapidly (June 29, 2005).

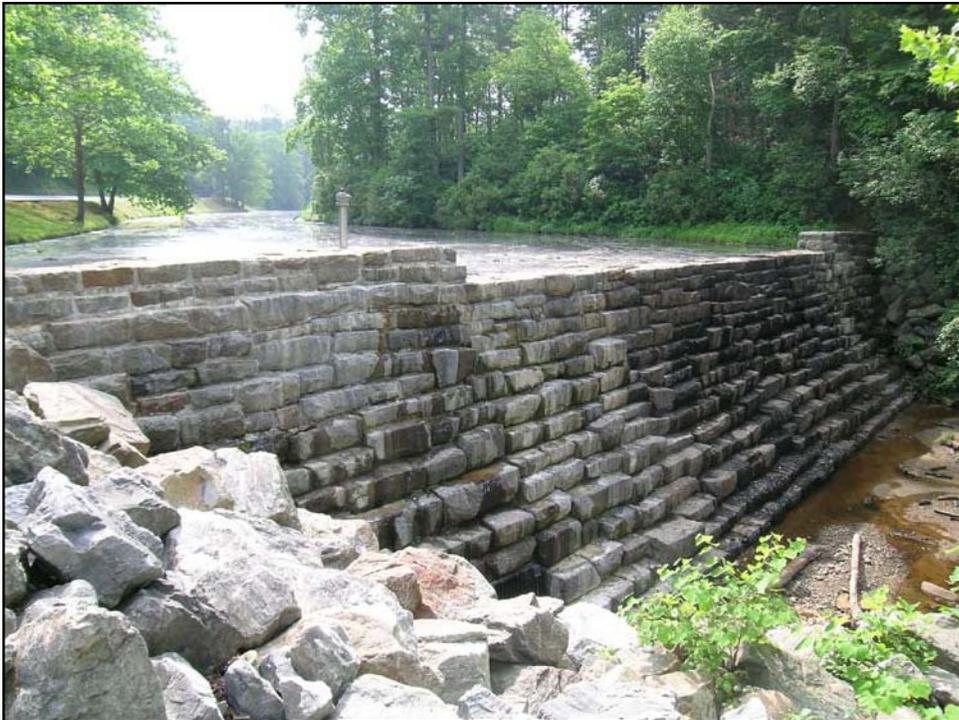
Figure 29.—Grouting complete. Outlet works slide gate closed with the lake just starting to pass over the spillway crest (June 29, 2005).
