Reclamation's Seepage Barrier Experience - A cursory Scoping Study

MERL Report Number 2011-42

September 30, 2011

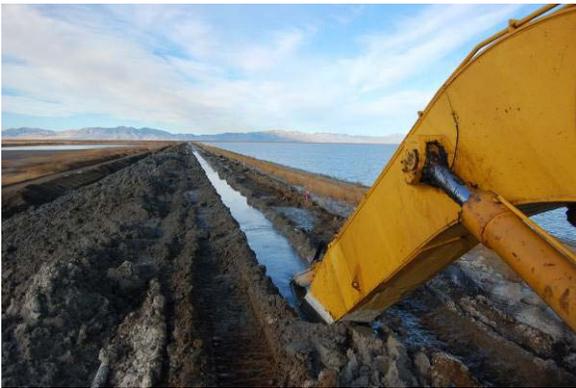
A. V. Watkins Dam Cutoff Trench Installation, Fall 2008
