OPERATION AND MAINTENANCE EQUIPMENT AND PROCEDURES

RELEASE NO. 5

July-August 1953

PERFORMANCE OF CORRUGATED METAL PIPE TURNOUTS

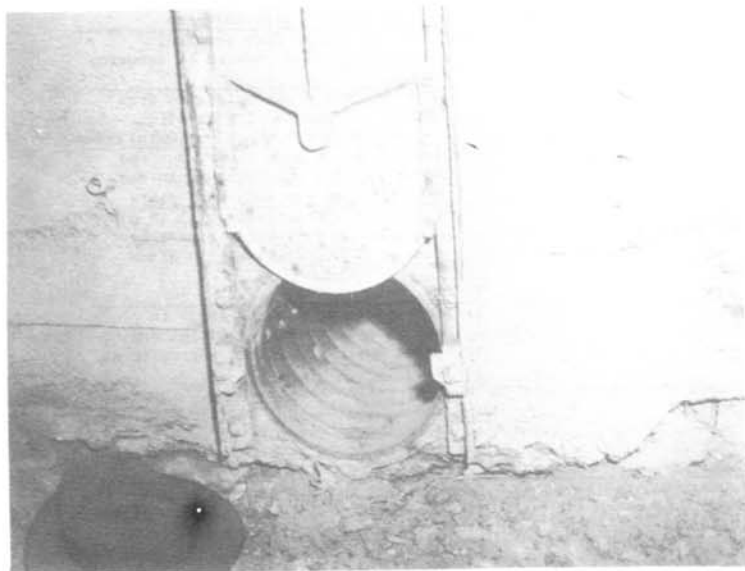
Rough and Ready Ditch
Photo No. 1 Farmers' Extension

Wetty Turnout, 12" diam. asphalt dipped asbestos bonded CMP. In excellent condition after 15 years of service under average conditions.

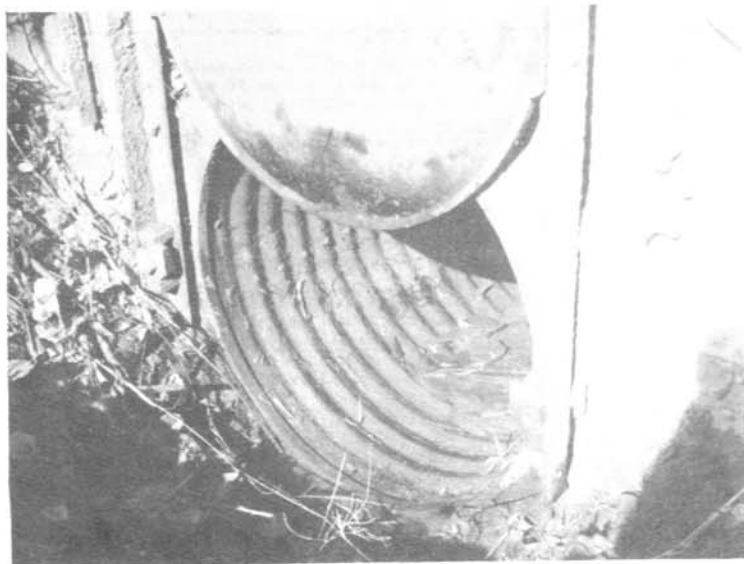
Rough and Ready Ditch
Photo No. 2 Farmers' Extension

Newman turnout, 30" asphalt dipped asbestos bonded CMP. After 15 years of service the asbestos bonding is still intact protecting the galvanizing and base metal. There is some sand carried in the water and other conditions are about average.

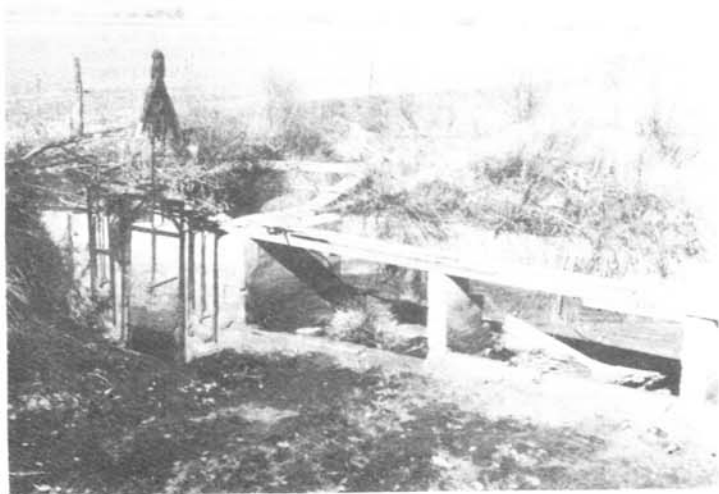
Rough and Ready Ditch
Photo No. 3 Farmers' Extension

General view of Newman turnout showing pipes depicted in Photos Nos. 2 and 4.

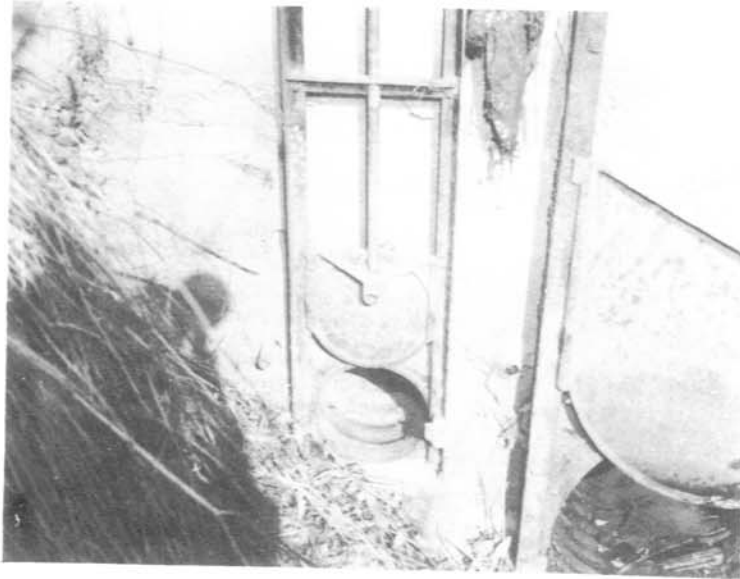
Rough and Ready Ditch
Photo No. 4 Farmers' Extension

10" galvanized Ingot Iron CMP installed at Newman turnout. Much of the galvanizing is gone from the invert of the pipe and there is a little corrosion of the base metal so the pipe should be good for many more years service. The advantages of asbestos bonding are readily apparent by comparing this pipe with that shown in Photo No. 2.

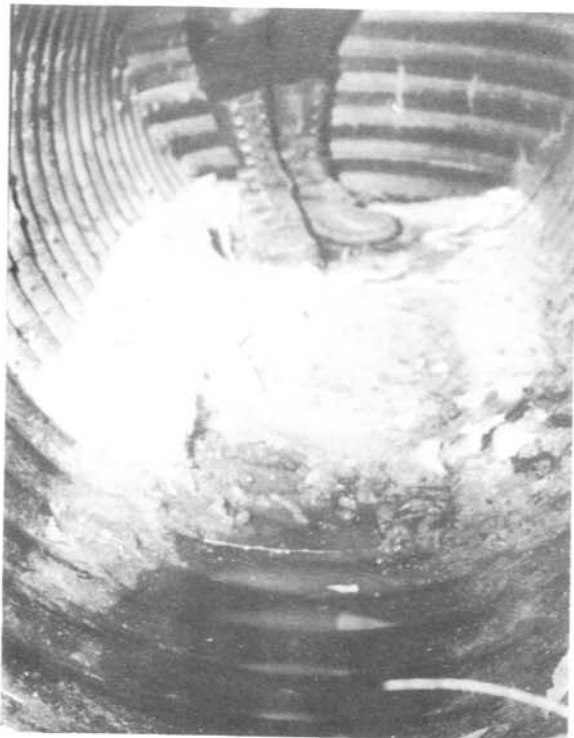
Rough and Ready Ditch
Photo No. 5 Farmers' Extension

Metergate turnout to Clennon Lateral, inside of 36" asbestos bonded, asphalt dipped, CMP. Welds to form elbow show little corrosion and what there is does not appear to be spreading badly. This pipe has been in service about 15 years.

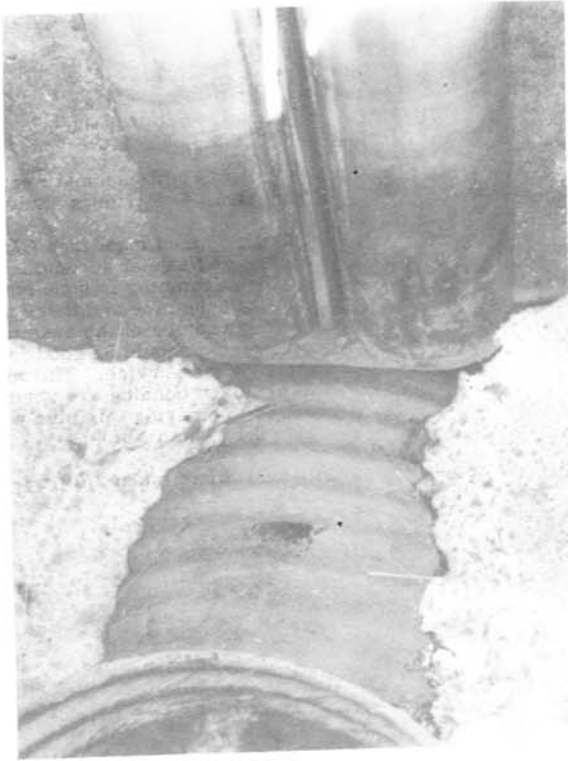
Photo No. 6 Rough and Ready Ditch
Farmers' Extension

View of downstream portion of structure shown in Photo No. 5. Meter-gate wells are of plain galvanized steel and are badly pitted after 15 years of service while the asbestos bonded pipe is in perfect condition.

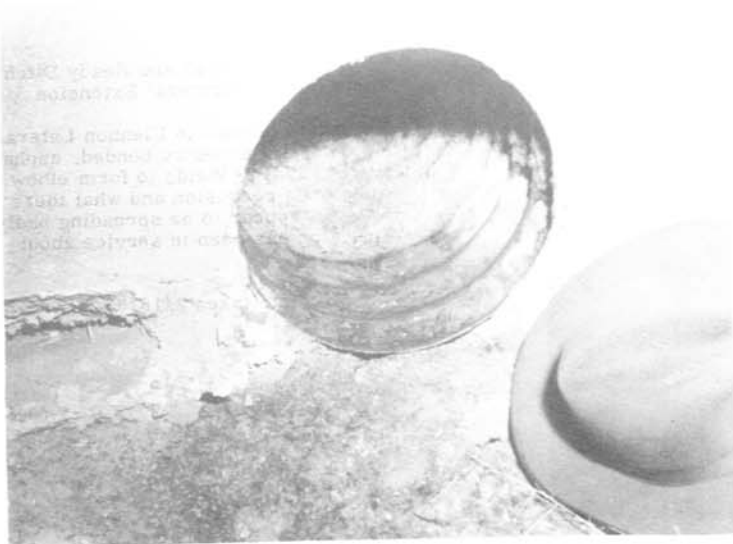
Photo No. 7 Sullivan Canal

12" galvanized CMP turnout about 50 yds. east of Hwy. 185 north of Denver. This pipe has been in service about 33 years and while most of the galvanizing is gone from the inside of the pipe, the base metal is not too badly corroded and will likely serve for many more years.

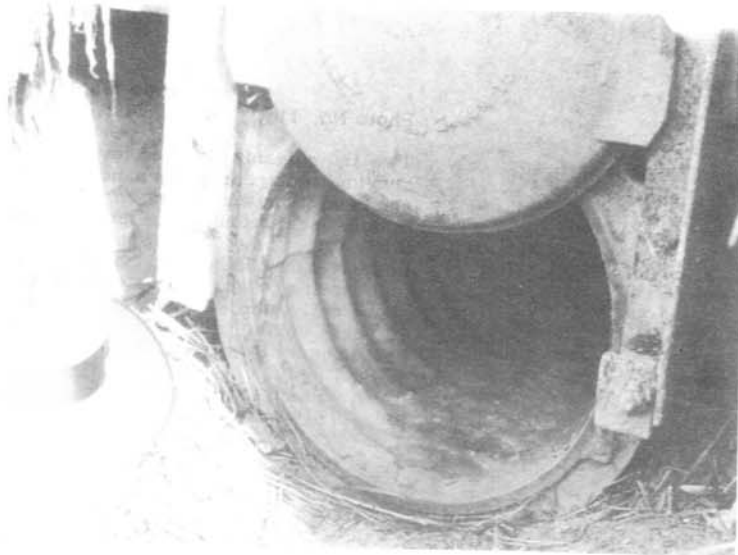
Photo No. 8 Brantner Extension Ditch

Brantner Ext. Ditch, south of Brighton, Muir Turnout	15"	25	Average, set above canal bottom	Galvanized only	Less erosion of galvanizing than two preceding cases because of being set higher above ditch bottom. Takes less sand
Brantner Ext., 1/2 mile north of Denver Poor Farm, Harris Turnout	12"	25	Average, some sand in water	Galvanized only	Most of galvanizing is gone from the invert, but the base metal is OK. Corrosion is not serious. Good for many years more
Fountain Mutual Main Canal, east of Colorado Springs, Colo. Foster Siphon Wasteway	18"	20	Better than average. Not steady operation	Galvanized only	Galvanizing is gone from the bottom of the invert, but the base metal is not badly corroded or pitted
Fountain Mutual Main Canal, east of Colorado Springs, Foster Turnout	15"	17	Average, some sand in water	Galvanized only	Galvanizing is mostly gone from lower 1/4 of pipe. Rest of galvanizing OK. Base metal is in good condition

15" galvanized CMP turnout to Muir place south of Brighton, Colorado. While much of the galvanizing is gone from the invert the pipe is still in good shape after 25 years of service. The base metal is not badly corroded. This pipe was set with the invert about a foot above the bottom of the canal which probably permitted the entry of less of the bed load of sand and gravel.

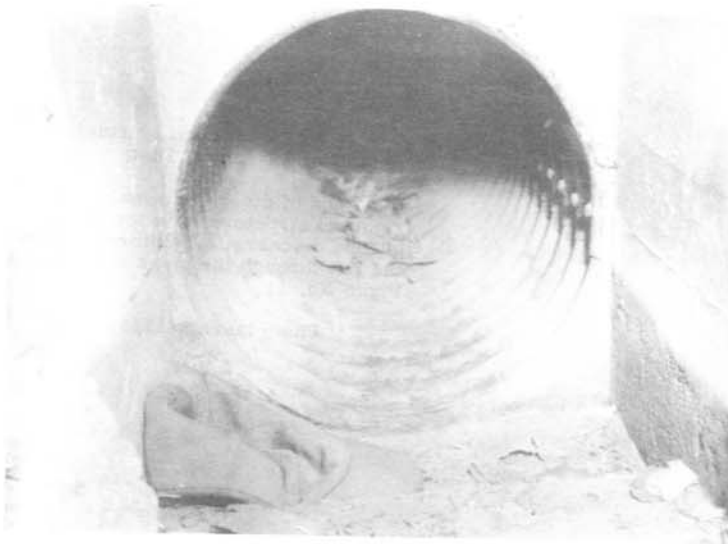
Photo No. 9 Fountain Mutual Irrig. Dist.

Fountain Mutual Main Canal, east of Colorado Springs, West Foster Turnout	15"	20	Average, some sand in water	Galvanized only	Galvanizing is gone from the invert, but the base metal is good, not badly corroded. Good for many more years
Fountain Mutual Main Canal, east of Colorado Springs, Vorhees Turnout	12"	14	Better than average. not used steady	Galvanized only	The galvanizing is intact in spite of the water-carrying average amounts of sand; however, the amount of water passing through this pipe averages 10 A.F./year
Fountain Mutual Main Canal, east of Colorado Springs, Thomas and Farmer Turnout	12"	30	Average, some sand in water	Galvanized only	Most of galvanizing is gone from invert of pipe, but base metal is sound and not badly corroded. Good for many more yrs.
Fountain Mutual Diversion Canal Desilting Pipes	18"	10	Very severe; heavy bed load, corrosive water, constant operation	Galvanized with paved invert	That part of the pipe overhanging the outlet headwall has been eroded through the paving and the pipe itself by the heavy load of sand and gravel removed from the canal by this installation. This structure operates continuously throughout the year

15" galvanized CMP turnout (West Foster Turnout), the outlet end. Sand carried by the water has eroded the galvanizing out of the invert but the base metal is sound and the pipe is good for a lot more service. It has been in service for 20 years.

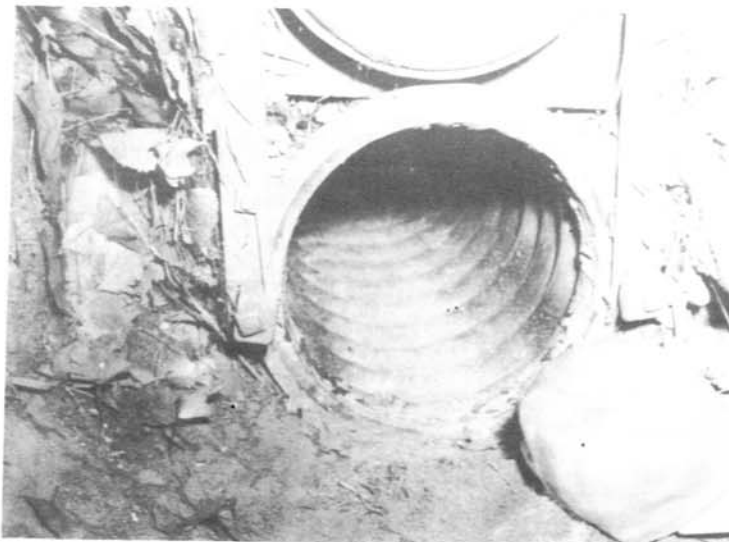
Photo No. 10 Fountain Mutual Irrig. Dist.

12" galvanized CMP turnout to Thomas and Farmer places. This structure carries about 110 acre feet of water annually with considerable sand in it. It has served for 30 years and, while the galvanizing is gone from the invert, the base metal is still sound and good for a long time more.

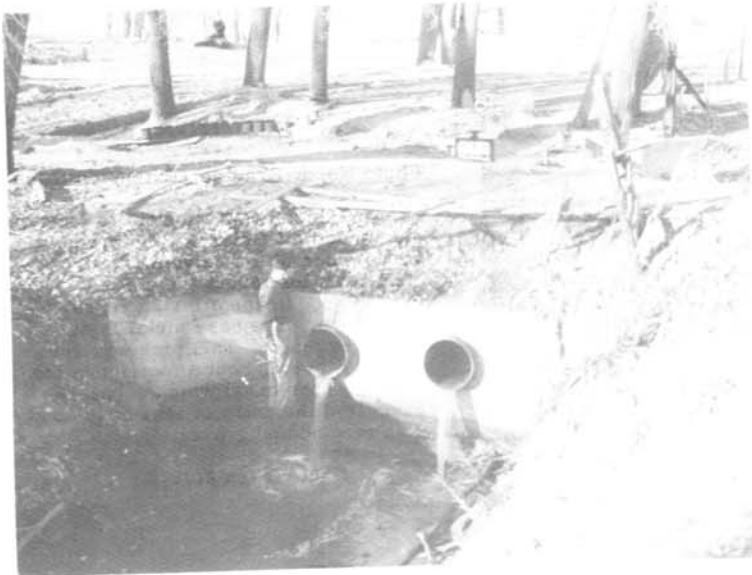
Photo No. 11 Fountain Mutual
Irrig. Dist.

Two 18" galvanized paved invert CMP's serving to discharge the sand and gravel removed from the diversion canal in the middle background. The left pipe gets the heaviest load of sediment since it is upstream. The paved invert and the pipe itself are worn completely through at the outlet end. It has served about 10 years during which time it has run continuously throughout the years.

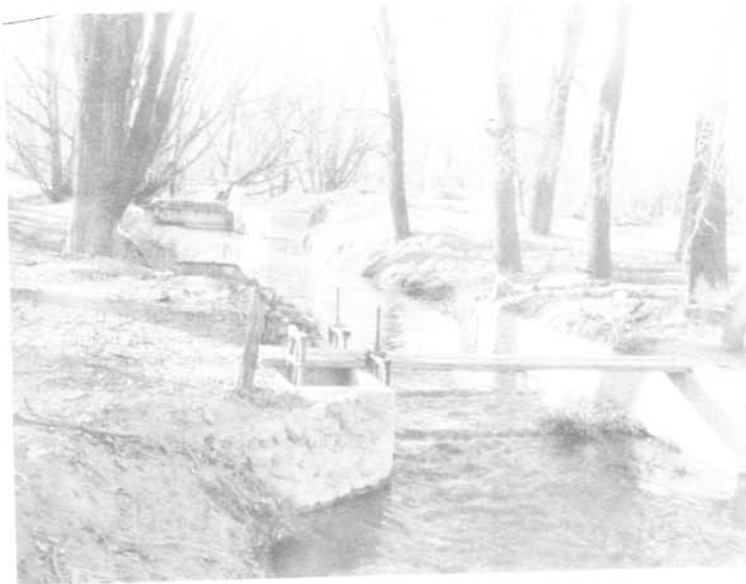
Photo No. 12 Fountain Mutual
Irrig. Dist.

Head end of diversion canal. Sand removal structure is in the foreground discharging sediment towards the left through the pipes shown in Photo No. 11.

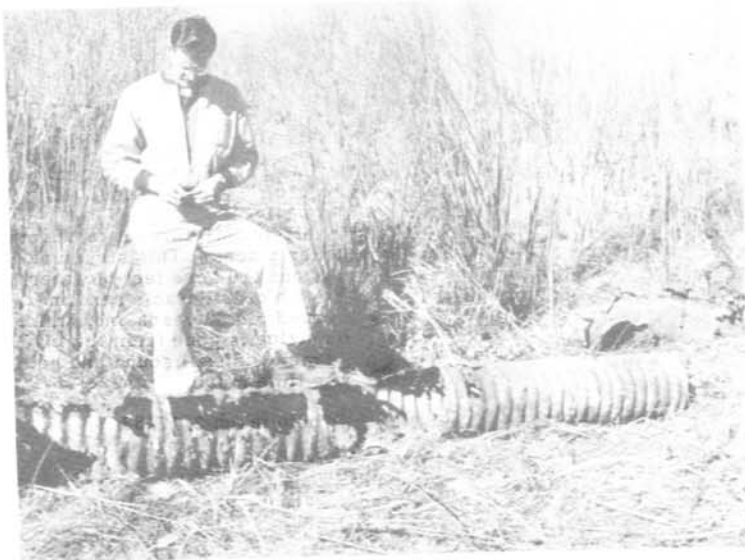
Photo No. 13 Fountain Mutual
Irrig. Dist.

Remains of 12" galvanized dipped (not asbestos bonded) perforated CMP used to outlet toe drains from Fountain Mutual Irrigation District dam east of Colorado Springs. The dam was built in 1901 but the toe drains were not installed until about 25 years later when high concentrations of salts had built up in the area just below the dam. The pipe in the picture served for about 25 or 26 years before being replaced. The same type of pipe installed at the toe of the dam as pick-up drains is still in service.
