Department of the Interior
Bureau of Reclamation

OPERATION AND MAINTENANCE EQUIPMENT AND PROCEDURES

RELEASE NO. 18

RESURFACING DETERIORATED CONCRETE LININGS

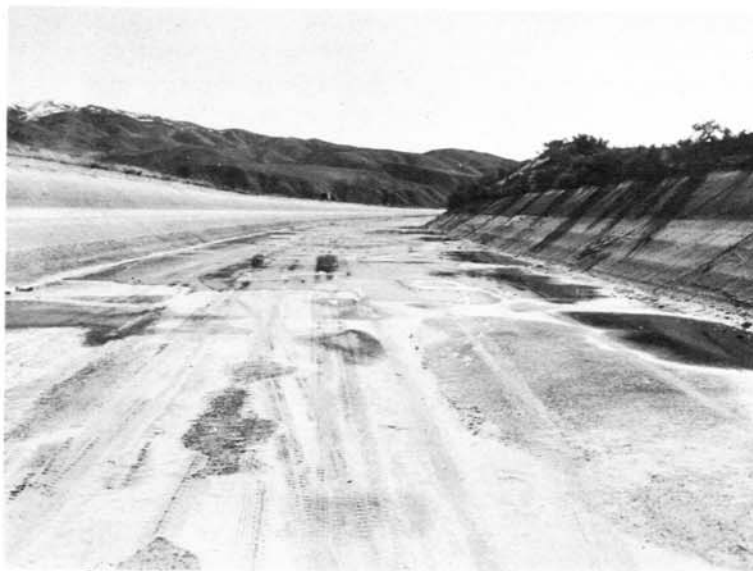
An inspection in April 1952, after 8 years of service, photograph

below, revealed little change in the general condition of the lining. Close examination of several representative areas, photograph at top of the following page, showed little, if any, erosion and no deleterious effects from mud curling. Bond between the portland cement concrete and the asphaltic concrete appeared to be excellent throughout the length of the repaired sections. The Manager of the Board of Control reported in 1952 that no

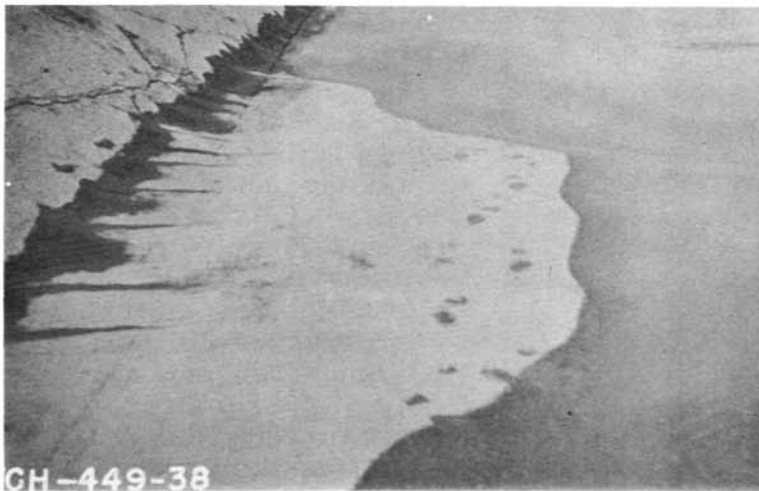
Although there was a thin sheet of water over much of the lining the asphalt mat was discernible and there did not appear to be any evidence of cracks in the older concrete lining being reflected or transmitted through the asphaltic concrete mat.

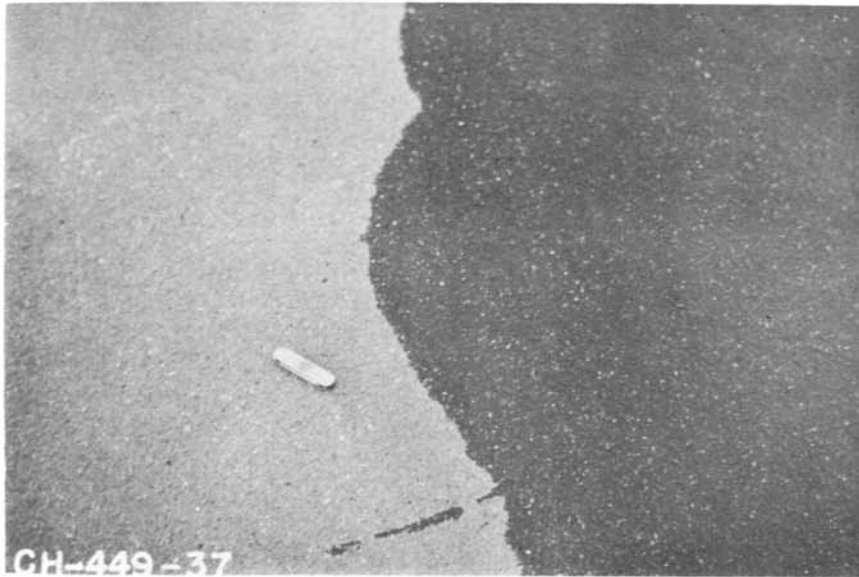
The lower photograph on this page is a view of the $1\frac{1}{2}$ -inch thick asphaltic concrete on the bottom of the canal at approximately mile 2.8 after $10\frac{1}{2}$ -years of service. In the photograph at the top of the following page a close up of the asphaltic concrete surface is shown. The surface has been roughened over the intervening $10\frac{1}{2}$ years, but there were few cracks and little erosion was apparent.

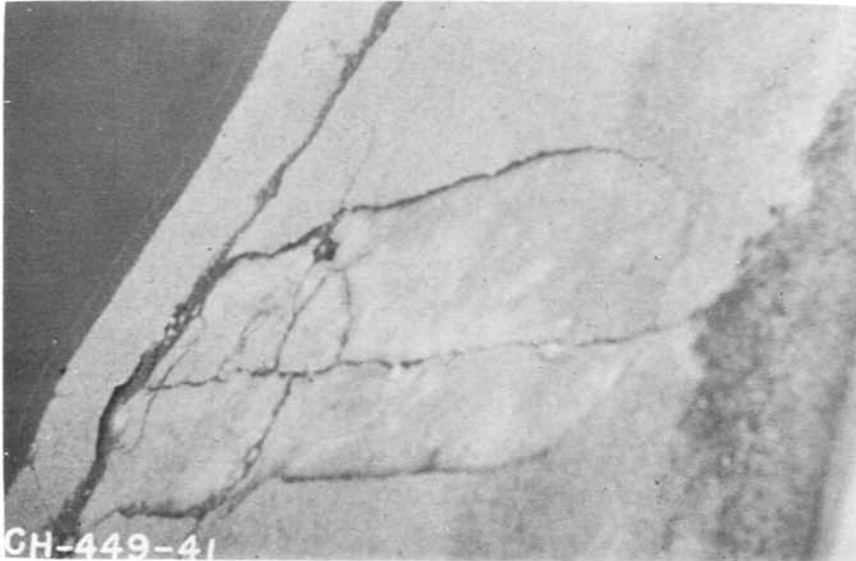
The 1½-inch thick pneumatically applied portland cement mortar or shotcrete resurfacing had a very good appearance at the time it was placed, as shown in the upper photograph on the previous page. After 8 years, in addition to the spalling and cracking apparent in the lower photo-

graph on the preceding page and in the photograph at left, the resurfacing material was drummy, with voids apparent between the old portland cement concrete and the resurfacing of portland cement mortar.

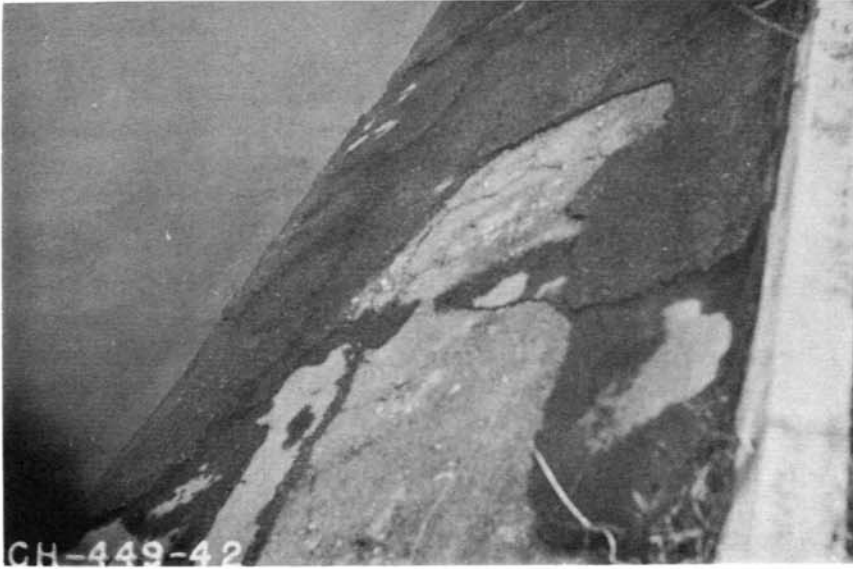
the cut back asphalt to properly cure under this condition of use. The photograph at the top of the following page is a view of this resurfacing material after 8 years of exposure. Large areas of the resurfacing material had

been eroded and that remaining was soft and badly spalled and cracked. This resurfacing material was applied after first applying a tack coat of the same material to the old concrete lining.

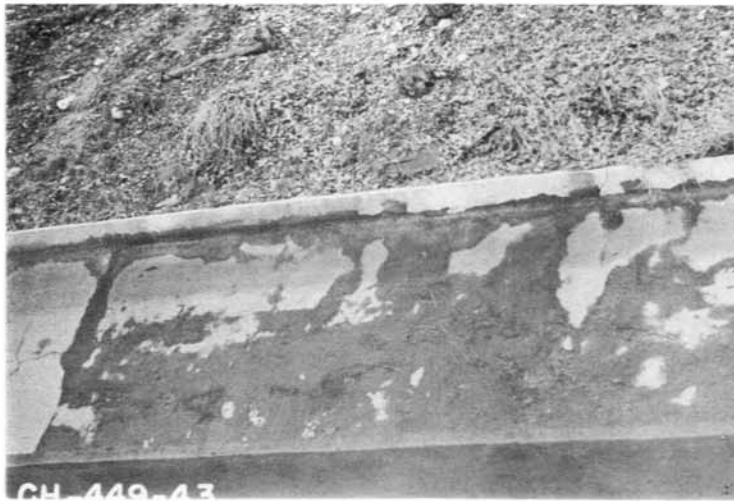
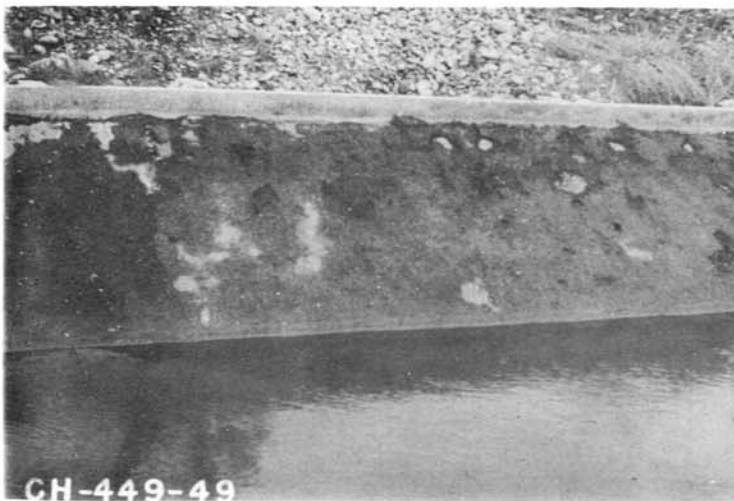
Views of the asphalt emulsion resurfacing after 8 years of service are shown in the two lower photographs on this page. Severe disintegration and spalling is apparent in the first treatment as shown at left, with total erosion in some areas.

That placed by the simultaneous application by hand spraying the asphalt emulsion and pneumatic application of the sand, is in better condition, as shown in the lower photograph. Although in somewhat better condition than that shown above, it also was badly spalled and cracked and the remaining material was soft.

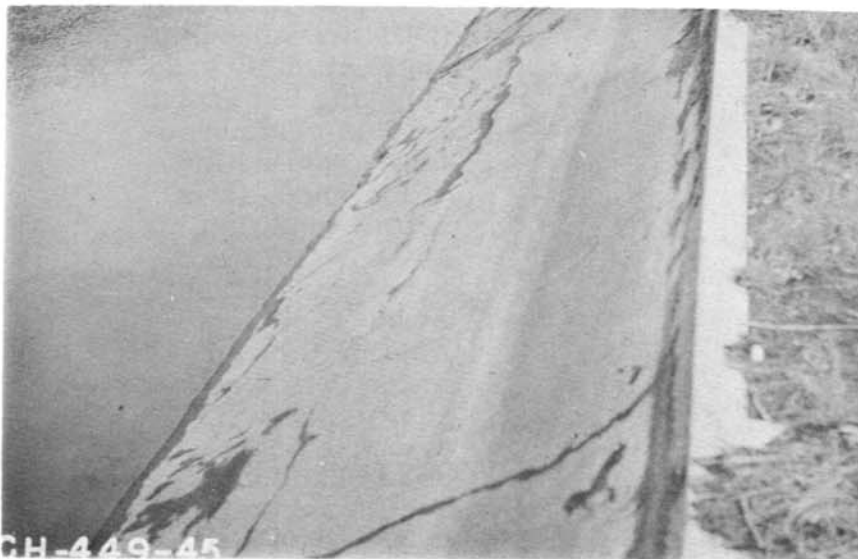
The condition of the thin membrane after 8 years of service is shown in the photograph at left. For practical purposes, the membrane has been eroded from the surface of the old concrete where the surface was not primed with the RC-O cutback asphalt, prior to application of the filled asphalt cement. There is

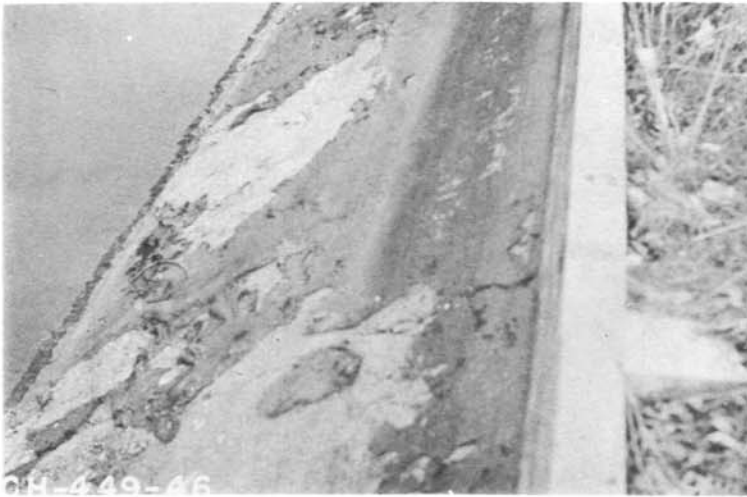
much sagging, curling and erosion apparent where the surface was primed, as shown in the photograph at the top of the following page.

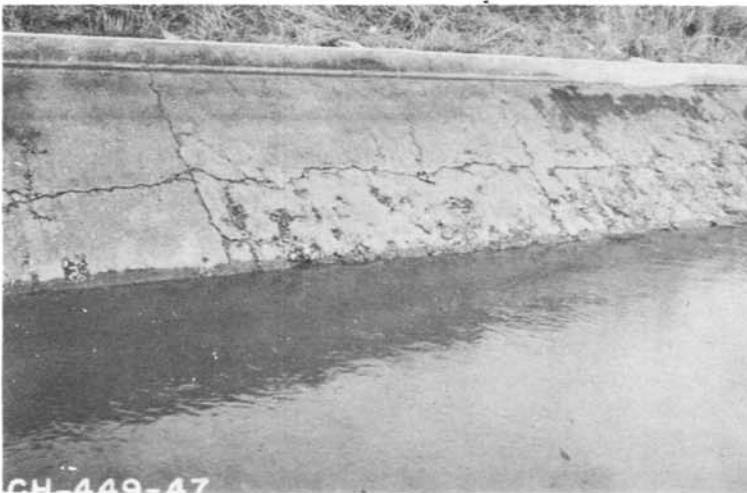
As shown in the lower photograph this material also had been badly eroded from the surface of the old concrete lining when inspected in 1955 after 8 years of service.

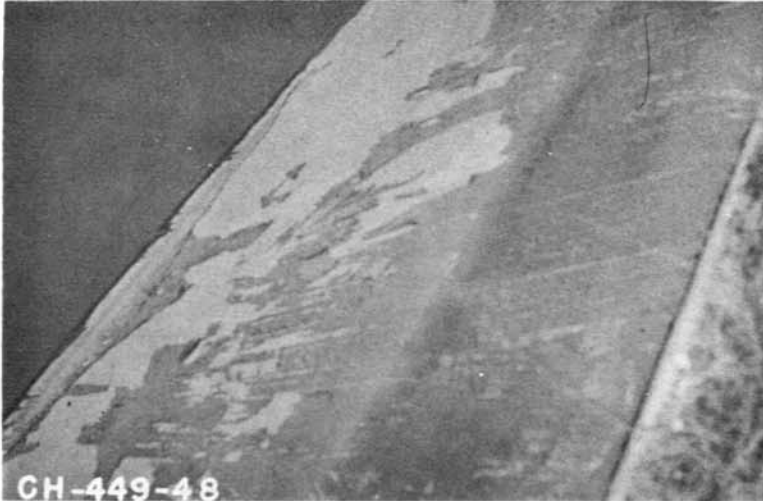
of the coating had been lost in the 8 years of service, as shown below, and the remaining portion of the filled asphaltic-emulsion was thin, oxidized and brittle.

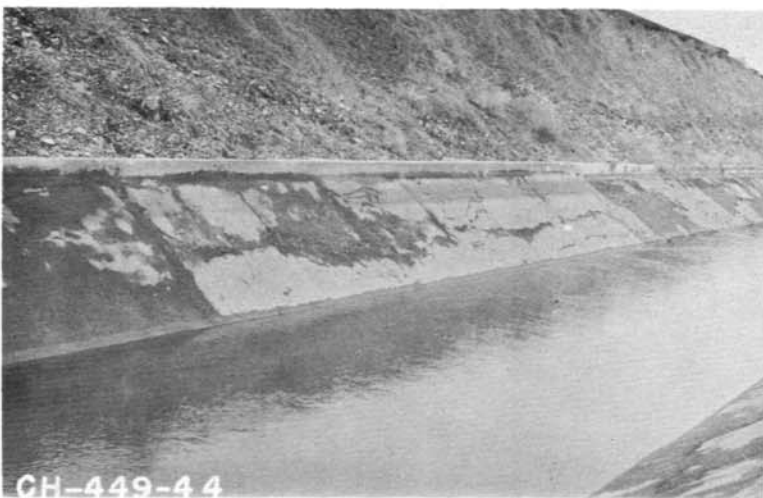
In a short reach of the test section, a coal tar waterproofing was placed on the surface of the old concrete lining. The condition of this resurfacing material after 8 years of service and exposure is shown in the photograph below. At least 50 percent of the resurfacing material has been eroded and that remaining is thin, badly oxidized and brittle.

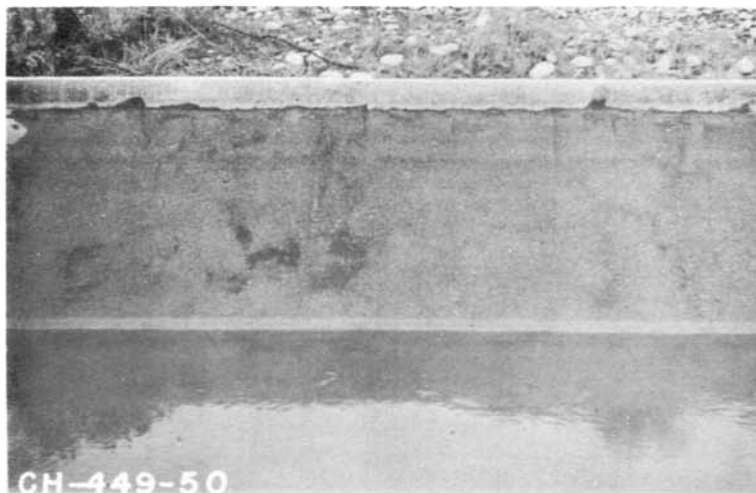
The asphaltic-emulsion concrete, as shown at left, after 8 years of service is still in place. It exhibits numerous cracks and is soft in spots.

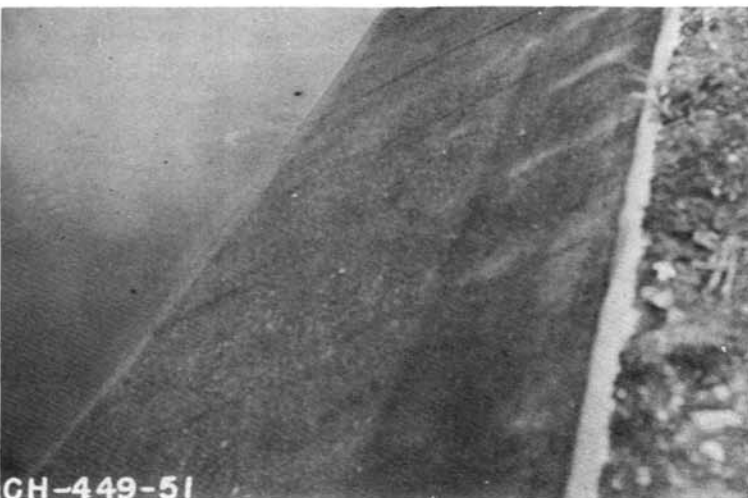
The resurfacing material was very good in appearance at the time placed and, as shown in the lower photograph, there are few cracks and very little spalling after 8 years of service and exposure. Some roller marks are still apparent and the protective resurfacing mat is intact and hard.
