WATER OPERATION AND MAINTENANCE

BULLETIN NO. 128

JUNE 1984

REBUILDING THE HOLLOW-JET OUTLET VALVES AT MONTICELLO DAM, SOLANO PROJECT

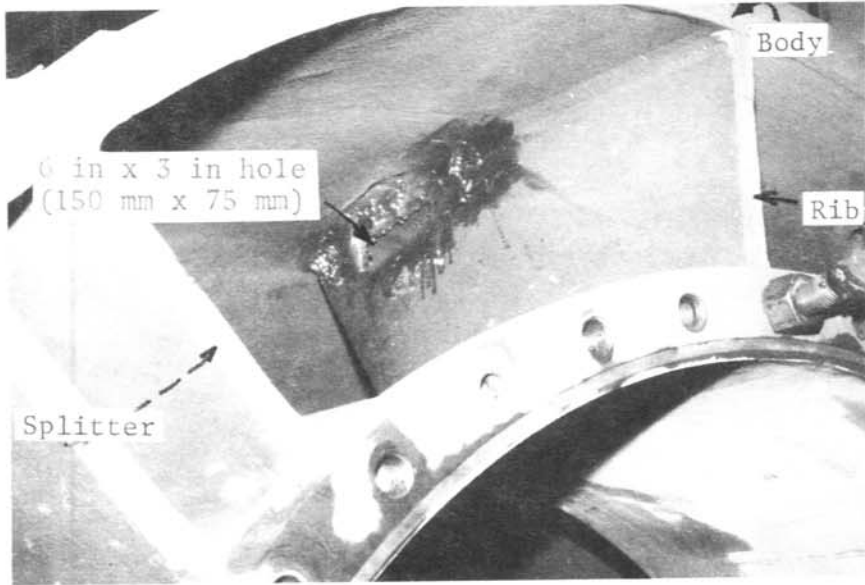
Extensive cavitation damage was noted when the valves were examined in June 1980. The damage to valve No. 1 included a 3-in (76-mm) diameter hole in one of the ribs, a 5-in-long by 2-in-wide (127-mm-long by 50-mm) gouge in another splitter, a small hole which had penetrated the 1-1/2-in (38-mm) thick cast iron body, and severe damage to both metal seats. Valve No. 2 was in similar condition. The valves were installed in 1954 and first used in 1958. See figures 2, 3, 4, 5, 6, and 7.

Figure 3. Cavitation damage to hollow-jet valve.

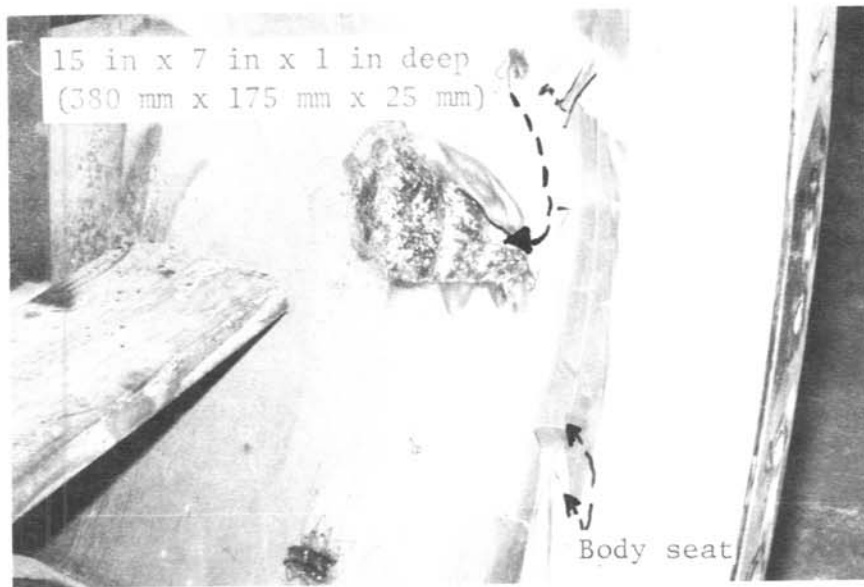
Figure 4. Cavitation damage to hollow-jet valve body.

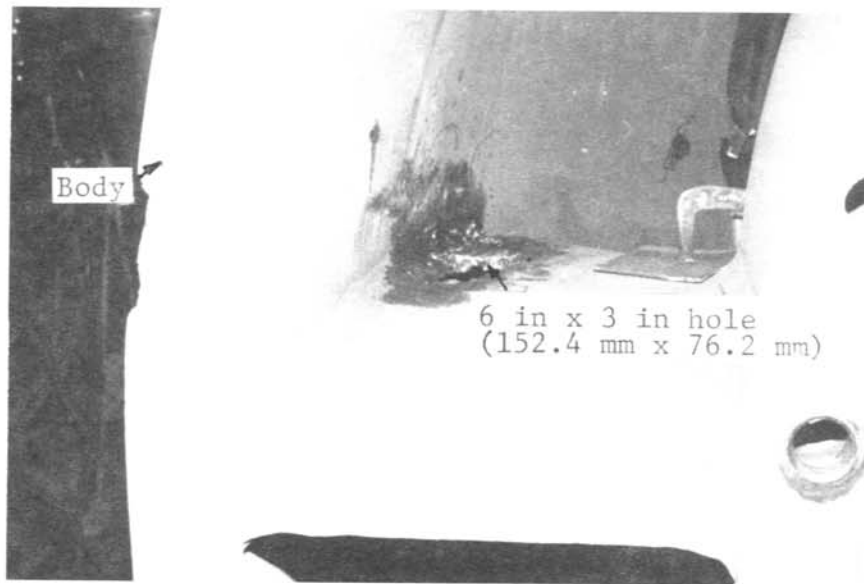
Figure 5. Cavitation damage to the hollow-jet valve rib.

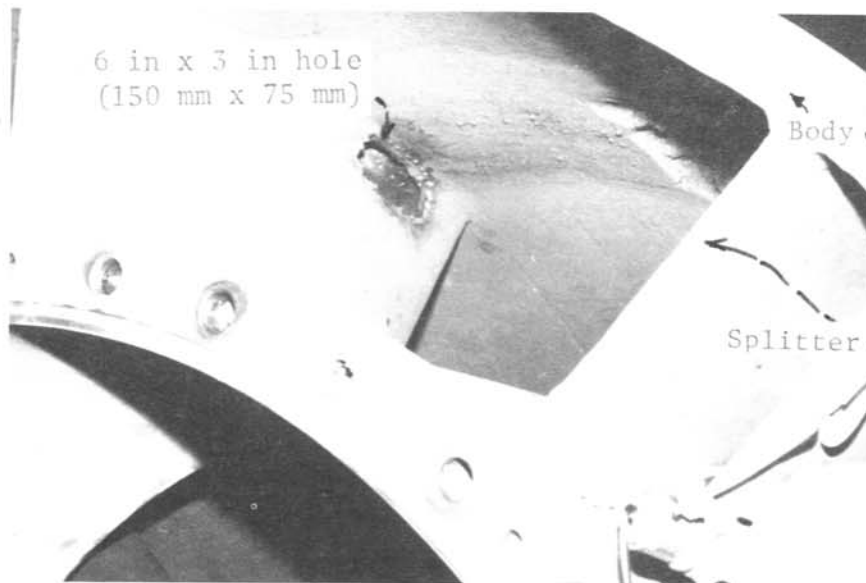
Figure 6. The hole is completely through the valve rib.

Note: Valve leaking about $5\text{ft}^3/\text{s}$ ($0.14\text{m}^3/\text{s}$)
because of damage to body
and needle seat

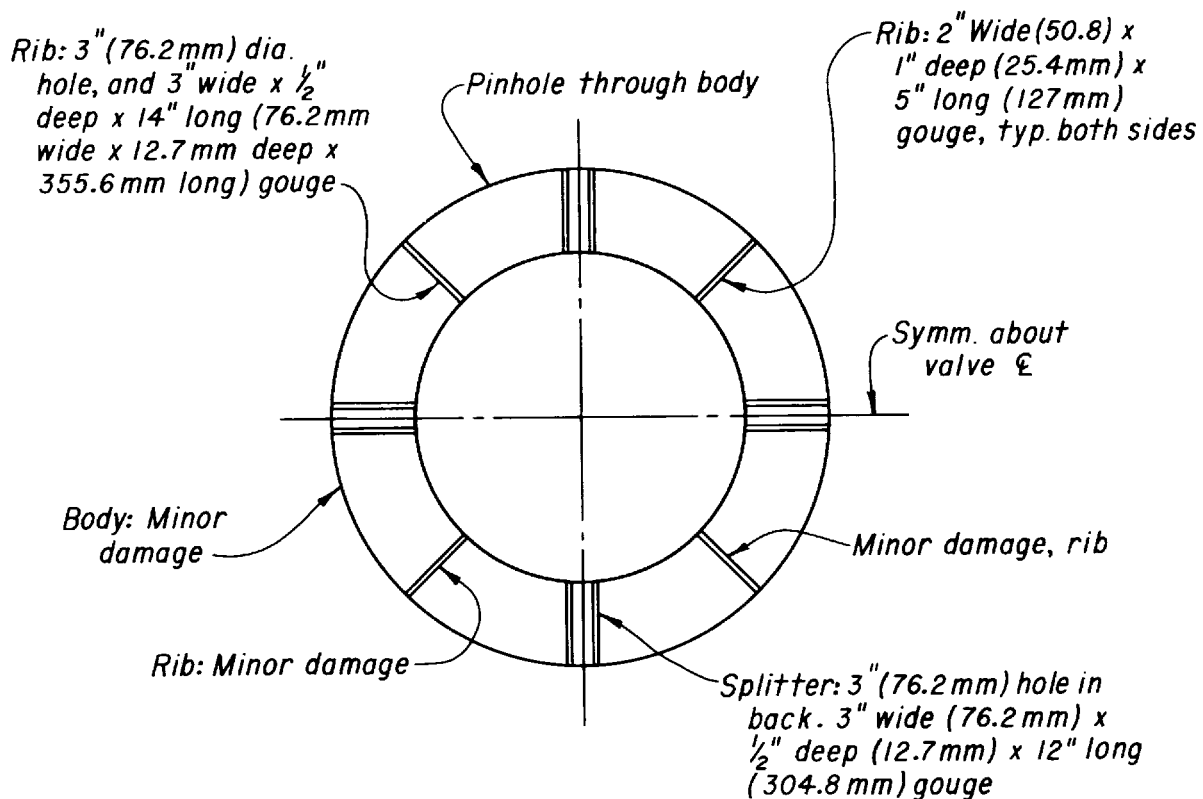
Figure 7. Summary of cavitation damage to hollow-jet valve No. 1 (looking upstream).

8. The cavitation damage would not have been enough to cause a problem if each hollow-jet valve had not been mounted too close to the pivot valve outlet. The cavitation is caused by turbulence introduced in the water by the pivot valve. To keep maintenance expenses within reason, the hollow-jet valves should have been located greater than 50 ft (15 m) (10 pipe diameters) downstream of the pivot valve.

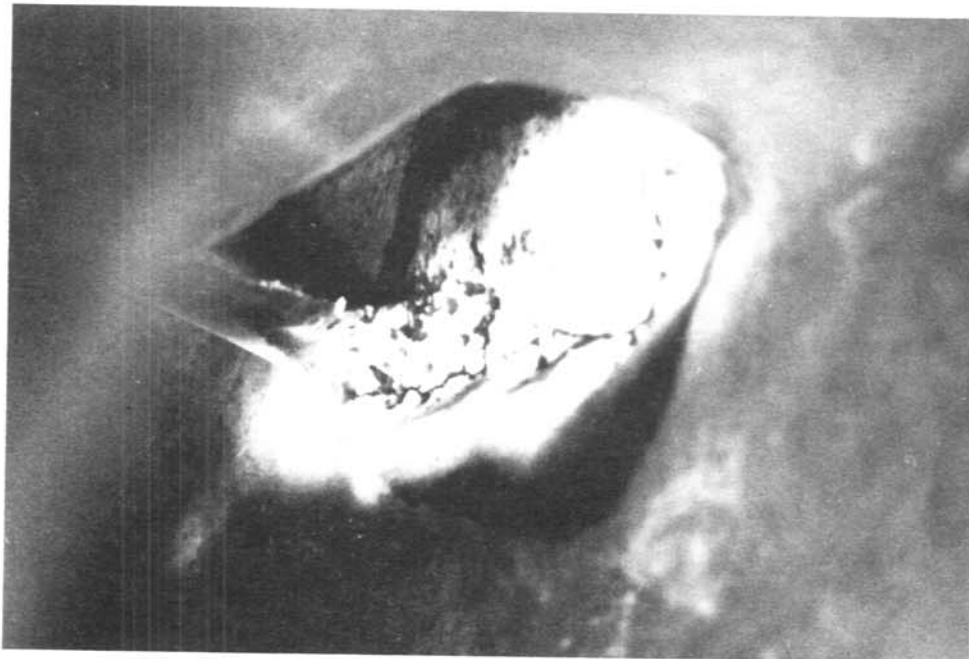
The following procedure for quality control was implemented: Upon delivery of the valve to the Groth plant, it was cleaned and the damaged areas identified. After the paint coating, rust, and epoxy filler were removed, the damage was found to be more extensive than first suspected. In order to determine the extent of the damage, it was necessary to grind away the rough, cavitated metal down to sound base. A dye penetrant was used to determine if all cracks had been removed before the repair welding could begin. See figure 8. As can be seen in this figure, there were cracks that continued in the casting.

Figure 8. Damaged area of valve No. 1 splitter. (Note: Rough cavitated metal has been ground away to clean cast iron, and surface has been treated with dye penetrant).

Before the repair welding began, Groth conducted numerous sample welds to determine the best procedure for the cast iron repair. The procedure finally selected was a "cold technique" proposed by the Eutectic Corporation: short weld passes with a high nickel content rod to reduce the heat input to the cast iron body, thereby reducing cracking. This technique was found to be very time consuming but necessary to avoid cracking the weld metal and the cast iron body. Another technique used to reduce the propagation of cracks was to "butter" the cast iron with a mild steel rod. This was found to provide a good anchor for the continuation of the weld procedure.

After each pass, the welds were examined thoroughly for cracks before the next pass was made. If cracks were discovered, they were gouged out before the repair procedure was continued.

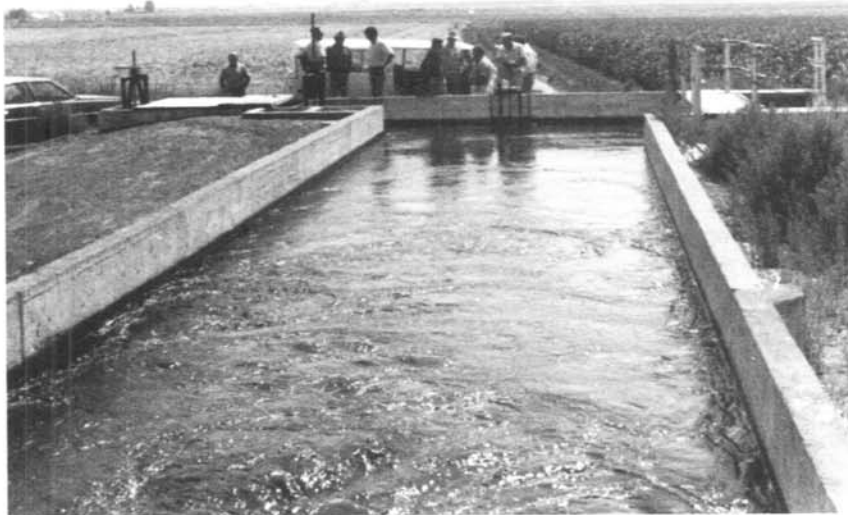
A problem the District was having with obtaining measurements in a lateral was solved with the installation of large square concrete stilling wells. A right angle turn at the outlet end of the railroad siphon crossing had created turbulence in the lateral, making it difficult to read the staff gages for the large constant head orifice turnouts. Pipe stilling wells installed outside the constant head orifice structures had not stilled the water enough to obtain accurate measurement. The round pipe stilling wells were removed and new large square concrete stilling wells were constructed. The new facilities have improved the conditions and accurate reading can be obtained from the constant head orifices. See figure 9.

Figure 9. Square concrete stilling wells were constructed to replace round pipe stilling wells.

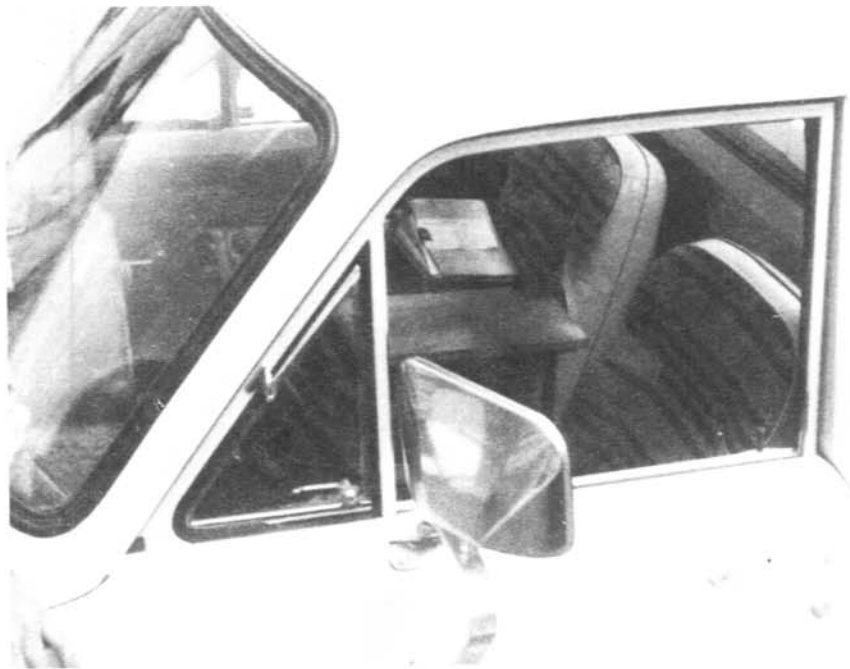
The East Columbia Basin Irrigation District has been using compact pickup trucks, such as the Ford Courier and Chevy Luv, as ditchriders' vehicles. The ditchriders complained that the vehicles did not provide as soft a ride as the heavier pickups did when traveling the gravel O&M roads. As a result, the bench seats were removed and replaced with bucket seats which provided a more comfortable ride. A small writing table was built into the space between the seats, providing the ditchriders with a table to do their book-work. See figure 11.

Figure 11. Rebuilt seats provide softer ride.
