# **WATER OPERATION AND MAINTENANCE**

**BULLETIN NO. 139**

MARCH 1987

**DETERIORATED REINFORCED CONCRETE CANAL LINING  
GRANITE REEF AQUEDUCT  
CENTRAL ARIZONA PROJECT**

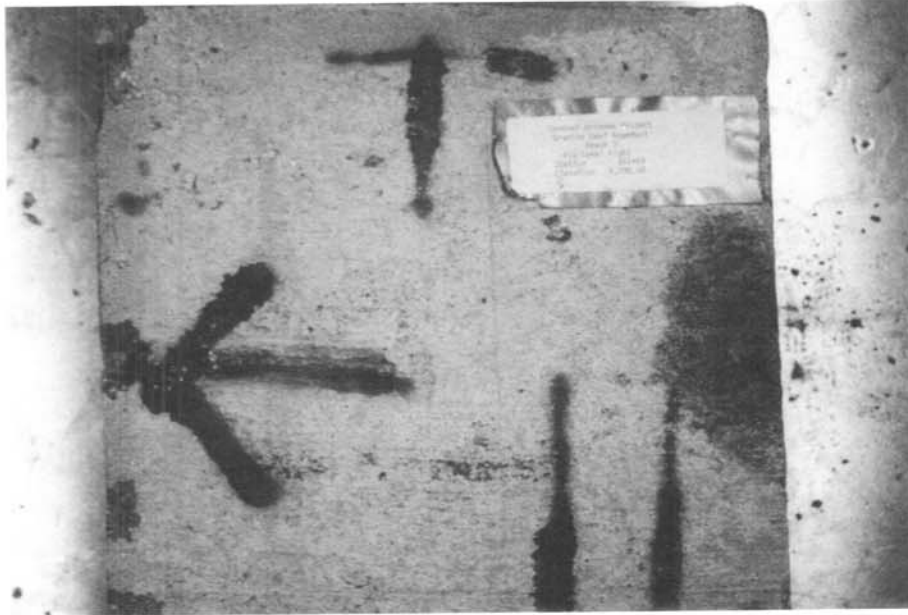
Figures 1 through 10 are views of the reinforced concrete samples. Figure 1 depicts the concrete consolidation on the surface of sample No. 11, which was found to be satisfactory and typical of surface consolidation on other samples.

Figure 1. Upper surface of Sample No. 11. Consolidation of the concrete on the exposed surfaces was generally satisfactory.

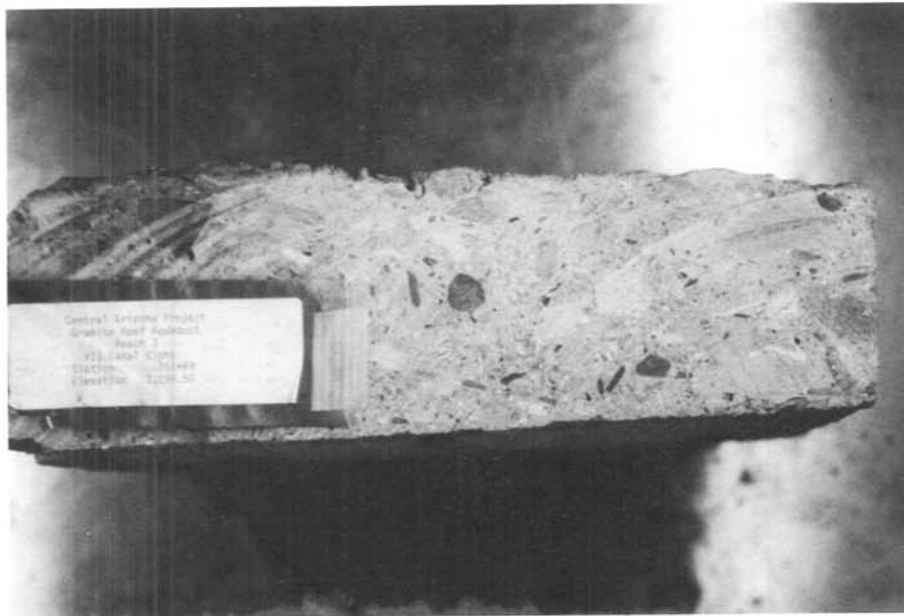
Whereas figure 2 depicts satisfactory consolidation throughout the thickness of the lining on sample No. 11, figure 3 shows a large void beneath the longitudinal reinforcement on sample No. 12. The void is the result of inadequate consolidative effort on concrete below the steel. The void and the steel appear to have formed a weakened plane for the subsequent contraction cracking above the bar.

Figure 2. Side view of Sample No. 11. This edge shows generally satisfactory consolidation.

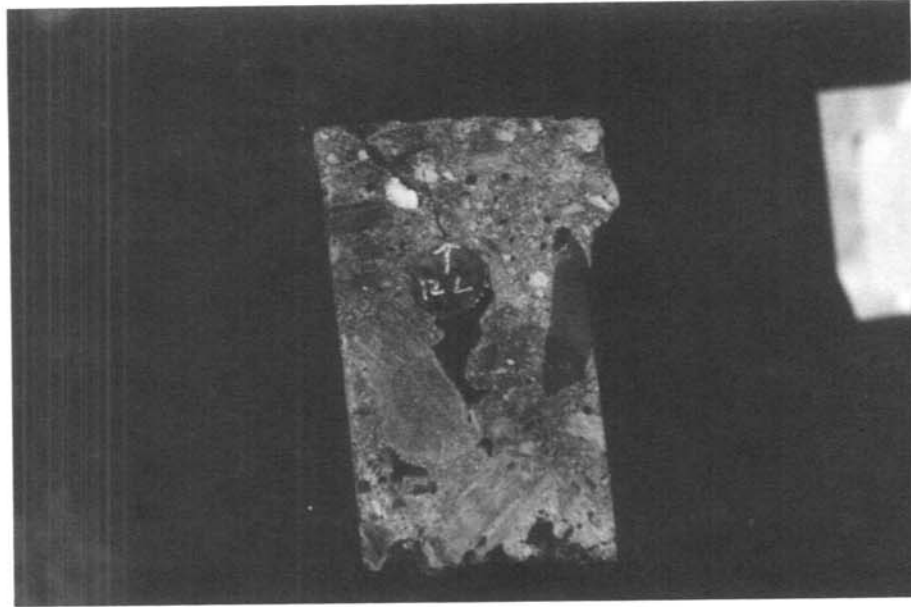
Figure 3. Edge view of Sample No. 12 showing longitudinal No. 4 (1/2-inch diameter) reinforcement. Note large void beneath the steel and crack from the surface of the concrete to the steel.

1. The bottom cover requirements should be increased to 2 inches minimum with sound concrete. Two inches of concrete cover has been found to be normally adequate even in highly aggressive exposure such as to seawater.
2. Since cracking of the concrete can also result in diminution of concrete cover, all practicable measures should be taken to minimize this effect including:
  - a. Saturate subgrade immediately prior to placement of concrete

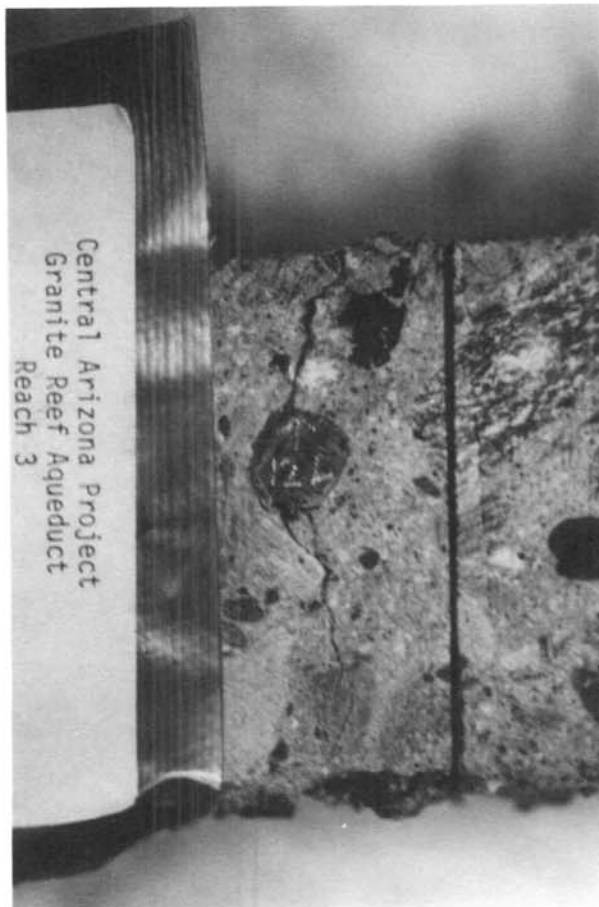
Figure 4 is the opposite end of the sample shown in figure 3. Note that the crack completely penetrates the thickness of the concrete.

Figure 4. Opposite end of view shown in Figure 3 above. Note cracking completely through section containing the longitudinal reinforcement.

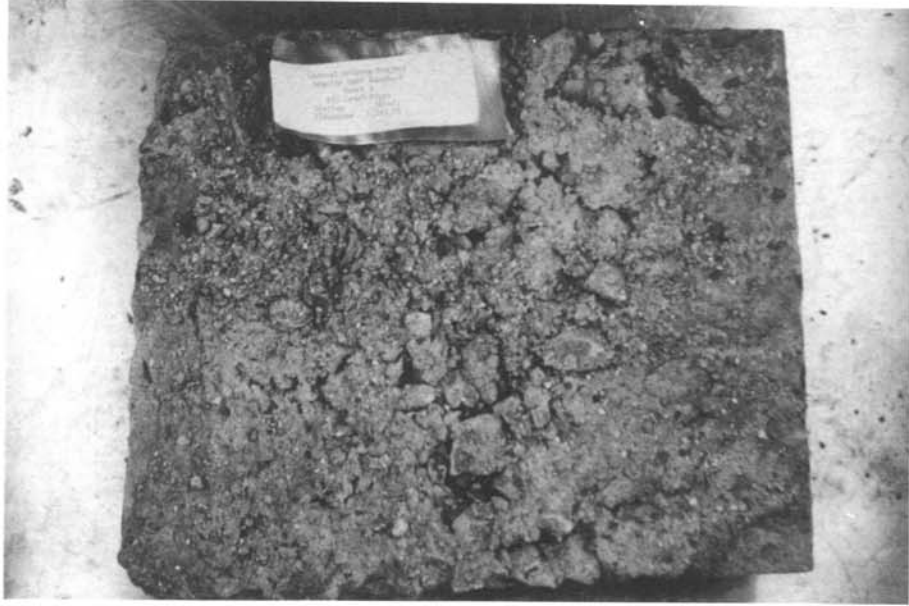
Figure 5 generally typifies the soil-side concrete of all samples. The concrete generally is poorly consolidated, and the consolidation appears to be worse directly under the reinforcement. Some of these voids from the bottom completely penetrate to the steel as shown in figures 6 and 7. If well consolidated, a vivid impression of the reinforcement bar including deformations would be clearly visible. From these photographs, one cannot determine if deformed bars were installed.

Figure 5. Bottom surface (soil side) of Sample No. 10. Concrete is not completely consolidated.

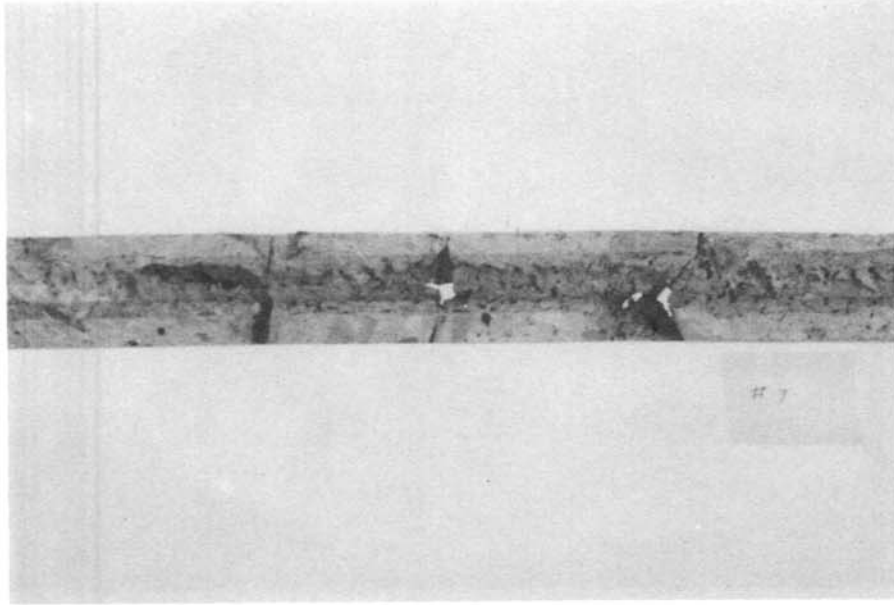
Figure 6. Slice of concrete below transverse reinforcement on Sample No. 7. In some cases, voids are continuous from the bottom surface to the steel reinforcement.

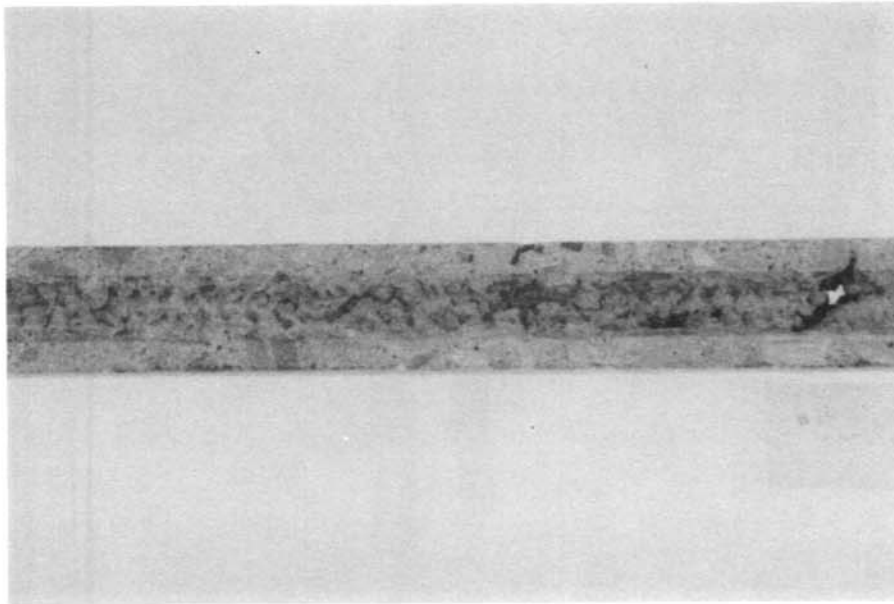
Figure 7. Concrete removed from below transverse reinforcement on Sample No. 12. Note hole and voids beneath reinforcement.

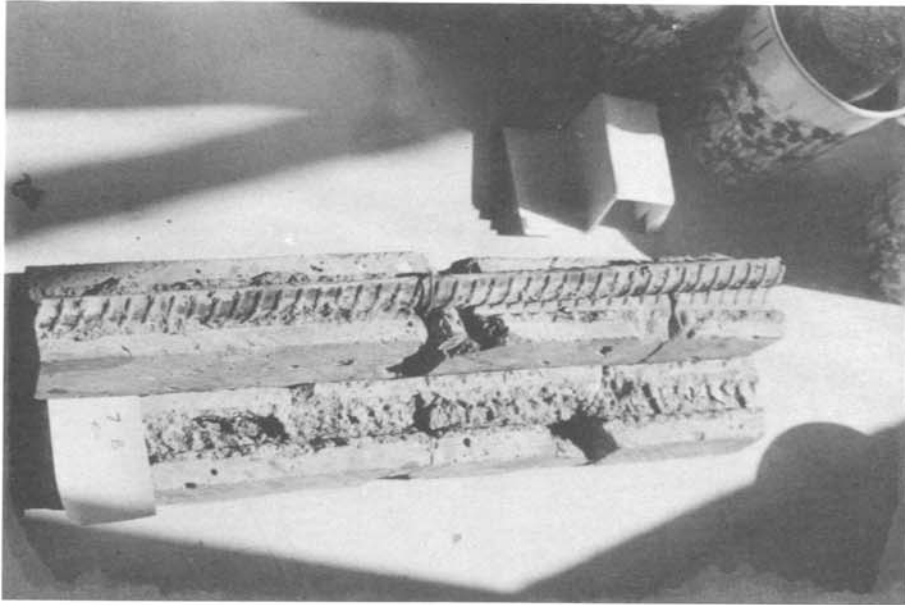
Figures 8 and 9 show the active corrosion on the reinforcement opposite voids which completely penetrated the concrete cover. Again no vivid imprint of the steel configuration can be seen.

Figure 8. Slice of concrete containing the transverse reinforcement on Sample No. 7. Note poor consolidation and active corrosion of the steel.

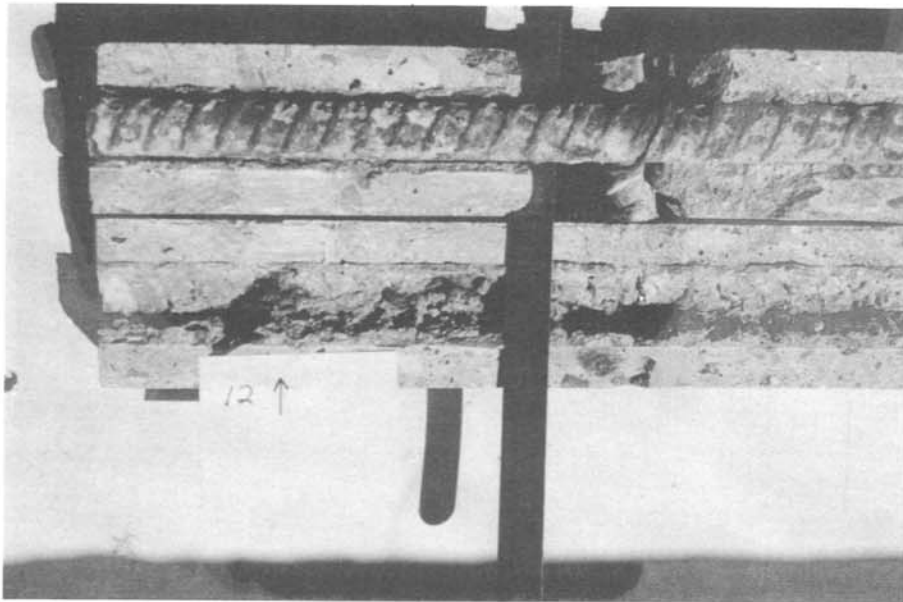
Figure 9. Slice of concrete containing the transverse reinforcement on Sample No. 12. Again note poor consolidation and active corrosion of reinforcement.

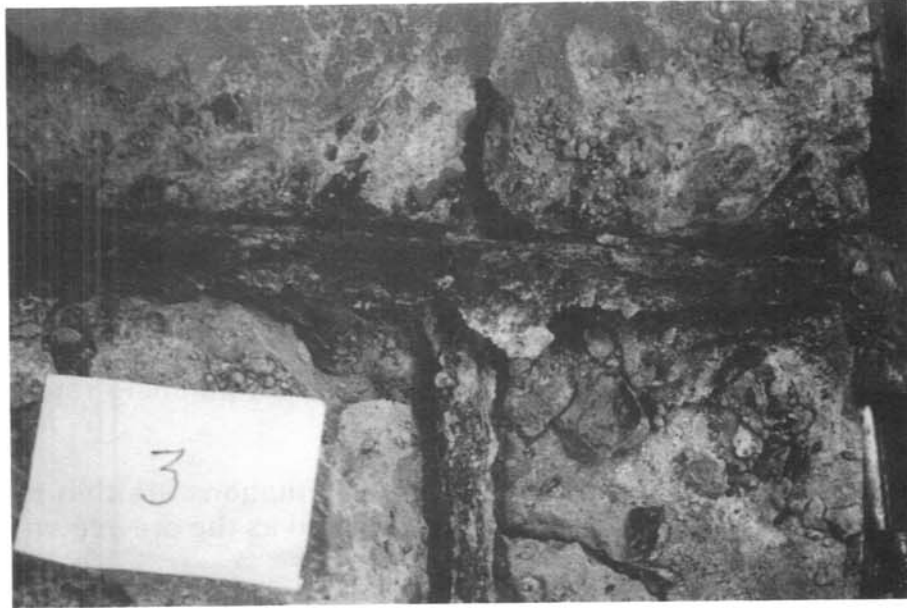
Figures 10 and 11 display severe corrosion of the steel and cracking and spalling of the concrete such that the degree of consolidation above and below the reinforcement cannot be determined.

Figure 10. Underside of Sample No. 3. Steel is severely corroded and concrete is severely cracked and spalled.

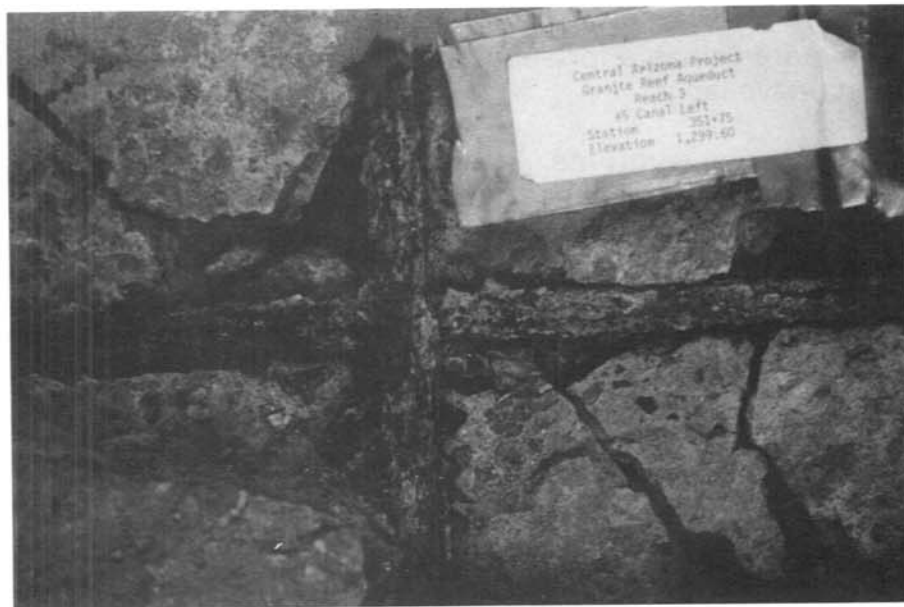
Figure 11. Underside of Sample No. 5. Again steel is severely corroded and concrete is severely cracked and spalled.

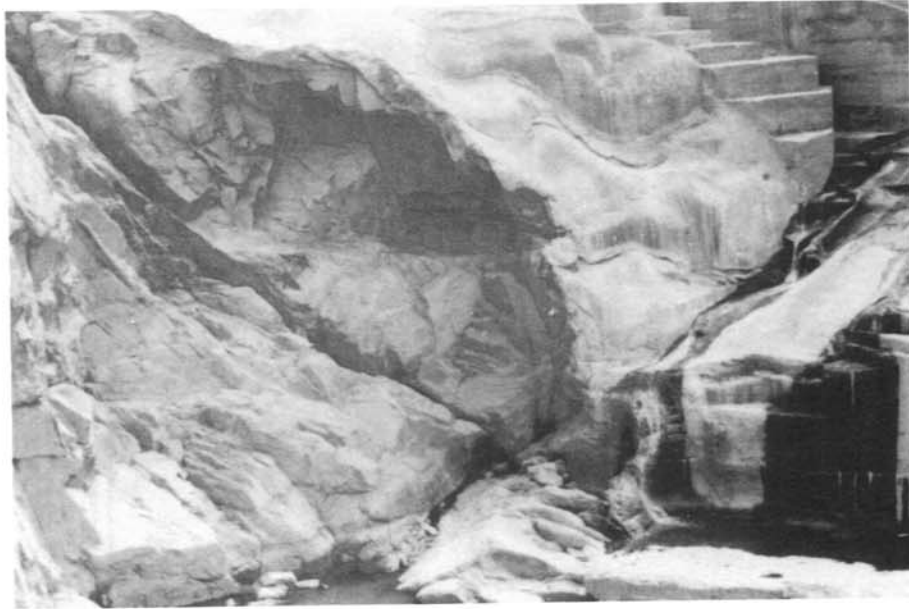
**Incident:** During the first moderate spill of 28,000 ft<sup>3</sup>/s, in December 1965 and January 1966, considerable damage occurred in the discharge channel below the spillway chute flip structure. Undermining of the chute was occurring. Continued massive erosion of the discharge channel could undermine and cause the spillway to fail completely. Criticality is high.

**Causes:** An abrupt turn in the channel and the open joints in the weathered rock of the channel contributed to the damage. A shotcrete repair program was implemented in 1966-68. The entire outlet channel for a distance of about 100 feet downstream from the end of the spillway was paved with a 9- to 12-inch thickness of shotcrete. Frequent discharges for a few years caused no detrimental effect. Major storms in early 1978 necessitated large releases peaking at 98,000 ft<sup>3</sup>/s during March 1 to 8. Major damage occurred to the armored area. A 50-foot-deep and 100-foot-long hole was eroded in the canyon wall. The reinforced gunite was undercut. More storms in December 1978 resulted in spillway discharges up to 65,000 ft<sup>3</sup>/s which further enlarged the plunge pool. High flows in January 1979 caused further damage.

Bartlett Dam – General view of damage downstream of spillway chute. Note open joints and overhanging rock and concrete. Photo taken April 25, 1978.

**Remedy:** The rock slopes on the channel sides were scaled back for rock bolts and concrete. A cyclopean masonry wall was constructed to protect the nearly vertical rock below the spillway flip structure.

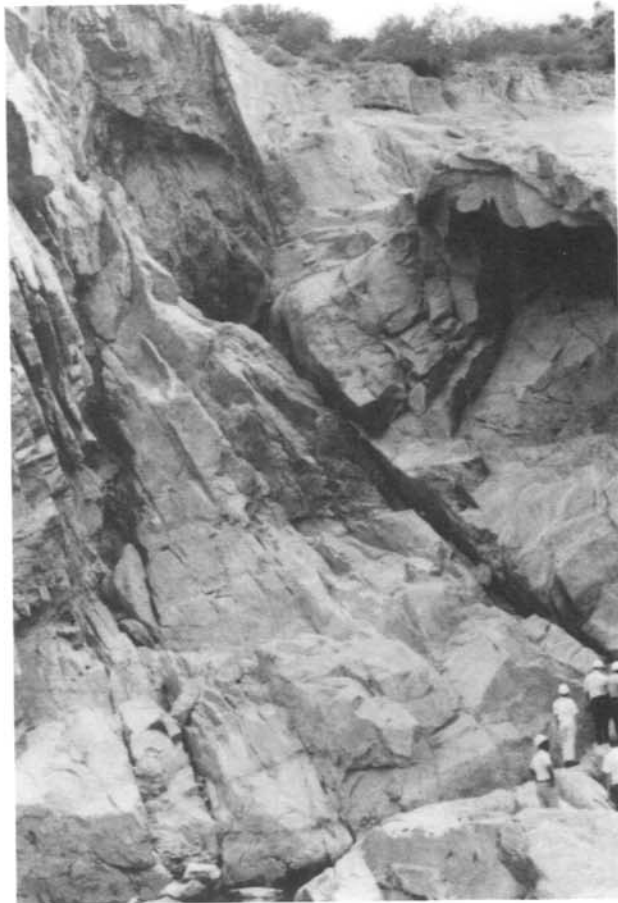
Bartlett Dam – Damage downstream of spillway chute, showing open joints and overhanging rock and concrete. Photo taken April 25, 1978.

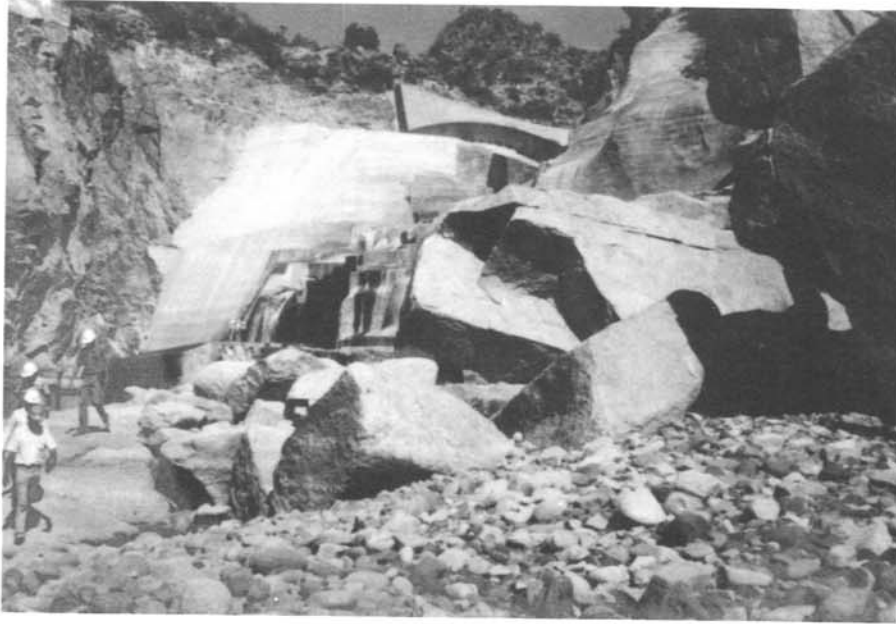
Bartlett Dam - Downstream end of spillway chute and channel armoring. Photo taken October 10, 1984.

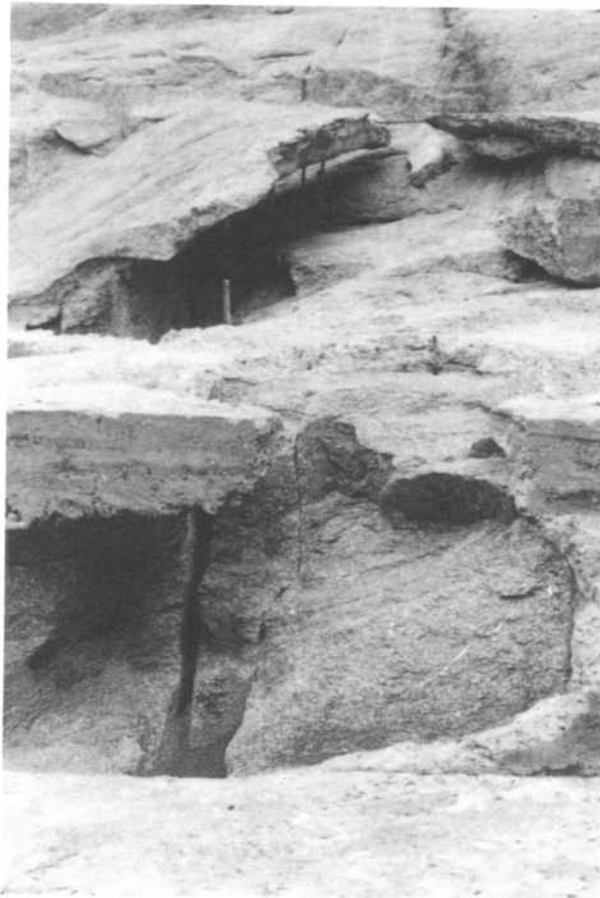
Bartlett Dam - Damage concrete and gunite and open joints in rock foundation. Photo taken April 25, 1978.
