# **WATER OPERATION AND MAINTENANCE**

**BULLETIN NO. 140**

June 1987

## OUTLET WORKS BYPASS PIPE FAILURE

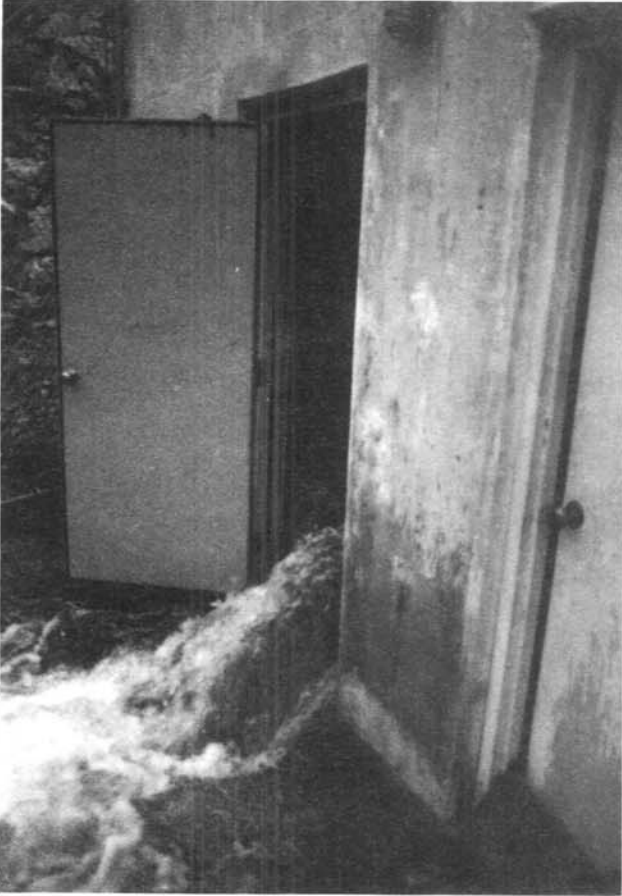
Photograph 1

On arriving at the dam, he observed that the tunnel access door was open with approximately 26 ft<sup>3</sup>/s flowing from the tunnel (photographs 1, 2, and 3). Notification of the emergency was implemented immediately in accordance with the requirements of the SOP (Standing Operating Procedures). Regional personnel were at the dam in the afternoon to assess the situation. It was quickly discovered that the 12-inch bypass sleeve valve was apparently closed and could not be opened. It was also discovered that the sleeve valve only had approximately 5 feet of head on it from the tunnel; therefore, it was concluded that the tunnel was only partially flooded. Plans were initiated immediately to have the regional dive team study the situation to possibly access the flooded portion of the tunnel and shut off the upstream guard valve. As an alternative, a bulkhead gate for the intake structure was located and readied for shipment if required.

Mason Dam — Outlet works tunnel access doorway. Approximately  $26 \text{ ft}^3/\text{s}$  flowing from flooded area of the downstream tunnel.

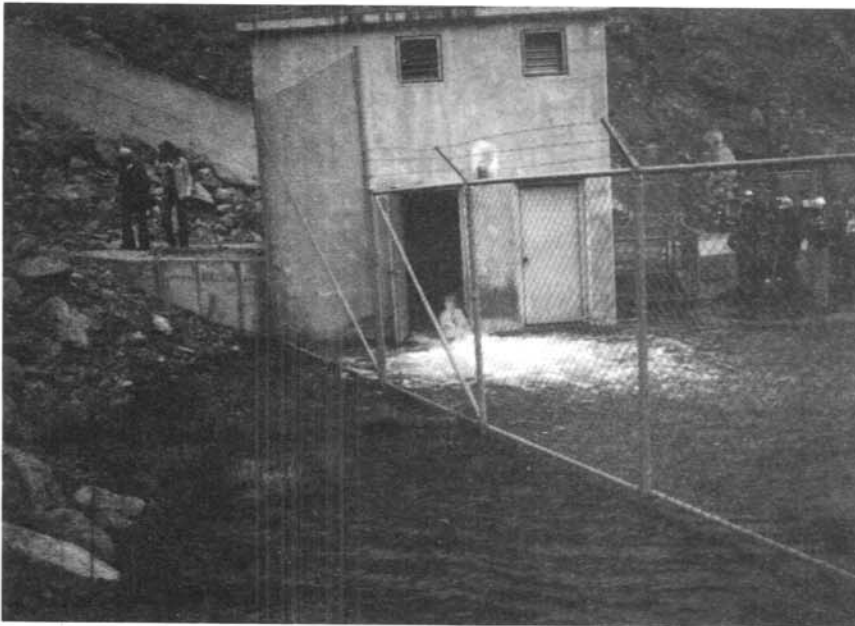
Photograph 2

Mason Dam — Flooded area around outlet works gatehouse.

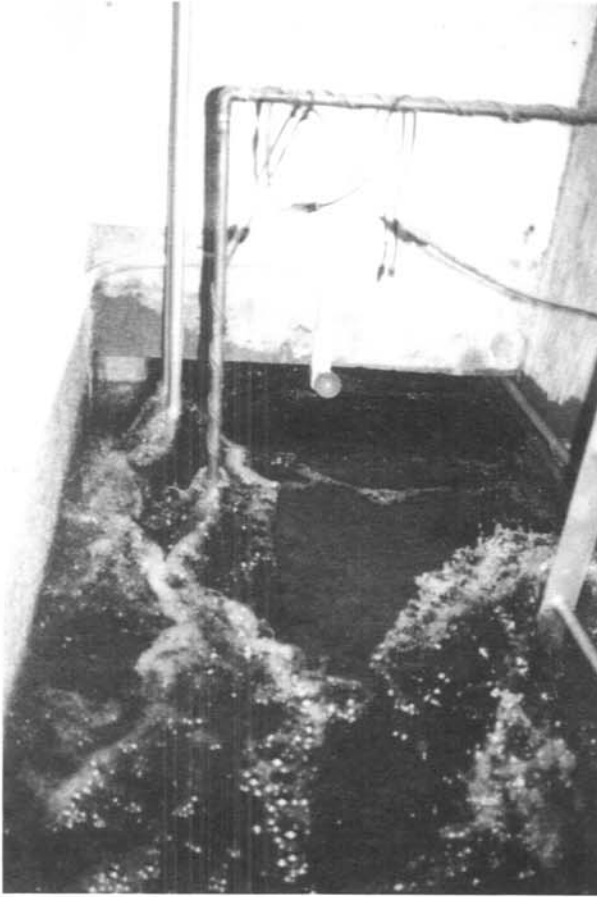
Photograph 3

Mason Dam — Outlet works tunnel access. Note that water level is slightly below top of tunnel.

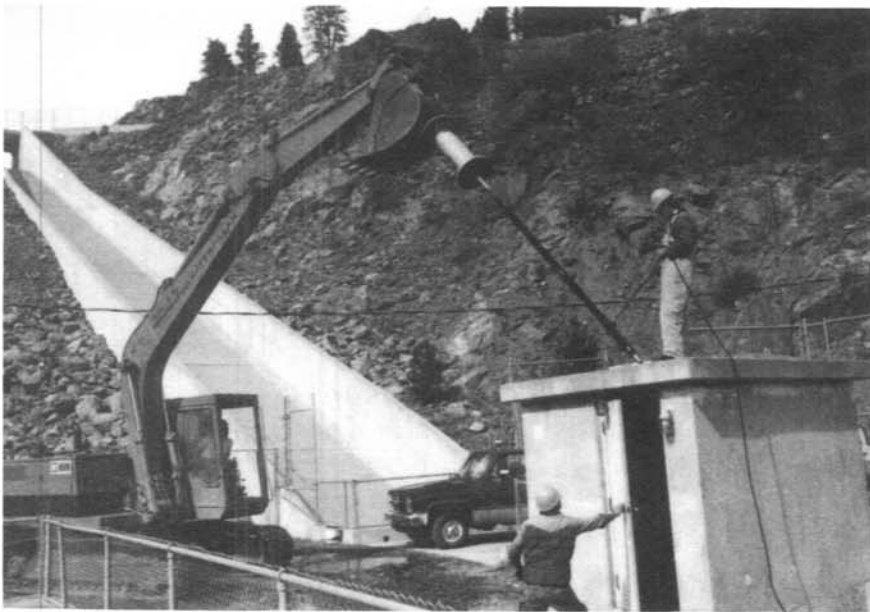
Photograph 4

1. The stem nut (part 37) had backed off the operating stem, allowing rapid movement of the sleeve (part 4) to the closed position (photograph 4). The hole through the stem and nut for cotter pin (part 46) was clean (photograph 5). The cotter pin could not be found.
2. Prior to disassembly, and with approximately 5 feet of head on the sleeve valve, the flange connections on part 1 were all squirting water around their circumference (photograph 6). Disassembly of the sleeve valve revealed that the 7/8-inch stainless steel flange bolts (part 31) had stretched in the vertical portion of the sleeve valve connector (part 1), and bent in the horizontal inlet flanged connection to the connector (photograph 7).

Mason Dam — Removing the sleeve valve operation and stem. Note that the sleeve is not attached to the lower end of stem.

- a. Repair and/or modify the sleeve valve to eliminate vibration and provide a means to lock the sleeve on the operating stem.
- b. Uncover the section of buried 12-inch bypass pipe between the tunnel and sleeve valve house for inspection. Replace as required.
- c. Remove damaged section of pipe from the downstream end of the tunnel and replace as required.
- d. A rigid pipe support should be constructed at the 90° elbow to restrain the pipe against water hammer.
- e. After the bypass system has been repaired and/or modified, the system should be pressure tested and inspected for integrity. The sleeve valve should then be test operated.

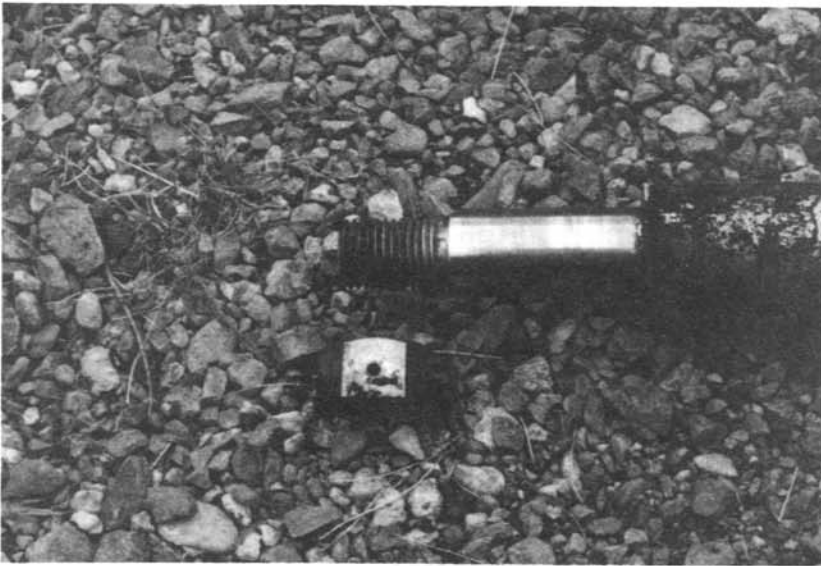
Photograph 5

Mason Dam — Sleeve valve stem and nut. Nut had backed off of stem, allowing the sleeve to slam shut. Cotter pin was not found.

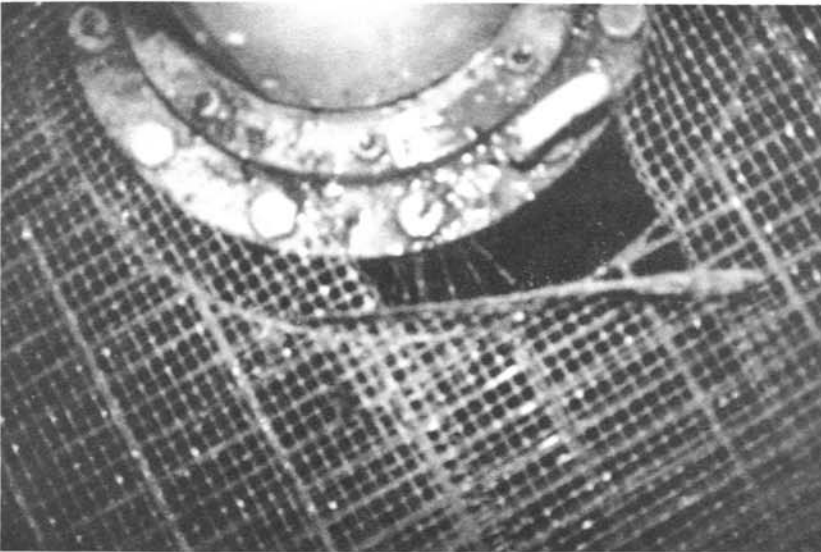
Photograph 6

Mason Dam — Sleeve valve flange located directly below operator. Note squirting water.

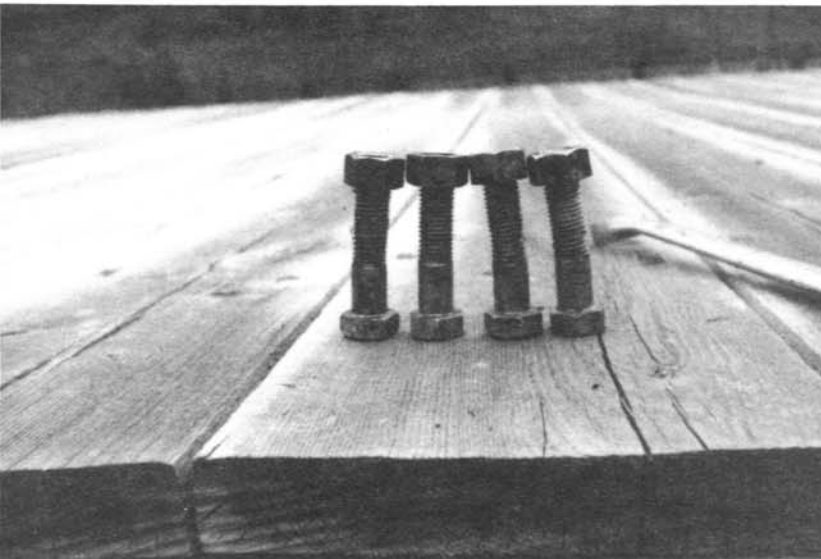
Photograph 7

Mason Dam — 7/8-inch stainless steel bolts from inlet flange to sleeve valve.

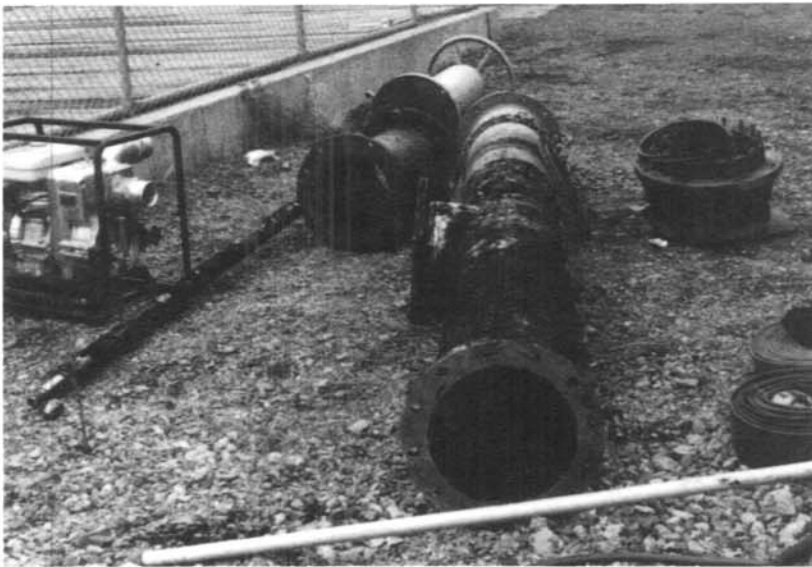
Photograph 8

Further inspection of the flange connections (photograph 8) revealed that the stainless steel flanges had warped inward as much as 3/16 to 1/4 inch from the water hammer hydraulic transient (photograph 9).

Mason Dam — Sleeve valve as removed from the house.

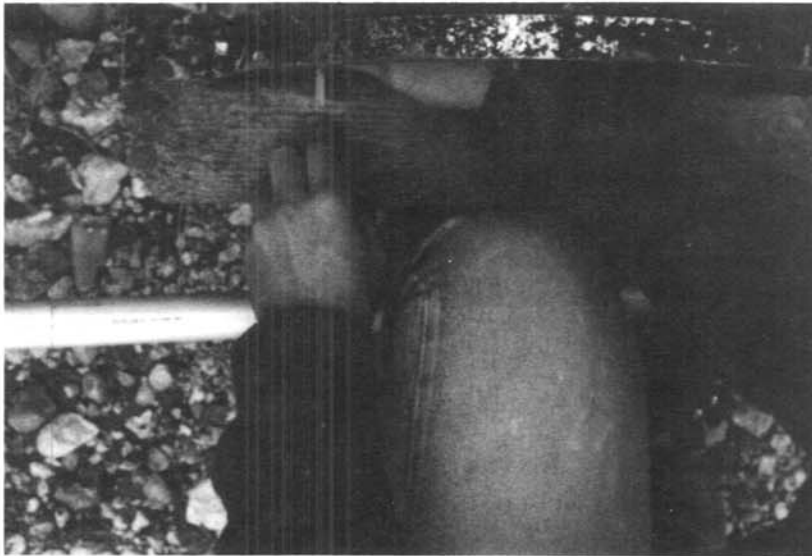
Photograph 9

Mason Dam — Warped flange on connector section of sleeve valve.

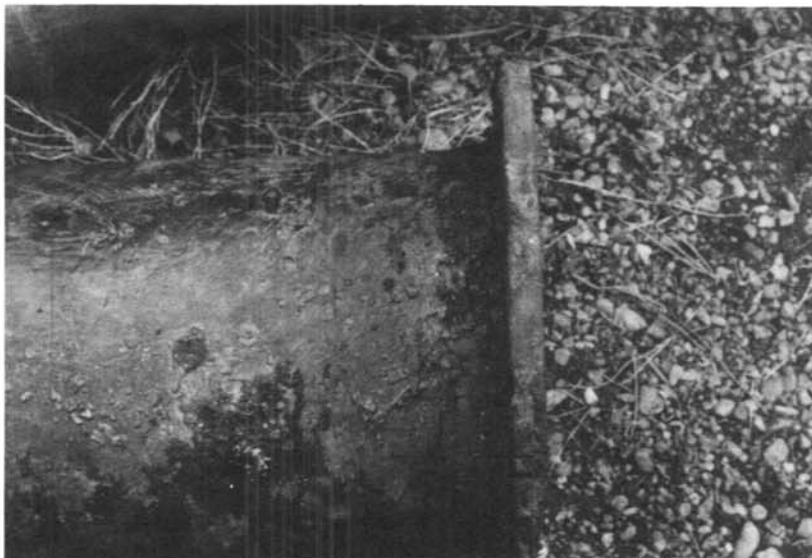
Photograph 10

3. The coal-tar coating on the exterior of the connector (part 1) near the flanges, had cracked and chipped off in places (photograph 10). This condition could indicate stretching of the connector, due to the water hammer hydraulic transient.

Mason Dam — Sleeve valve connector section. Note cracked and chipped coal-tar coating.

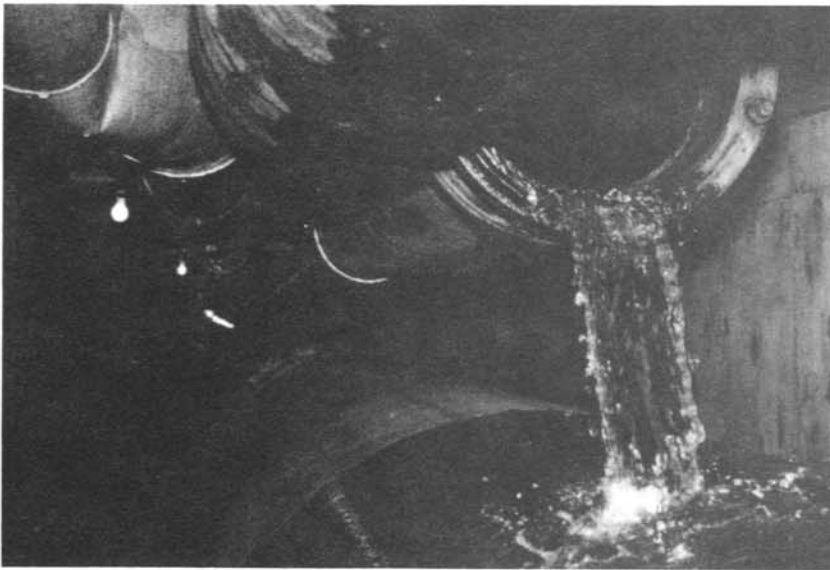
Photograph 11

Failure of the outlet works bypass pipe in the tunnel occurred as a result of a water hammer pressure wave created when the downstream regulating valve (sleeve valve) closed rapidly. Extensive damage was done to the sleeve valve and a section of the 12-inch bypass pipe located in the downstream area of the outlet tunnel.

Mason Dam — Separation of 12-inch pipe at sleeve-type coupling.

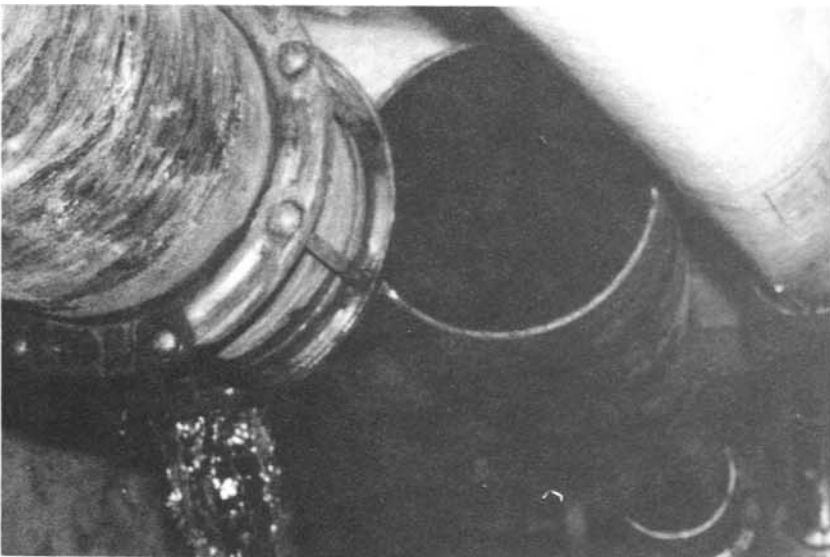
Photograph 12

Mason Dam — Separation of 12-inch pipe at sleeve-type coupling.

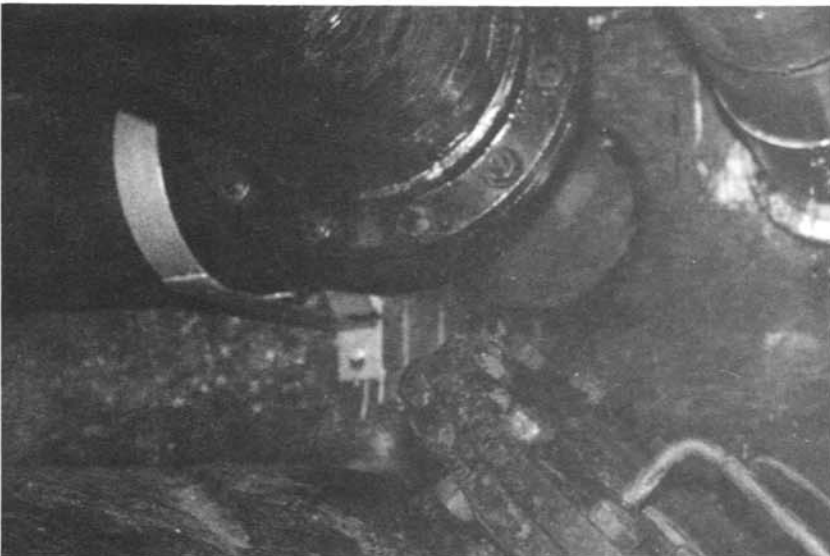
Photograph 13

The unsupported elbow undoubtedly created a weak point in the bypass system, which may have prevented a more adverse failure in the system at a point where the water could not be shut off. If the pipe system would not have separated at this point, the water hammer pressure could have fractured the casting of the 12-inch 150-pound or 8-inch 125-pound gate valves in the outlet works gate chamber.

Mason Dam — 90° elbow on 12-inch bypass piping. Note virtually no support against water-hammer thrust.

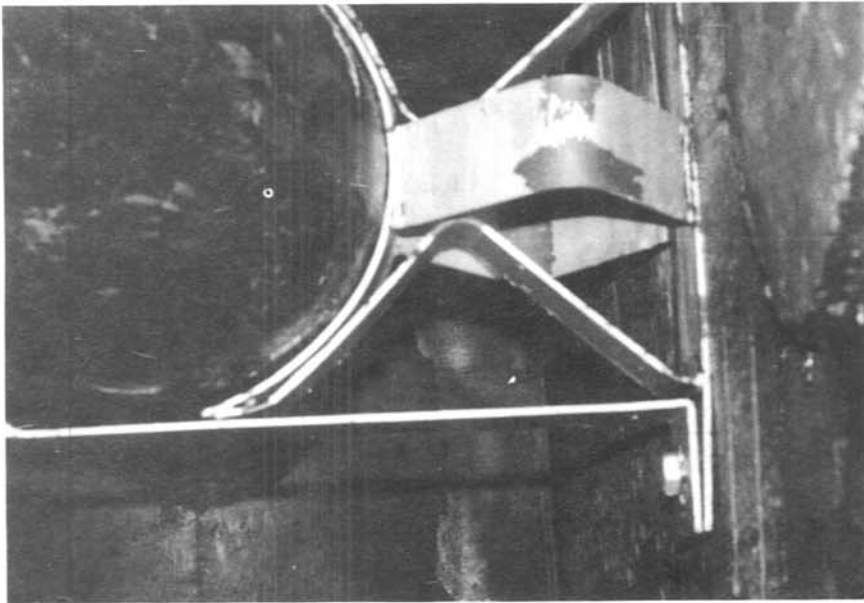
Photograph 14

Mason Dam — Bent pipe bracket downstream of 90° elbow.

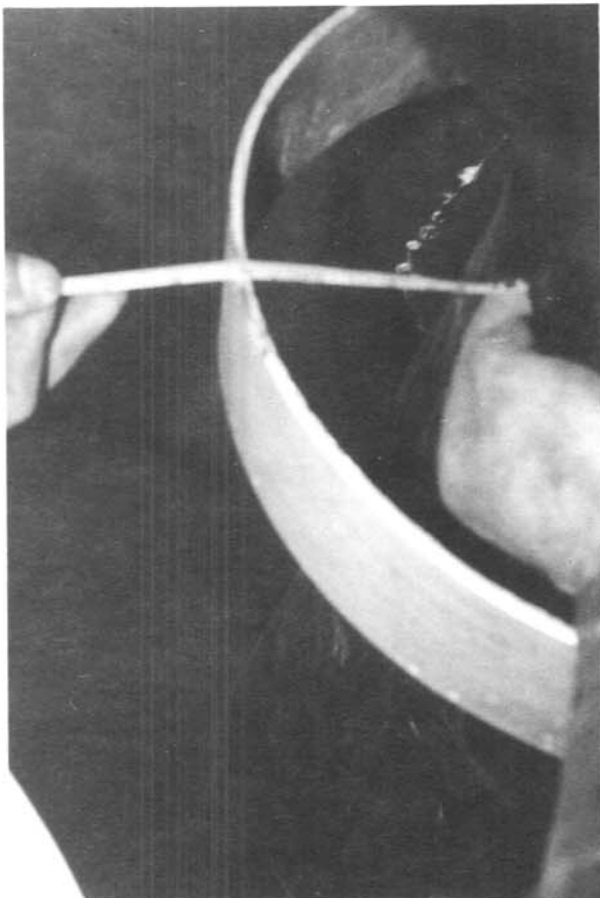
Photograph 15

Mason Dam — 6-inch movement of pipe downstream.

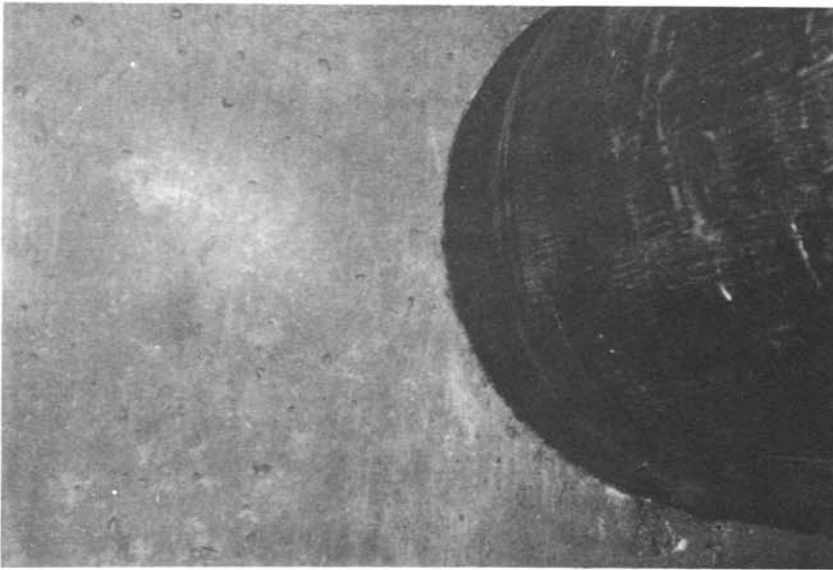
Photograph 16

3. The 12-inch pipe buckled where it is embedded in the left wall of the tunnel (photographs 16 and 17).
  4. The sleeve-type coupling and pipe support hanger directly upstream of the separated joint shows movement of approximately one-eighth inch in the downstream direction (photograph 18). There appears to be no further movement or damage of the pipe upstream from this point.

Mason Dam — 12-inch bypass pipe. Note movement of pipe from wall.

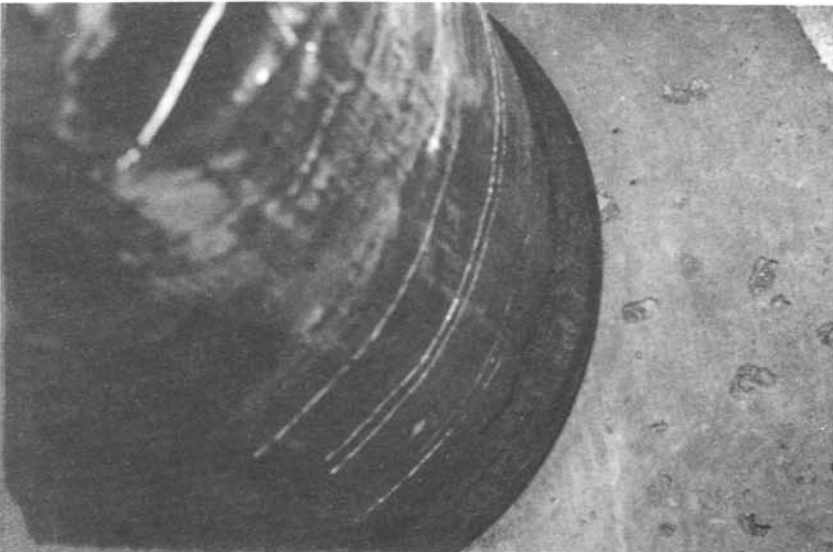
Photograph 17

Mason Dam — 12-inch bypass pipe. Pipe is buckled at wall.

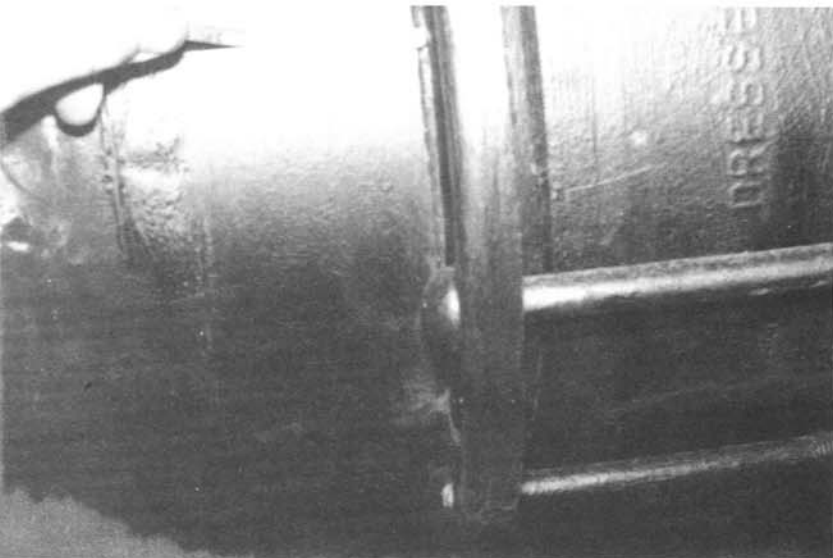
Photograph 18

Mason Dam — Sleeve-type coupling upstream of the one that separated.

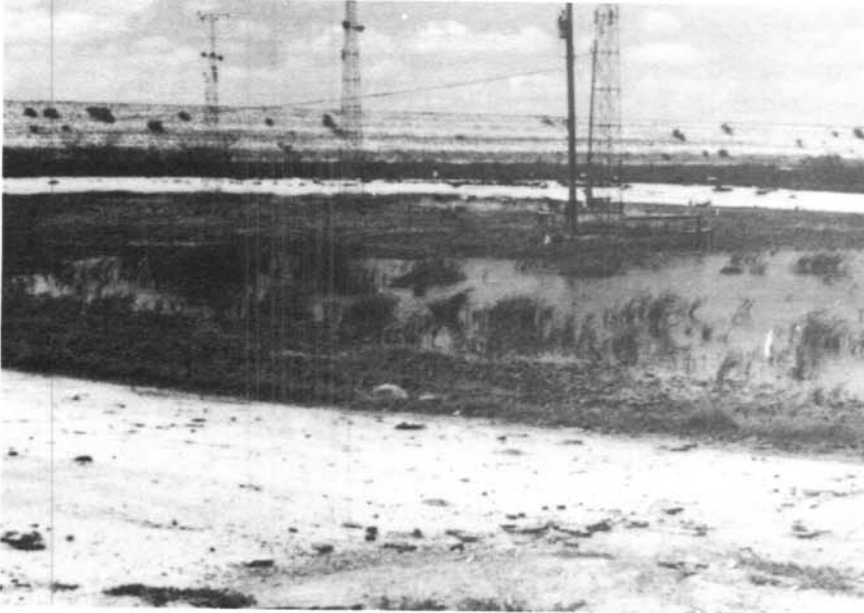
Twin Buttes Dam

Ponded water at racetrack is being drained by 4-inch outlet pipe. Intake is near white flags and pipe crosses road under tamped area in foreground. Water in track has dropped considerably during the summer of 1975.

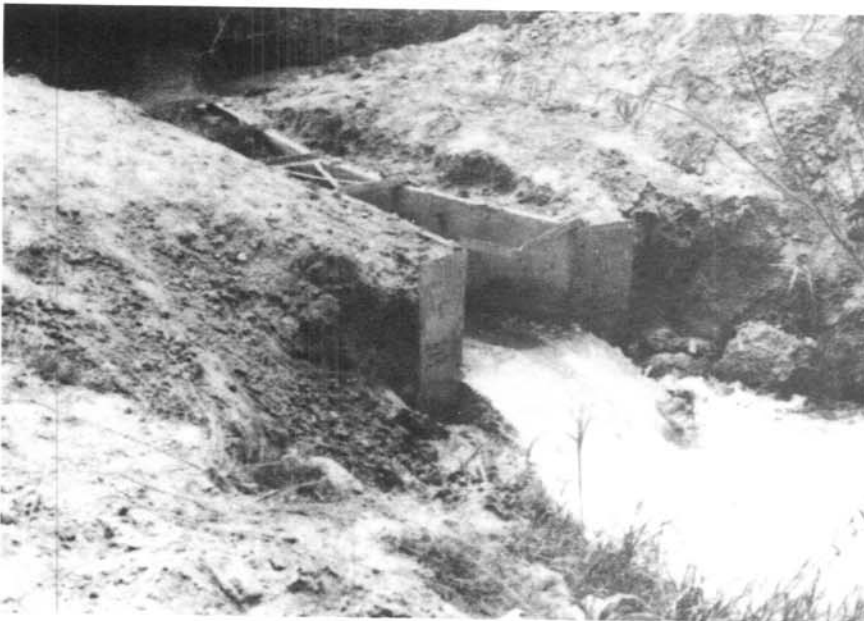
Twin Buttes Dam

Flume measuring flow in ditch No. 1. Flow is  $6.6 \text{ ft}^3/\text{s}$  which is close to maximum capacity. Flume will be replaced.
