SPOTLIGHT ON GLEN CANYON DAM

POLICY FOR SAFETY RECOMMENDATIONS¹

**CRITERIA¹ FOR THE
REMOVAL OF TREES, OTHER VEGETATIVE GROWTH, AND
RODENT BURROWS FROM EARTH DAMS, DIKES, AND
CONVEYANCE FEATURES (1987)**

LEMON DAM-CONCRETE SPILLWAY INLET WALL FAILURE

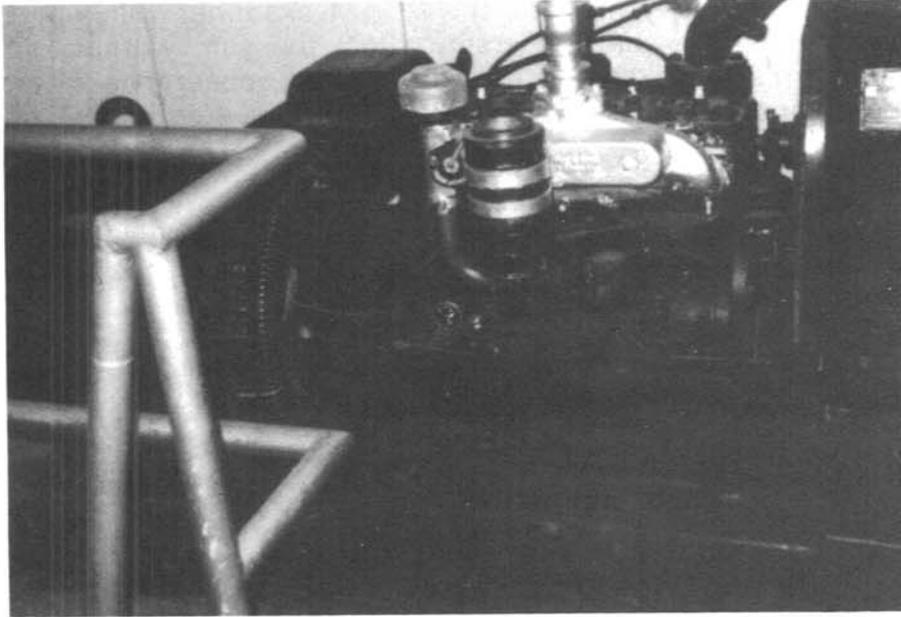
Photo 1. - Potential for gasoline fire or explosion. Carburetor is inoperable and replacement parts are no longer available. Gasoline is poured into engine in order to operate.

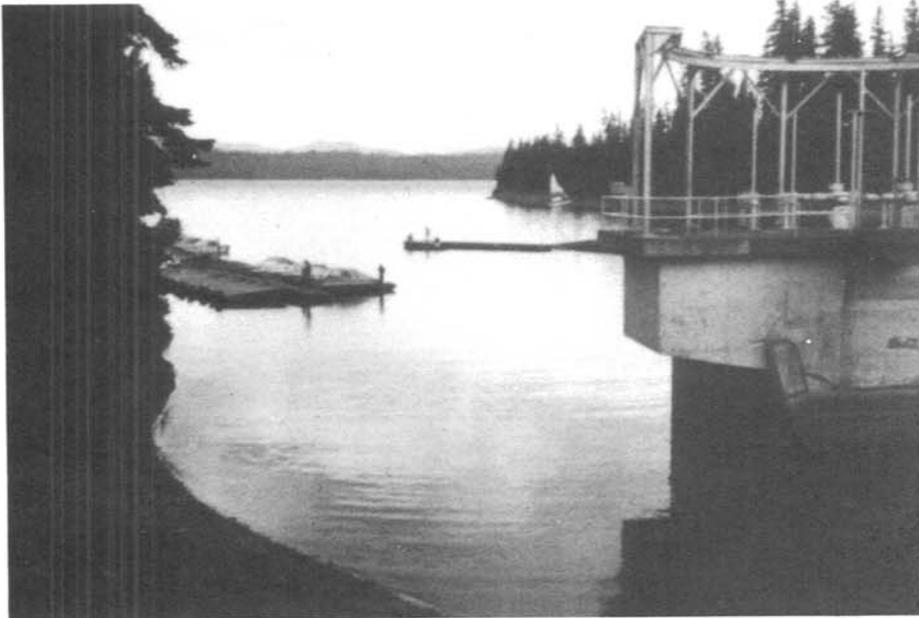
Photo 2. Potentially hazardous intake tower. A safety buoy line should be installed to prevent swimmers and boaters from drifting into intake tower. A sign should also be posted warning recreationists of high-velocity flows.

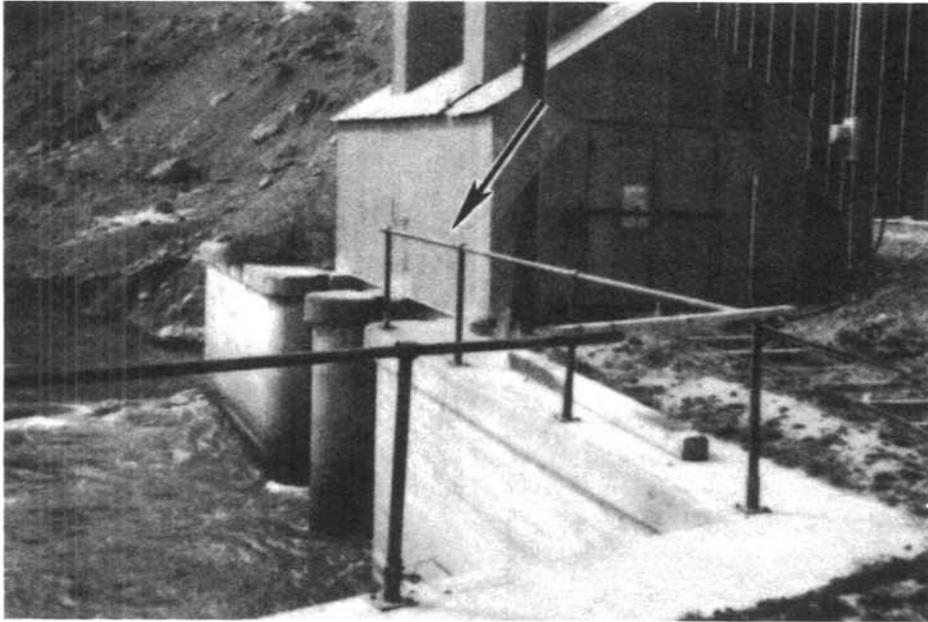
Photo 3. - Broken guardrail has been patched with a timber board and should be replaced with a pipe of original design. Also, the guardrail should be extended to the equipment house to prevent anyone from falling through the opening.

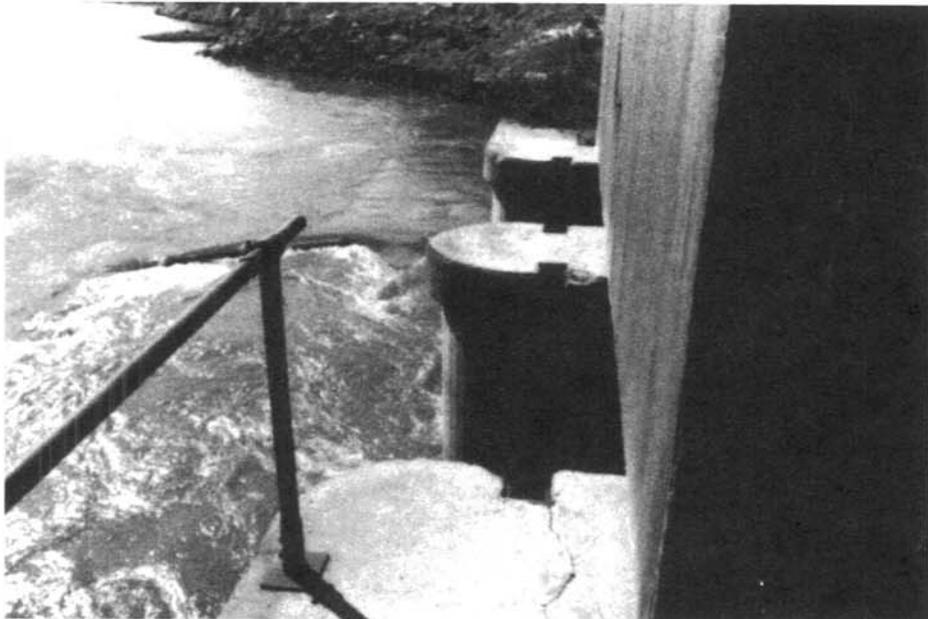
Photo 4. - Closeup view of above photo showing opening.

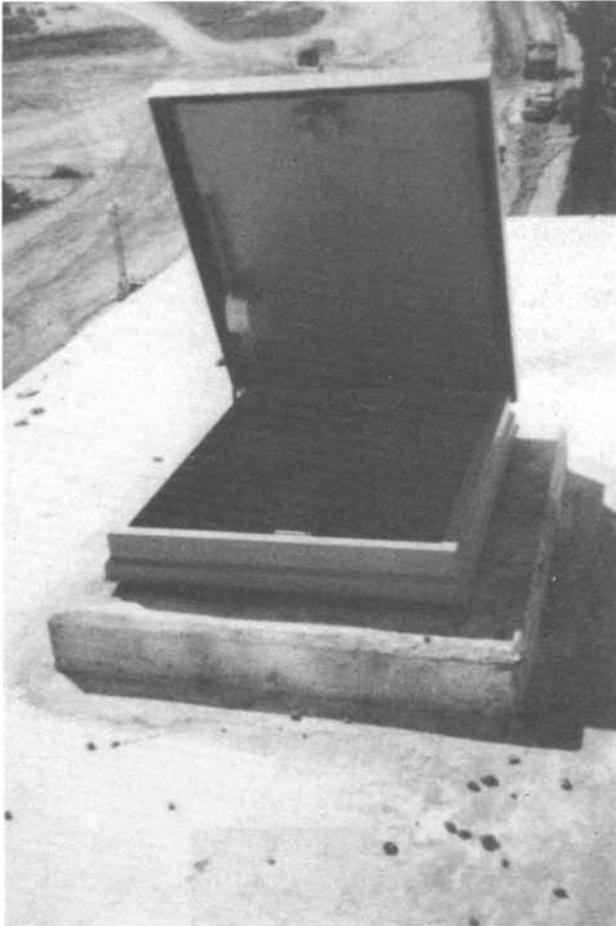
Photo 5. - Grab bars are needed to allow operating personnel to climb safely through the roof hatch.

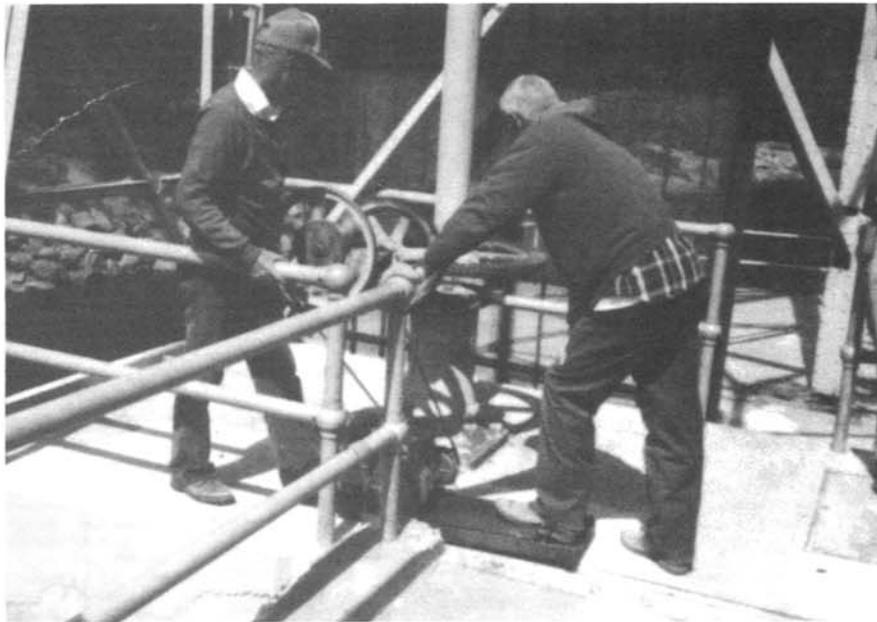
Photo 6. - Unscreened motor-driven gate operator. A rubber fan belt is connected between a 3-hp gasoline engine and a 14-inch-diameter pulley on the handcrank shaft. Tension in the belt is maintained by foot pressure against the engine base. The equipment should be screened because serious injury can result.

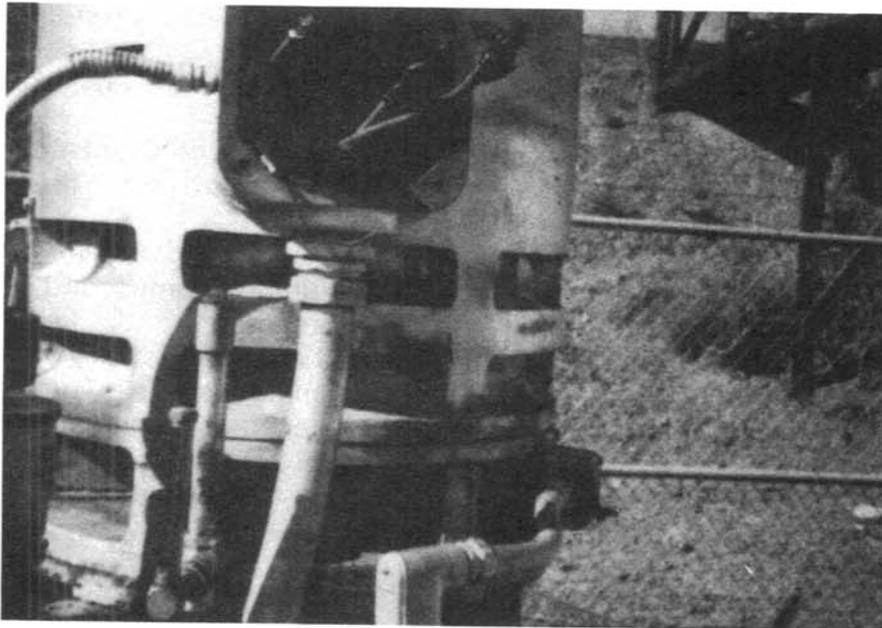
Photo 8. The missing faceplate should be replaced. Exposed electrical wiring on the motor junction box can cause serious injury to operating personnel.

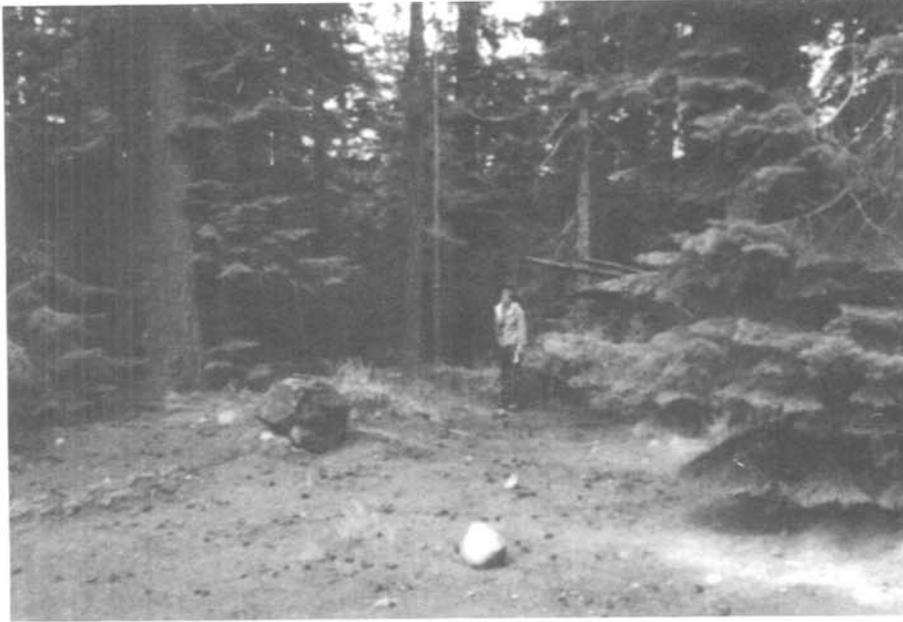
Photo 1. - The dense conifer stand has been allowed to grow in the lower end of an unlined spillway and will adversely affect and impede flood flows.

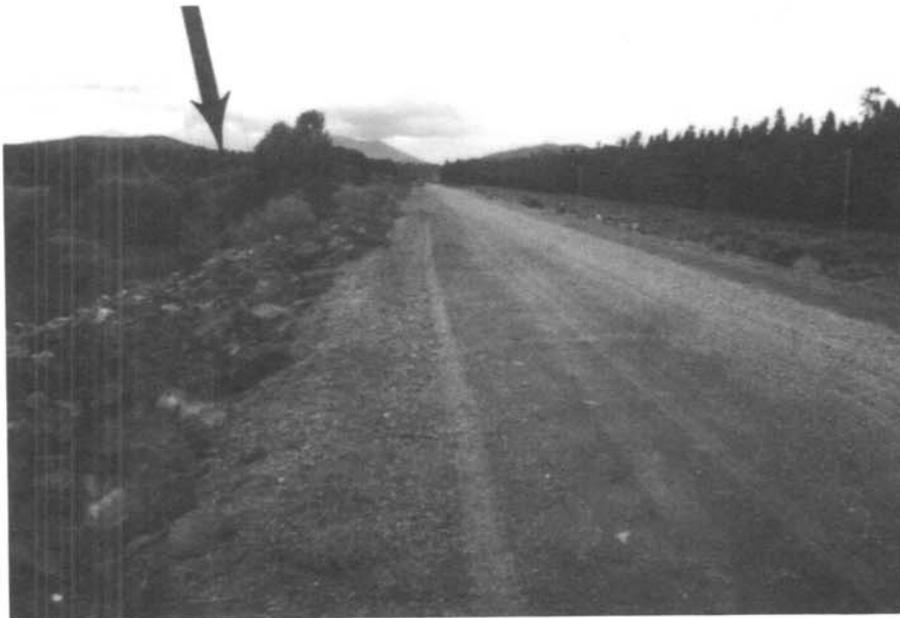
Photo 2. - Conifers and deciduous trees are established in a large area immediately upstream of the dam (arrow) and need to be removed to permit surveillance of any problems such as reservoir seepage which is known to exist.

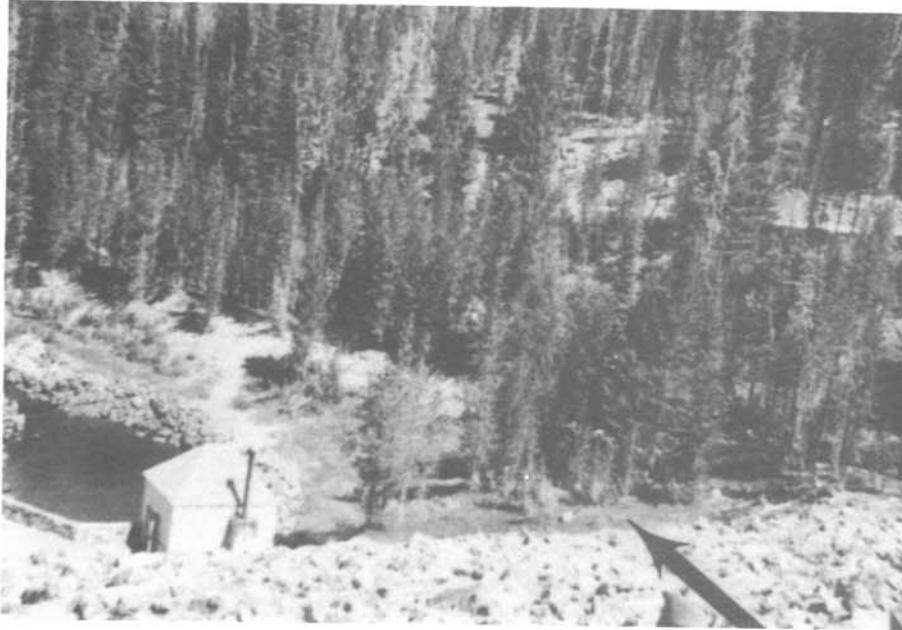
Photo 3. - Conifers have established themselves in the seepage area to the right of the valve house (arrow). They should be removed because they are partially concealing the seepage area and any evidence of adverse changes that may occur.

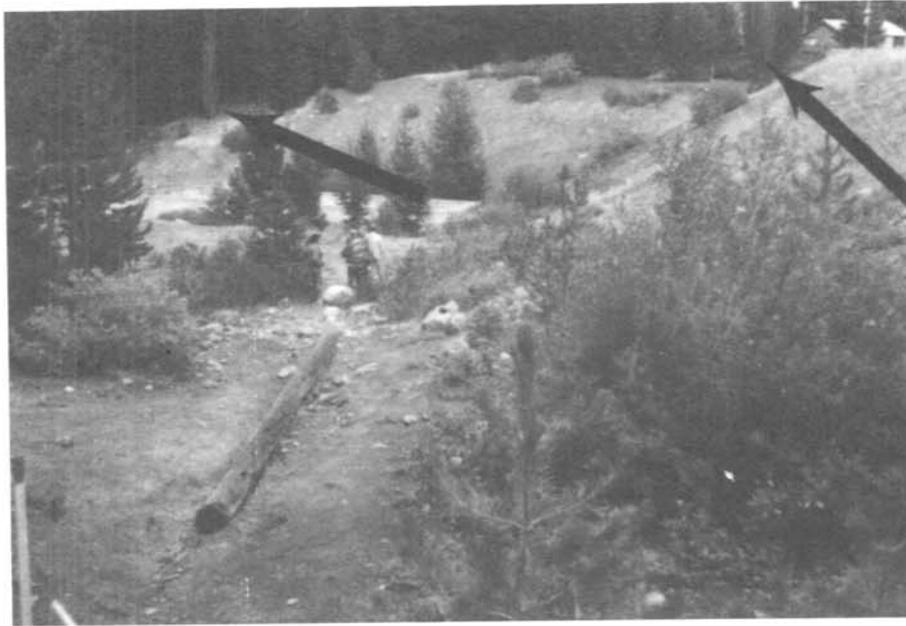
Photo 5. - The mature conifers (arrows) can provide seed stock for the emerging juvenile conifers located on the abutment contact.

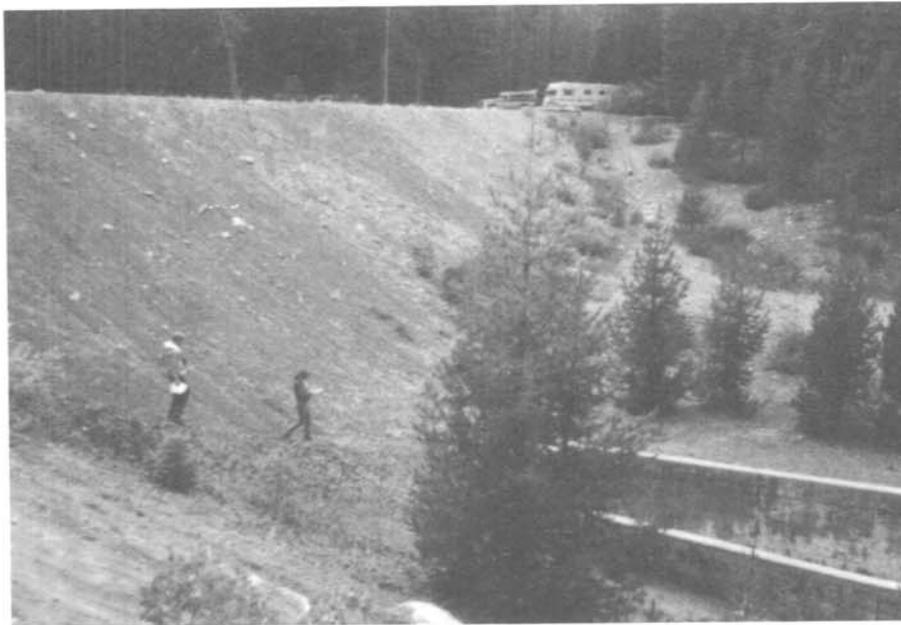
Photo 6. - Apron downstream of the toe of the embankment. The conifers on the apron are masking the stilling basin and any evidence of problems that may exist in these areas.

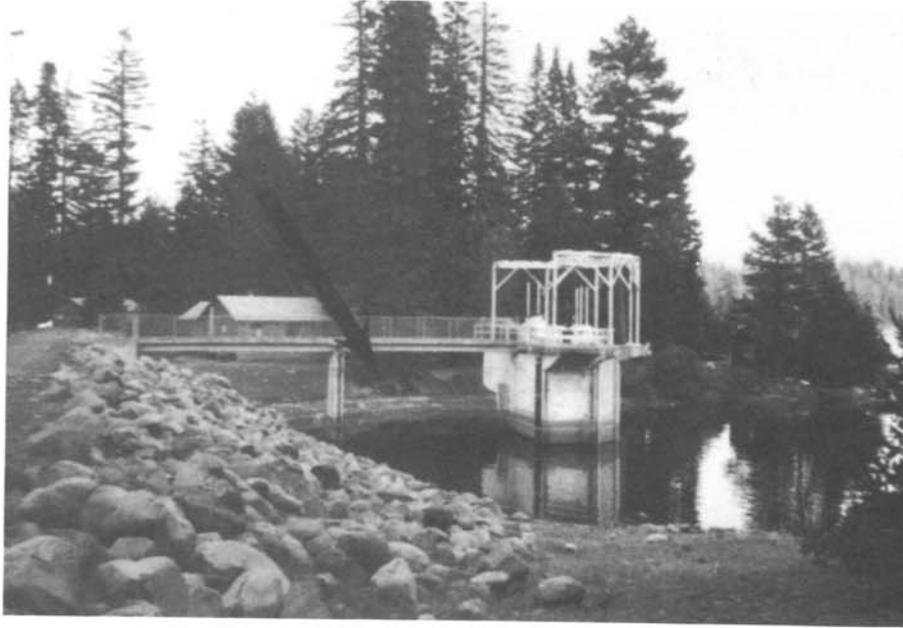
Photo 7. - The soil around the root system of the mature conifer (arrow) has been eroded by fluctuating reservoir levels and wave action. This conifer needs to be removed because it can fall and destroy the access bridge or equipment on the intake tower.

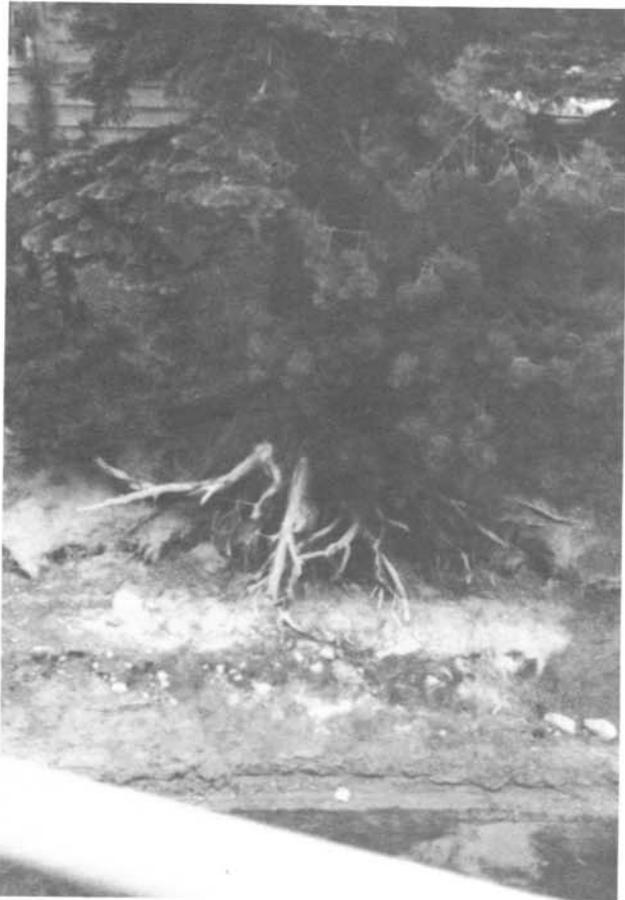
Photo 8. - Exposed root system of conifer in above photo.

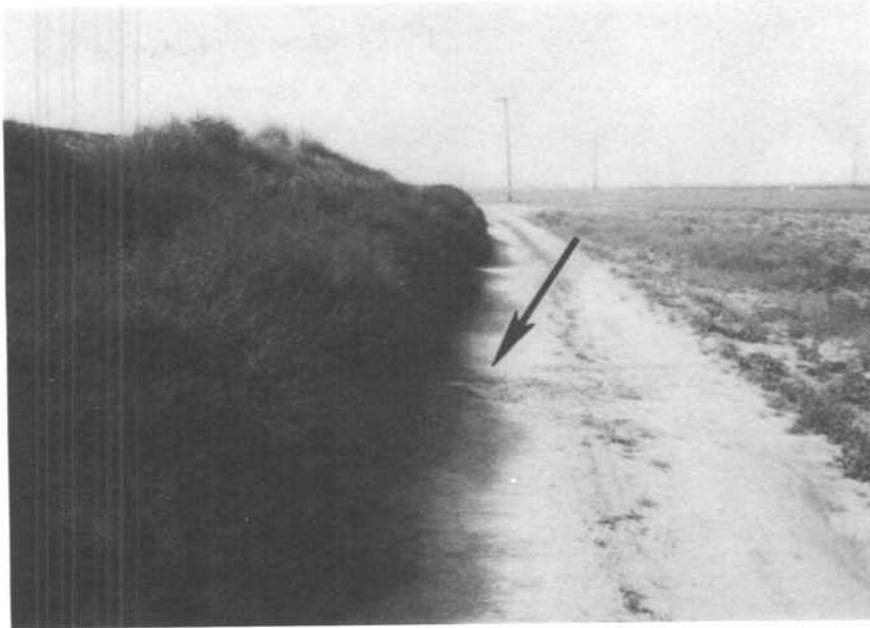
Photo 9. - The chaparral-type growth on the outside slope of the canal fill is concealing exit points of subsurface seepage channels. Material eroded from the fill has been deposited at the toe of this slope (arrow).

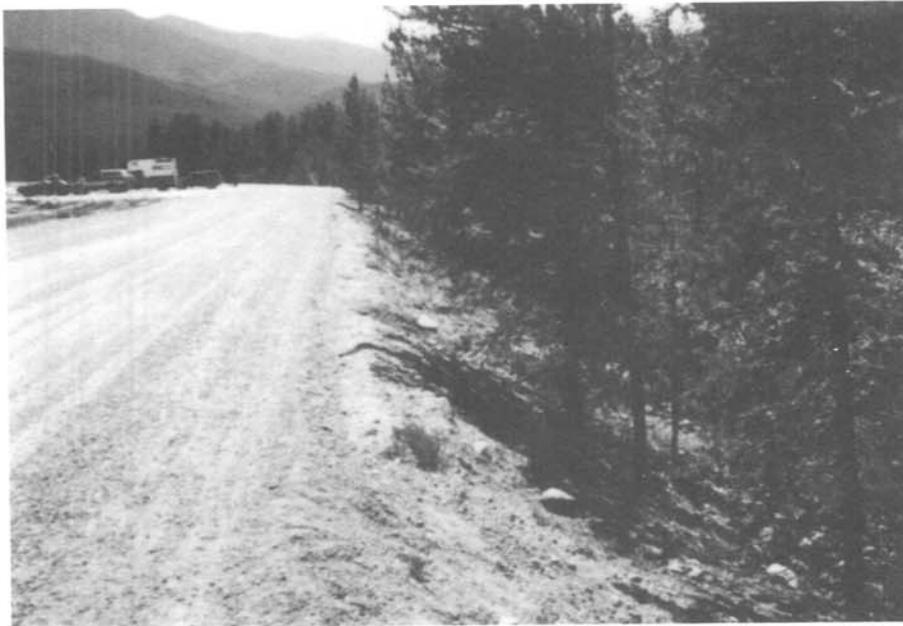
Photo 10. - Conifers have established themselves on the downstream face of this saddle dike and can conceal evidence of any problems in this area.

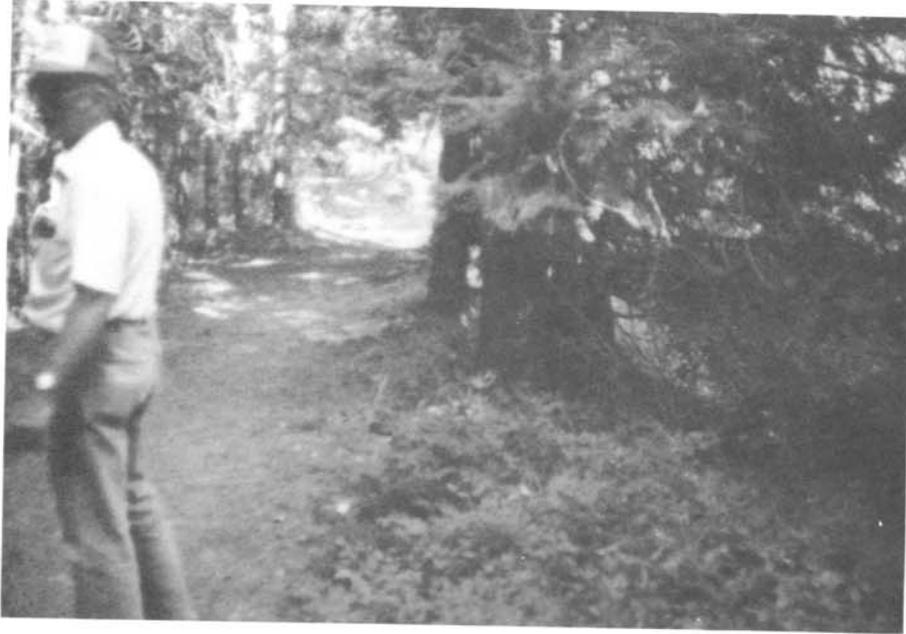
Photo 11. - Mature conifers have established themselves on both the upstream and downstream faces of this low saddle dam. Surveillance of rodent habitats and structural problems is difficult to perform.

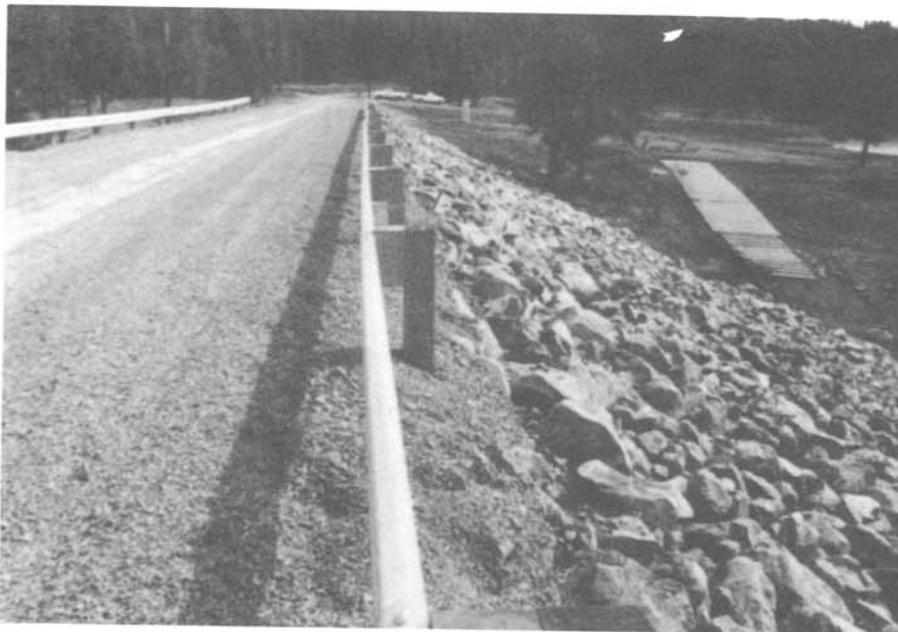
Photo 12. - The two conifers near the right upstream abutment can provide annual seed stock for more conifers and result in the spread of undesirable growth in this area.

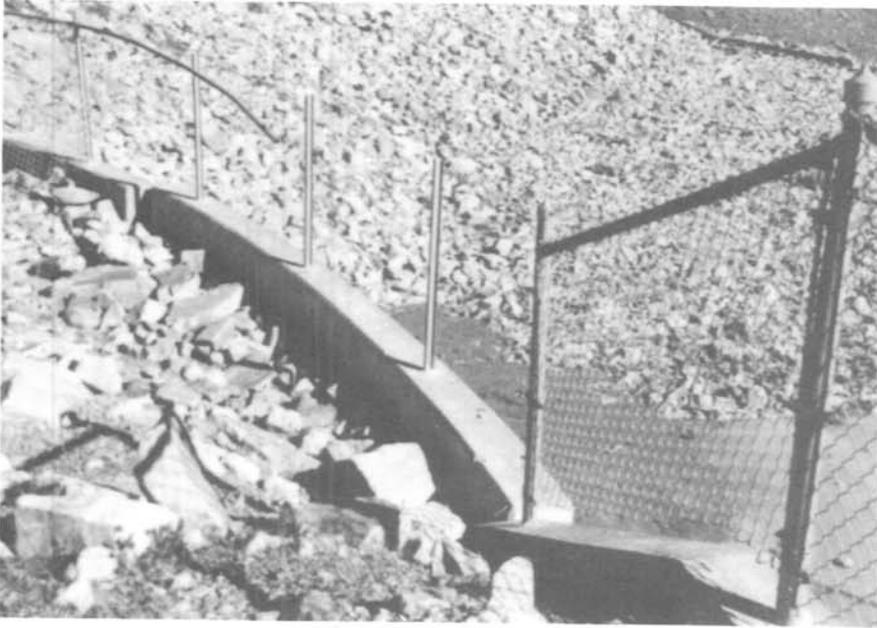
Photo No. 1. - Lemon Dam

Evidence: The first sign of a problem with the spillway concrete wall was in July 1966, when minor deflections were noted. Additional deflection occurred during the winter of 1966-1967. During the winter of 1971, an additional 1 to 1-1/2 inches of deflection occurred, with the total deflection now being 4-1/2 inches on the right wall and 5-1/2 inches on the left wall. Some rupturing was also noted at the base of the right inlet wall. During April 1973, at the request of the Acting Regional Director, the Director of Design and Construction at the E&R Center conducted a special examination of the spillway entrance walls. Total deflections had now reached up to 12 inches, and repair was recommended within the year.

Right wall of spillway approach channel. Deflection of the wall damaged the fence.

Remedy: Since it was determined the deflections were caused by freezing action in the impervious soil blanket behind the concrete walls, a portion of the backfill was excavated and a pervious blanket of soil was placed beneath a layer of impervious soil. Several pipe drains extending to the base of the wall penetrated the pervious backfill. Insulation board, 1-1/2 inches thick, was placed between the back face of the walls and the pervious backfill. Seepage wells to collect the pipe drainage and heaters were installed at the base of the walls to allow drains to operate through the winter months. The curved inlet walls were replaced with adequate reinforcement anchoring the walls to the footings.

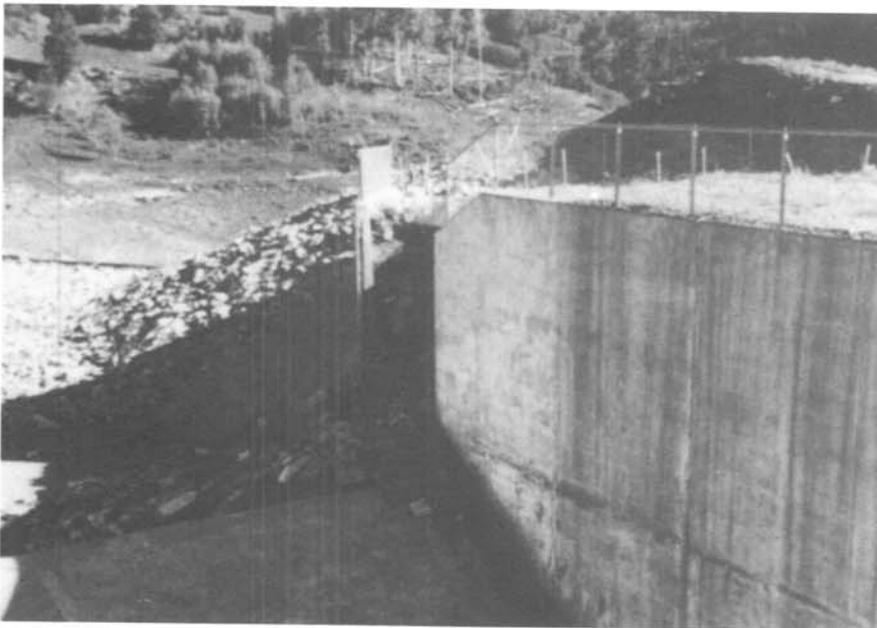
Photo No. 2. - Lemon Dam

Incident: Beginning in 1966, progressive deflections were noted in both concrete spillway inlet walls. By 1973, deflections as much as 12 inches were apparent; and on May 14, 1973, the left wall failed and fell into the spillway. The incident did not cause any operational problems.

Causes: Lemon Dam receives significant snowfall and experiences large variations in surrounding temperatures with extremely low temperatures. In 1967, it was believed that due to the temperature variations, surface water was entering between the concrete walls and the backfill; and subsequent freezing action was causing the walls to deflect.

Upon examination of the exposed reinforcement at the base of the wall stems during the reconstruction, it was discovered that only one-third of the required face wall movement reinforcement extended into the footings. In addition, for the left face wall that had overturned, only stubs of moment reinforcing bars protruded above the footing, and only two or three of these showed the characteristics of tension failure. It appeared that most of the bars did not extend continuously into the face wall, and two-thirds of the bars did not extend into the wall footing. Lack of proper reinforcement was probably the major cause of the failure of the spillway entrance walls.

Left wall of spillway approach channel. Failure was result of repeated cycles of frost action on saturated fill.
