# **WATER OPERATION AND MAINTENANCE**

**BULLETIN NO. 143**

March 1988

# WATER OPERATION AND MAINTENANCE BULLETIN

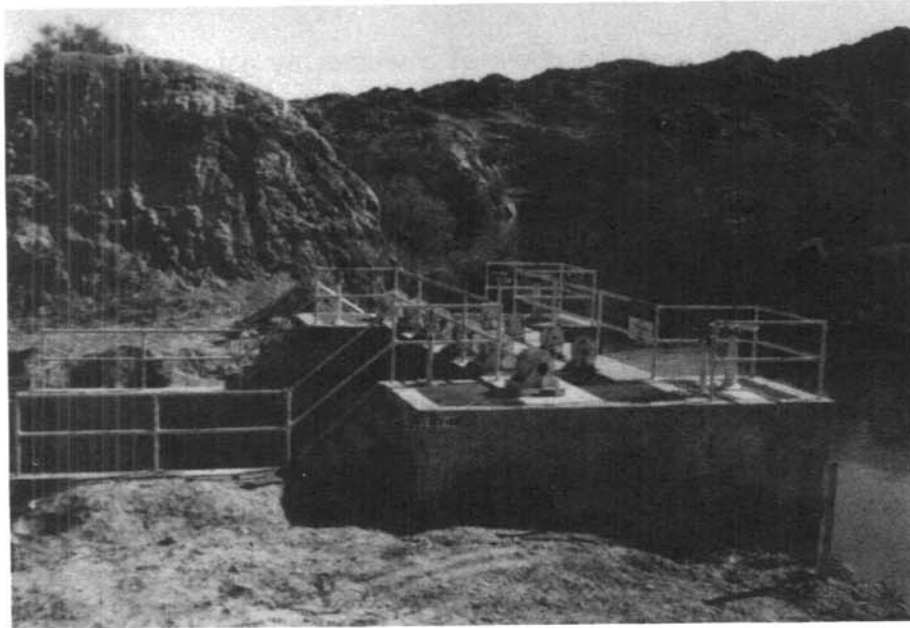
Automatic Wasteway Structure No. 3 was constructed in 1939. A 1986 RO&M inspection disclosed severe spalling of the concrete and severe corrosion of the exposed steel (figure 1) such that the stability of the structure was questioned. Sometime during the period between construction and the 1986 inspection, the Wellton-Mohawk Irrigation District performed some repairs (judged as being primarily cosmetic) around the wasteway gates pivots (figure 2).

Figure 1. View of downstream side of Automatic Wasteway Structure No. 3 after excavation of backfill from outside wall of the downstream floatwell.

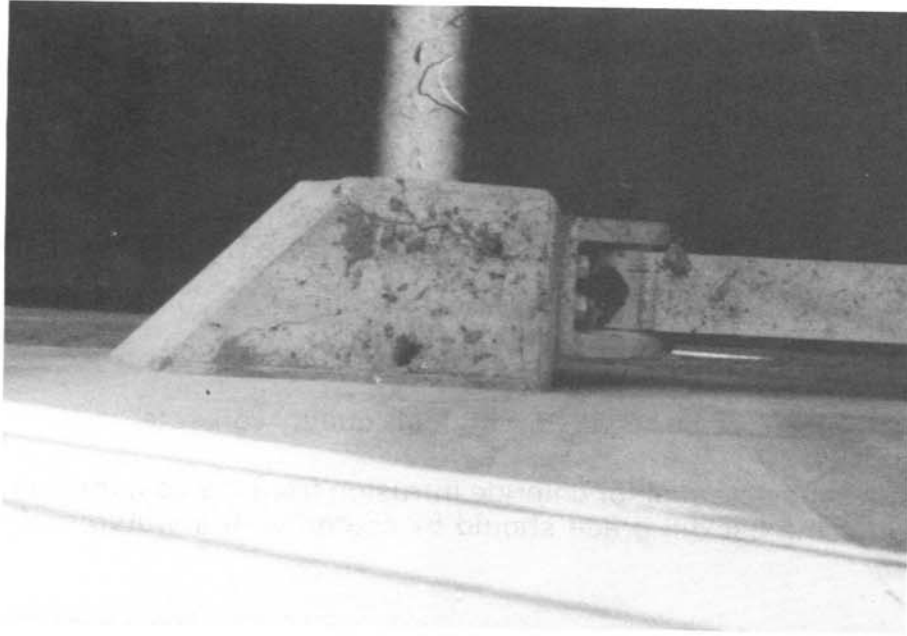
Figure 2. View looking down at a wasteway gate pivot where repairs, primarily cosmetic, were previously made.

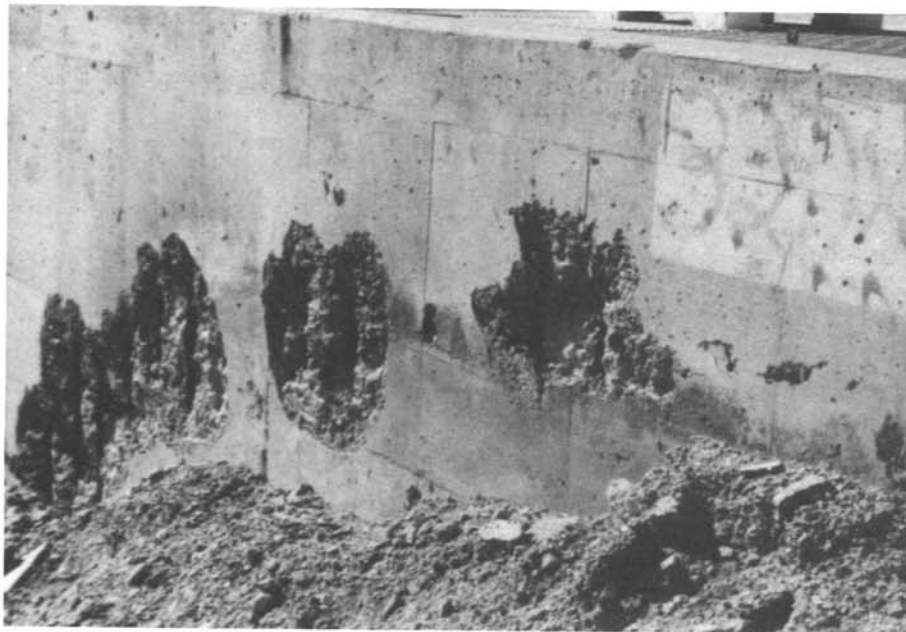
The current deterioration (figures 3a. and 3b.) appears to be isolated to the outside walls of the structure floatwells with no effect on the canalside surfaces of the structure. The areas of spalled concrete and subsequently exposed steel reinforcement generally follow the backfill grade which is 5 to 6 feet above normal canal water surface. The ground water reportedly is high at this location.

Figure 3a. Outside wall of upstream floatwell.

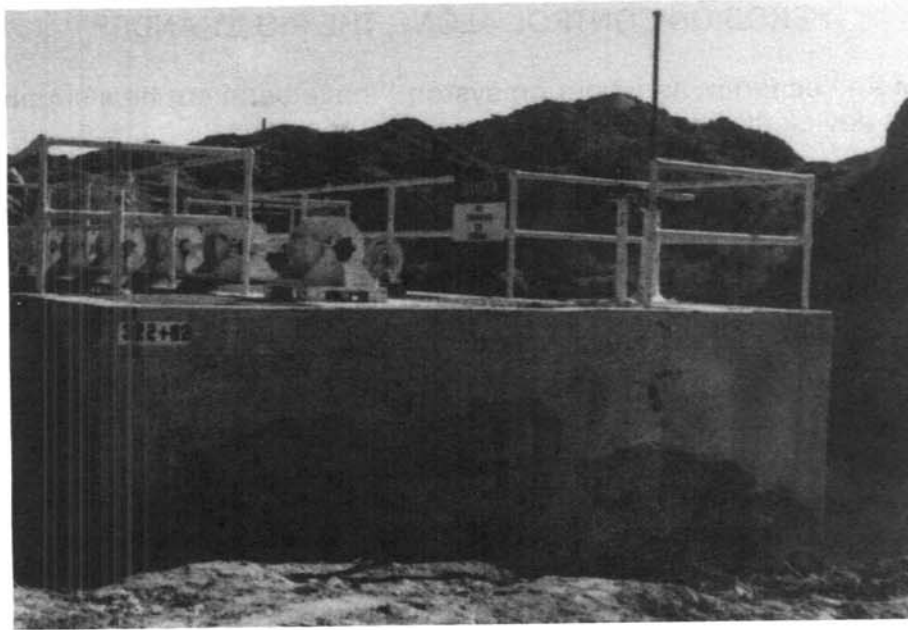
1. The distress of the concrete at Wasteway Structure No. 3 is the result of chloride-induced corrosion of the embedded steel.
2. The source of the critical chlorides is likely the backfill soil.
3. The structure should be repaired with high-quality concrete.
4. To minimize the potential for chloride intrusion from the soil, the concrete surfaces within 2 feet of the backfill grade should be coated with a waterproofing membrane for longer life.

Figure 3b. Outside wall of downstream floatwell. Note that severe damage is isolated to surfaces adjacent to original grade.

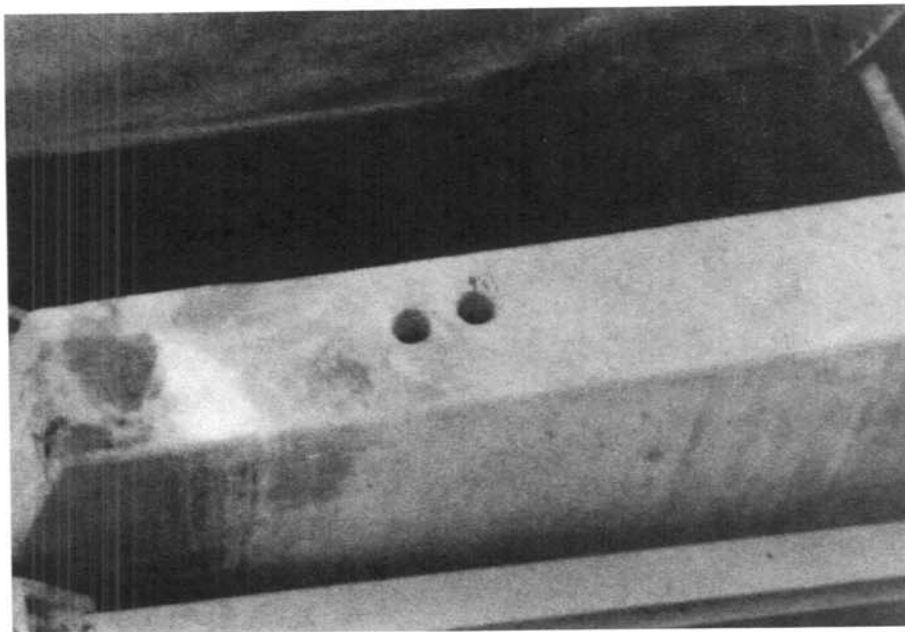
Figure 4. View of center wall from which core No. 4 was removed. Wall is 14 inches thick.

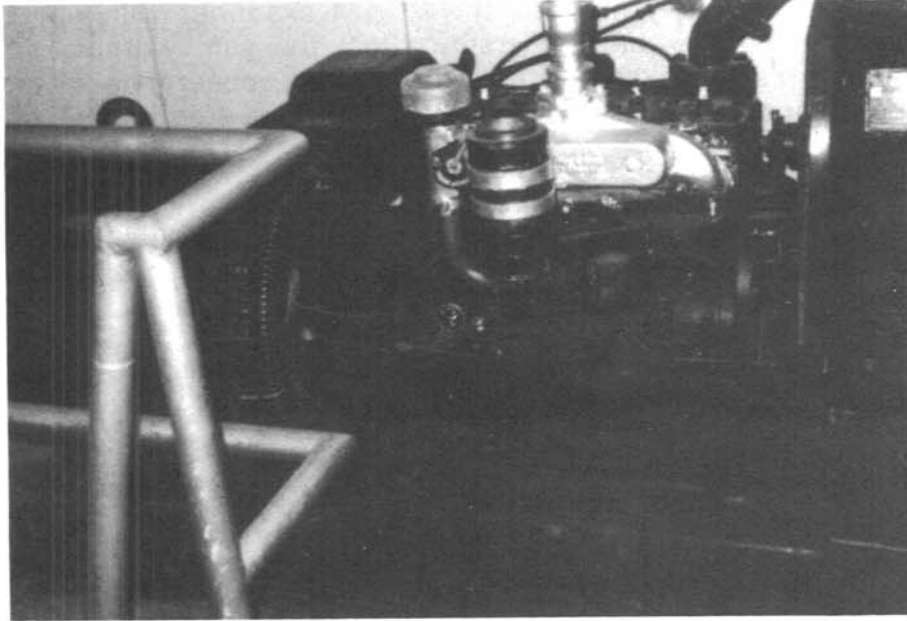
Photo 1. - Potential for gasoline fire or explosion. Carburetor is inoperable and replacement parts are no longer available. Gasoline is poured into engine in order to operate.

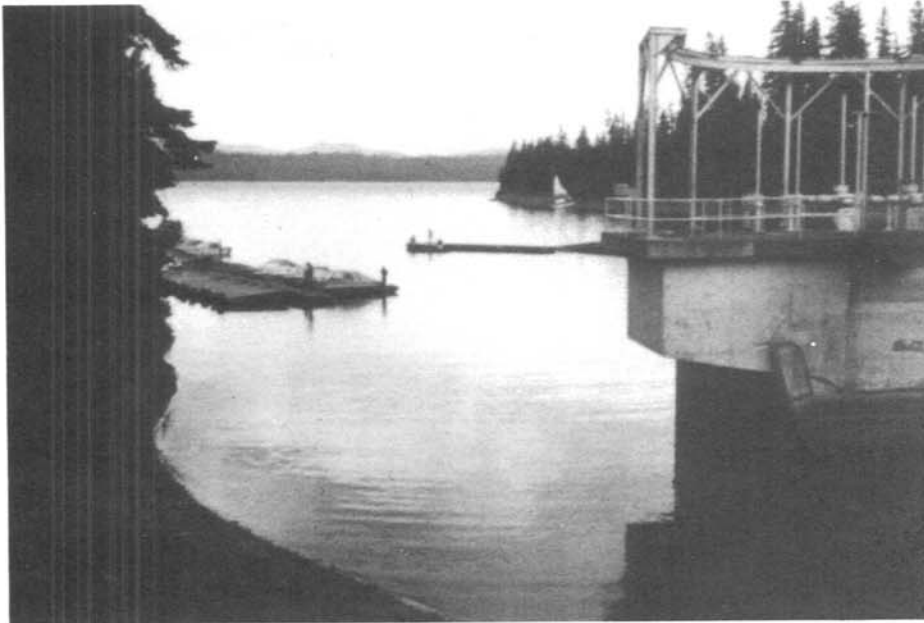
Photo 2. Potentially hazardous intake tower. A safety buoy line should be installed to prevent swimmers and boaters from drifting into intake tower. A sign should also be posted warning recreationists of high-velocity flows.

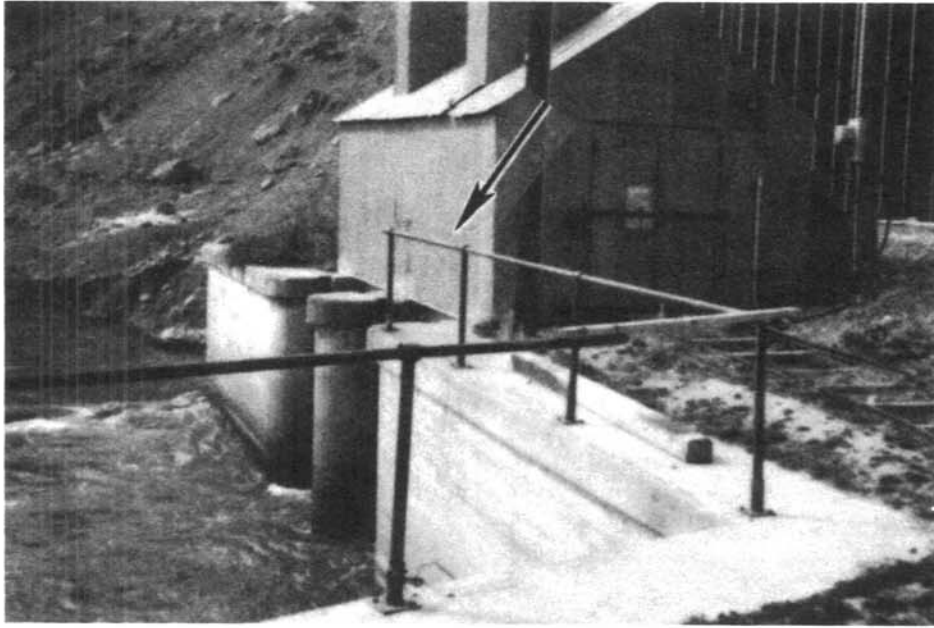
Photo 3. - Broken guardrail has been patched with a timber board and should be replaced with a pipe of original design. Also, the guardrail should be extended to the equipment house to prevent anyone from falling through the opening.

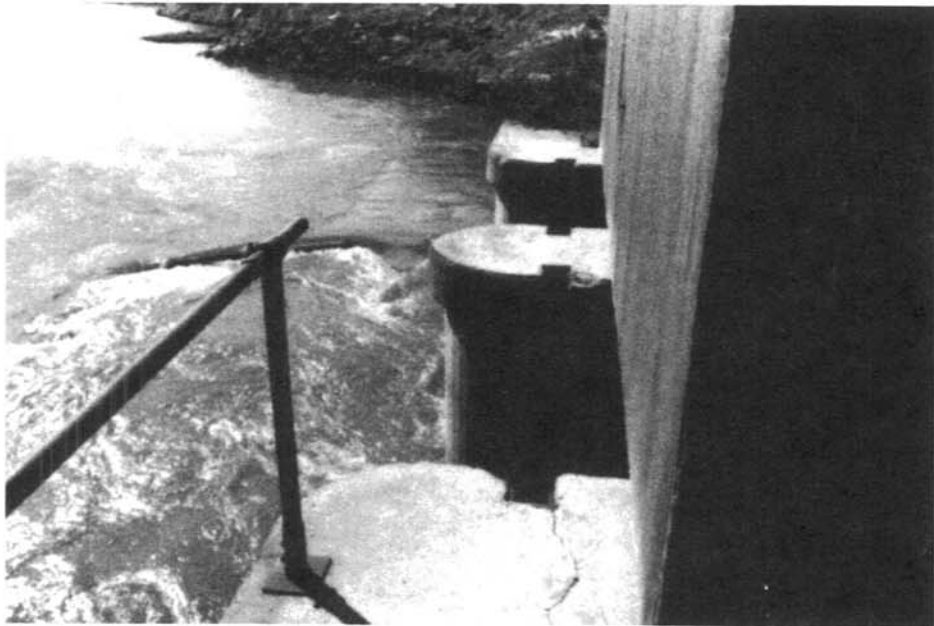
Photo 4. - Closeup view of above photo showing opening.

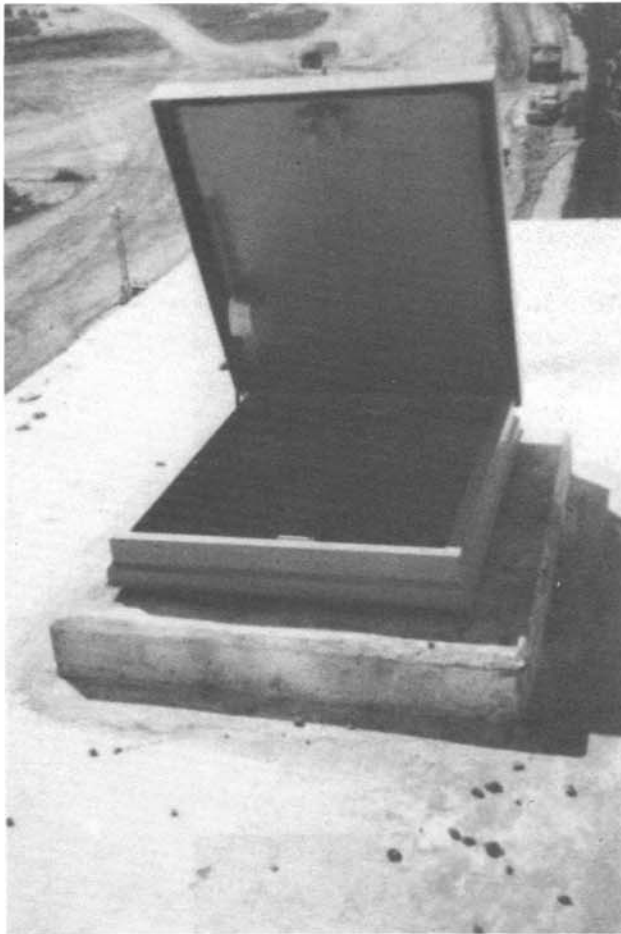
Photo 5. - Grab bars are needed to allow operating personnel to climb safely through the roof hatch.

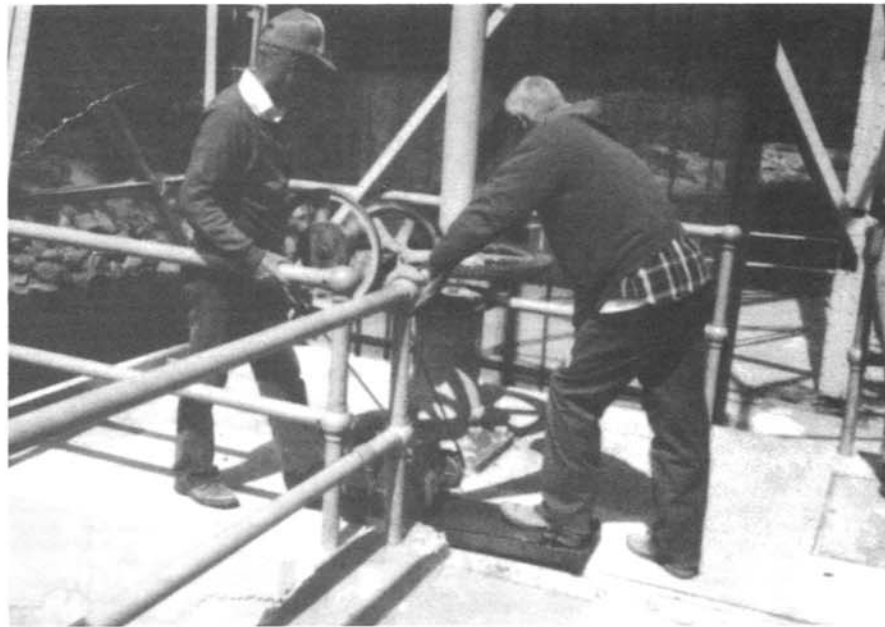
Photo 6. - Unscreened motor-driven gate operator. A rubber fan belt is connected between a 3-hp gasoline engine and a 14-inch-diameter pulley on the handcrank shaft. Tension in the belt is maintained by foot pressure against the engine base. The equipment should be screened because serious injury can result.

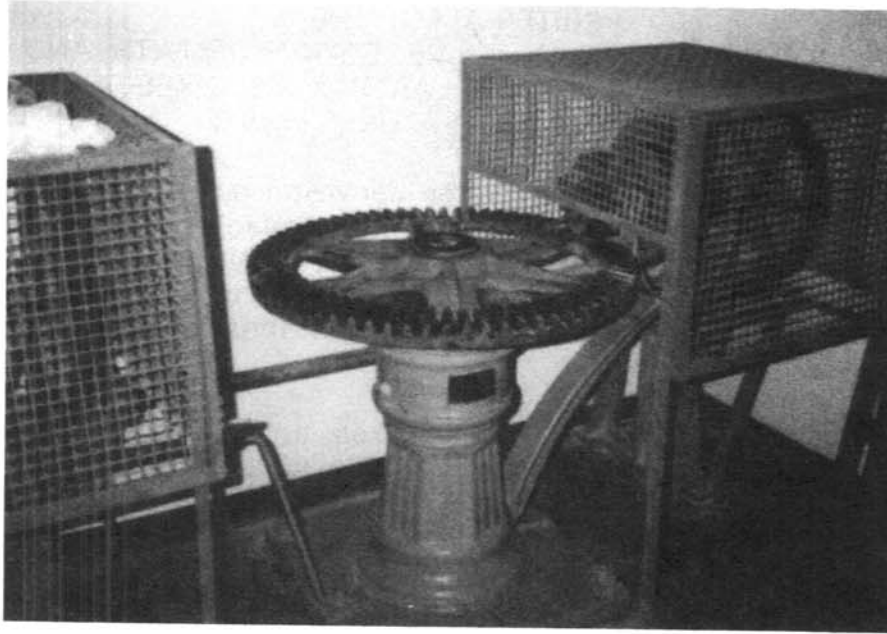
Photo 7. The safety screens around the motor-operated gears can protect operators from serious injury.

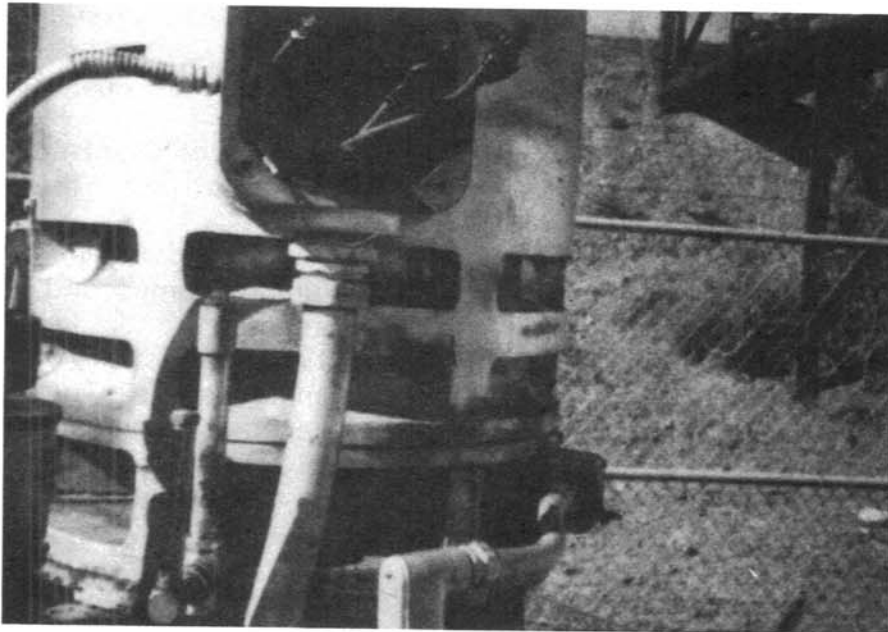
Photo 8. The missing faceplate should be replaced. Exposed electrical wiring on the motor junction box can cause serious injury to operating personnel.

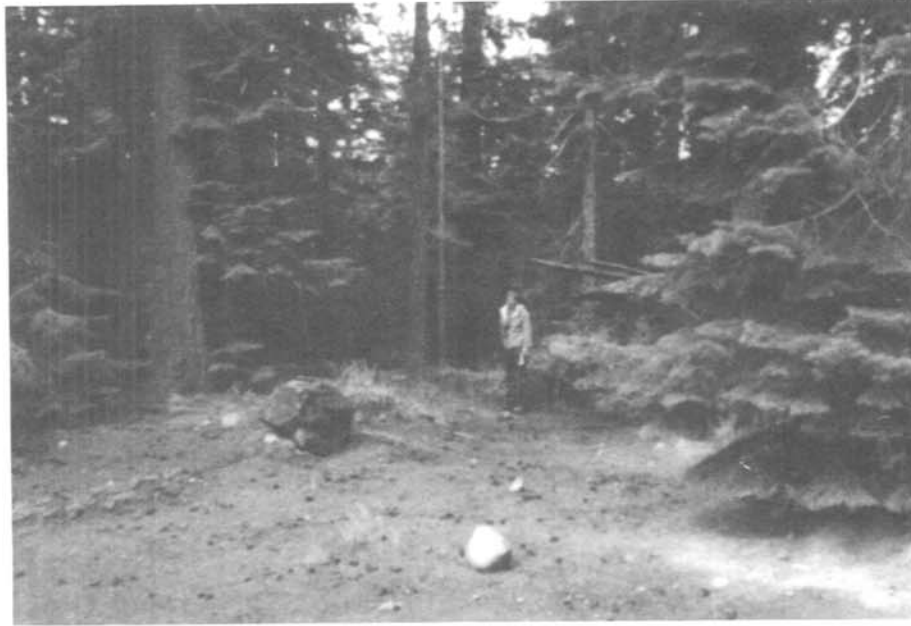
Photo 1. - The dense conifer stand has been allowed to grow in the lower end of an unlined spillway and will adversely affect and impede flood flows.

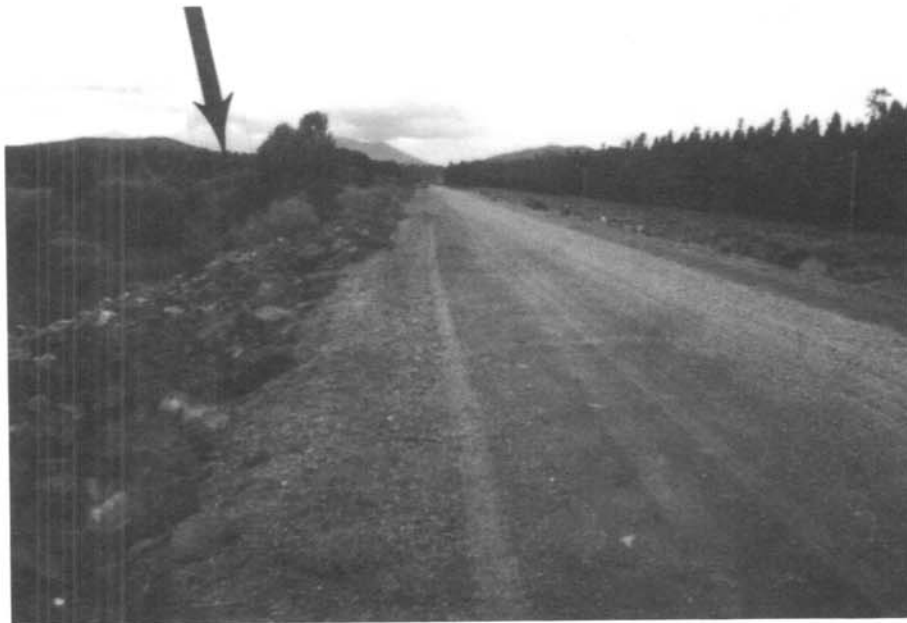
Photo 2. - Conifers and deciduous trees are established in a large area immediately upstream of the dam (arrow) and need to be removed to permit surveillance of any problems such as reservoir seepage which is known to exist.

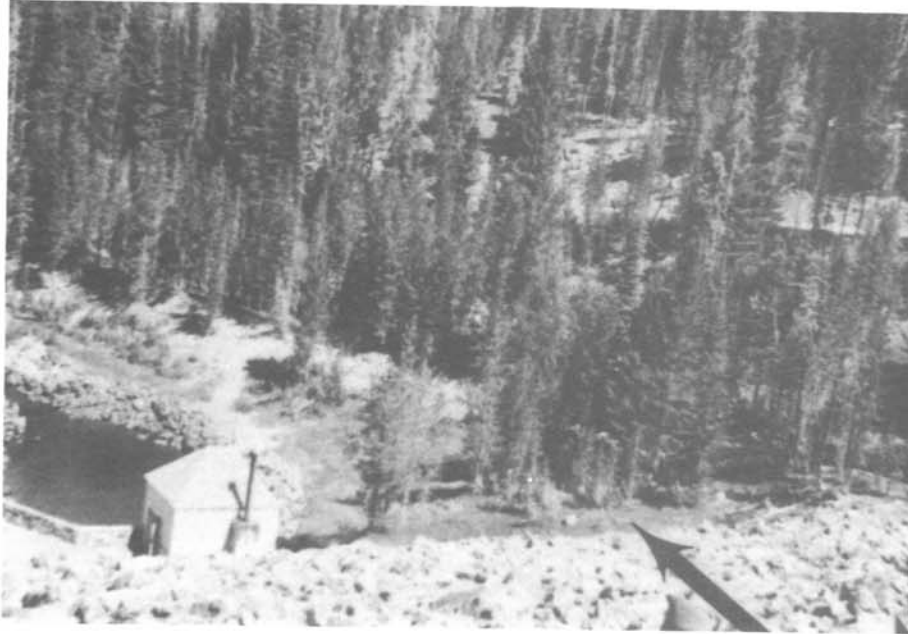
Photo 3. - Conifers have established themselves in the seepage area to the right of the valve house (arrow). They should be removed because they are partially concealing the seepage area and any evidence of adverse changes that may occur.

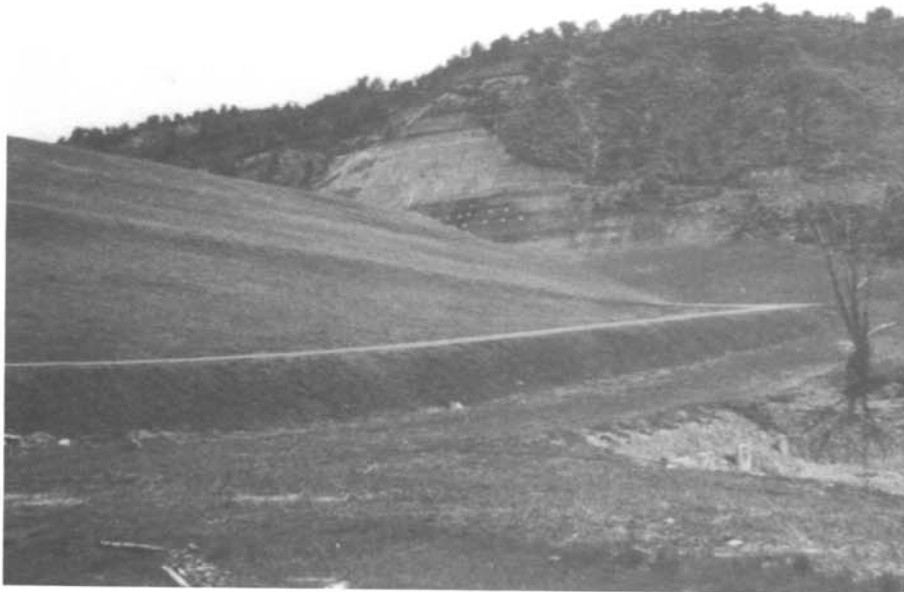
Photo 4. - The vegetation clearance zone and natural grasses on the embankment satisfy the criteria.

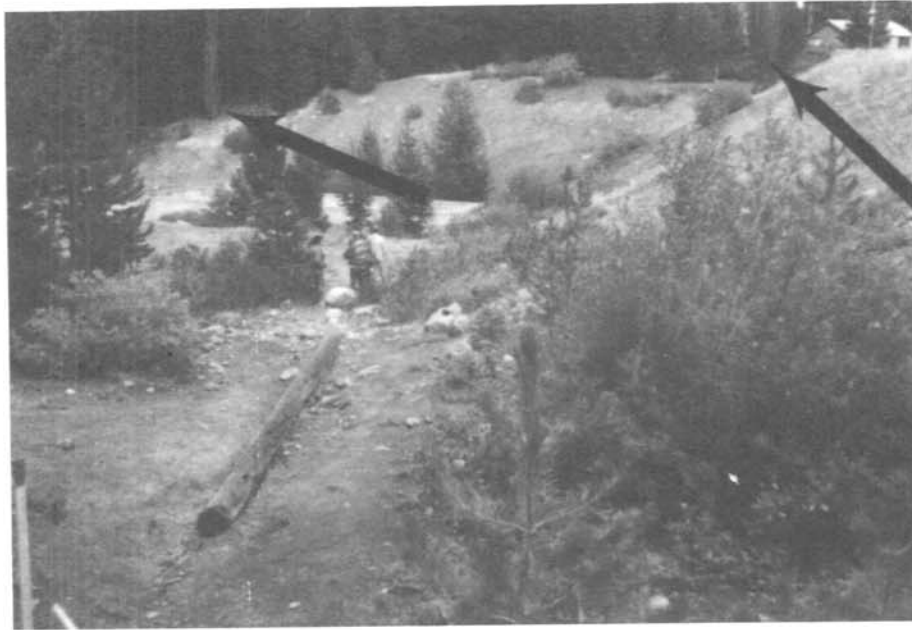
Photo 5. - The mature conifers (arrows) can provide seed stock for the emerging juvenile conifers located on the abutment contact.

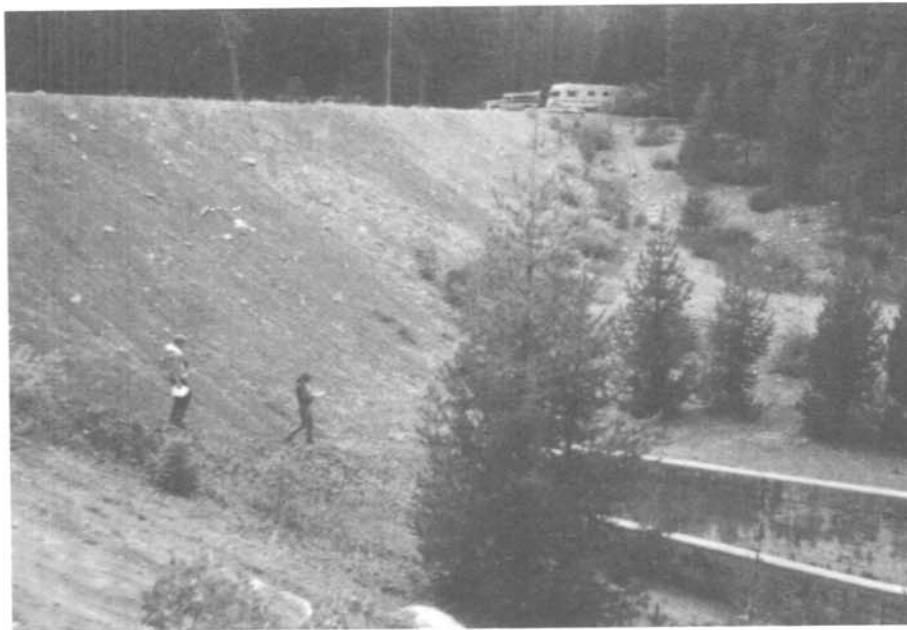
Photo 6. - Apron downstream of the toe of the embankment. The conifers on the apron are masking the stilling basin and any evidence of problems that may exist in these areas.

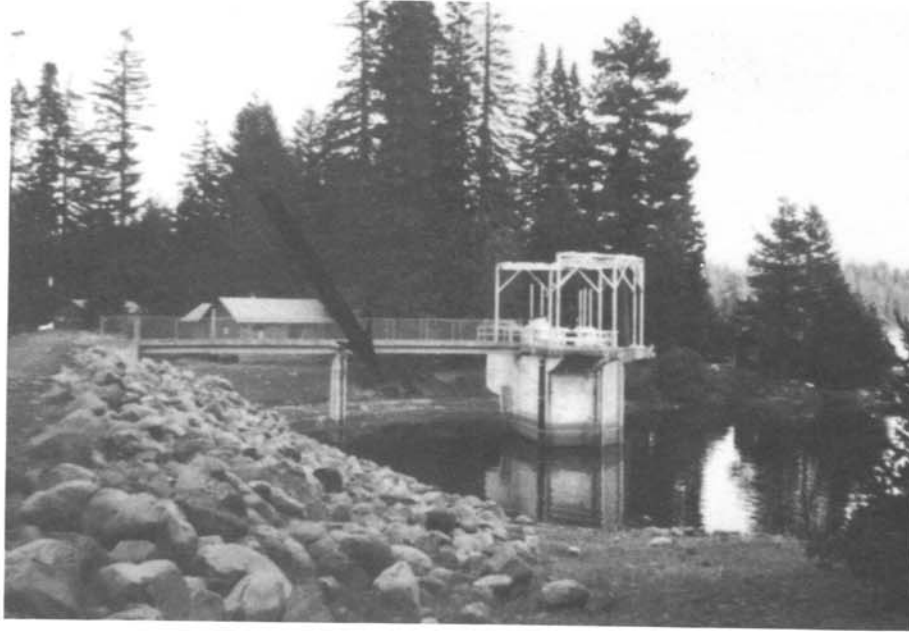
Photo 7. - The soil around the root system of the mature conifer (arrow) has been eroded by fluctuating reservoir levels and wave action. This conifer needs to be removed because it can fall and destroy the access bridge or equipment on the intake tower.

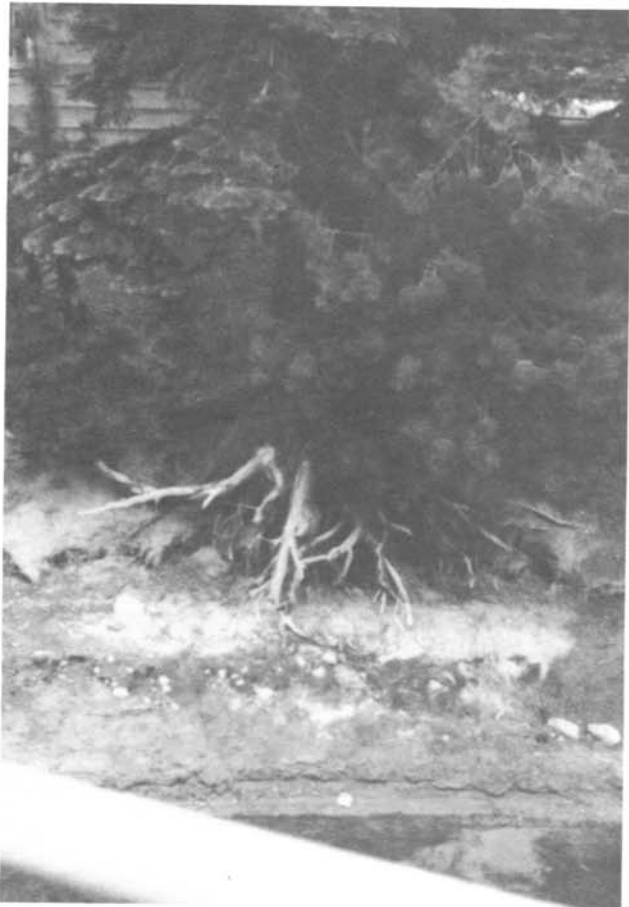
Photo 8. - Exposed root system of conifer in above photo.

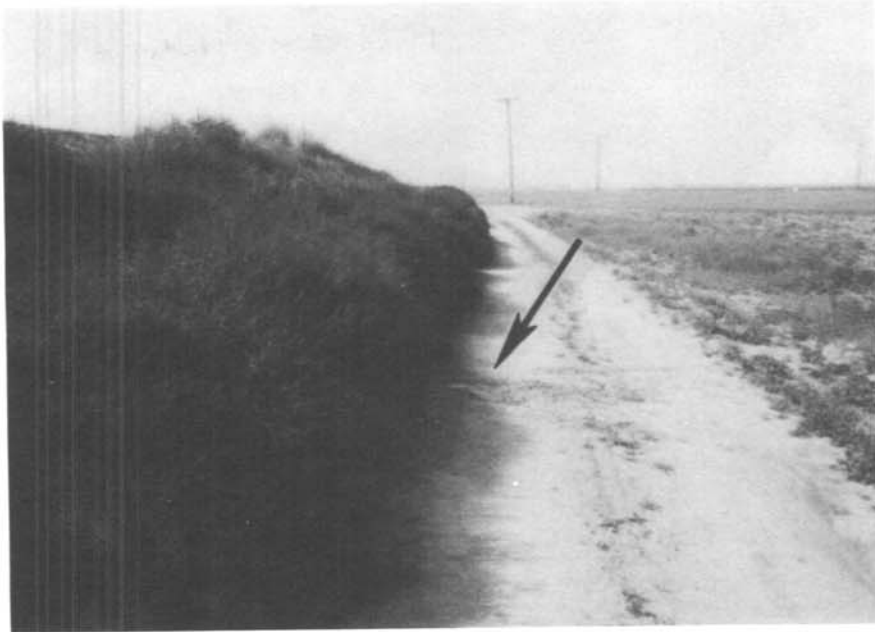
Photo 9. - The chaparral-type growth on the outside slope of the canal fill is concealing exit points of subsurface seepage channels. Material eroded from the fill has been deposited at the toe of this slope (arrow).

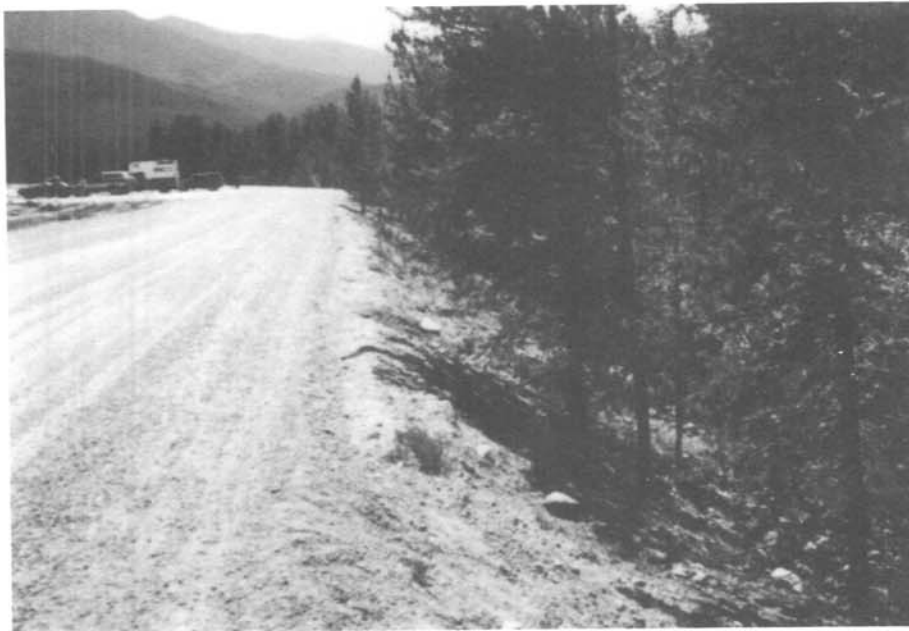
Photo 10. - Conifers have established themselves on the downstream face of this saddle dike and can conceal evidence of any problems in this area.

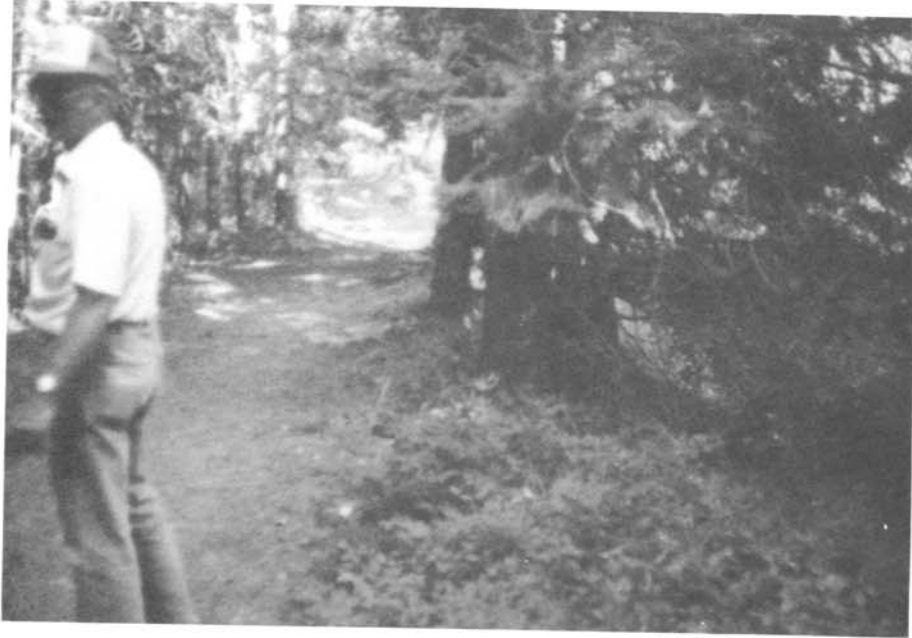
Photo 11. - Mature conifers have established themselves on both the upstream and downstream faces of this low saddle dam. Surveillance of rodent habitats and structural problems is difficult to perform.

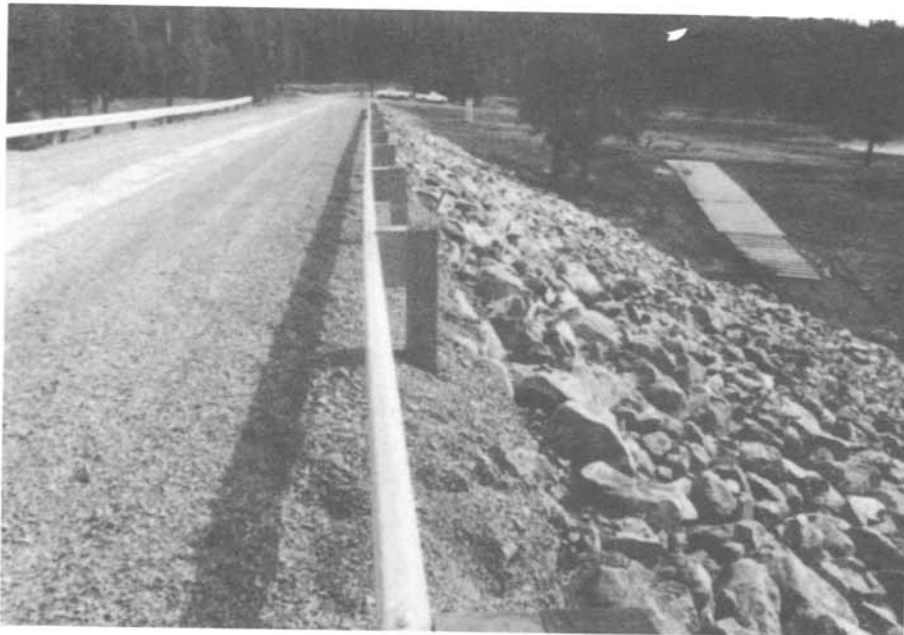
Photo 12. - The two conifers near the right upstream abutment can provide annual seed stock for more conifers and result in the spread of undesirable growth in this area.

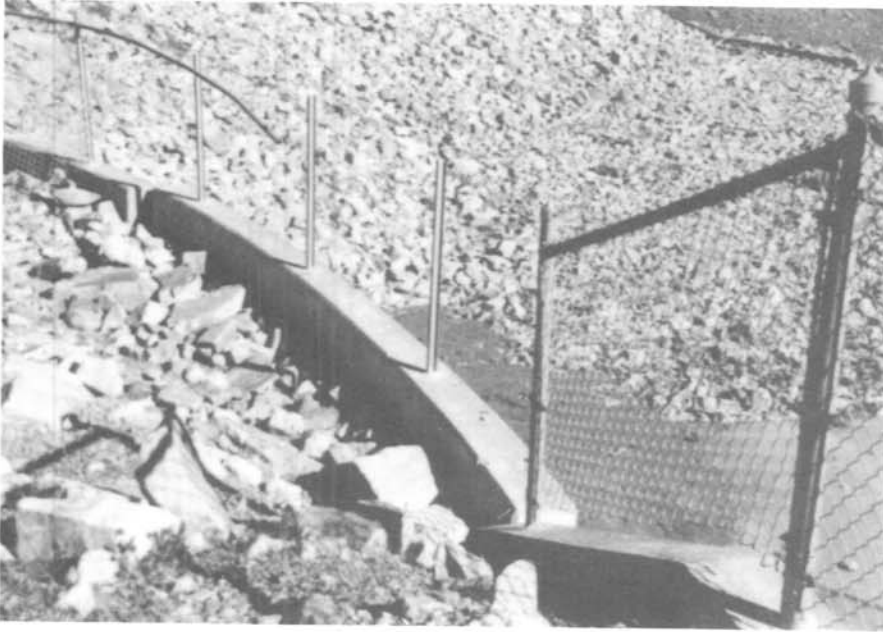
Photo No. 1. - Lemon Dam

**Conclusion:** Although above-normal runoff was expected when the wall failed in 1973, sufficient storage capacity and outlet works capacity existed to avoid using the spillway. Both inlet walls were replaced and no major interruption of service was experienced. The replacement walls have experienced no problems.

Right wall of spillway approach channel. Deflection of the wall damaged the fence.

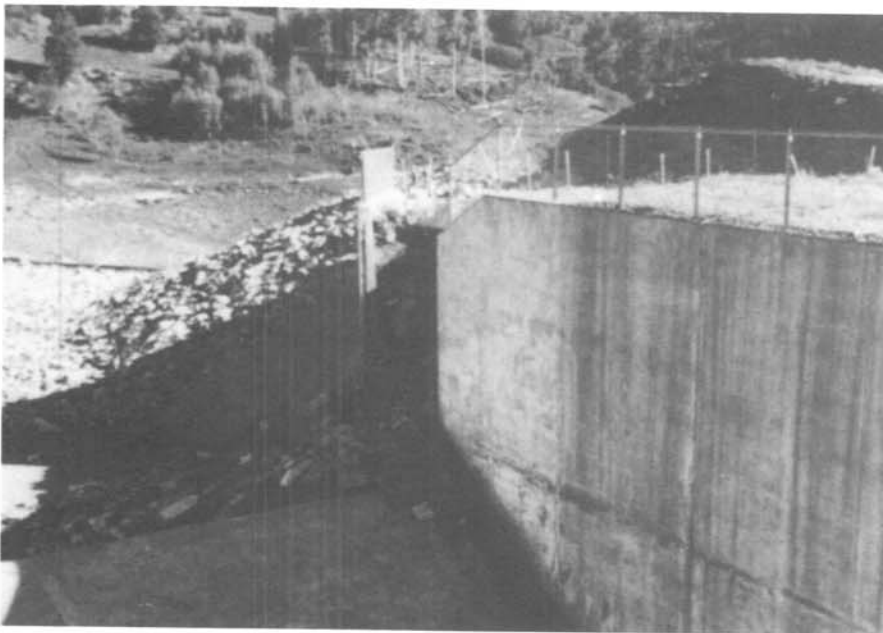
Photo No. 2. - Lemon Dam

Left wall of spillway approach channel. Failure was result of repeated cycles of frost action on saturated fill.
