WATER OPERATION AND MAINTENANCE

BULLETIN NO. 144

June 1988

BUREAU OF RECLAMATION'S NEEDLE VALVE INVESTIGATION PROGRAM AND NEEDLE VALVE REPLACEMENT PROGRAM

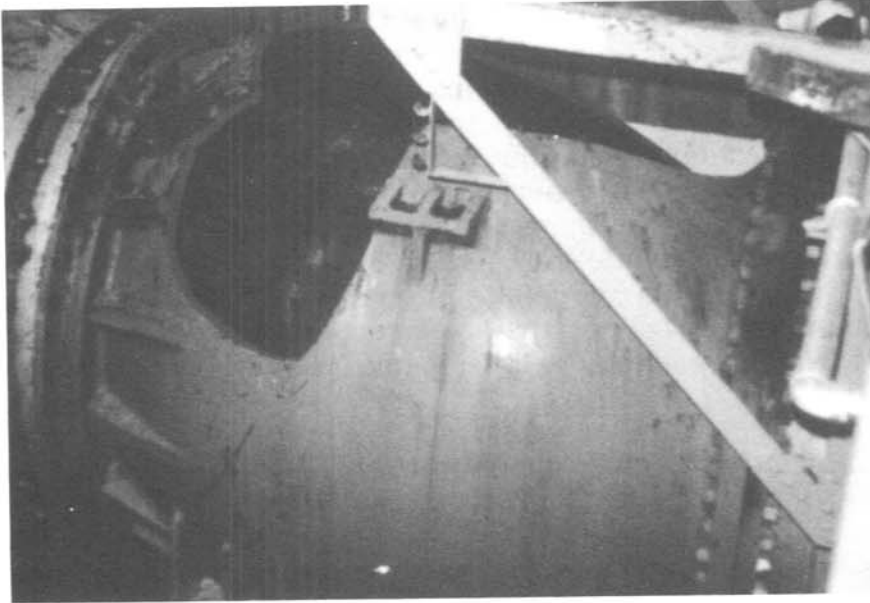
Photo 1. - Bartlett Dam, Arizona

On January 7, 1984, a needle valve failed (photographs 1 and 2) at Bartlett Dam in Arizona while the operator attempted to reduce the flow from the valve. This failure resulted in the death of the operator.

66-inch needle valve after failure. Large sections of valve body were blown out.

On January 7, 1984, a 66-inch outlet works needle valve at a Bureau of Reclamation dam failed when operating personnel were changing the discharge. The valve failure resulted in the death of the dam tender. Failure of the valve was attributed to an open drain valve between the gooseneck piping and paradox control which permitted draining of the operating chambers within the needle valve. The presence of air in the operating chambers resulted in failure of the needle valve casting due to violent movement of the needle.

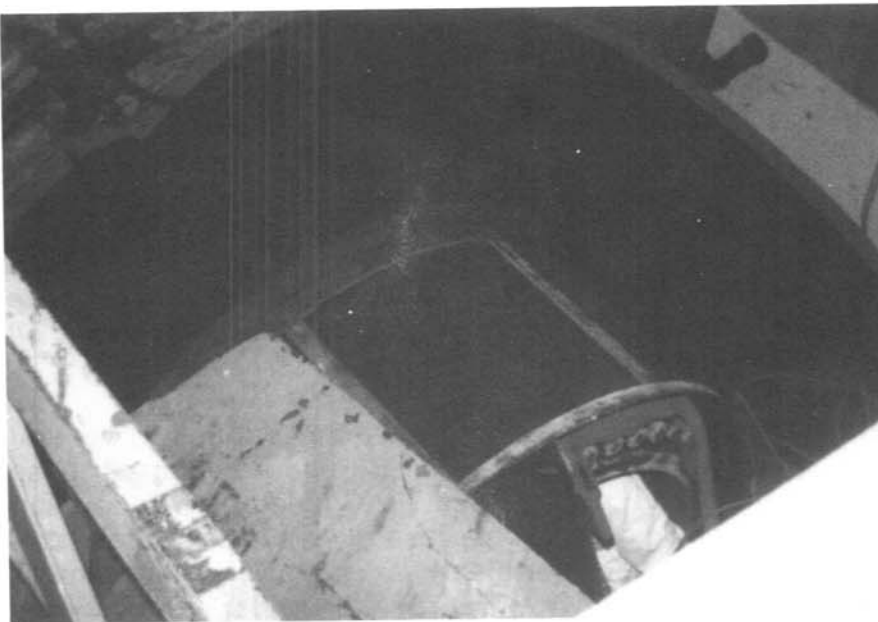
Photo 2. - Bartlett Dam, Arizona

66-inch needle valve failure as viewed from above. The valve casing is made of 1-7/8-inch-thick semi-steel. The operator stand was directly above this hole.

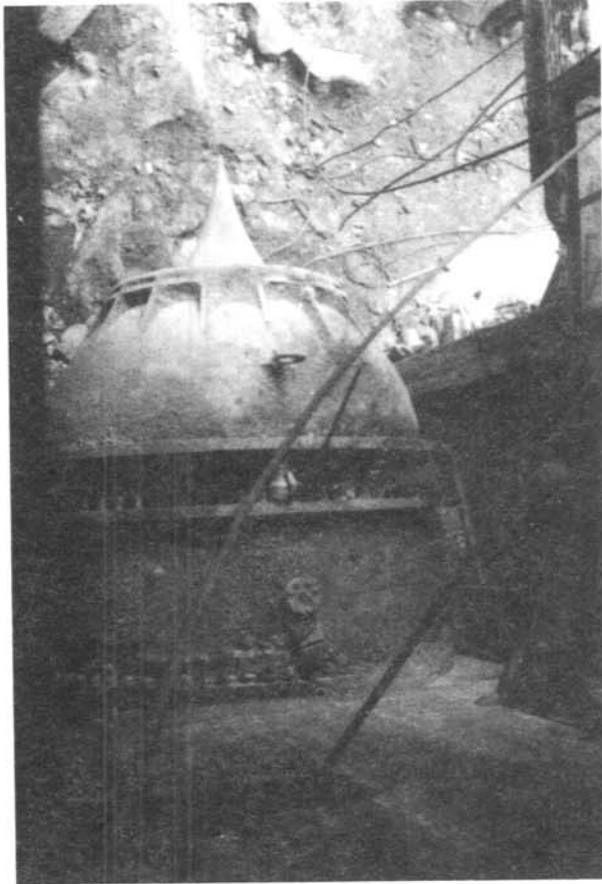
Photo 3. - Pathfinder Dam,
Wyoming

58-inch needle valve as viewed from above. The front portion of the valve body is being removed using mechanical and hydraulic jacks.

Needle valves have been replaced at Pathfinder Dam in Wyoming (photographs 3 through 7) and Echo Dam in Utah (photographs 8 through 12). It is expected that all Bureau water-operated needle valves will be replaced by the end of fiscal year 1991.

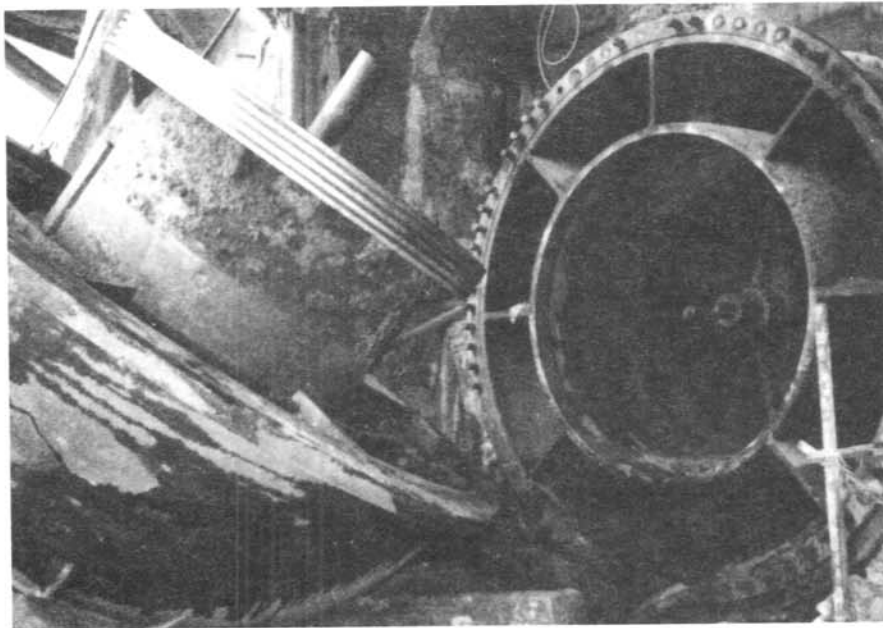
Photo 4. - Pathfinder Dam,
Wyoming

58-inch needle valve. Needle and front portion of valve body removed from rest of valve. Note condition of interior surfaces of valve.

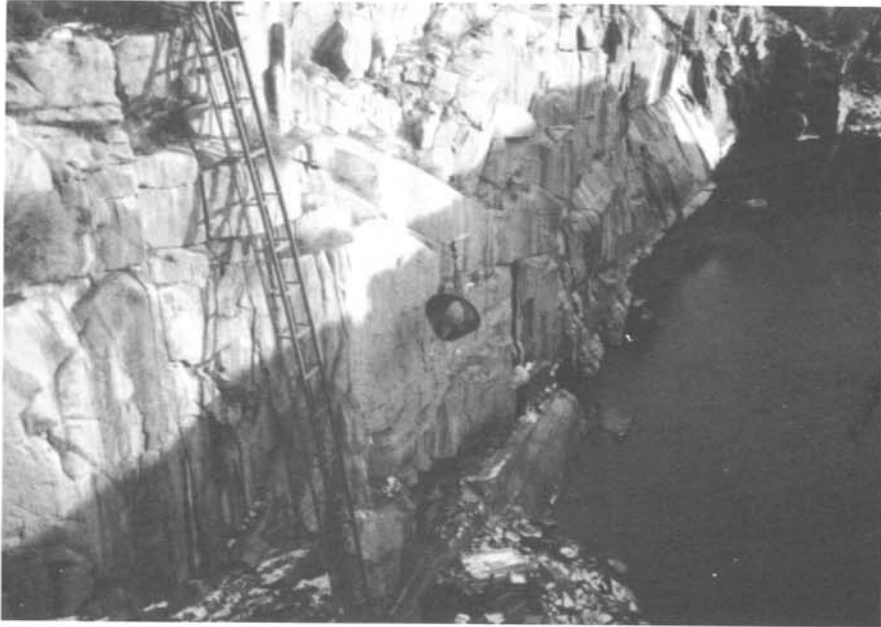
Photo 5. - Pathfinder Dam, Wyoming

Removal of front portion of valve body and needle as shown in photo 4. This piece weighs about 17 tons.

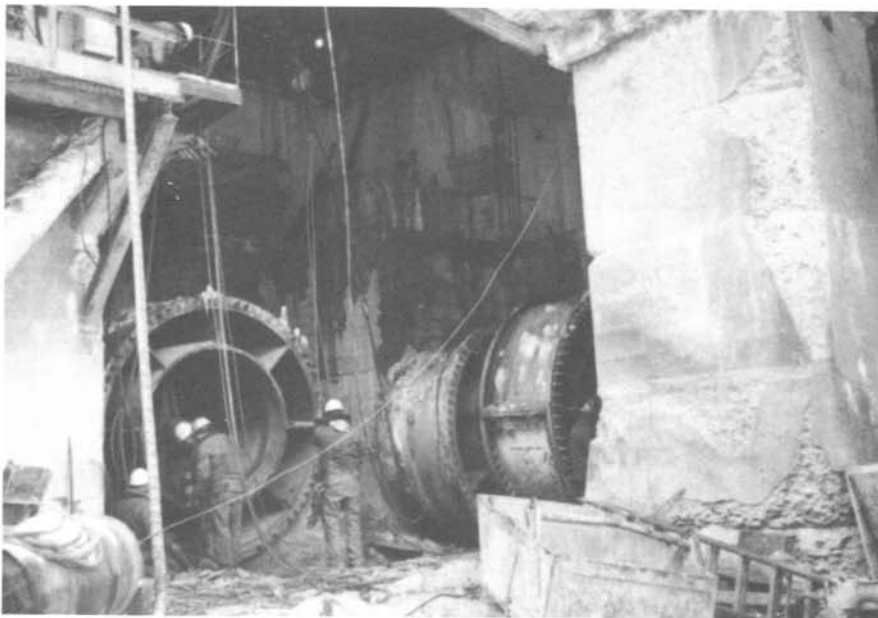
Photo 6. - Pathfinder Dam, Wyoming

58-inch needle valves in process of removal. The middle portion of the valve body (in background) was freed from the rest of the valve for removal.

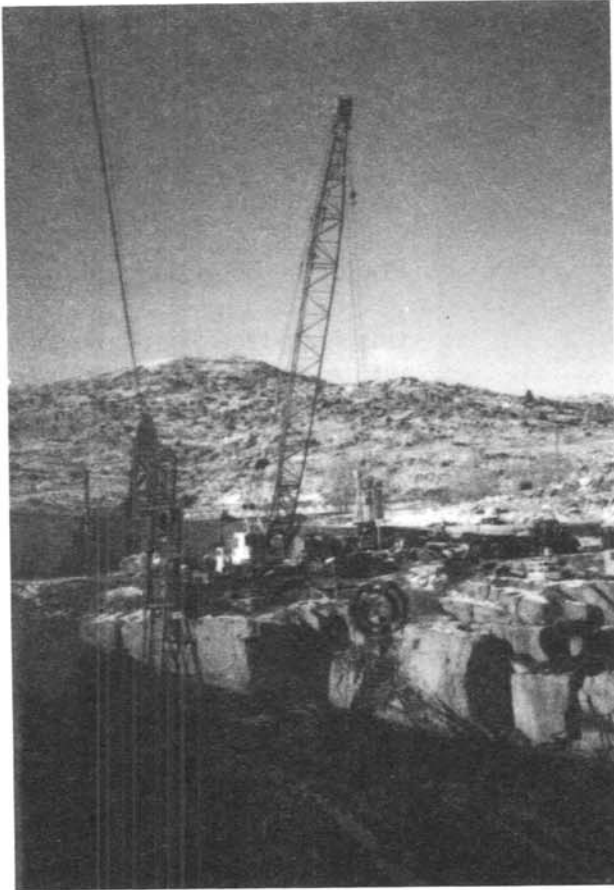
Photo 7. - Pathfinder Dam,
Wyoming

Removal of middle portion of
the valve body. This piece
weighed just under 12 tons.
The entire weight of one of the
valves was in excess of
44 tons.

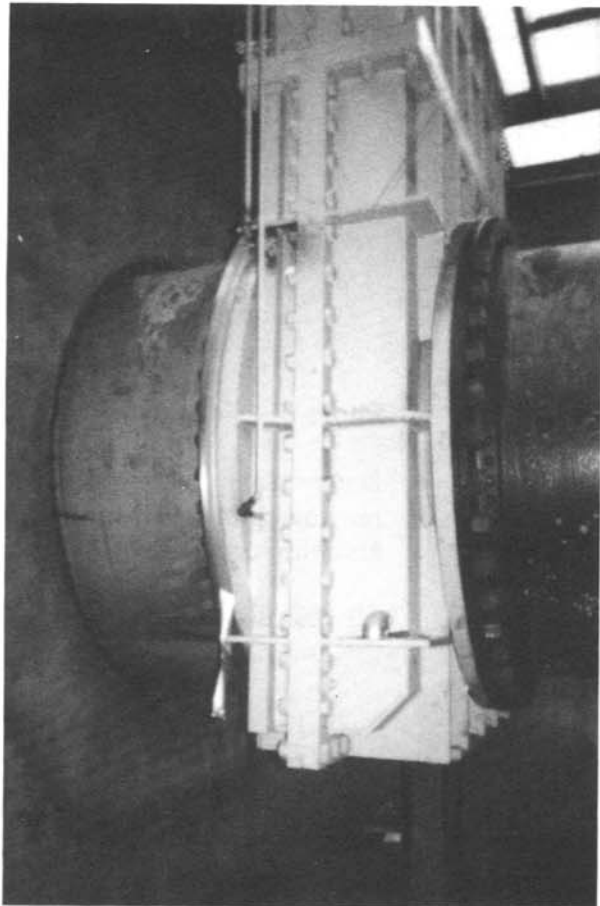
Photo 10. - Echo Dam, Utah

60-inch jet-flow gate in place. This gate replaced a 60-inch needle valve. Note additional pipe extension necessary to convey discharge from gate through the wall.

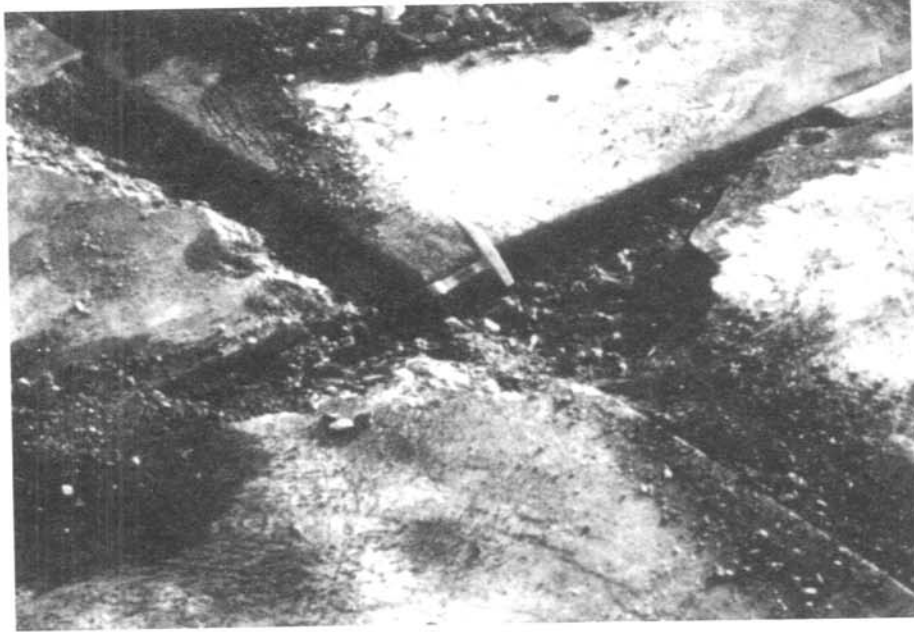
Photo No. 1. - Webster Dam - example of localized severe deterioration. 10/72

Areas replaced, to date, have been on the flat section of the spillway apron and were relatively easy to repair. However, the sloped section of the spillway chute is also deteriorating and will be much more difficult and time consuming to repair.

Conclusion: Repairs to be made on a yearly basis until all the deteriorated joints have been repaired. "D" cracking can be prevented by proper petrographic testing of aggregates.

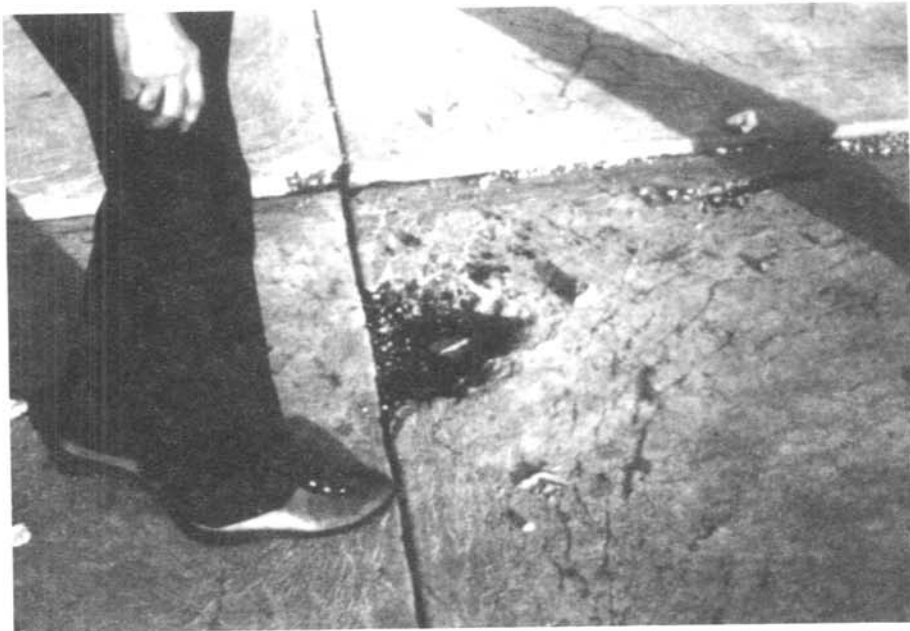
Photo No. 2. - Webster Dam - example of "D" cracking present on many slabs. 10/72

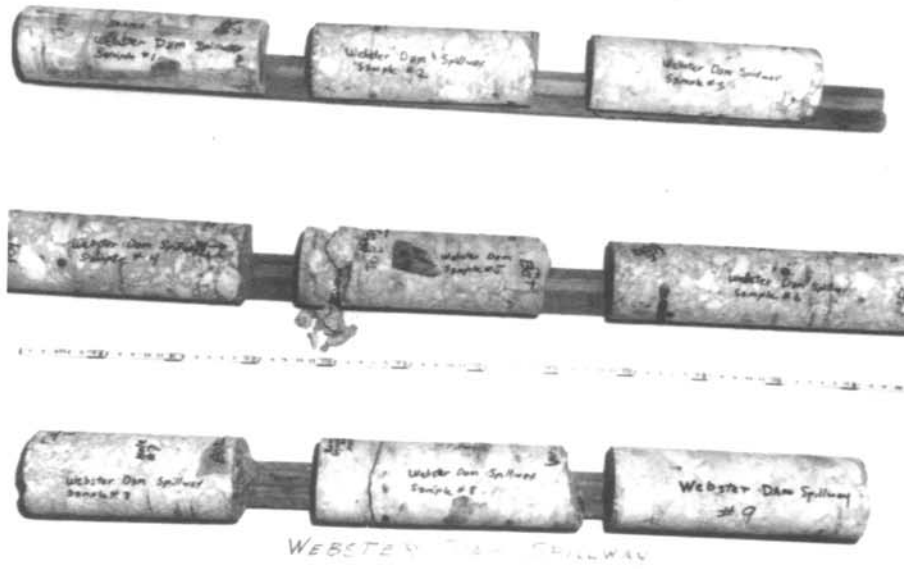
Photo No. 3. - Webster Dam - cores No. 1, 5, and 8 fractures near the top are from edge of floor slabs adjacent to areas of visible deterioration. Cores No. 2, 3, 4, and 9 are from centers of floor slabs and appear to be sound. Core No. 6 from toe of wall and No. 7 from cover over gallery also are sound. 11/2/72
