# **WATER OPERATION AND MAINTENANCE**

**BULLETIN NO. 150**

December 1989

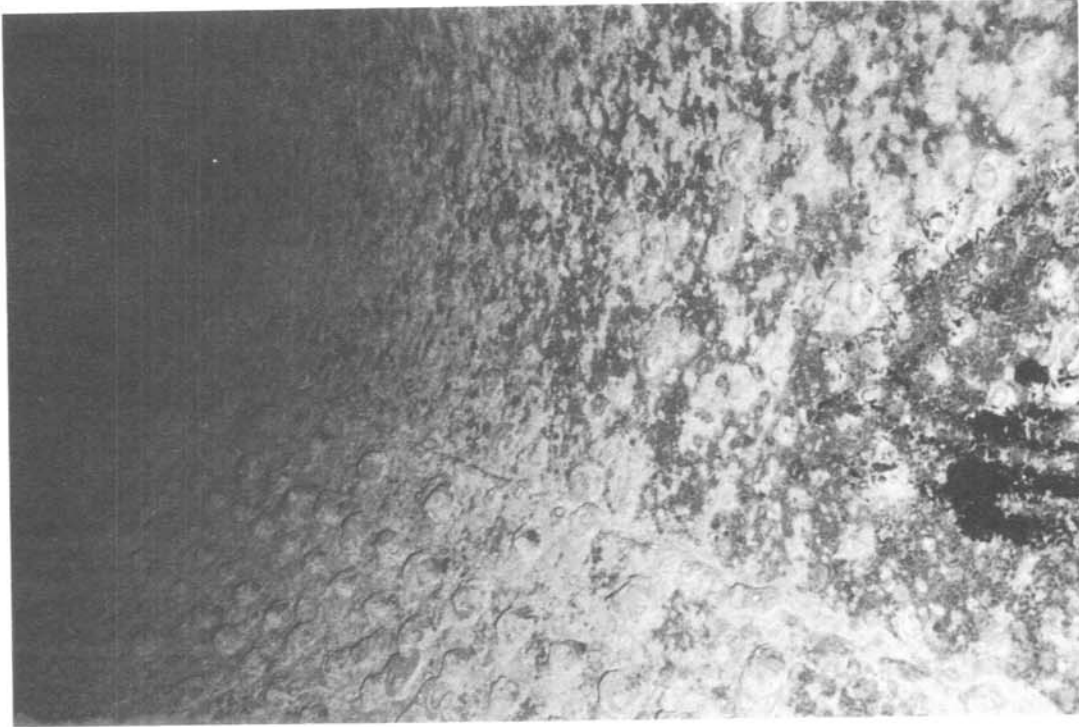
The cleaned inside pipe surface showed random cratering due to galvanic corrosion. Care was taken to detect any cratering pattern that would seriously concentrate the pipe hoop stresses. Particular attention was given to the longitudinal Lock-Bar swage area. Neither the swage itself nor the immediate plate showed any significant corrosion. Material cracking was not evident and, for the most part, the pitting did not concentrate the shell stresses above tolerable limits. The rivet heads on the circumferential seams did not exhibit objectionable deterioration. Portions of the penstock that were unearthed showed minimal corrosion on the pipe exterior, and the original exterior bituminous penstock coating was in good condition. Based on these findings, repair and reuse of the existing penstock were then considered. The 25,000 pits estimated from the visual examination to be present eliminated as a practical solution an attempt to locate and weld all the potentially leaking pinholes as a workable solution. Sandblasting and painting the inside could inhibit further corrosion, but would offer no protection against pinhole leaks. It seemed desirable to investigate the possibility of lining the pipe. Therefore, several vendors for both cement and fiberglass linings were consulted. Several cement lining vendors discouraged the use of cement lining in this application, because of the exposure of the pipe to freeze-thaw action and the relatively high water velocity.

Figure 1. - Condition of interior surface of penstock before preparation for repair. Note that rivet heads add to the roughness of the surface.

The interior of the penstock was first abrasive-blasted to a white-metal condition. Welded patches were placed in a few selected areas that had severe pitting. Immediately after blasting, each area was primed to preserve the white-metal condition. Next, the corrosion pits were filled with a putty material to make a smooth surface. Spaces around rivets were also filled with putty and tapered to provide a gradual buildup over contours. High-tensile-strength fiberglass reinforcement was embedded into the putty and saturated with resin. After this layer cured, two layers of chopped strand mat were applied and allowed to cure. Two topcoats containing abrasion-resistant additives and wax sealers were then applied to complete the system. A metal band was lapped over the leading upstream edge of the fiberglass-to-steel transition to provide additional protection against the possibility that waterflow might separate the fiberglass from the steel. The thickness of the fiberglass at the downstream terminus of the lining was tapered to prevent localized turbulence. The \$250,000 repair project was completed on December 10, 1987, after 11 weeks of work.

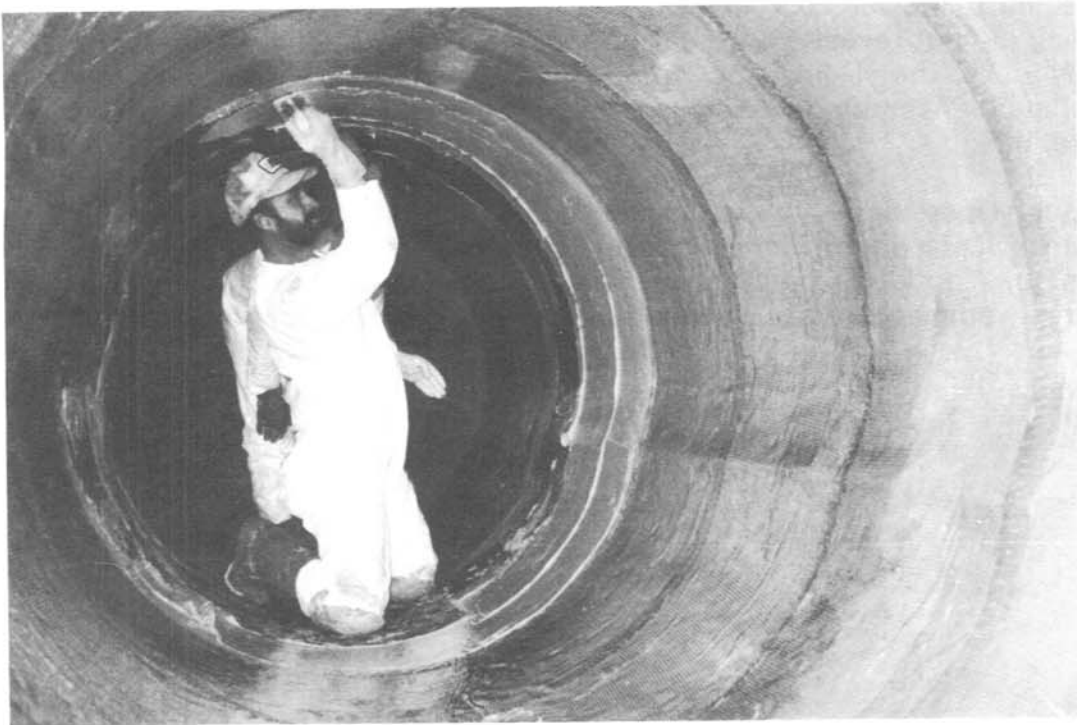
Figure 2. - After the damaged surface has been abrasive blasted, a putty material is applied over corrosion pits and around rivets to make a smooth surface.

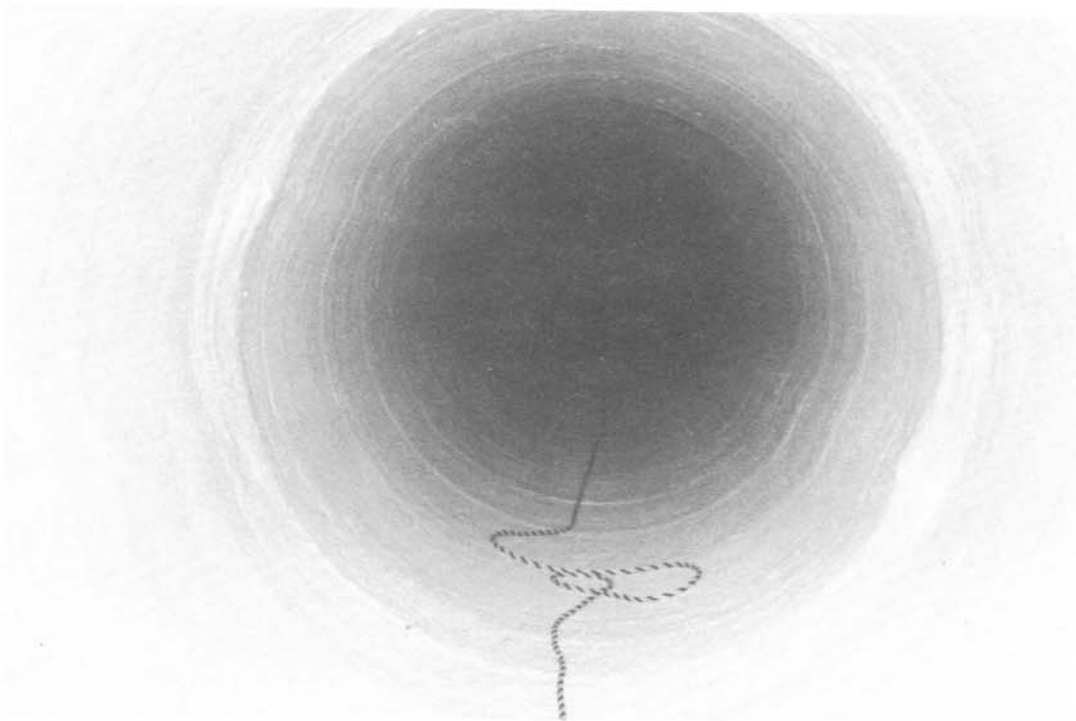
Inspection of the penstock interior in early September 1988, after 10 months of continuous service, did not reveal any visual evidence of lining wear or distress, nor are we aware of any leaks. The surface appeared as smooth and clean as immediately after the initial installation. According to I. W. Construction Services, the coating is expected to last "a lifetime plus."

Figure 6. – When the project has been completed, the interior of the penstock shows the desired smooth surface which, according to the supplier, should last over 25 years.

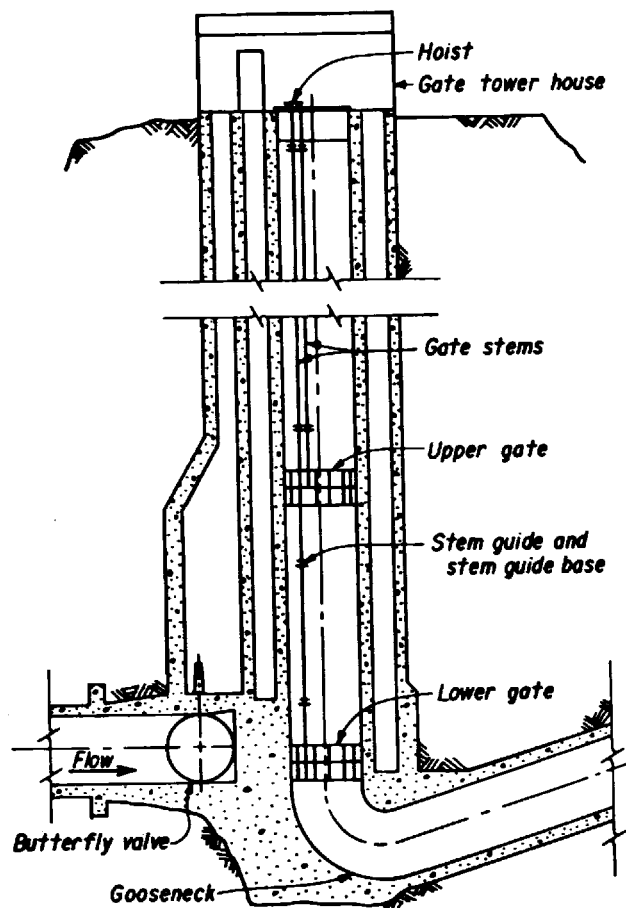
Figure 1. - Gate tower

During failure, guide brackets for the gates either break off completely, or the bolts holding them break. The extra radial displacement is then transferred to the first stem guides above the gates. These stem guides crack, and the bolts holding the stem guide base to the concrete wall break; this process continues until finally the stems themselves fail. Then the gates fall onto the seat rings and sustain additional damage. This scenario took place at Crow Dam in 1980 [1].\*

With the three sets of stem guide bases for the lower gate broken away from the gate tower wall and the stems broken, engineers decided to hang the lower gate from cables attached to the undamaged stems 42.5 feet above the gate. After only one season of operation, the cables broke, and the lower cylinder gate shell structure sustained cracks [2]. Releases from the gate tower were then possible only through the upper gate. In 1984, the lower cylinder gate was removed, and the open ports in the gate casing were blocked with steel plates [3]. In addition to the damage to the gates and stems, the concrete below each gate sill had been eroded, and the embedded reinforcing bar in the gooseneck concrete section was exposed for several feet.

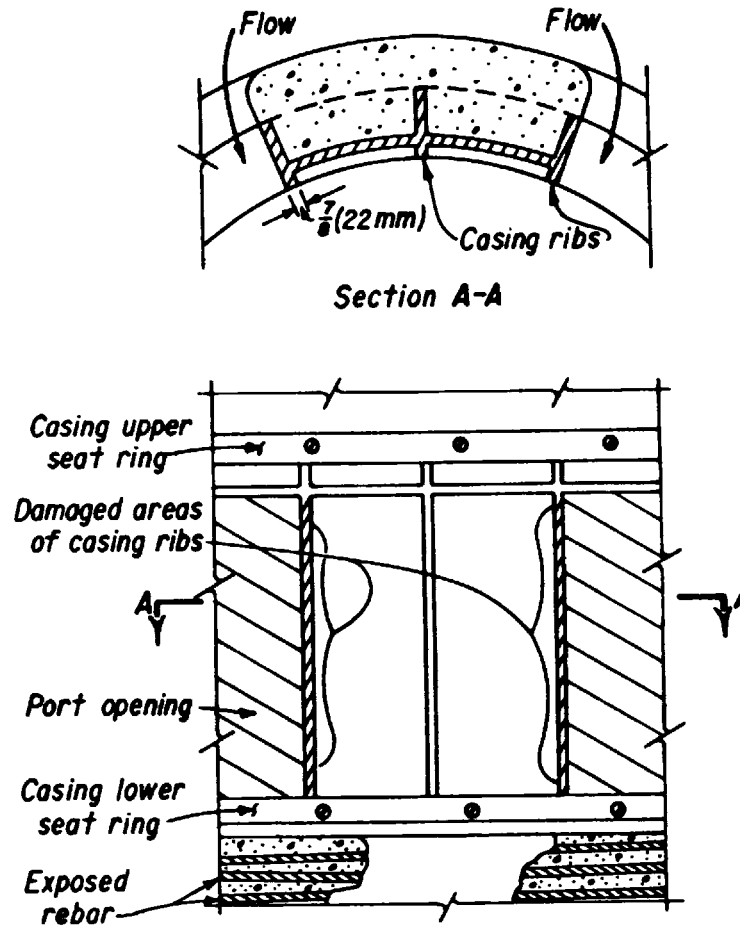
Both upper- and lower-gate casings had damage on the inside surfaces of the vertical ribs (figure 3). The casing ribs adjacent to the port openings had suffered from erosion, and the fluctuating radial movement of the gate at different openings had caused the casing ribs to break away. Because the gate casing is embedded in concrete, the cost of replacing it would have been extremely high. Also, because the casing is made of cast iron, repairing it with conventional welding techniques would have been difficult. However, molecular welding, a modern technology that uses proprietary materials to build up damaged metallic areas, can be used to repair the type of casing damage found at Crow Dam. A base and solidifier mixed together to form a compound that has nonslump, nonshrink characteristics and a short curing time is ideal for field applications in which access and working conditions are confining and awkward. Once cured, the material has the mechanical properties of a low carbon steel and can be machined or ground for final sizing.

Figure 3. - Gate casing damage

Steps involved in the repair included brushing away any loose contaminates, grit-blasting with copper slag, mixing and applying Belzona Molecular Ceramic R-Metal\*, curing for 2 hours, measuring and reapplying the repair material until the buildup was satisfactory, and finally brush coating with 10 to 15 thousandths of Belzona Molecular Ceramic S-Metal\* to give added protection against erosion and corrosion.

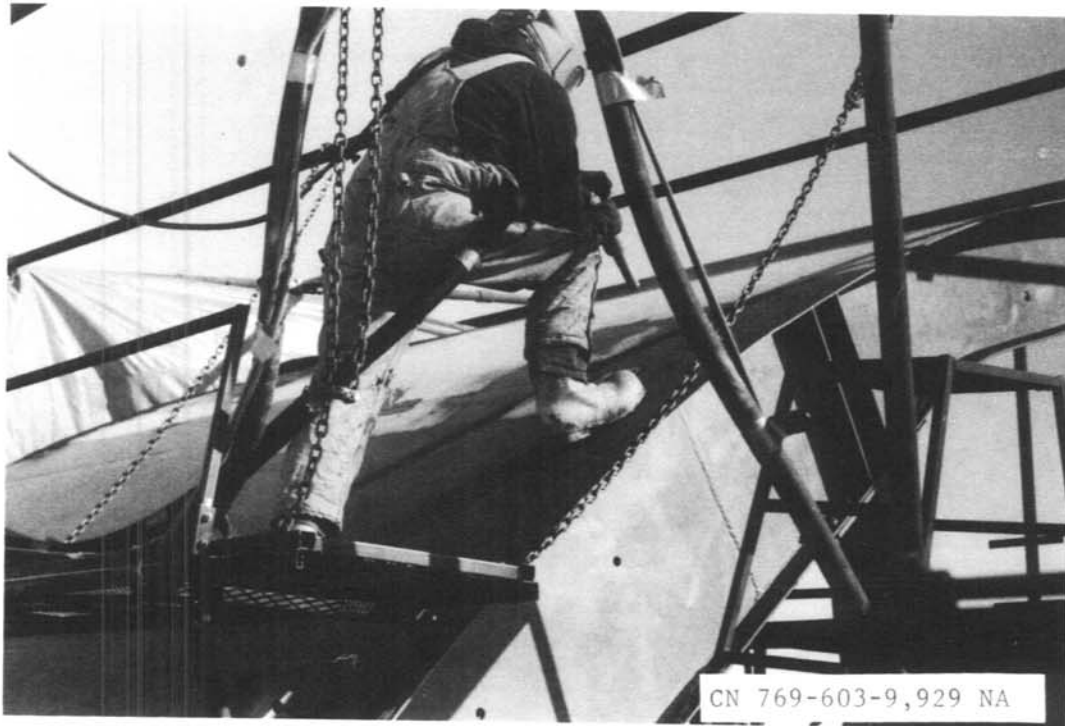
Photo 1. - McClusky Canal. Contractor is using a coal slag grit to sandblast and remove the VR-6 paint off the outside face of the south gate on Reach 3A, New Johns Lake. 3/4/89

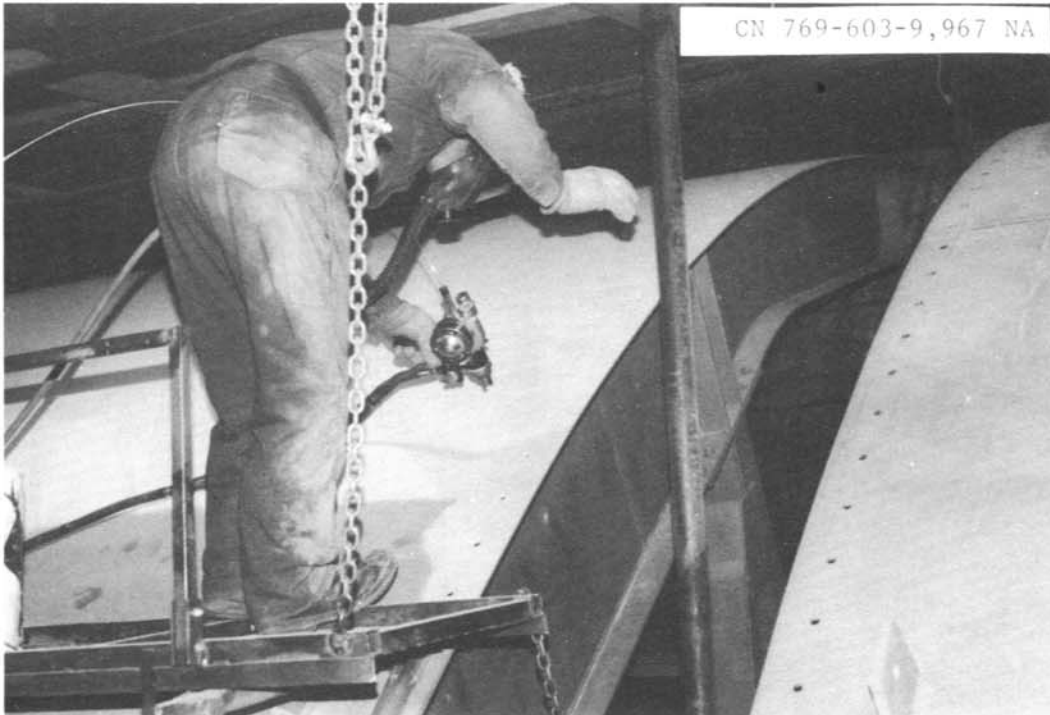
Photo 3. - McClusky Canal. Contractor applying zinc to surface to north gate. Note position of metalizing gun. 3/8/89
