FILL SLOPE REPAIR USING SOIL BIOENGINEERING SYSTEMS¹

by Robbin B. Sotir and Donald H. Gray, Ph.D.²

THE SLUICEWAY FAILURE OF RIVERSIDE DIVERSION DAM

by Bill Bouley and Arthur Glickman¹

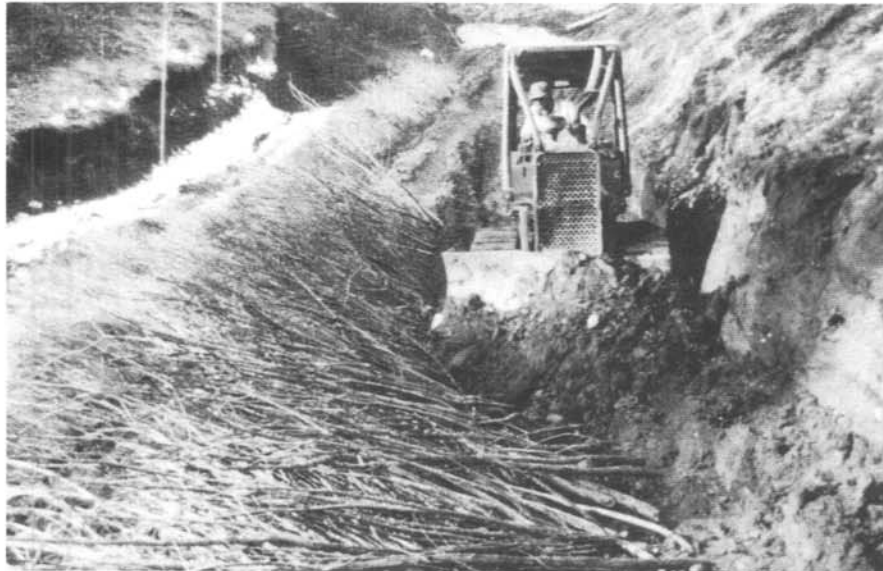
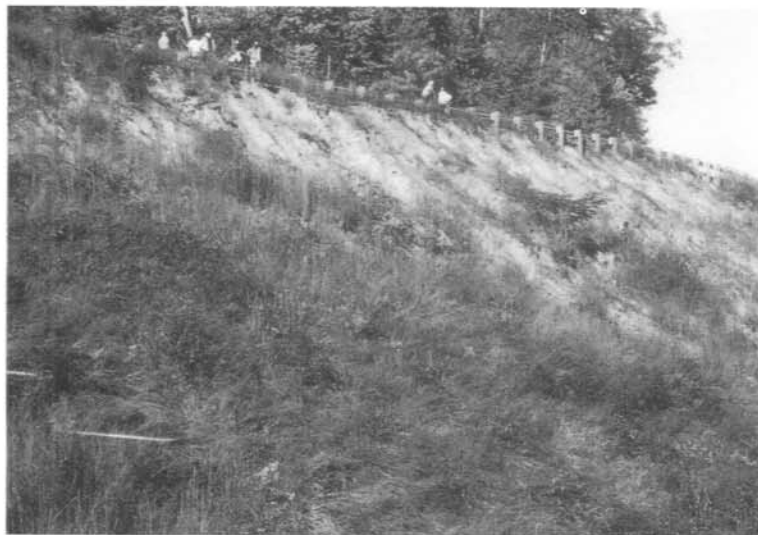
height of 60 feet with a slope face ranging from 100 to 200 feet long. This fill section was constructed in 1980-81 with the slope varying from 1.5:1 to 2:1. The slope began to fail and erode shortly after construction and was repaired several times using conventional treatments. When the decision was made to repair the slope with soil bioengineering systems, face sliding and erosion had started to undermine the guard rail posts at several locations and encroach on the pavement structure.

Installation of fill brushlayer during North Carolina embankment stabilization project, top; and a view of the slope before repairs began.

A small bulldozer was used to prepare the fill brushlayer terrace lifts in Area 2. Terraces for cut brushlayers and live fascine trenches were dug by hand. Typically, plant material delivered to the site consisted of bundles containing long live stems of brush. The average truck load contained 40 bundles. Based on these estimates, the quantities of plants and cuttings installed in each area are given in Table 1. In addition to live stems, quantities of lime, fertilizer, grass seed, and jute mesh were used at the project site.

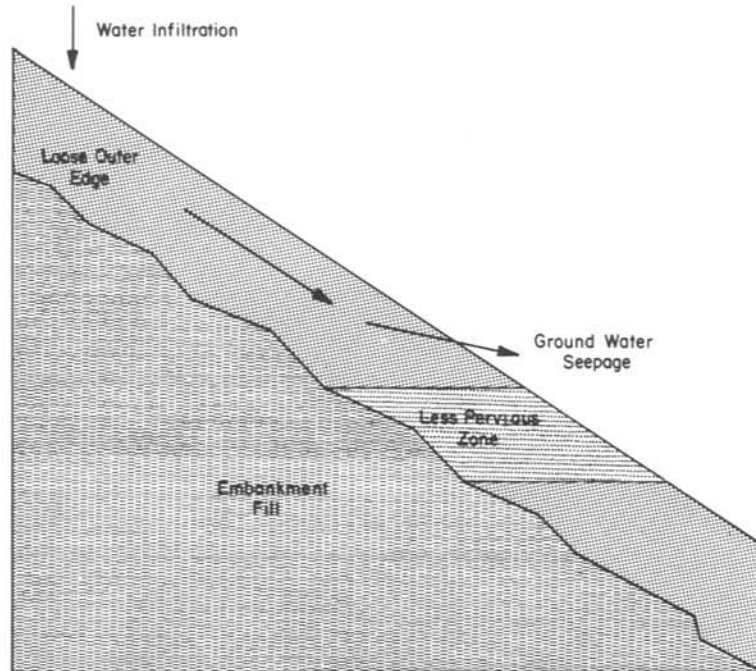
Figure 1. – Schematic illustrates variables controlling shallow slope failures in compacted fill slope.

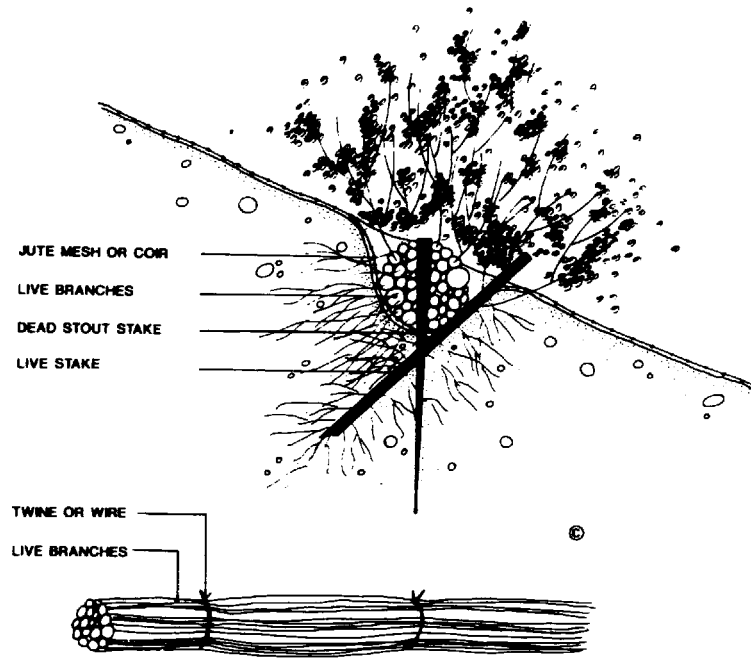
Figure 2. - Live fascine with jute or coir. Rooted/leaved condition of the living plant material is not representative at time of installation.

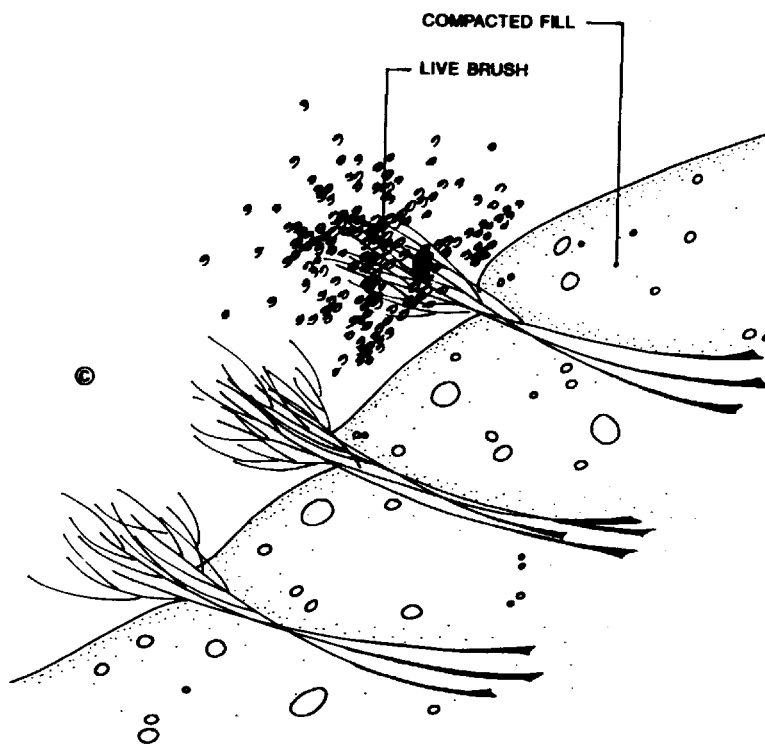
Figure 3. - Schematic representation of a brush-layer fill installation.

Brushlayering system.—This system (figure 3) includes brushlayers cut into a slope and those used in a new or repair fill that abuts the slope face. The branches are placed as the fill is raised in the latter case. This system works very well as porous filter units to control surface erosion from heavy rains during and after construction. This filtering action was observed during construction when 4.5 inches of rain fell in a 3-day period. The brushlayers prevented erosion of the outer edge of the loosely compacted fill material placed in the fill brushlayer system in Area 2. Those areas of the slope where such systems had not been installed experienced large soil flows and earth failures.

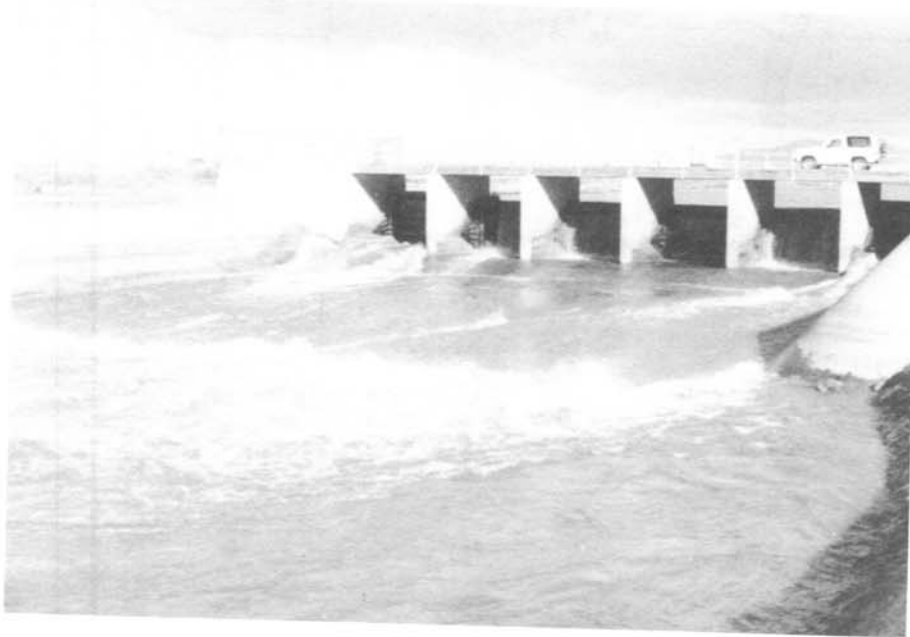
Photograph 1. - Riverside Diversion Dam. Sluiceway stilling basin. 3/17/87

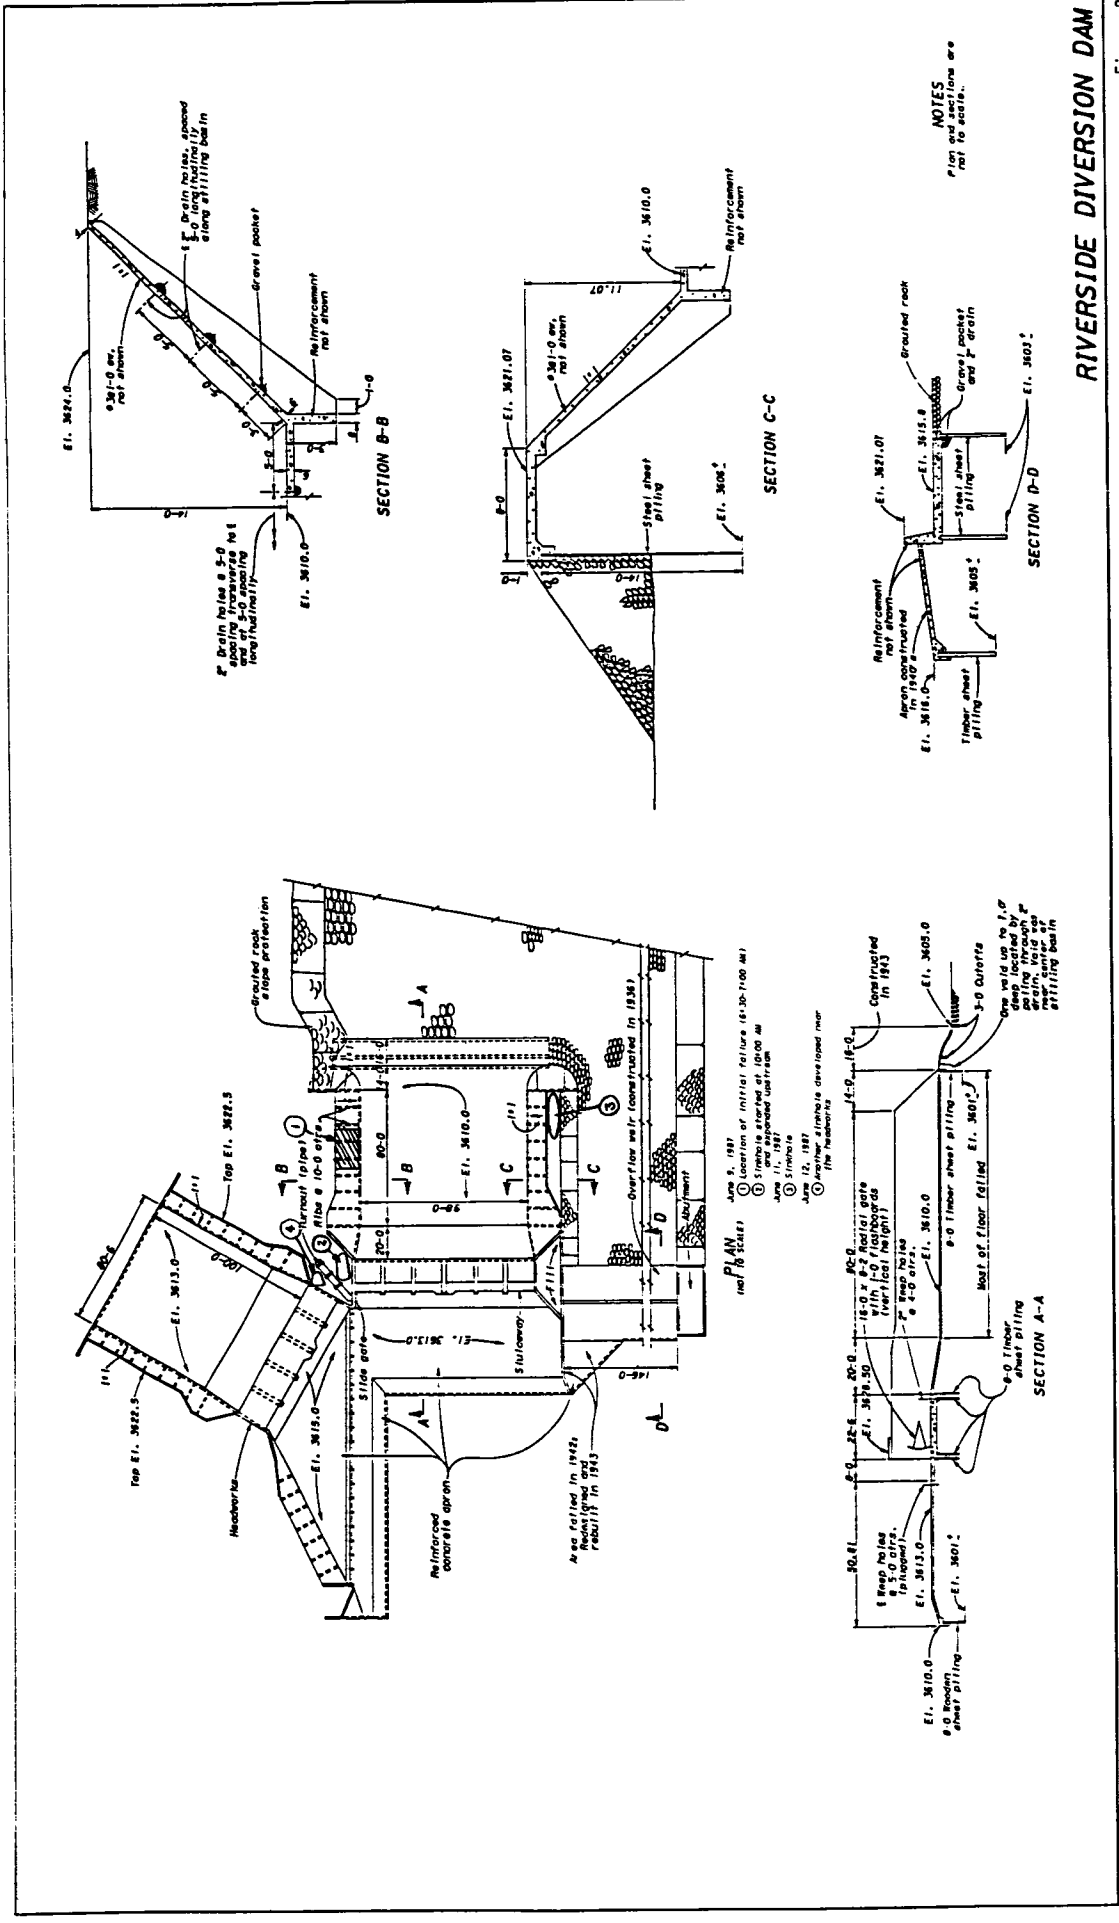
RIVERSIDE DIVERSION DAM
 Figure 2

1. A section of left downstream side slope failed at 6:30 to 7 a.m.
2. Most of side slope failed by 9 a.m. (photograph 2).
3. Closed sluice gate on left side by 10 a.m.
4. Upstream sinkhole, near headworks, started by 10 a.m. to noon.
5. Crack in left upstream sluiceway abutment noticed at noon (photograph 3).
6. Filled upstream sinkhole with concrete.
7. Dumped rock in failed embankment area.
8. Excess flow from Caballo Dam stopped.
9. All sluiceway gates raised to lower upstream water surface.

1. Another sinkhole developed near the right abutment of headworks.
2. Right downstream abutment of sluiceway failed.
3. Sluiceway gates were raised and diversions were stopped.
4. Excess riverflows were reduced.

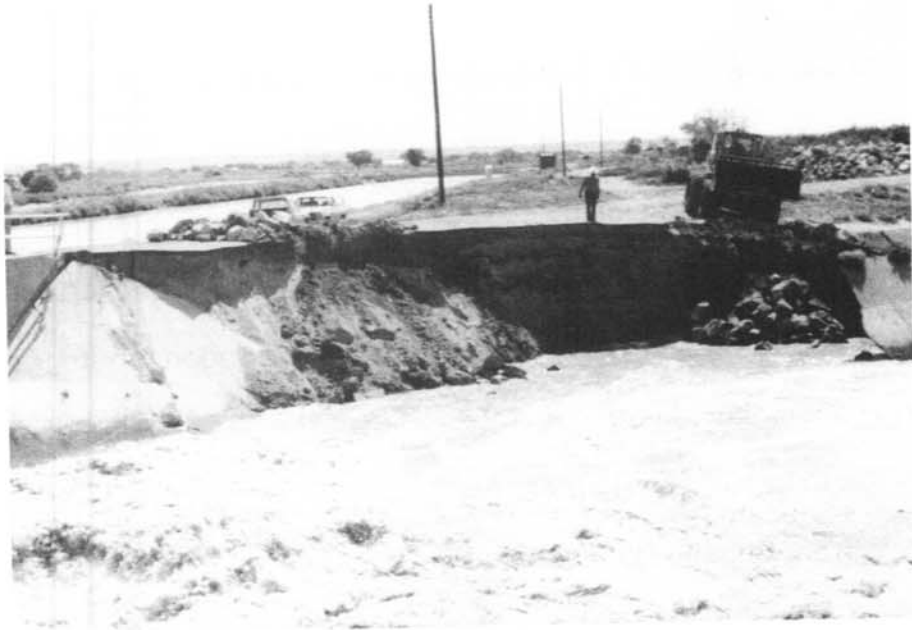
Photograph 2. - Riverside Diversion Dam. Left abutment of sluiceway stilling basin. 6/9/87

1. The left downstream embankment of the sluiceway became saturated and failed. This includes failure of the adjacent floor and then undermining of the remaining structure. Hydrostatic uplift underneath the apron may have contributed to this mode of failure.

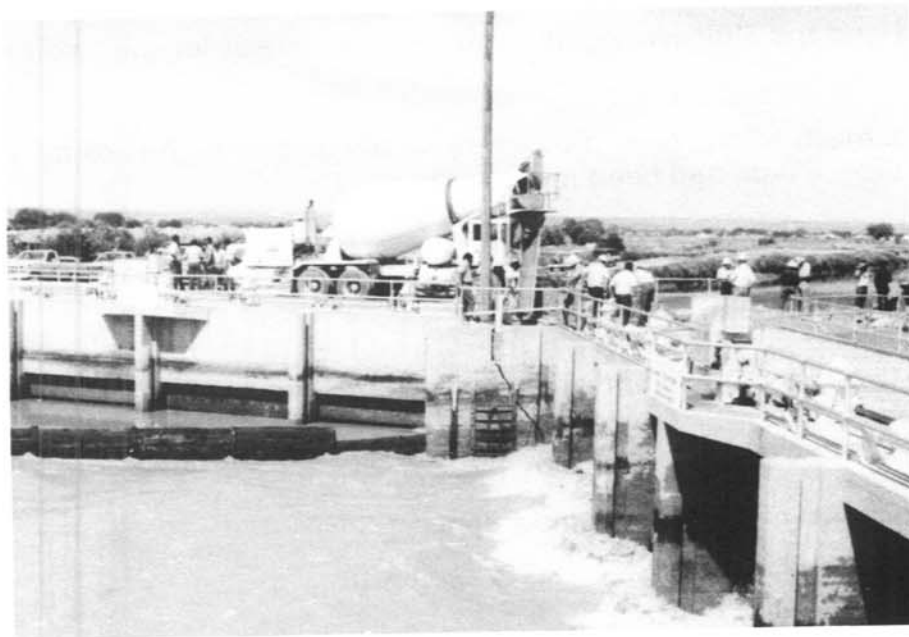
Photograph 3. - Riverside Diversion Dam. Notice crack in left upstream abutment wall of sluiceway. 6/9/87

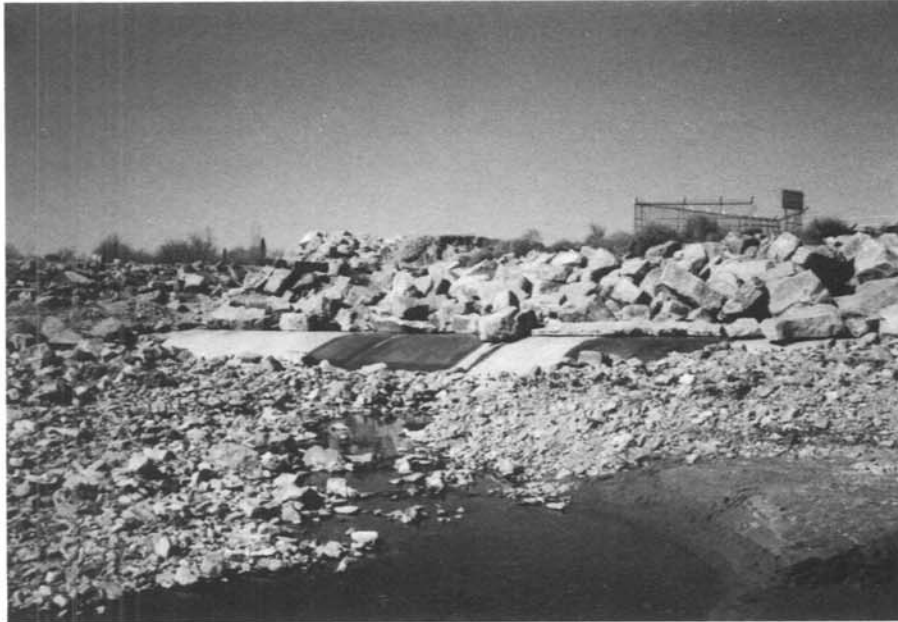
In addition to the above, it was noticed the floor of the sluiceway was destroyed and much of the area where the floor used to be was undercut. Photograph 4 shows the concrete drop, constructed in 1943 at the downstream end of the stilling basin, which remained in place.

Photograph 4. – Riverside Diversion Dam. Concrete drop at downstream end of sluiceway stilling basin. 2/11/88

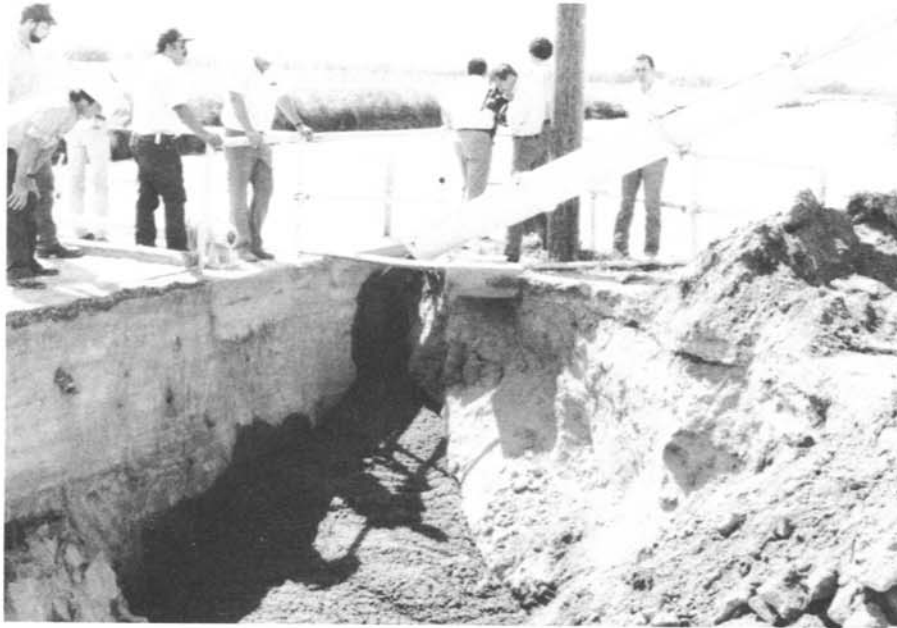
Photograph 5. - Riverside Diversion Dam. Filling sinkhole at left side of sluiceway. 6/9/87

1. Filled sinkhole near headworks with concrete. Concrete had polymer fibers (photograph 5).
2. Rebuilt right downstream abutment of sluiceway with rock, which was then covered with concrete.
3. Constructed a rock cofferdam across downstream concrete apron of sluiceway. Covered upstream face and crest with concrete. Top of crest is at elevation of top of concrete weir.
4. Placed rock in sediment cover on upstream concrete apron of concrete weir.
5. Placed rock on downstream concrete apron of concrete weir. This rock was subsequently washed away.
6. Added rock protection to right bank of concrete weir.

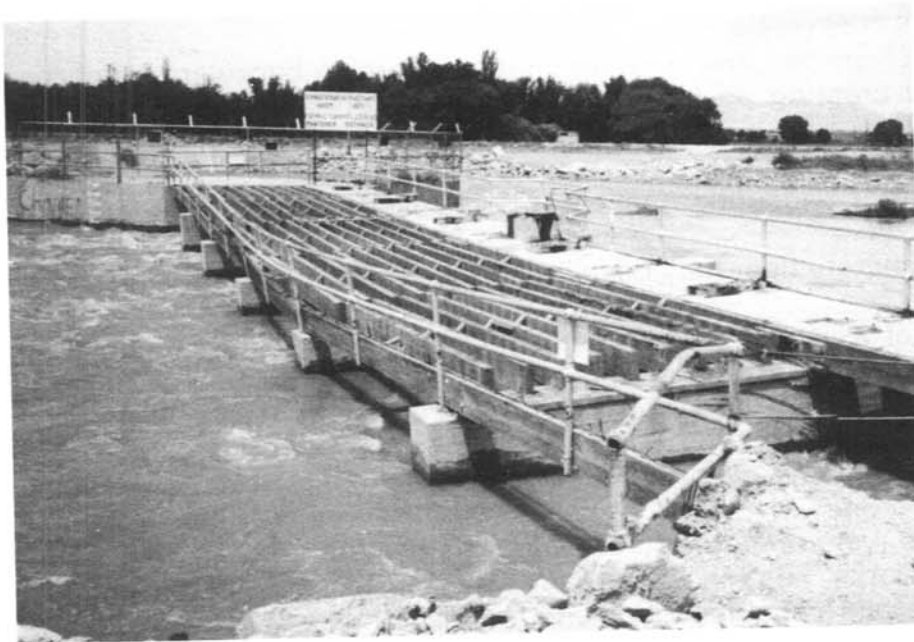
Photograph 6. - Riverside Diversion Dam. Dismantled sluiceway structure from left abutment after the failure.
7/15/87

Since the failure of the Riverside Diversion Dam sluiceway, all hoist motors and equipment were removed to the El Paso County Water Improvement District No. 1 service yard. The wooden operating deck was dismantled to restrict access onto the twisted deck (photograph 6). Sluiceway radial gates were left in place to provide additional upstream protection to the temporary rockfill diversion. Plans to replace the failed structure are being determined. Costs for reconstructing the sluiceway were estimated at \$4.2 million in 1987 by the Water Conveyance Branch. IBWC will design and construct the replacement structure over the international boundary if that option is chosen. Another option being considered is extending the American Canal to join the existing Riverside Canal.

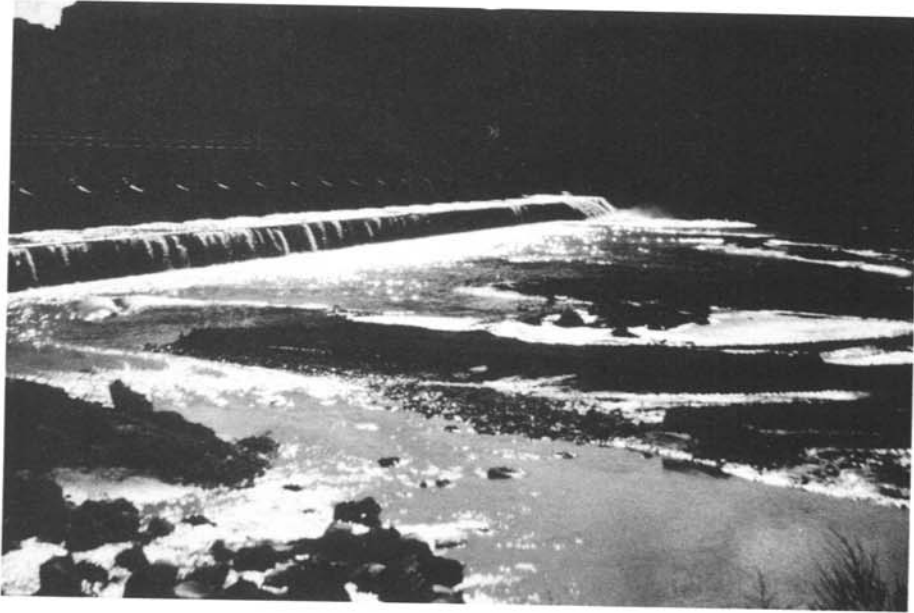
The average riverbed elevation, the summer of 1988, was 6 to 10 feet below the dam's concrete apron, with localized scour holes of 18 feet immediately downstream of the dam. After an RO&M (review of operation and maintenance) examination, the threat of foundation erosion resulted in a Category 1 recommendation for correction. This meant repairs were critical for stability of the structure and must be completed prior to the 1989 runoff season.

Figure 2. - Downstream view of San Acacia Diversion Dam showing depth of scour prior to rehabilitation. 11/88

Repair work consists of placing riprap, bedding material, and geotextile for a distance of 65 feet downstream of the dam along the entire 700-foot width to an elevation of 7.5 feet below the apron elevation. The riprap is held at the downstream end by a line of sheet piles driven up to 28 feet below the top of the riprap and capped with concrete. The riprap is part of a filter system which consists of a 5-foot-thick layer of 3/4-yd³-size riprap placed over a 1-foot thickness of 6-inch-size riprap which was placed over a 1-foot layer of gravel. Geotextile was placed between the gravel and the underlying fine sand material. To accomplish this work, most of the 1,000 to 1,800 ft³/s riverflows were diverted through the adjacent Low Flow Conveyance Channel for approximately 2 miles. The conveyance channel and river levee were breached at this point to return flows back to the Rio Grande. A minimum flow of 150 ft³/s was required to be passed through the dam to support an endangered species of fish. Storage was not required at upstream reservoirs.

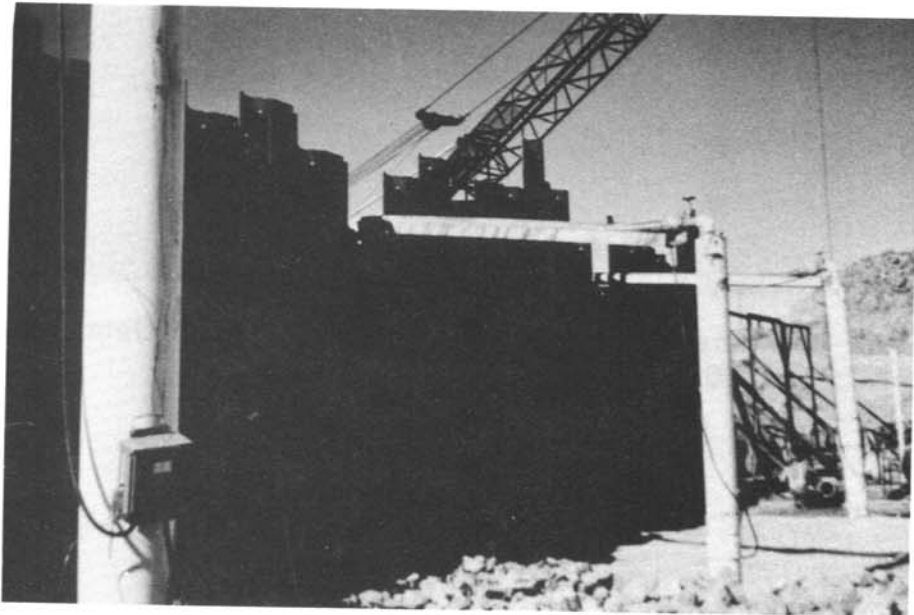
Figure 3. - Work area showing the dewatering wells just upstream of the steel sheet piling. 7/27/89

Dewatering of the work area was accomplished with 40-foot-deep 800-gal/min wells spaced as close as 30 feet. The dewatering operation lowered the water table in the riverbed 21 feet, allowing the 17-foot excavation to be done under dry conditions. Hydraulic jetting methods were used successfully in constructing the dewatering wells in the riverbed material. The ease in constructing the wells by this method allowed successful installation of wells outside of two-thirds of the excavation. Having the dewatering wells installed outside the excavation and still maintaining ground water at the design level significantly accelerated construction.

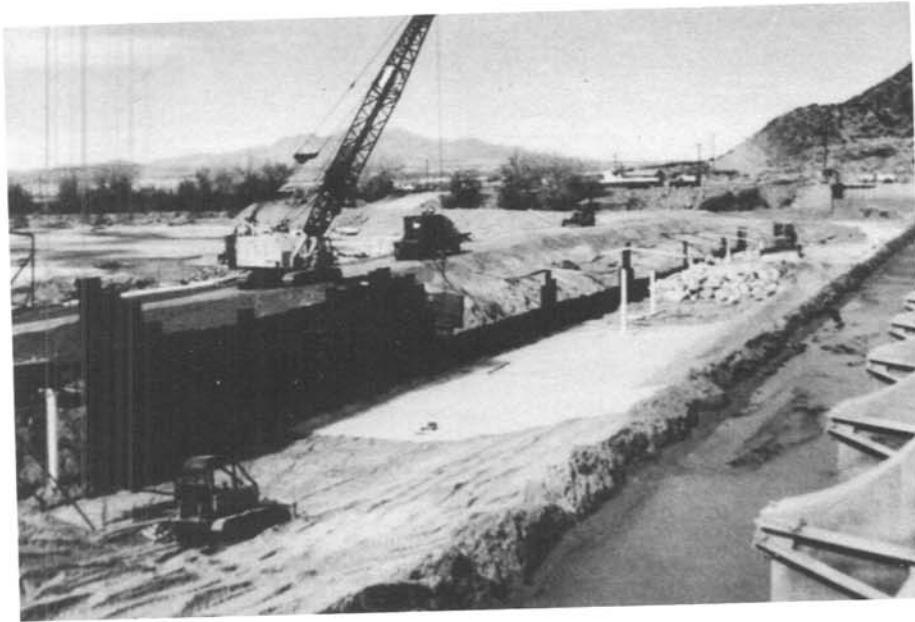
Figure 4. – Work area as viewed from the diversion dam. Some dewatering wells have been relocated to allow for geotextile placement and bedding material (center of photograph). 7/27/89

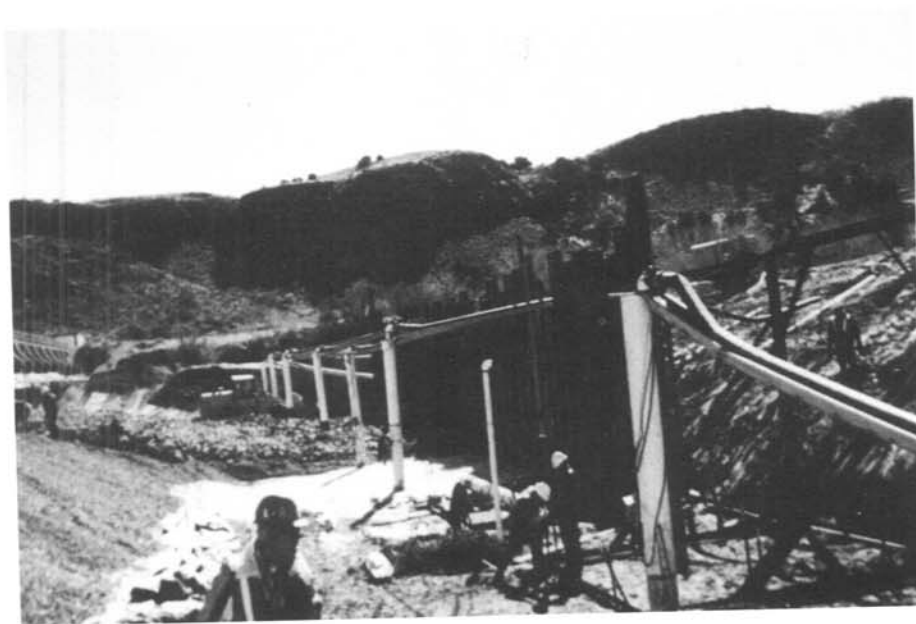
Figure 5. – Work area showing sheet piling dewatering wells, geotextile, bedding, and riprap placement. 7/27/89
