# WATER OPERATION AND MAINTENANCE

BULLETIN NO. 170

December 1994

# DESCHUTES CANAL LINING DEMONSTRATION - CONSTRUCTION REPORT

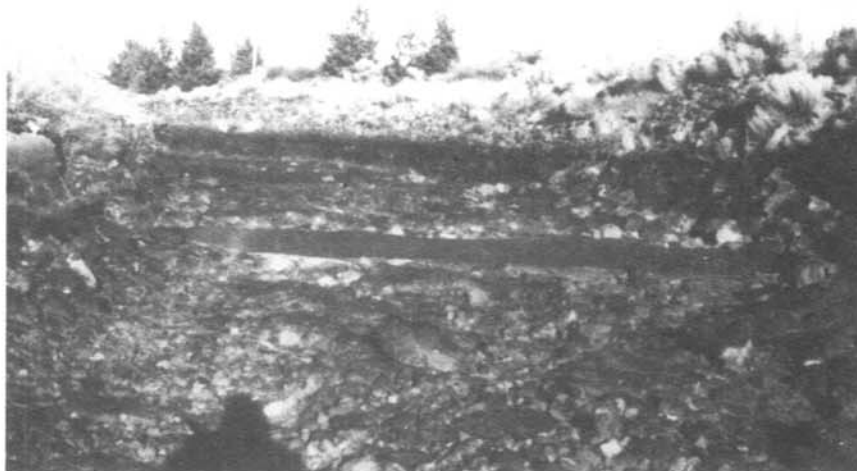
*Figure 1.—Typical existing canals consist of fractured basalt bottoms with sides of loose volcanic rock.*

These volcanic soils are highly angular and can easily damage geomembrane liners (Morrison and Starbuck, 1984). Removal and replacement would require extensive blasting, which is cost prohibitive.

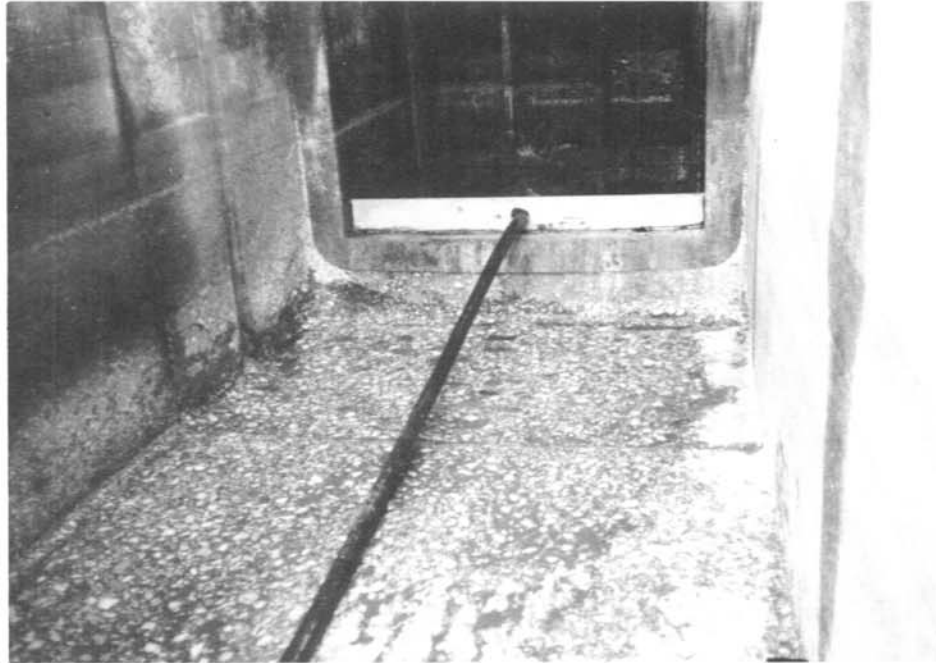
When the Mirdan Canal headworks first went into operation, no one anticipated that cavitation damage could occur downstream from the two 5- by 6-foot-high pressure slide gates. The Designers' Operating Criteria cautioned minimum gate openings of 1 inch to reduce the possibility of cavitation damage. The Twin Loups Irrigation and Reclamation District personnel strictly adhered to this minimum gate opening criteria. In spite of the strict adherence to the operating criteria, erosion of the floor concrete and cavitation damage were observed immediately downstream from the gates after the second season of use. Rather than repair the area with materials that could be periodically removed by the cavitation process, the District personnel opted to eliminate the potential for the cavitation process to occur.

*Damaged concrete removed from downstream canal invert. Pipe is to divert gate leakage away from work area.*

The impact area downstream from the gate made a 1-foot vertical drop from the gate sill. The eroded concrete was removed, and a smooth transition was created in the concrete floor from the sill to the Mirdan Canal invert 8 feet downstream.

Ron Wolf, the District Manager; Dave Ritchie, the District Superintendent; and their staff developed a steel air slot to be installed in the vertical corners adjacent to each gate. The air slot consists of steel plates bent to form a tube that fits the gate frame corner. The tube is attached to the concrete with anchor bolts. Openings for the anchor bolts are fitted with steel plugs to allow removal of the air slot if necessary. The air slot stops 6 inches short of the top and 3 inches short of the bottom of each side of the gate frame. This design allows air to be drawn from the top air vent above each gate corner, through the air slot, to the bottom portion of the gate frame. Negative cavitation pressures cannot occur with the atmospheric air flow coming through the air slot.

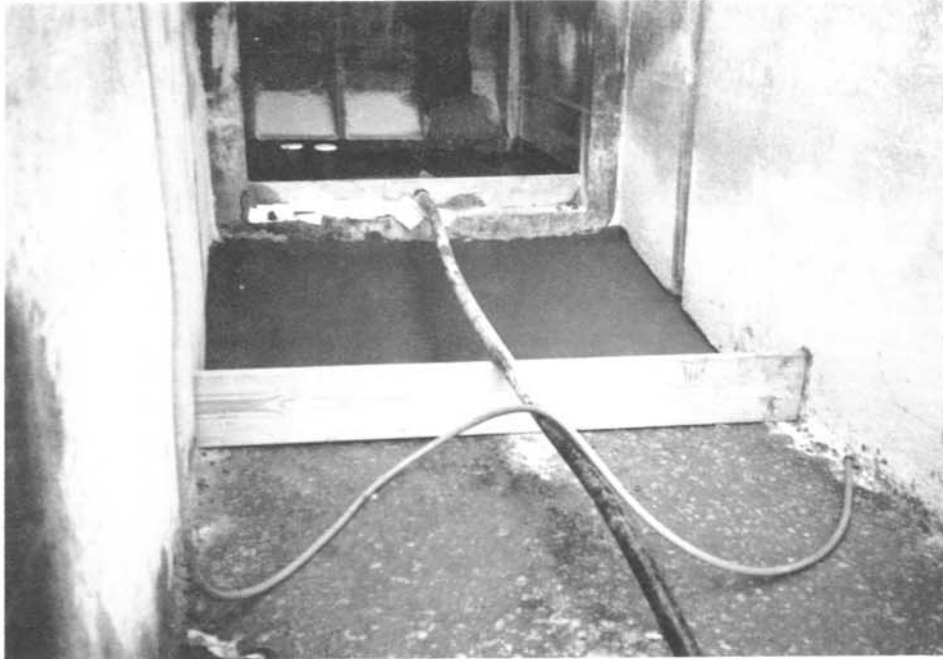
*Concrete placement in downstream canal invert.*

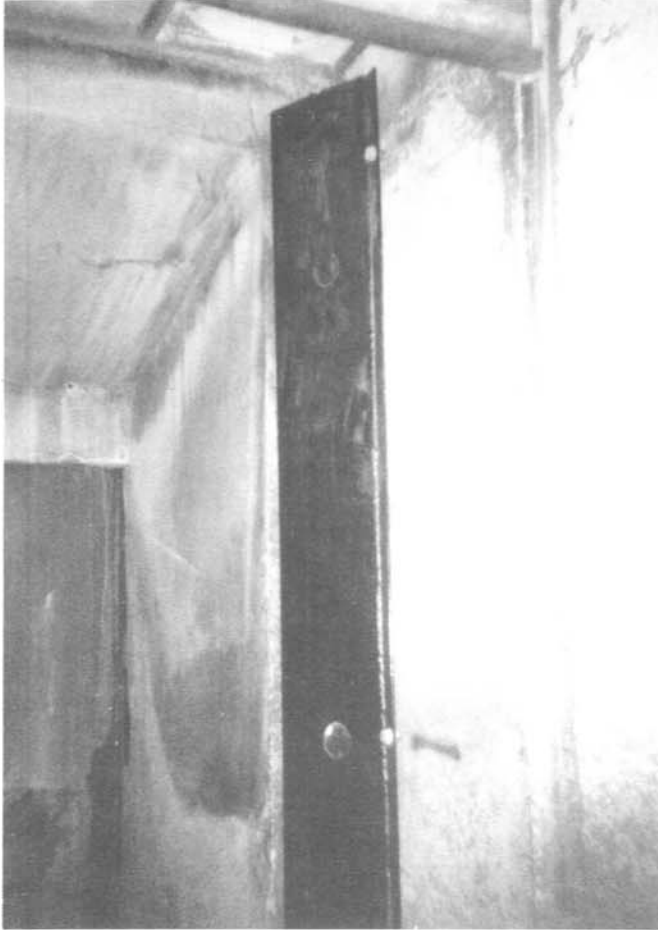
*Top portion of air slot. Note air vent above air slot.*

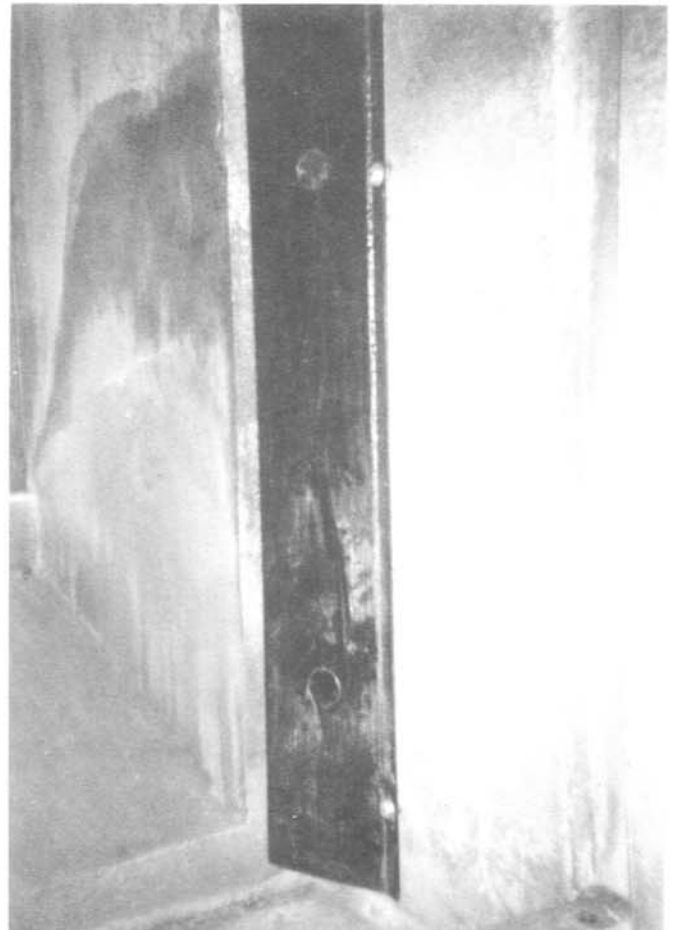
*Bottom portion of air slot.*

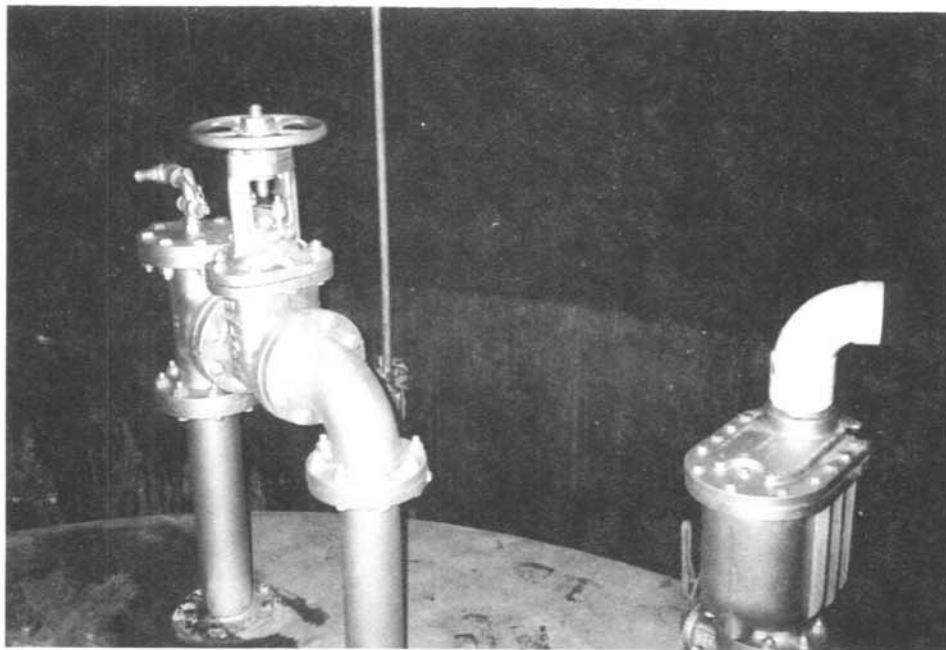
The air release/air vacuum valve assemblies in the upper gate chamber of the outlet works were modified to protect surrounding metalwork. During filling of the outlet works pipe, the valve assemblies tended to "burp" when releasing trapped air in the pipe. Some air assemblies are designed so water would sometimes spray upward through the valve assemblies and hit the deflector plate during filling operations. Once deflected, the water could shoot out in a circular path, getting surrounding metalwork wet. The air assembly supplied for Medicine Creek Dam did not have an outlet pipe to divert excess water.

*Plastic elbow installed on valve assembly.*

To reduce wear on the metalwork protective coatings, a plastic elbow was installed by the McCook Field Office to deflect dispelled water. The plastic elbow directs any water to the concrete chamber wall, where it falls harmlessly into the gutter. The plastic elbow has a slip joint for easy removal.

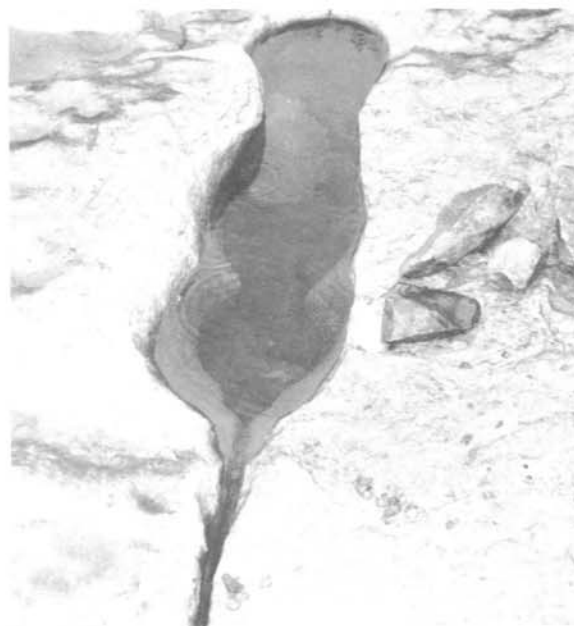
*This photo shows part of the fault line that runs through the area.*
