**WATER OPERATION
AND MAINTENANCE**

BULLETIN NO. 172

June 1995

REPAIR AND REHABILITATION OF PRESTRESSED CONCRETE PIPE AT THE CENTRAL ARIZONA PROJECT

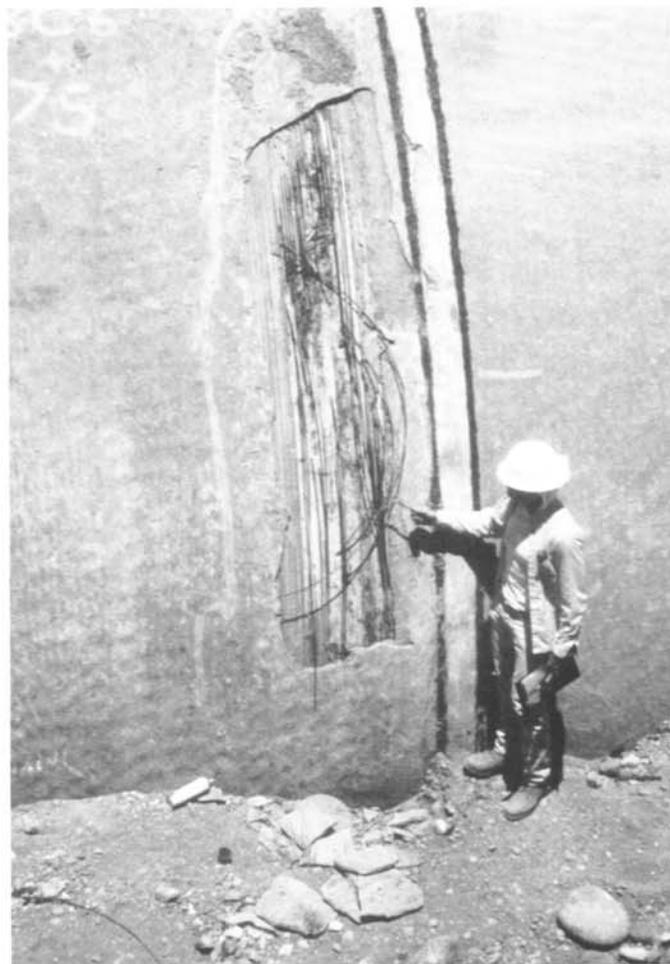
Pipe distress in the form of degradation of the mortar coating and the prestressing wire (i.e., corrosion) ranged in intensity from minor to extreme (figure 3). In many cases, the mortar coating had disbonded to expose the underlying prestressing wire. In other cases, sounding of the pipe by hammer tapping revealed hollow or drummy areas where the mortar coating had delaminated but had not completely disbonded. Visible coating cracking was sometimes apparent. Drummy areas commonly continued to expand or grow with additional exposure. Although inspection by hammer tapping proved to be fairly successful in pinpointing delaminated coating, mortar coating continued to disbond in certain instances, even in areas that had been previously inspected and thought to be sound.

Figure 3.—The pipe distress ranged in intensity from minor to extreme.

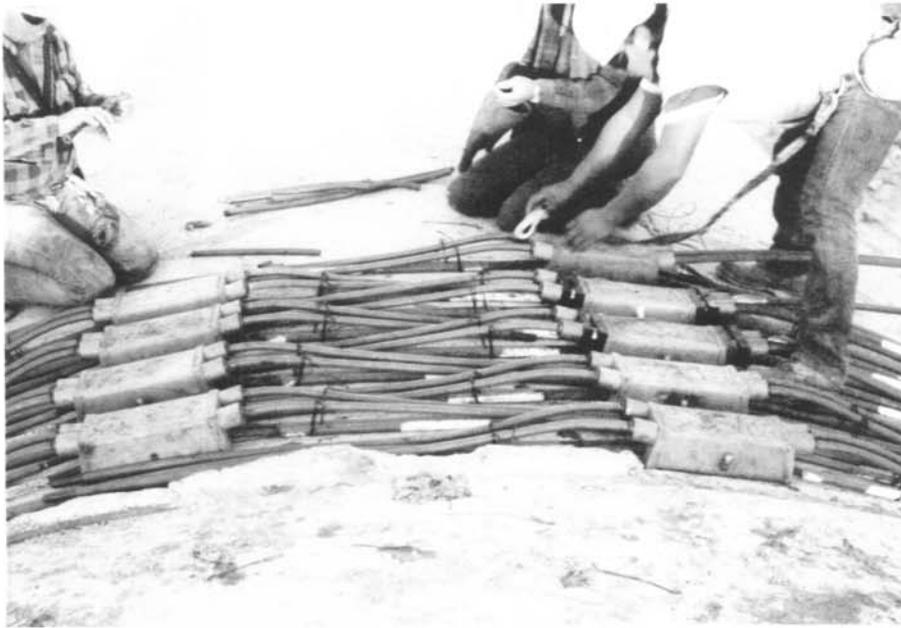
Figure 4.—During the siphon outage, the mortar coating and prestressing wire were completely removed from the pipe perimeter, tendons were wrapped around the core, and the overlapping ends anchored near the crown in epoxy-coated anchorage assemblies.

was limited to 2 feet. The mortar coating and prestressing wire were completely removed from the pipe perimeter, and tendons were wrapped around the core such that the overlapping ends anchored near the crown in epoxy-coated anchorage assemblies (figure 4). The tendons were placed so they extended at least 5 feet beyond the anchoring heads to allow for future restressing if that became necessary.

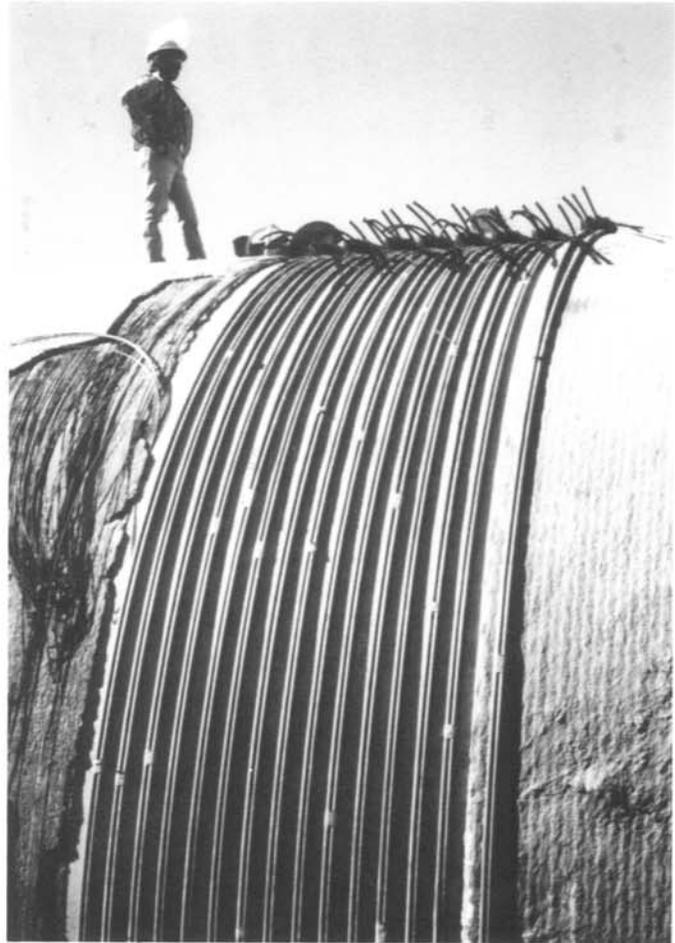
Figure 5.—To allow uniform stress transition from a repaired to a nonrepaired area, one set of tendons was placed around intact mortar coating at the terminus of each repair zone.

The overhang was also placed in a protective sheath. The anchorage assemblies were staggered over the entire length of the repair. To allow uniform stress transition from a repaired to a nonrepaired area, one set of tendons was also placed around intact mortar coating at the terminus of each repair zone (figure 5).

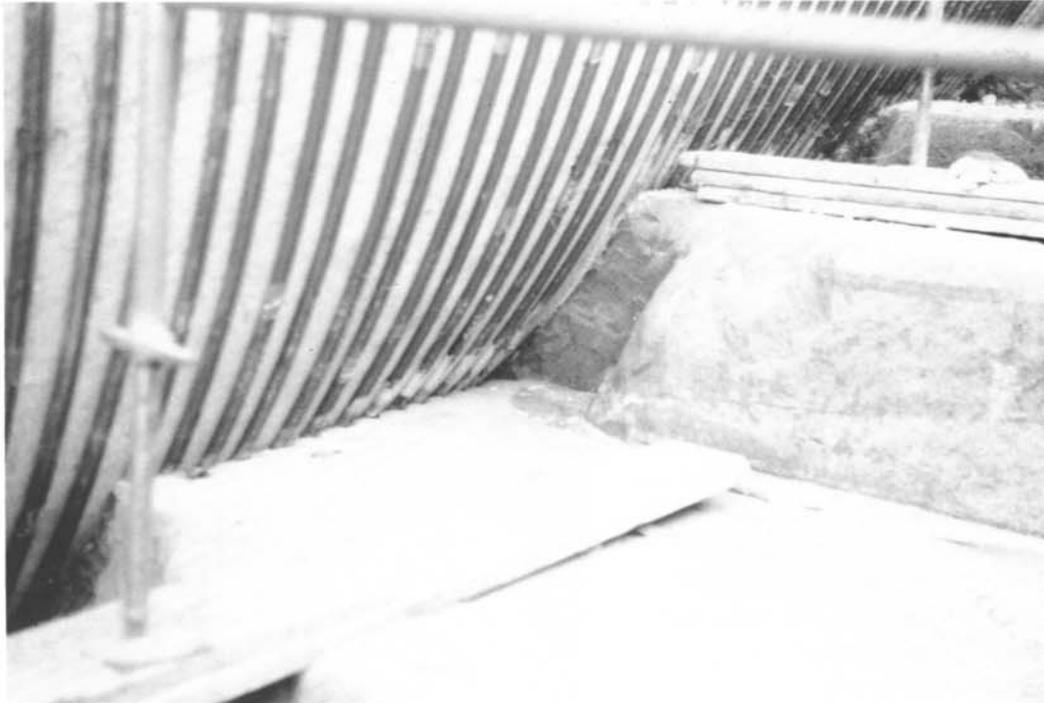
Figure 6.—After hardening, the soil-cement exhibited very little cracking or drying shrinkage.

After tendon installation, the excavated area below the 90-degree bedding angle was filled with soil-cement. The soil-cement was mixed at a local batch plant and hauled to the site by transit mixers. It was designed to be poured into place from one side of the pipe such that it flowed beneath the pipe and filled both haunches. The soil-cement typically contained a water to cement ratio of less than 3.5 to 1 and a cement content of 6 to 12 percent of the dry weight of the soil to provide a design strength of 50 to 100 pounds per square inch in 7 days. Other requirements included limiting the amount passing the #200 (75-micrometer) sieve and the #100 (150-micrometer) sieve to less than 30 and 50 percent by weight, respectively. In addition, particles greater than 3/8 inch and clay balls greater than 1/2 inch in diameter were not allowed. Ninety-five percent of the materials also had to pass a #4 (4.75-millimeter) screen, and clay balls could not exceed 10 percent of the total wet weight. Although the soil-cement generally flowed underneath the haunches of the pipe, sometimes it did not reach the 90-degree bedding angle on the side opposite the pour. In these instances, additional soil-cement was placed on the opposite side by bucket from a crane. After hardening, the soil-cement exhibited very little cracking or drying shrinkage (figure 6).

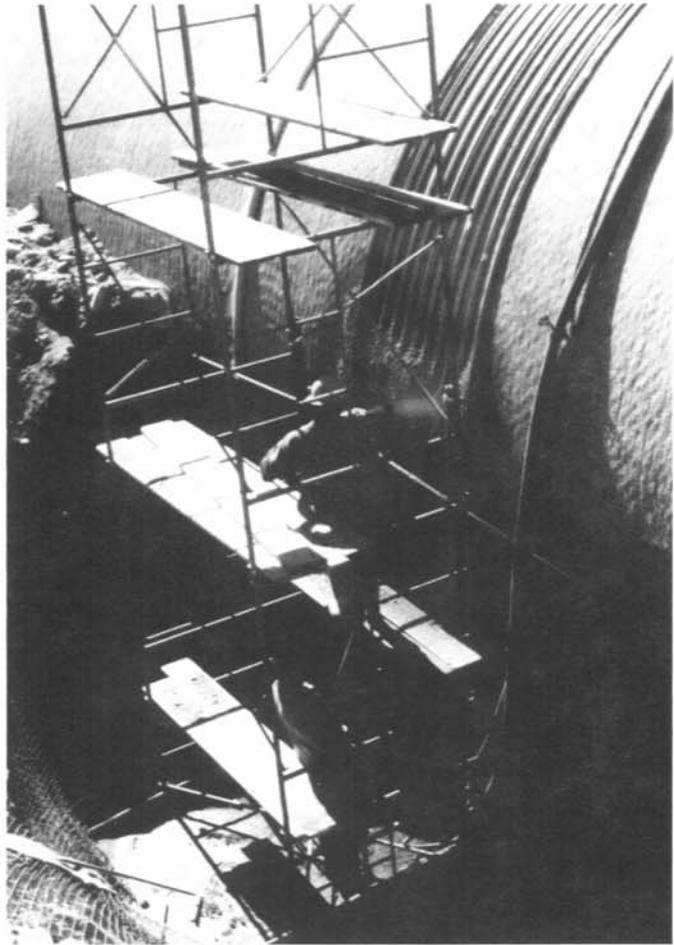
Figure 7.—Shotcrete application over the tendons.

Shotcrete was applied over the installed tendons above the 90-degree bedding angle. Because a saturated-surface-dry condition was required, a 10,000-pound-per-square-inch water jet was used to moisten the surface prior to application. The shotcrete was mixed at a local batch plant and was delivered by truck. It was proportioned so that it contained a cement to water ratio of 1 bag of cement

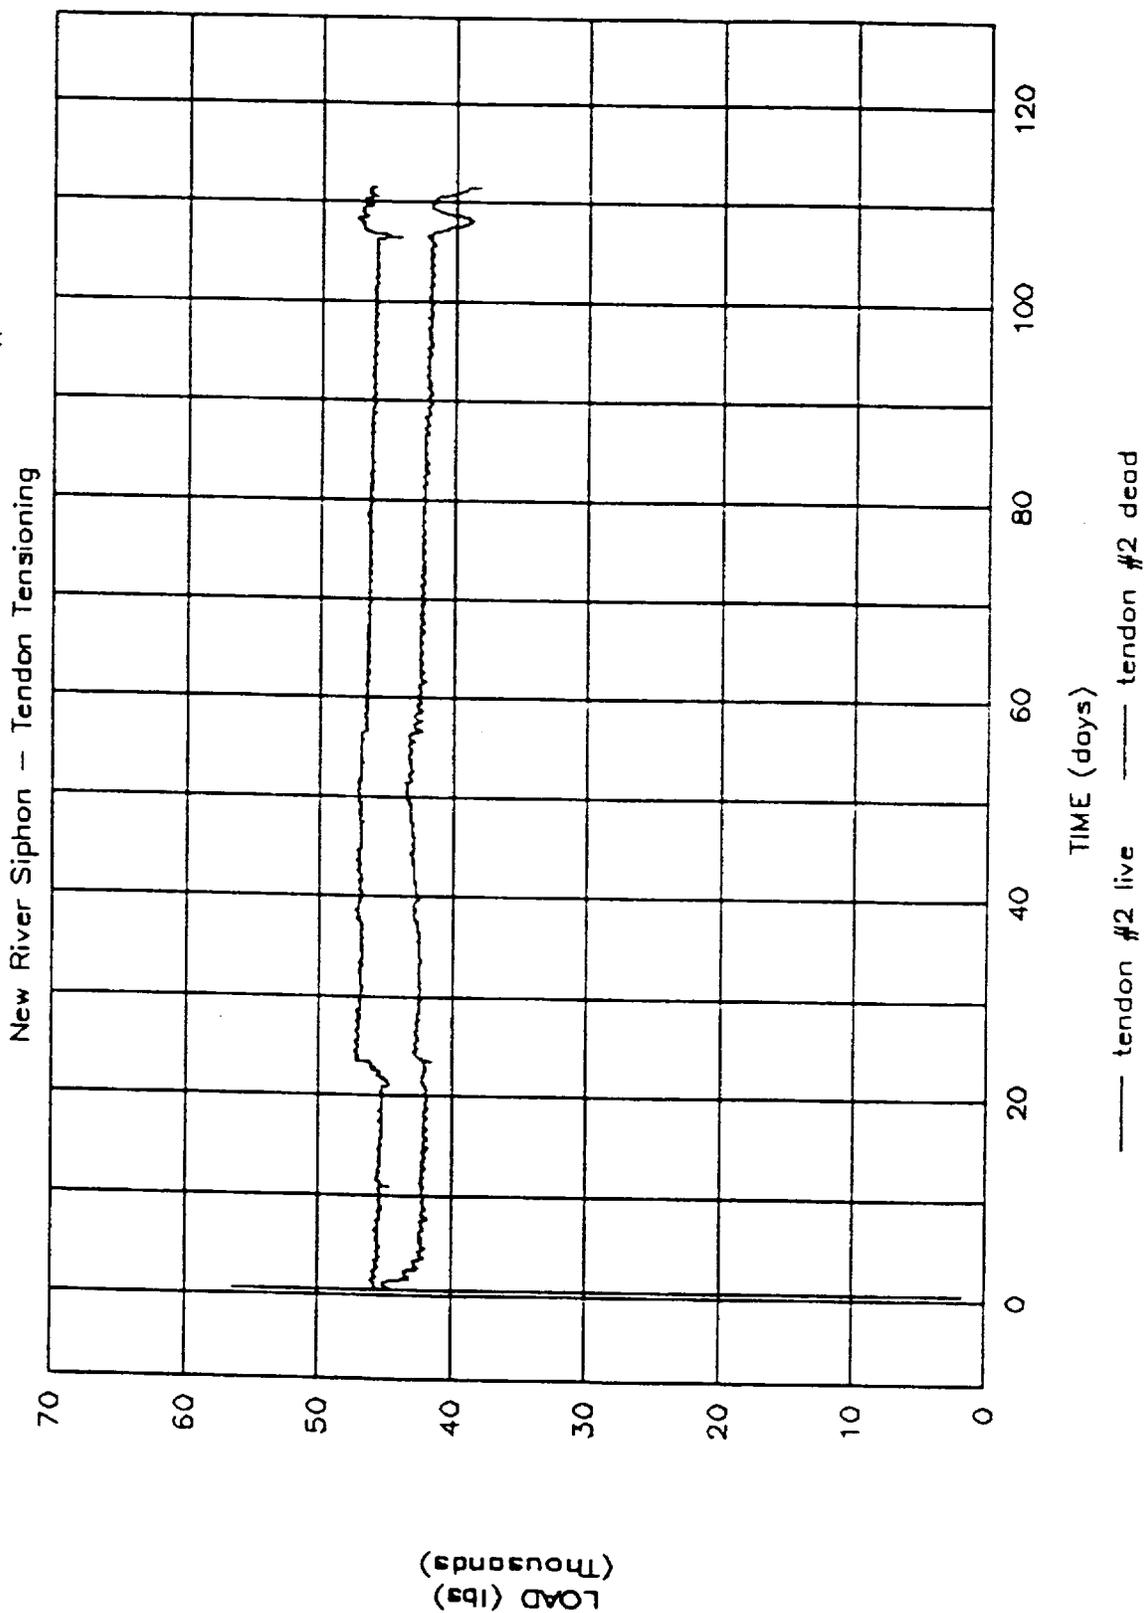
CENTRAL ARIZONA PROJECT PIPE #2012

Figure 8.—A typical load versus age curve for a type 1A repair on pipe 2012 of New River siphon.

Reclamation anticipated anchor slippage problems might occur because the supplied wedges exhibited features similar to those which pulled out during laboratory testing. Representatives were therefore on hand to instrument and monitor the first tendon repair. Slippage occurred as the wedges failed to completely penetrate the epoxy coating and pulled out shortly after anchoring. New wedges were fabricated in accordance with a proven pattern specifically designed for epoxy-coated strands. They were longer and exhibited a much coarser tooth pattern than previous versions. Minimal slippage problems were experienced thereafter. Additional testing was conducted on other type 1A repairs as tendons were instrumented and the load was monitored during and after strand tensioning and during restoration of flow to the siphons. A typical load versus age curve is shown in figure 8. The testing was performed on pipe 2012 of New River siphon.

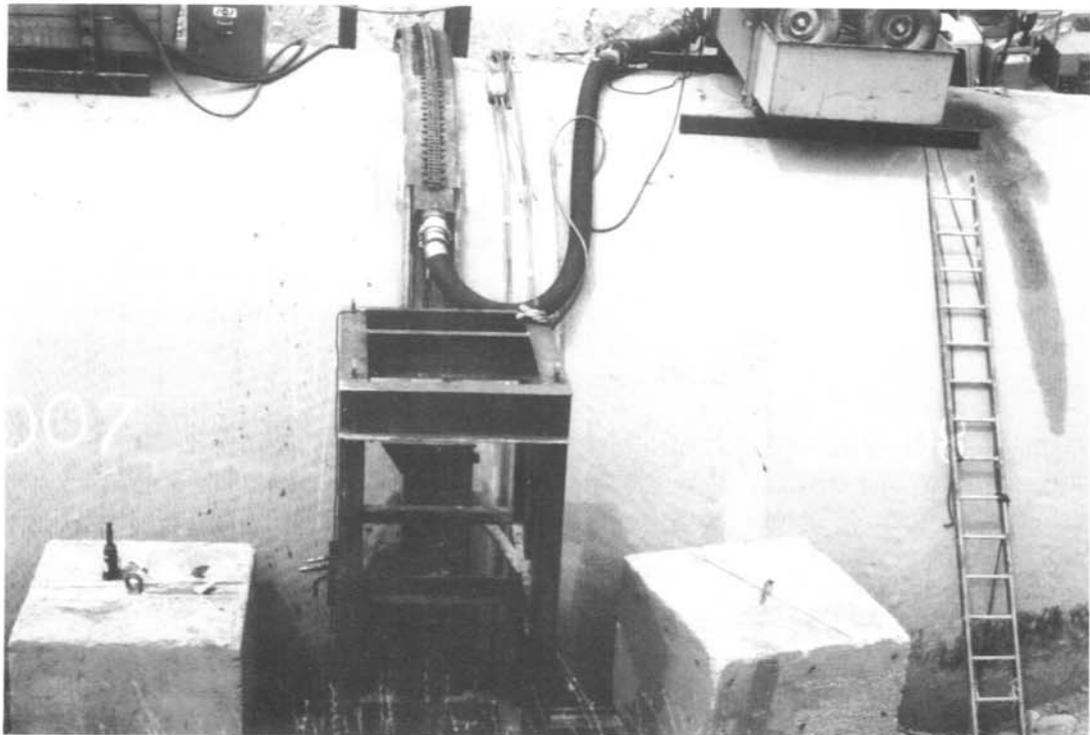
Figure 10.—When pipe was repaired in service, tendons were installed over mortar coating and corroded and broken prestressing wire through the narrow annulus beneath springline.

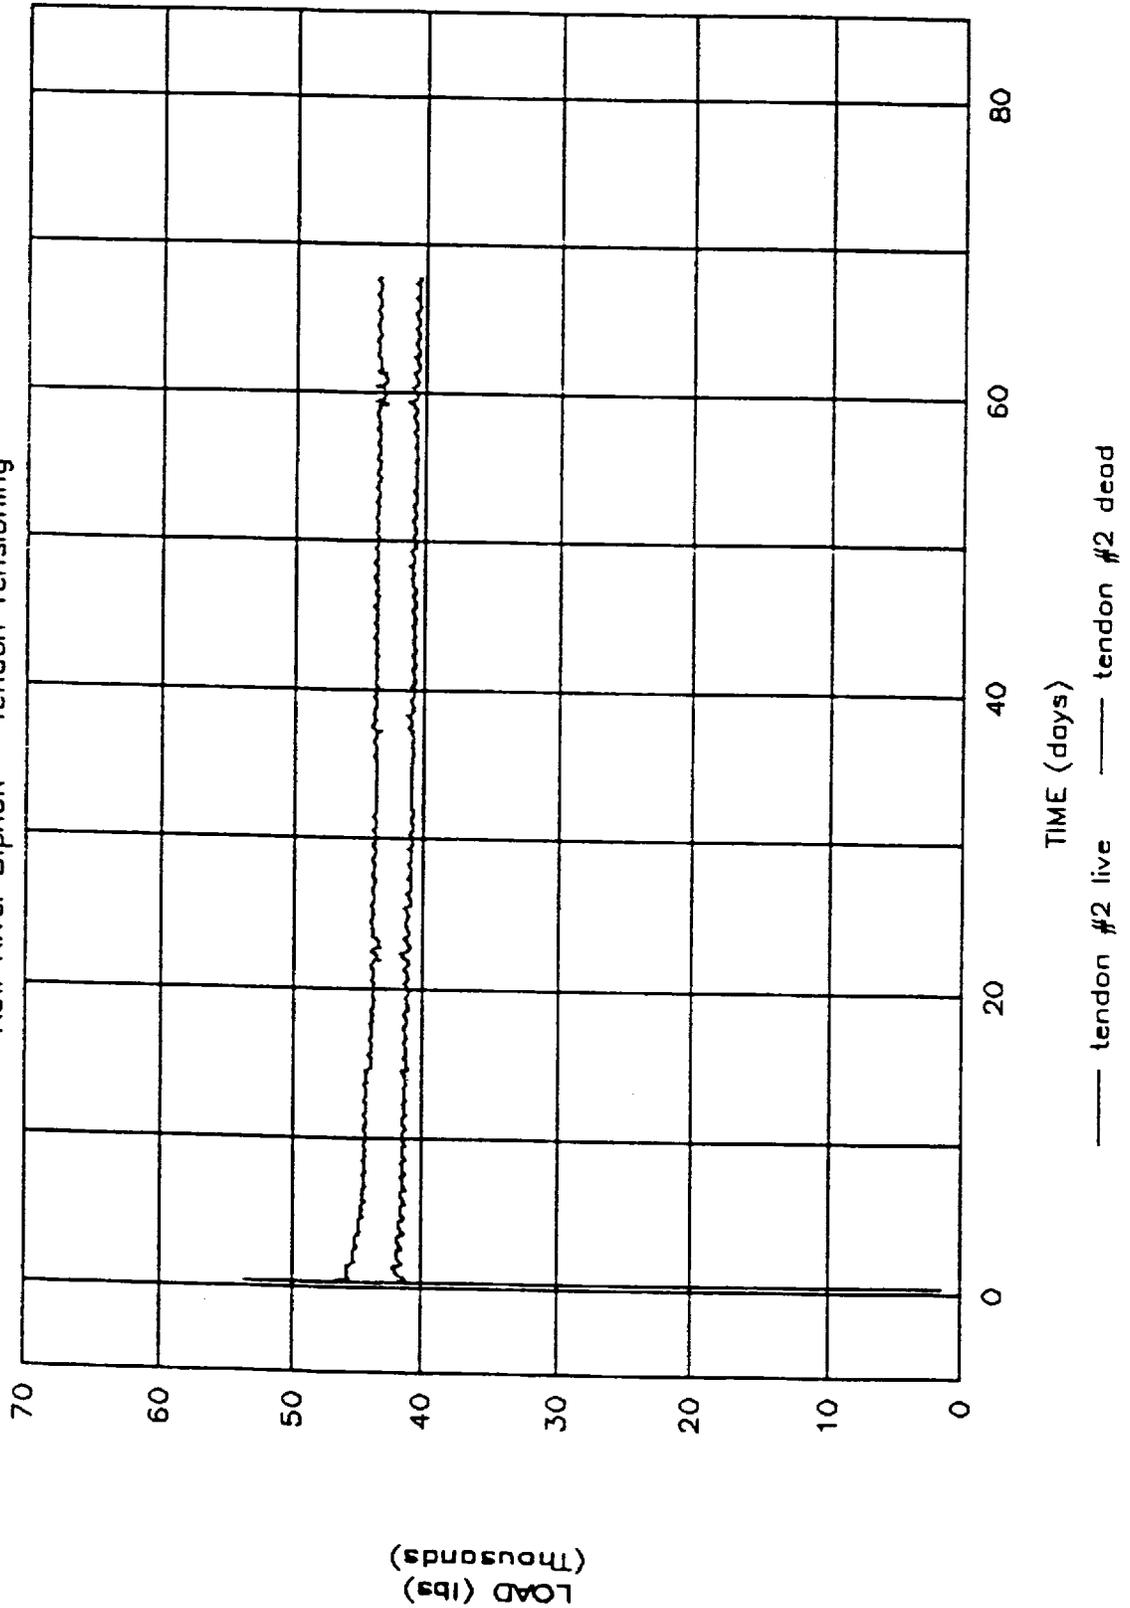
CENTRAL ARIZONA PROJECT PIPE #2007

Figure 11.—A typical load versus age curve for a type II repair on pipe 2007 of New River siphon.

Testing was again conducted on actual siphon repairs. Several tendons were instrumented, and load was monitored both during and after strand tensioning. The testing was performed on pipe 2007 of New River siphon. A typical load versus age curve is shown on figure 11. Over 125 tendons were used to successfully repair 8 areas on the Central Arizona Project siphons using this technique. Type II repairs were performed on five different pipe units, and in some cases, more than one repair was required on the same unit. Although the type II repair could be implemented while the siphons were flowing full, it was limited to those units where the wire of the deteriorated pipe had not fractured near springline.

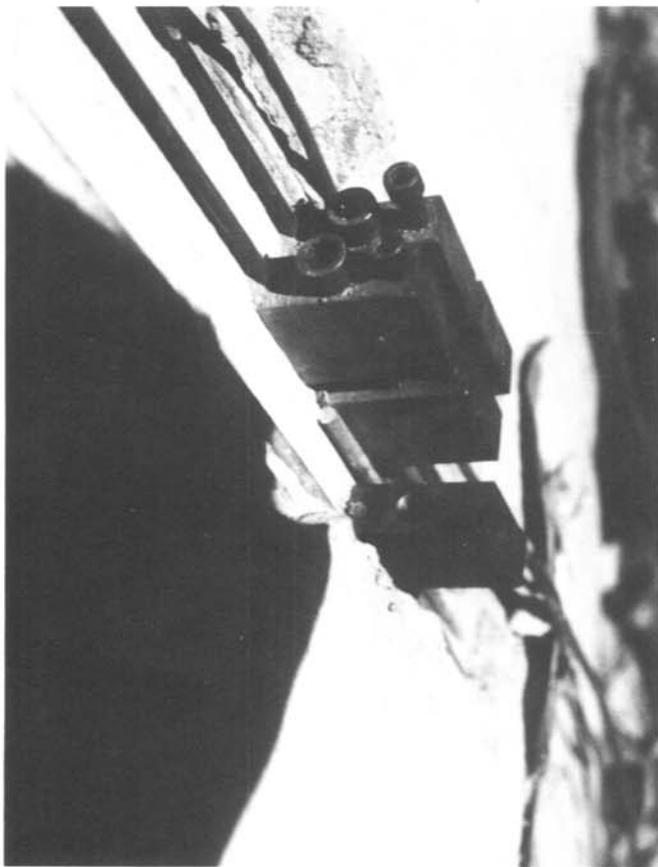
Figure 12.—Anchor blocks of a type III repair were fastened by hammering their teathed grooves onto the prestressing wire at splice juncture points. The anchor blocks also contained set screws as well as holes and threads for connecting bolts.

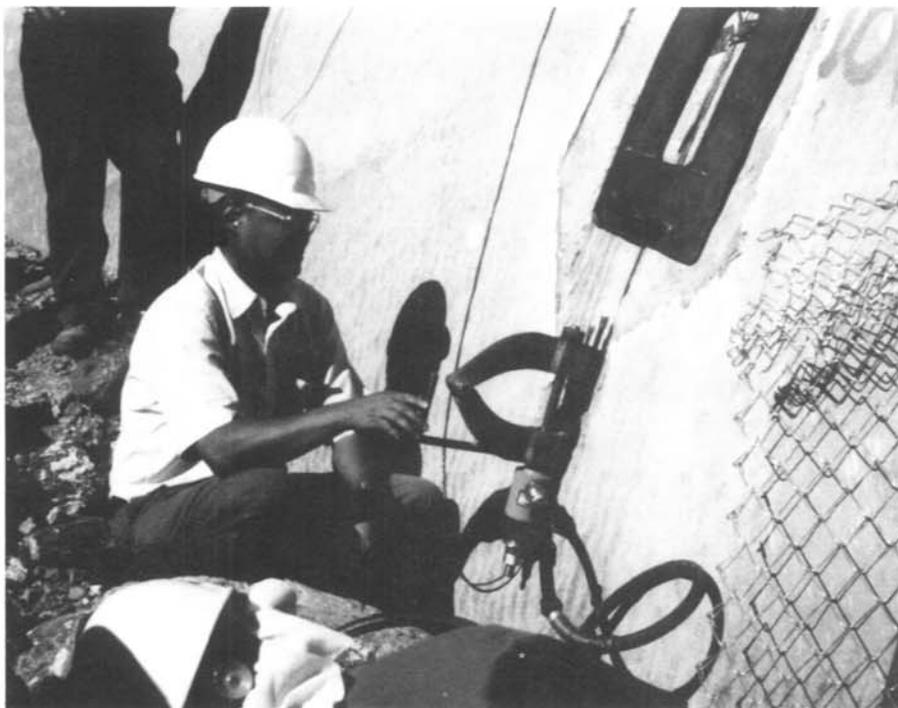
Figure 13.—The splice was tensioned to the desired stress level.

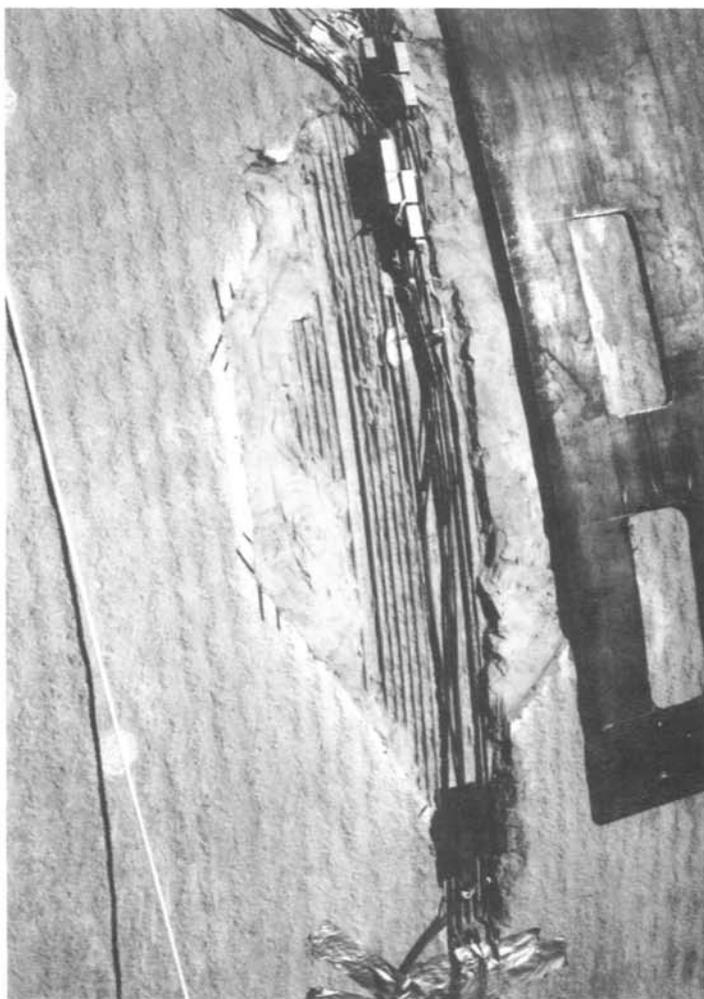
Figure 14.—A type III repair.
