# WATER OPERATION AND MAINTENANCE BULLETIN

No. 179

March 1997

## SLIPPAGE OF SPILLWAY RADIAL GATE WIRE ROPES AT YELLOWTAIL DAM, MONTANA

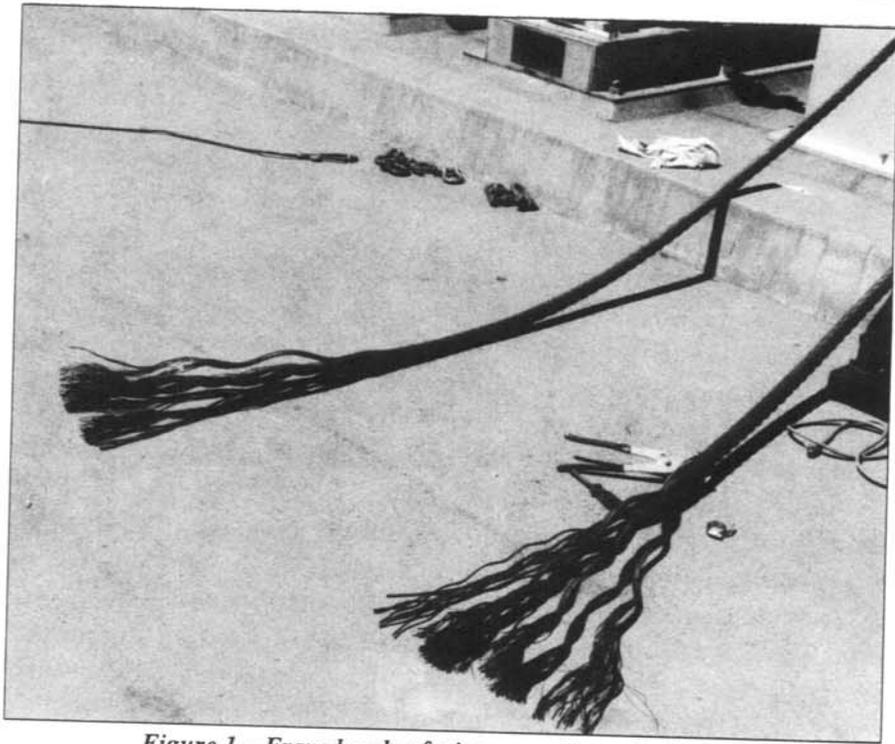
Further investigation provided clues about what had happened on gate No. 2. Divers were dispatched to help retrieve the cables for gate No. 2. Although the wire ropes were relatively new, having been replaced by in-house personnel approximately 2 years before the failure, about 3 feet of the end of each wire rope was badly frayed (figure 1). The steel wire rope clamps (figures 2 and 3) that had secured the wire ropes to the drums were still in place but were scarred from the ropes pulling out. The hose clamps that had encircled the ends of the ropes had come off and fallen to the bottom of the hoist enclosures. In addition, a lock washer was missing from the clamp on the right drum.

Conjecture as to why the wire ropes pulled out of the clamps has centered on a combination of factors. On the hoist drums, the machined grooves (that spiral around the circumference of the drum) taper to an end near the center of the drum, just past the clamp that anchors the rope ends to the drum. However, on the right drum, the grooves were not symmetrically machined, and the taper on one side ends approximately 2.5 inches prematurely when compared to the other taper (figure 4). In effect, the grooves were of different depth at the location of the wire rope clamp. This would tend to produce an uneven clamping force on the two rope ends, with the rope in the deeper groove receiving less force than the one in the shallower groove.

*Figure 1.—Frayed ends of wire ropes that pulled out of wire rope clamps on hoist drums.*

In order to continue making spillway releases, which require equal gate openings, the frayed ends were cut from the wire ropes of gate No. 2, the ropes were reattached to the drums and clamps, the limit switch was reset, and the ropes were marked to provide a visual aid to detect any further slippage. After further analysis of the problem, several actions were taken to increase the factor of safety and help prevent problems in the future:

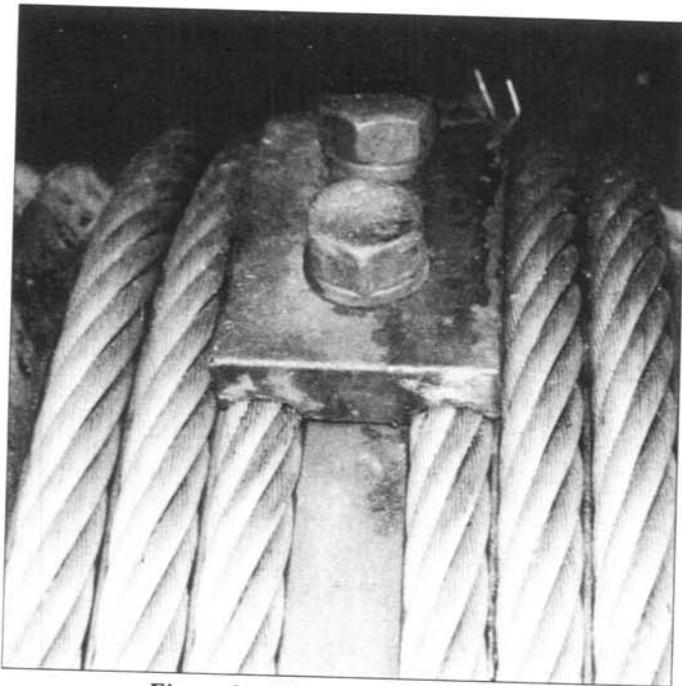
It is also thought that the clamping force may have been inadequate on all clamps because the bolts were torqued with the rope in an unstretched condition (as mentioned above, the ropes for gate No. 1 may have slipped 2 to 3 inches). Lifting the gates would elongate the ropes and reduce the diameter, which would reduce the clamping force on each rope. The missing

lock washer may also have contributed to inadequate clamping force if the washer broke and fell off, leaving a gap between the bolt head and the clamp.

*Figure 2.—Wire rope clamp bolted to hoist drum.*

1. The bolts at all clamps were replaced with Superbolt® tensioners from Superbolt, Inc. (see figure 5). The Superbolt® tensioners have several jack bolts around the perimeter of the bolt head. These jack bolts are torqued in order to tension the main bolt shaft. The jack bolts are designed to give a reliable relationship between torque on the jack bolts and tension in the main shaft; thus, the clamping force can be estimated more accurately. Also, a regular torque wrench can be used on the smaller jack bolts rather than the hydraulic wrench used for large conventional hex head bolts.
2. All the clamps, which were a 2-bolt design, were cut in half, in effect converting them to twice as many 1-bolt clamps (figure 6). The smaller 1-bolt clamps will provide a more uniform clamping force because they will be less likely to "ride high" where unsymmetrical groove depths might occur.

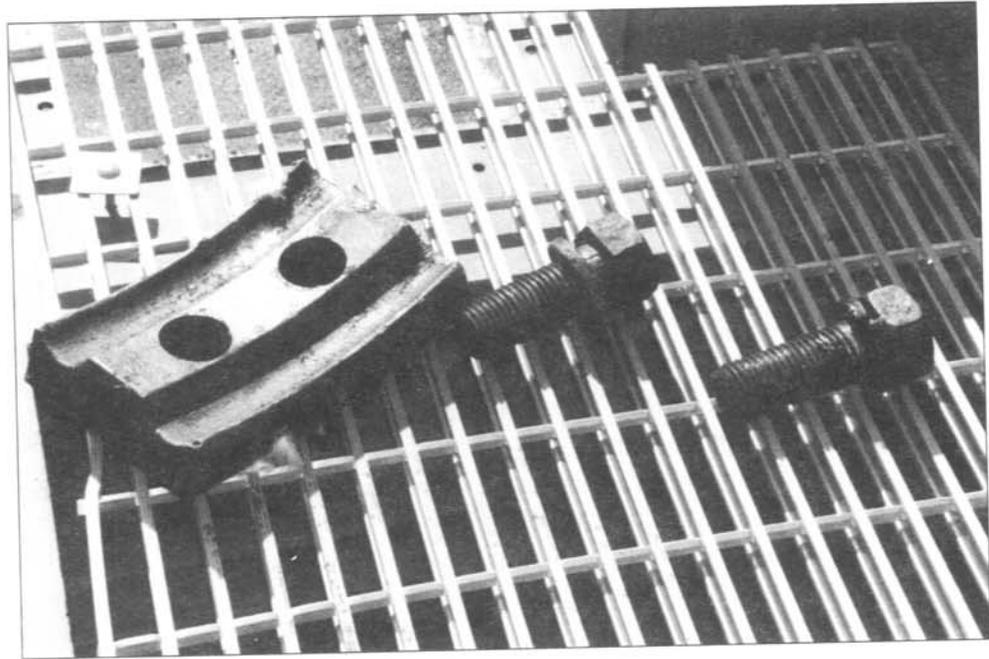
*Figure 3.—Under-  
side of wire rope  
clamp showing  
grooves that  
accommodate the  
wire rope.*

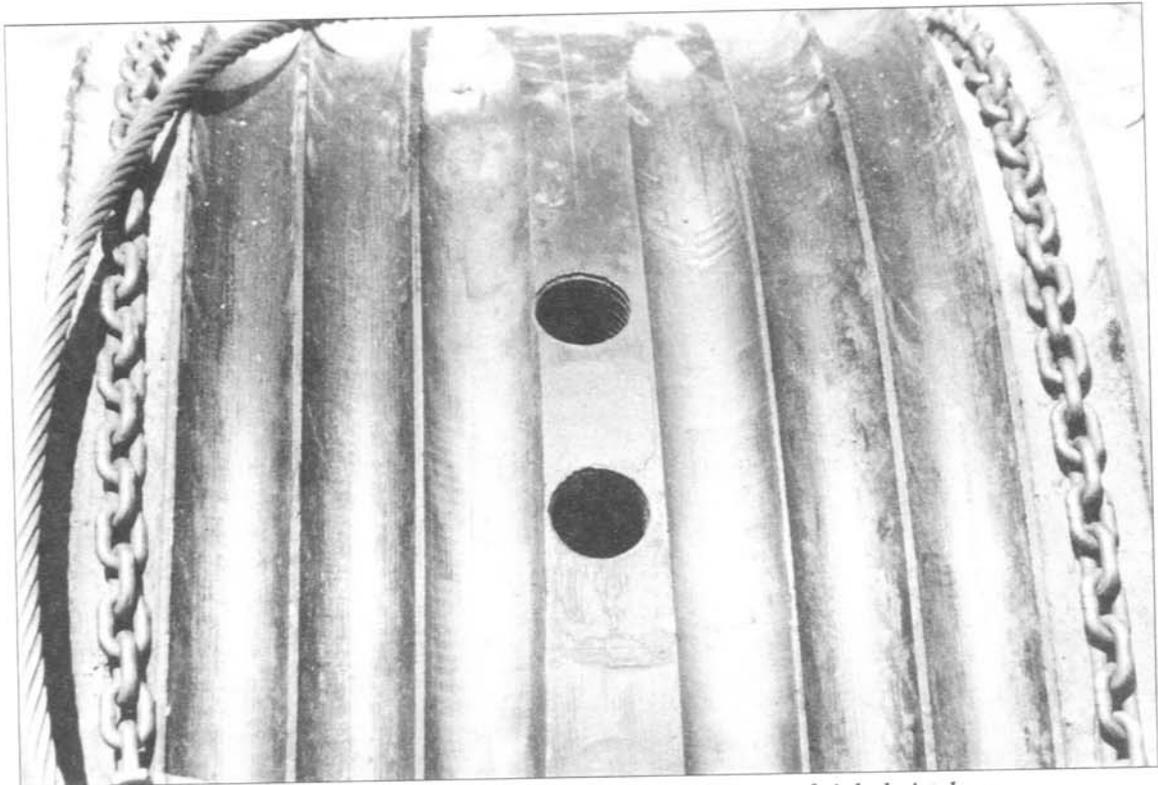
*Figure 4.—End tapers of machined grooves near center of right hoist drum,  
gate No. 2 (center top of photo). Note that the groove on the right tapers  
to an end sooner than the groove on the left.*

4. The shallower groove on the right hoist drum of gate No. 2 was ground somewhat deeper where it tapers to an end. This will help even the clamping force on the ropes.

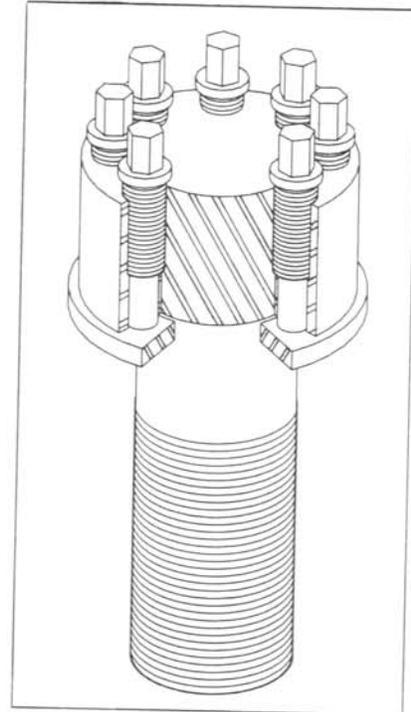
Figure 5.—Cutaway view of a Superbolt®.

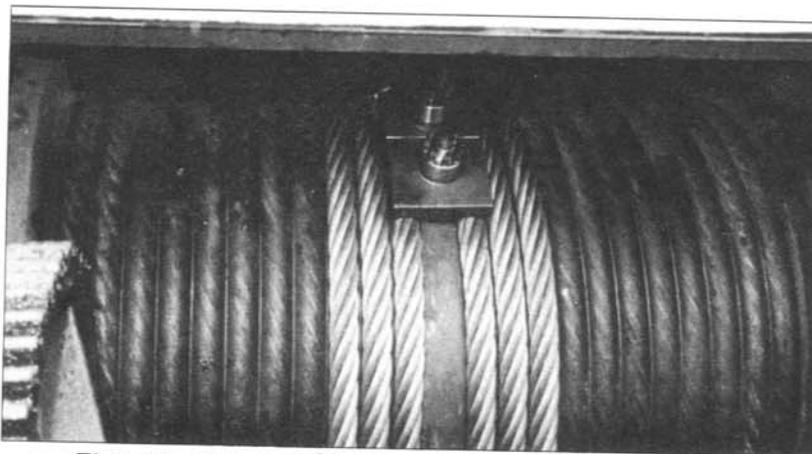
Figure 6.—Superbolts® holding wire rope clamp against wire ropes on hoist drum. Note that clamp has been cut in two.

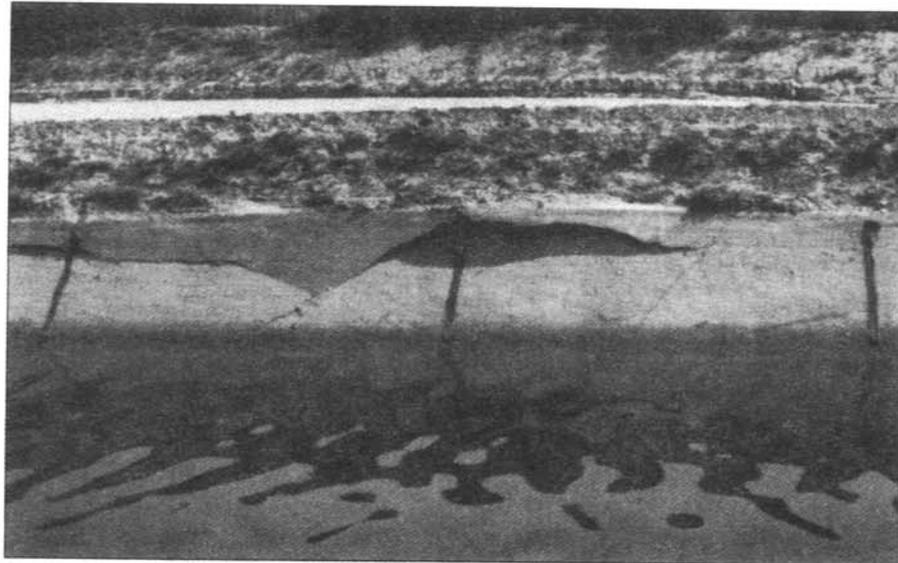
Approximately 2.4 km (1.5 miles) of the Tucson Aqueduct, Reach 3, concrete lining were found to be cracked, broken, and buckled due to settlement of saturated foundation materials (see Fig. 2). To eliminate water leakage, a repair contract was awarded. To minimize repair time and cost, a geomembrane was selected rather than overexcavating and replacing the subgrade and concrete canal lining.

*Fig. 2. Cracked concrete lining on the Tucson Aqueduct Reach 3.*

In the Fall of 1994, repairs to the damaged sections were made using a 1.5 mm textured white-on-black VLDPE geomembrane. Figure 3 shows placement of the geomembrane following patching of the concrete. The specifications required removal of large concrete chunks or smoothing of the existing surface with shotcrete to provide no offsets greater than 20 mm (3/4 in). Following placement of the geomembrane, a 75 mm (3 in) layer of shotcrete was applied to the geomembrane surface, as shown in Fig. 4. The shotcrete prevents flotation of the geomembrane and protects it from damage due to solar ultraviolet radiation, animals, vandals, and the equipment used during canal cleaning operations. This repair will be monitored to determine the long term effectiveness.

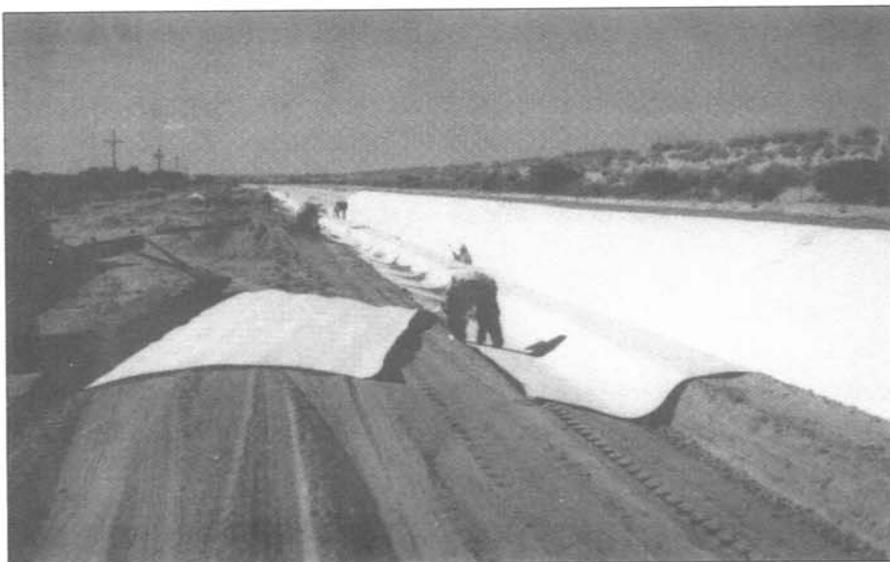
*Fig. 3. Placement of a 1.5 mm textured VLDPE geomembrane to repair a section of the Tucson Aqueduct Reach 3.*

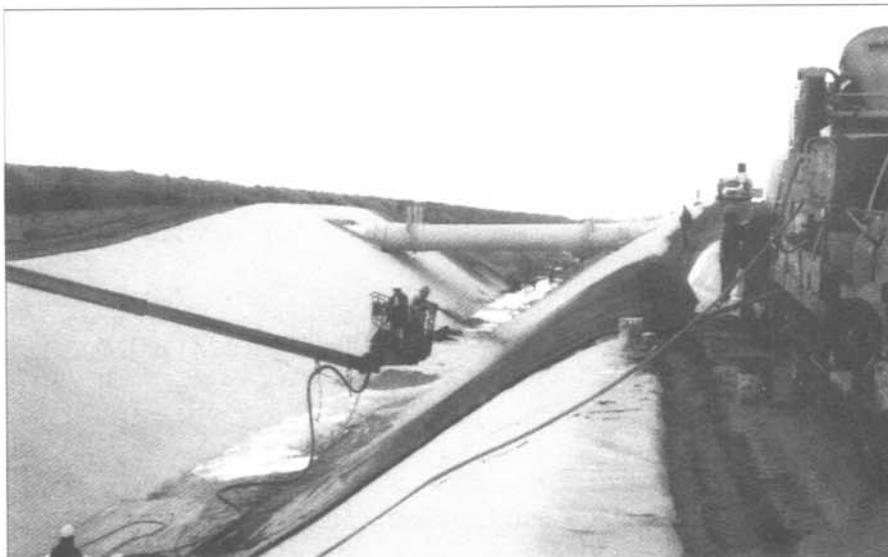
*Fig. 4. Shotcrete protective cover being placed on the geomembrane at the Tucson Aqueduct Reach 3.*
