WATER OPERATION AND MAINTENANCE BULLETIN

No. 185

September 1998

INSPECTION OF BRAKE MOTORS AND SPEED REDUCERS FOR GATE HOISTS

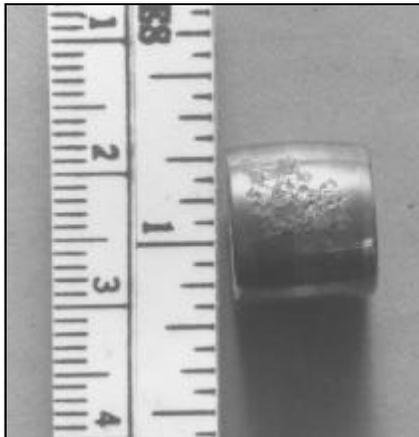
Cover photograph: Roller bearing removed from secondary speed reducer after approximately 40 years in service (left). Climbers of Reclamation's Climb Team (right).

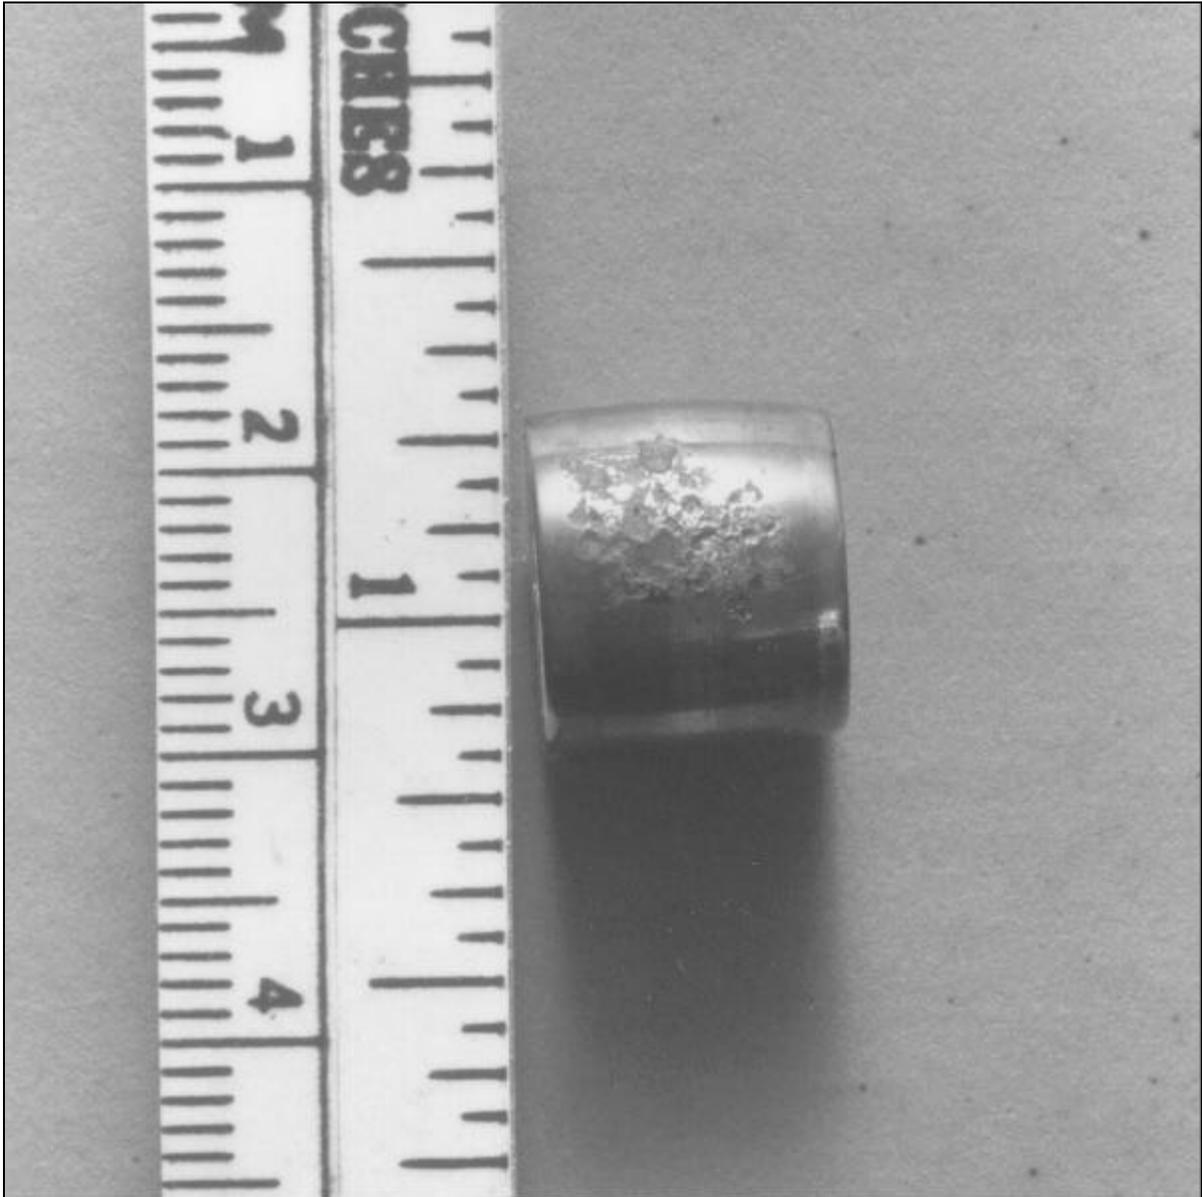
The following photograph shows a roller bearing removed from a secondary speed reducer. The unit had been in service for approximately 40 years. The oil had never been changed. There was water in the bottom of the gear box, and the bearings had been destroyed by corrosion.

Roller bearing removed from secondary speed reducer after approximately 40 years in service.

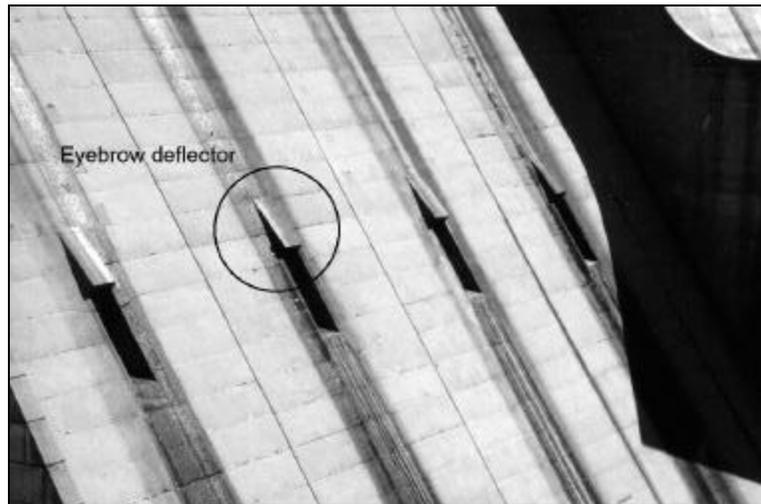
Figure 2.—Eyebrow deflector installed above an outlet exit on the Folsom spillway.

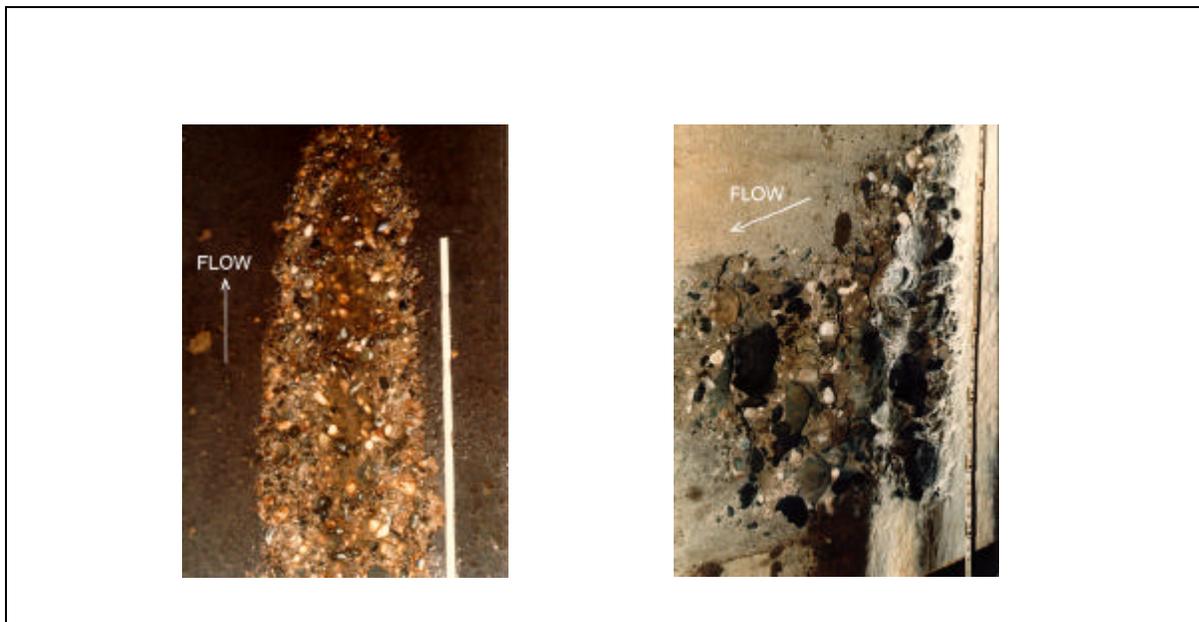
Additional repairs to the outlet conduits (Nos. 1-4) were completed in March 1988. These repairs followed discovery of damage to the invert and lower sidewalls of the low-level outlets at locations from 15 to 60 feet downstream from the end of the gate frame (figure 3).

Figure 3.—Damage to invert (left) and the sidewall (right) which occurred in 1987. This damage was 30 to 40 feet downstream from the end of the metal liner.

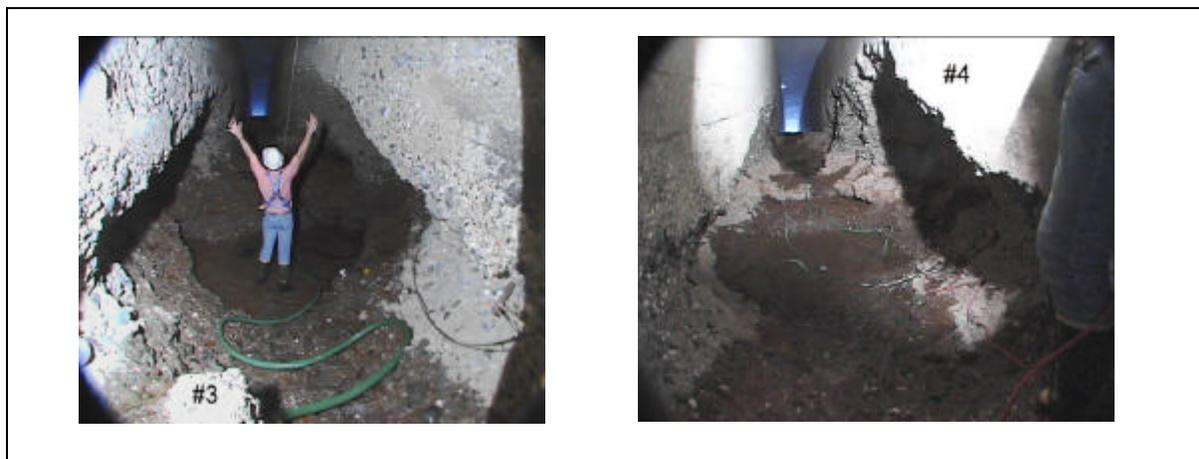
During major releases in the winter of 1996-97, observers noted that the trajectories of the discharge from outlet Nos. 3 and 4 were falling short of those from outlet Nos. 1 and 2. Inspections in May 1997 revealed major damage due to cavitation in outlet Nos. 3 and 4 (figure 4), minor damage in outlet No. 2 (figure 5), and little or no damage in numbers 1, 5, 6, 7, and 8.

Figure 4.—Damage to conduits 3 and 4, low-level outlets, May 1997.

This damage was initiated by cavitation and accelerated by a combination of both cavitation and abrasion. Abrasion damage is probably primarily responsible for the deep lateral extent of the damage in outlet Nos. 3 and 4, especially along the construction joints. There was a widely varying degree of damage between outlets 1, 2, 3, and 4. Cavitation intensity is largely a function of pressure and velocity, so the variation in damage is attributable to very low, localized pressures downstream from the gates due to air starvation. Previous studies have shown the manifold system to be undersized for the expected air demand. Outlets 3 and 4 are at the end of the air manifold that brings air to the conduits.

With the combination of the new aeration ramp and construction of an additional air intake manifold (over doubling the capacity), operation of the outlet works should be possible without any additional cavitation damage.

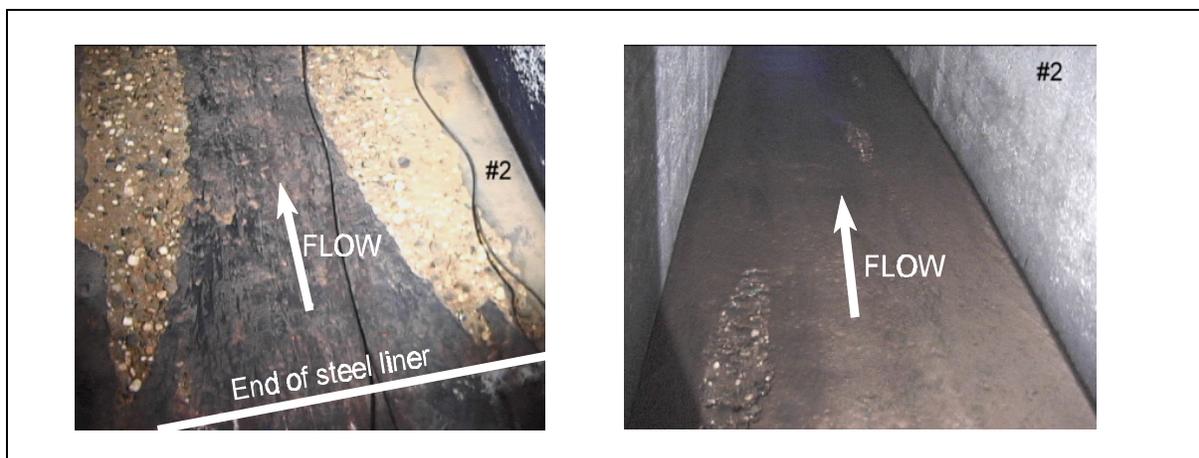
Figure 5.—Damage to invert of conduit 2. Left photo is at the end of the steel liner. Note the pattern of damage on the right photo.

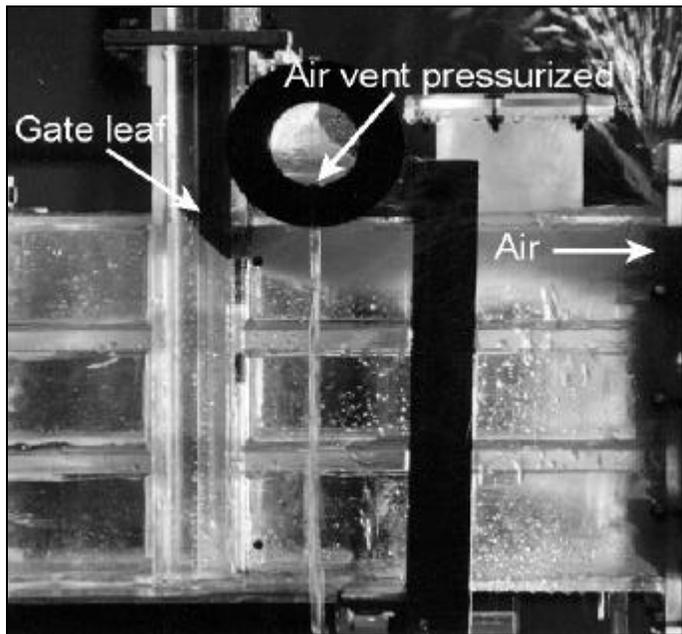
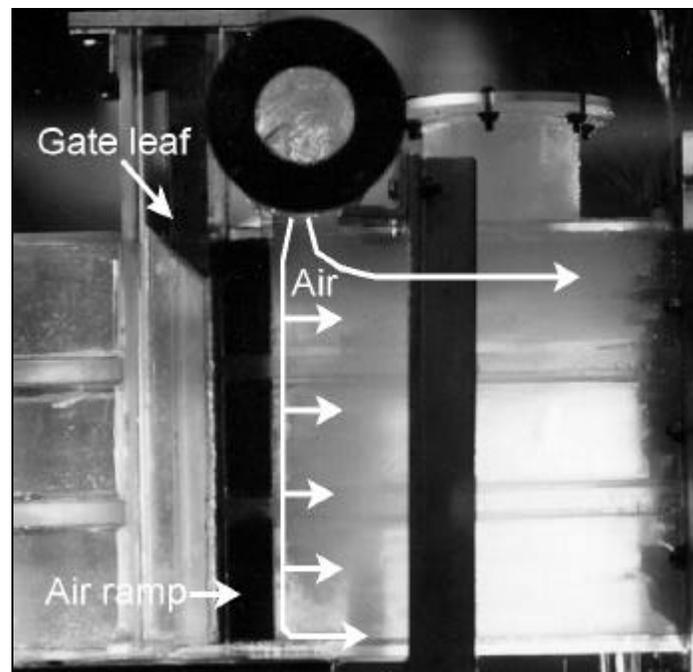
a) Gate position is 90 percent, head is 450 feet, as-built. Air vent is pressurized (note stream of water pouring out of air vent).

b) Gate position is 90 percent, head is 450 feet, final design aeration ramp installed just downstream from the gate slot. Note air vent is not pressurized, and air is being carried all the way to the floor.

Figure 14.—Comparison of as-built and final design for a gate opening of 90 percent at a head of 450 feet.

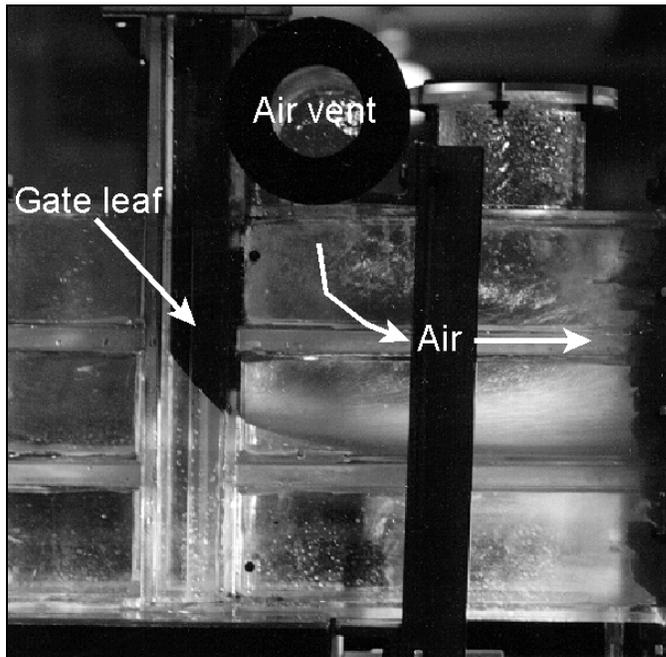
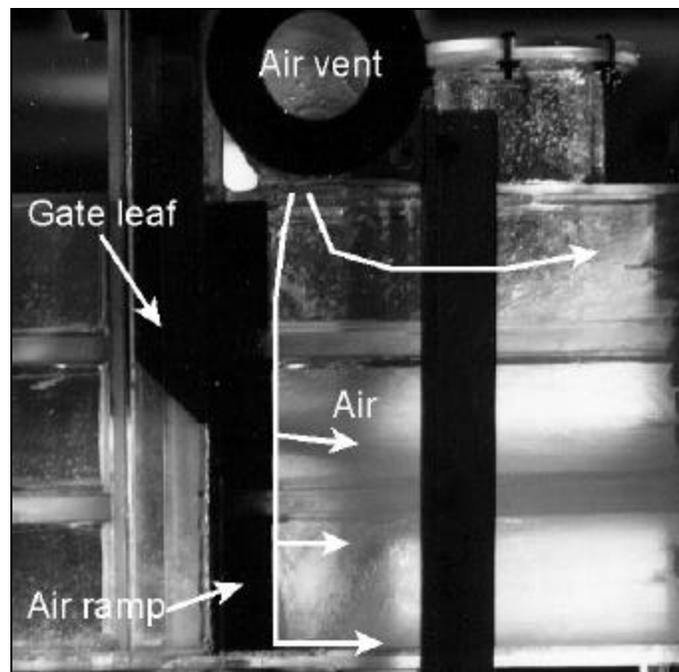
a) Gate position 50 percent, head 450 feet, as-built configuration. Note that aeration appears to be localized at the free surface.

b) Gate position 50 percent, head is 450 feet. Insert No. 3 aeration ramp installed. Note that air is carried down to the conduit floor, allowing for aeration over the entire fluid stream.

Figure 15.—Comparison of as-built configuration with the final design aeration ramp. Gate position 50 percent (5.5 feet open) at a head of 450 feet.
