# WATER OPERATION AND MAINTENANCE BULLETIN

No. 189

September 1999

UNITED STATES DEPARTMENT OF THE INTERIOR  
Bureau of Reclamation

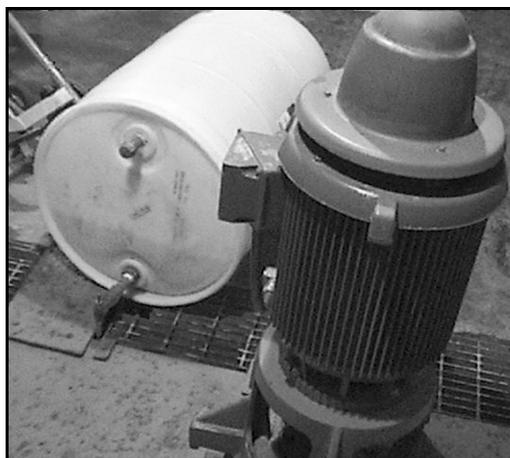
*Preventing Calcium Buildup*

*A 25-horsepower vertical shaft pump in the foreground of this photograph is one of two pumps that clear seepage water from the bottom of the 164-MW Morrow Point Dam on the Gunnison River in Colorado. Rapidly building calcium deposits in the pumps, however, required inconvenient maintenance twice a year. The problem was solved by the white barrel in the background, which contains a water softener that is slowly dripped into the sump hole, preventing the calcium buildup.*

The problems with the pumps began immediately after the dam became operational. The calcium in the seepage water rapidly built up deposits on the pumps' impeller, bulb, and casing. If uncorrected, the deposits would cause the pumps to freeze in six to ten months. If a pump had been allowed to seize, extensive internal damage would have been caused and the pump motor likely would have burned up.

The system was ingenious for its simplicity and economy. A 55-gallon barrel of Calgon, purchased from the Nu-Calgon Company of St. Louis, Missouri, was laid on its side beside the pumps. A tube such as those used in a hospital to provide intravenous (IV) feeding was attached to the outlet of the barrel and dropped down into the sump. A drip control on the IV tubing allowed a drop of chemical into the sump every few minutes.

The chemical causes the calcium, as calcium carbonate, to precipitate out in the bottom of the large sump, leaving calcium-free water to be pumped. The specific chemical used is No. 340 Liquid Scale Inhibitor. The barrel of chemical lasts about a year.

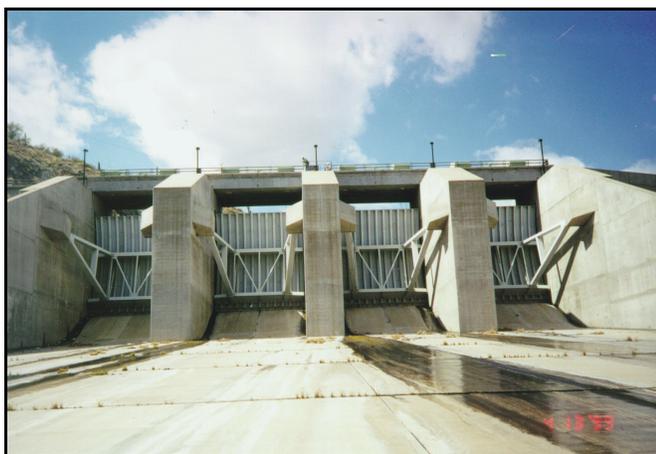
The intent of the Stewart Mountain Dam spillway gate testing was to raise each gate approximately 1 foot. Applying power to the hoist of gate No. 10 caused the wire ropes to fail without the gate even lifting off the sill. The same thing happened when gate No. 11 was tested.

*Figure 1.—Downstream side of the auxiliary spillway radial gates (Stewart Mountain Dam).*

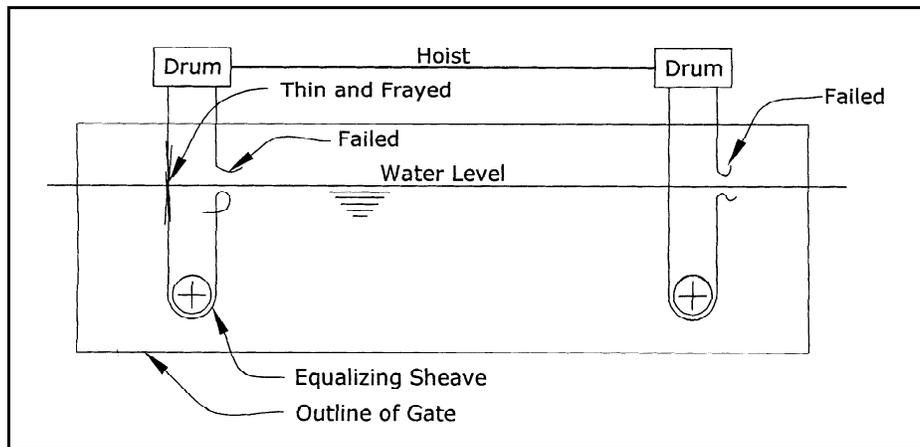
The wire ropes are connected at both ends to the drum dropping down at its center to pass through an equalizing sheave on the gate on the upstream side of the skin plate. The covers from both drums on gate No. 10 were not removed to examine the ropes. The wire ropes were severely corroded just below the water level and failed slightly below the normal high water mark. Figure 2 shows the approximate points of failure.

*Figure 2.—Approximate points of wire rope failure.*

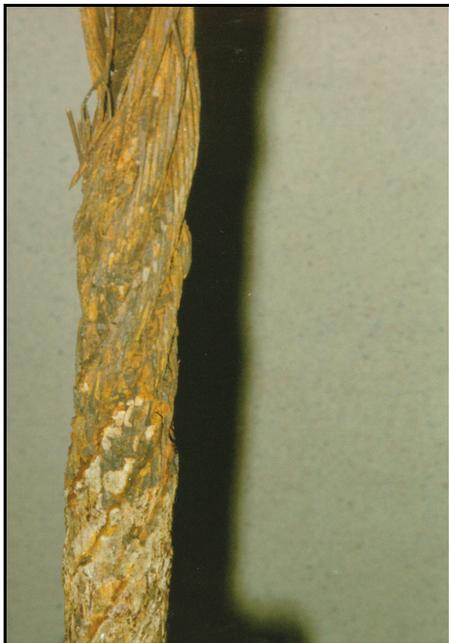
The wire rope installed under the Stewart Mountain Dam Safety Modification was extra improved plow steel (XIPS), 6 x 19, independent wire rope core, 1-inch diameter, right regular lay. The sample shows significant corrosion, especially at the failure location. The failure location is exposed to both air and water due to the daily lake level fluctuations. Shown below is the corroded wire rope (figures 3 and 4).

*Figure 3.—Stewart Mountain Dam wire rope.*

Stainless steel ropes were chosen to replace the existing ropes instead of galvanized ropes or the existing plow-type wire rope. Even though the galvanized ropes would start with a higher safety factor, the safety factor would be reduced quickly by the corrosive water. If the same rope (improved plow steel) were to be used, it would corrode within the same 10-year time period (auxiliary spillway hoists at Stewart Mountain Dam were installed in 1989). Therefore, the improved plow steel would have a reduced safety factor of 4.76 after 2 years and would continue to deteriorate with time. Installing stainless steel wire ropes will result in a much slower rate of corrosion and will prevent failure before a 10-year operating period.

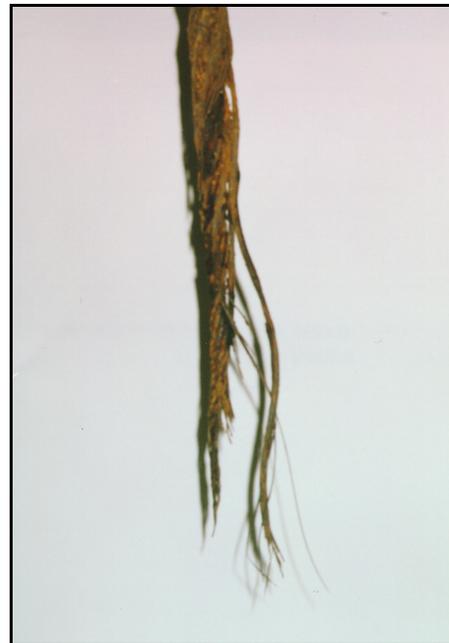
*Figure 4.—Stewart Mountain Dam broken wire rope.*
