## Water Operation and Maintenance Bulletin

No. 218

December 2006

# Can Your Spillway Survive the Next Flood?

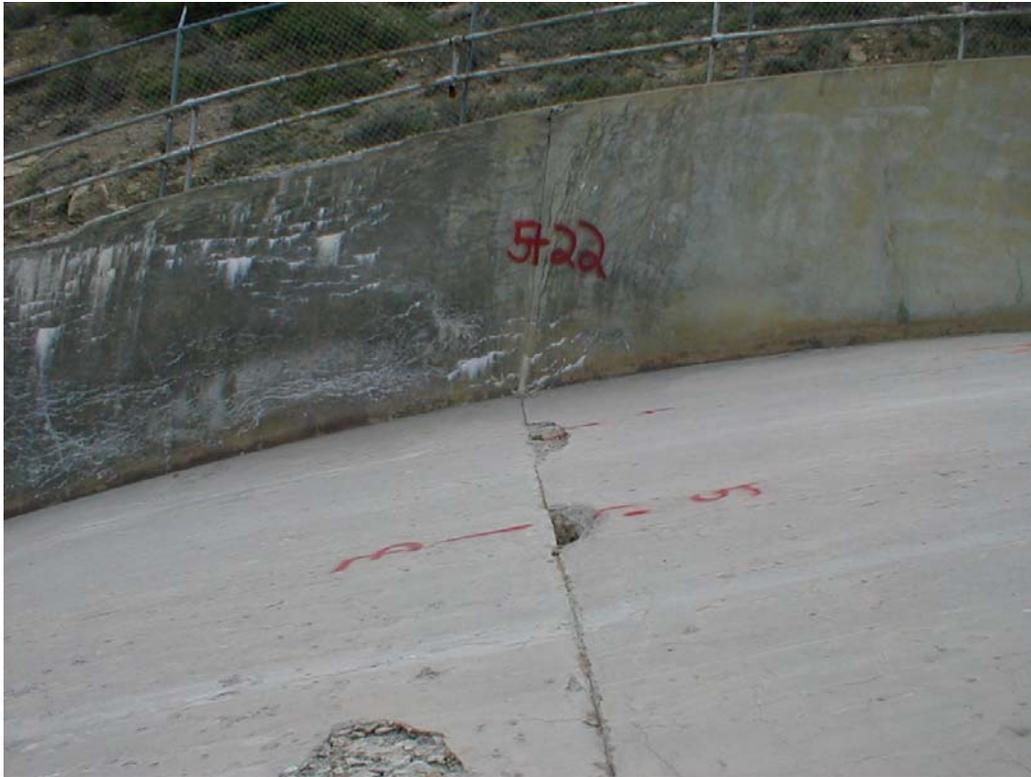
Existing structural damage – deterioration (Scofield Dam Spillway).

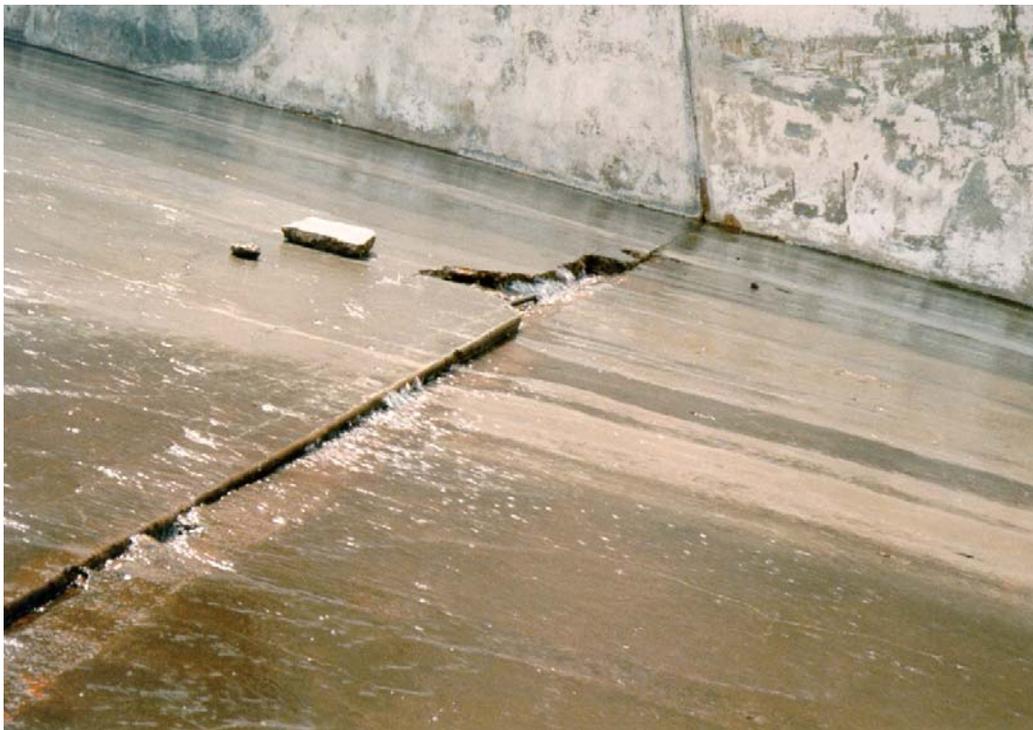
Existing structural damage – offsets and spalling (McPhee Dam Spillway).

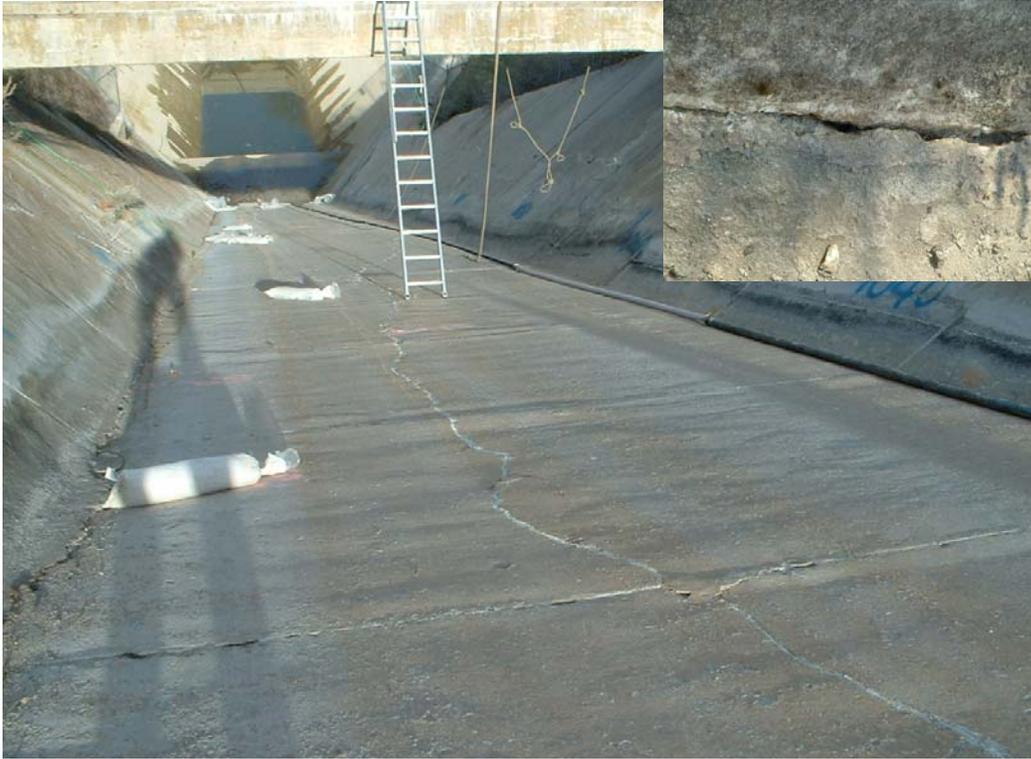
Existing structural damage – cracking (Hyrum Dam Spillway).

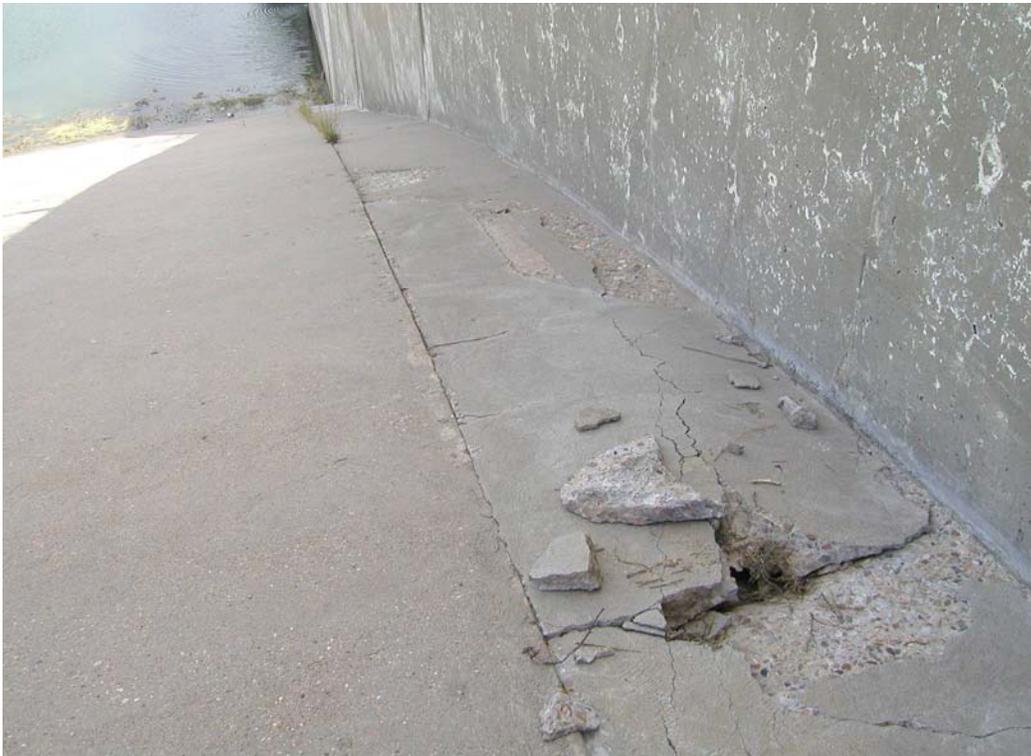
Existing structural damage – cracking and spalling (Bull Lake Dam Spillway).

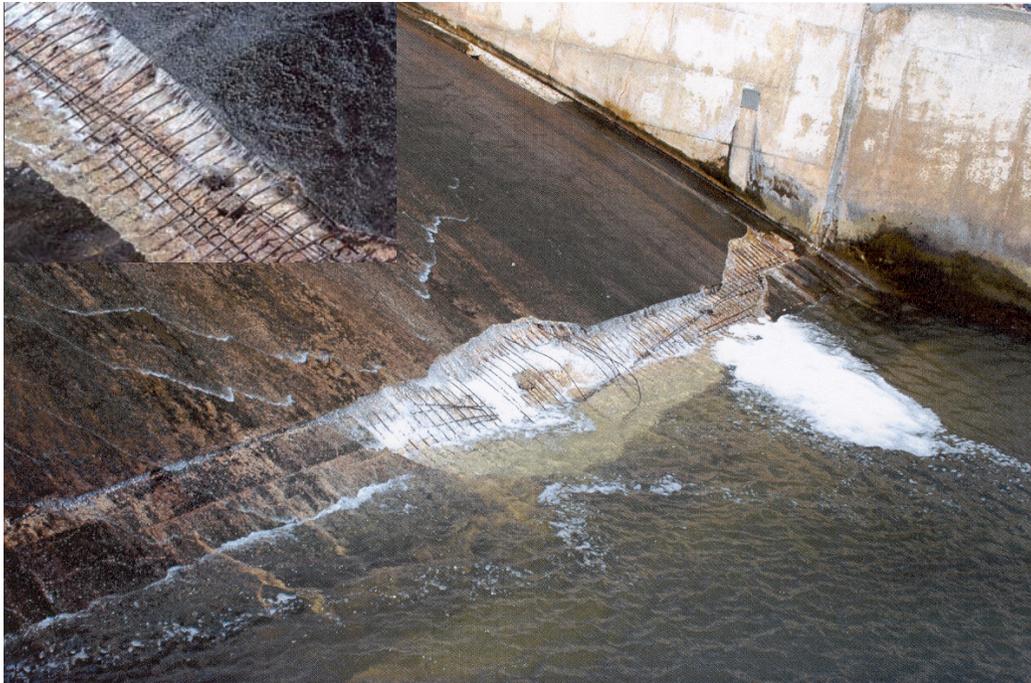
Existing structural damage – delamination (Deer Creek Dam Spillway).

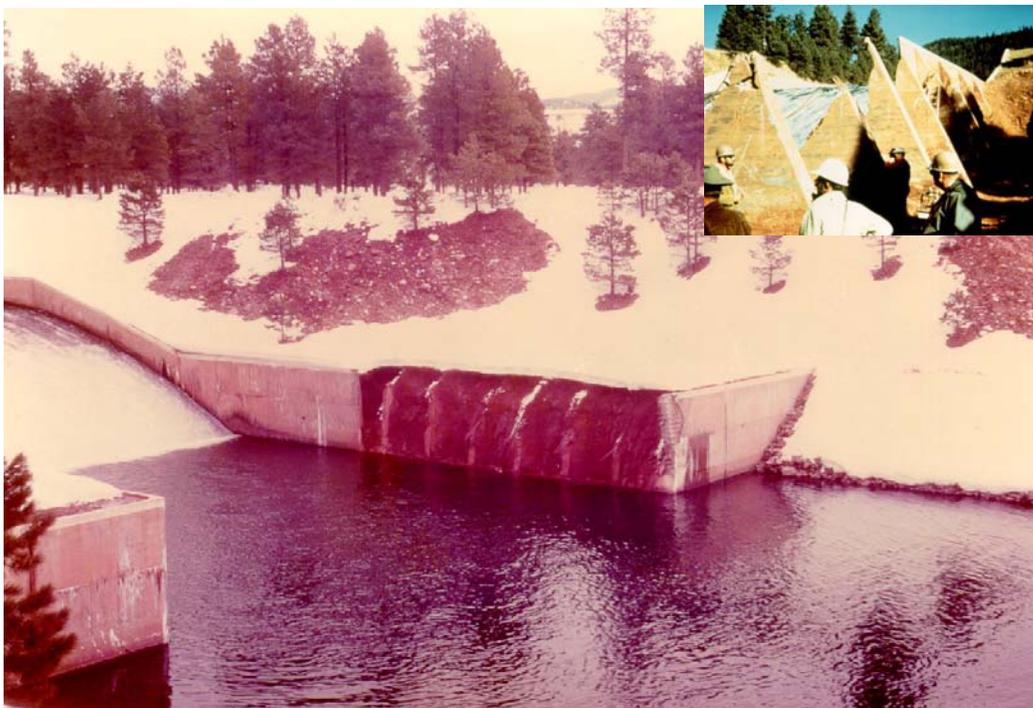
Existing structural damage – collapse (Vallecito Dam Spillway).

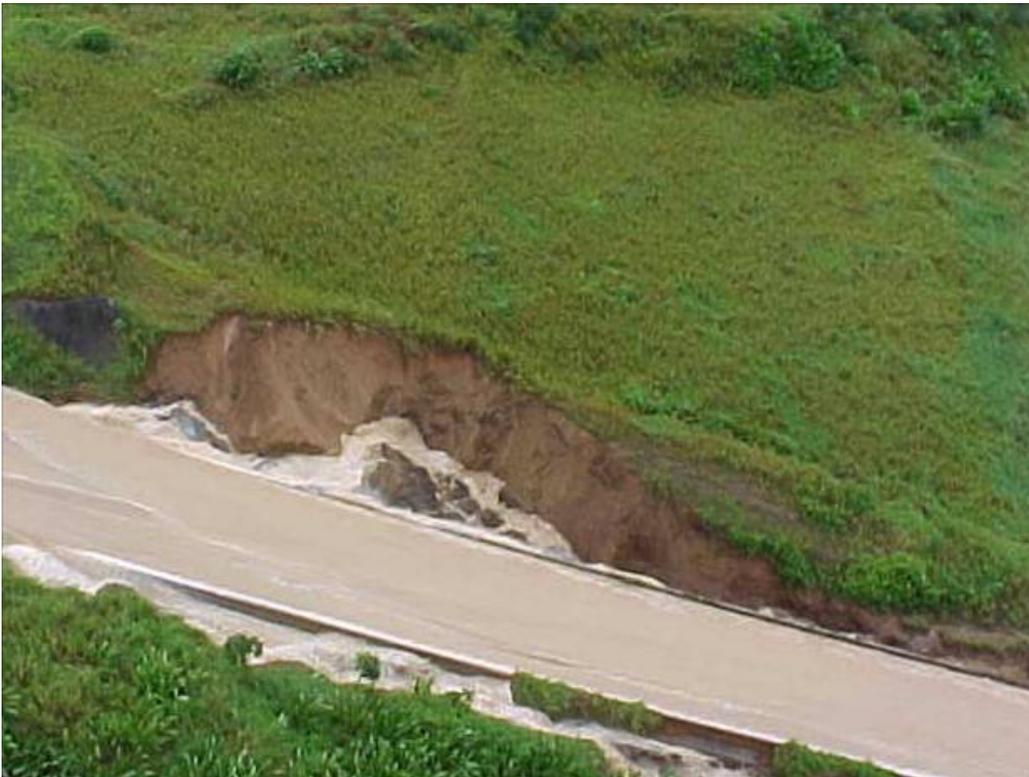
Spillway capacity exceeded (El Guapo Dam Spillway).

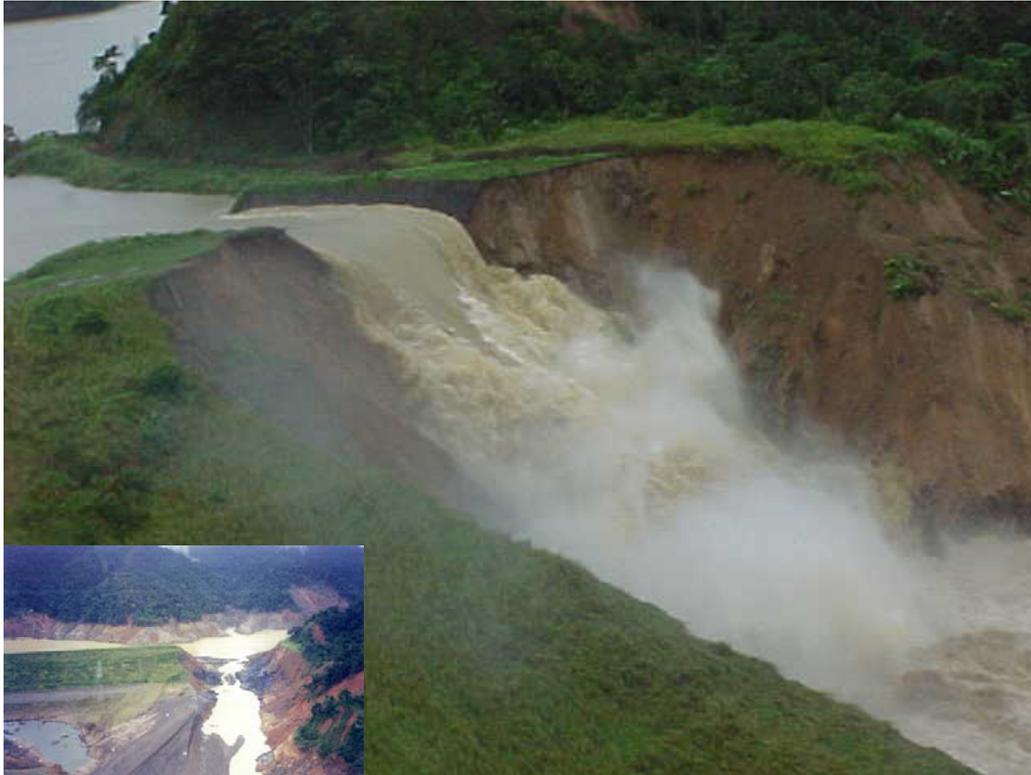
Spillway capacity exceeded (El Guapo Dam Spillway).

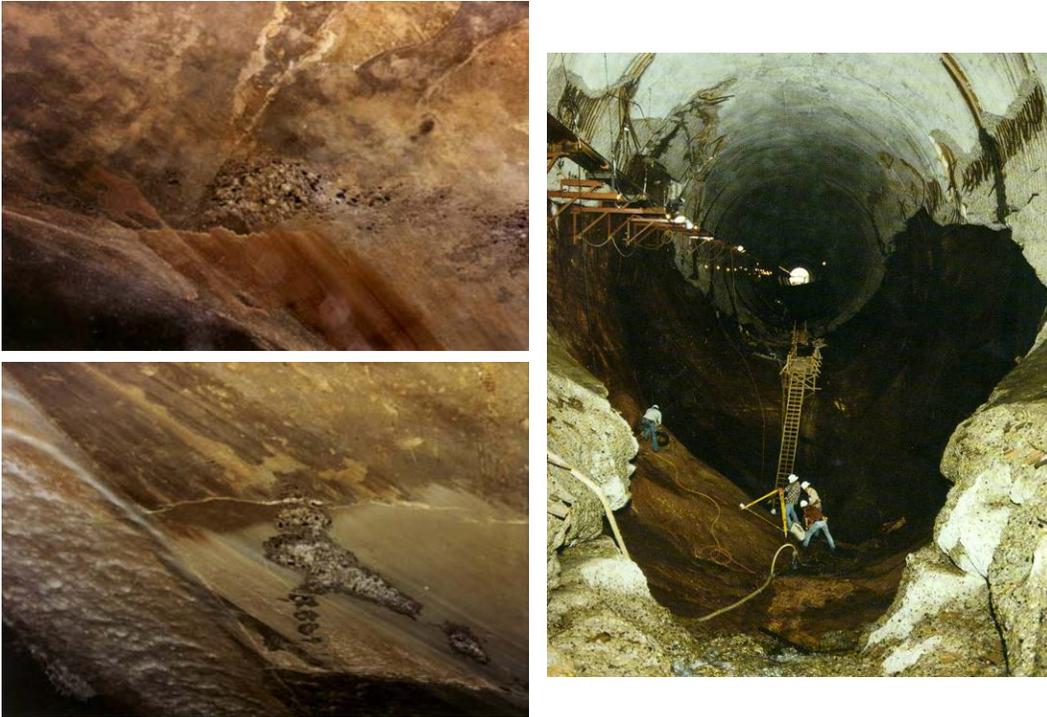
Cavitation damage (Glen Canyon Dam Spillway).

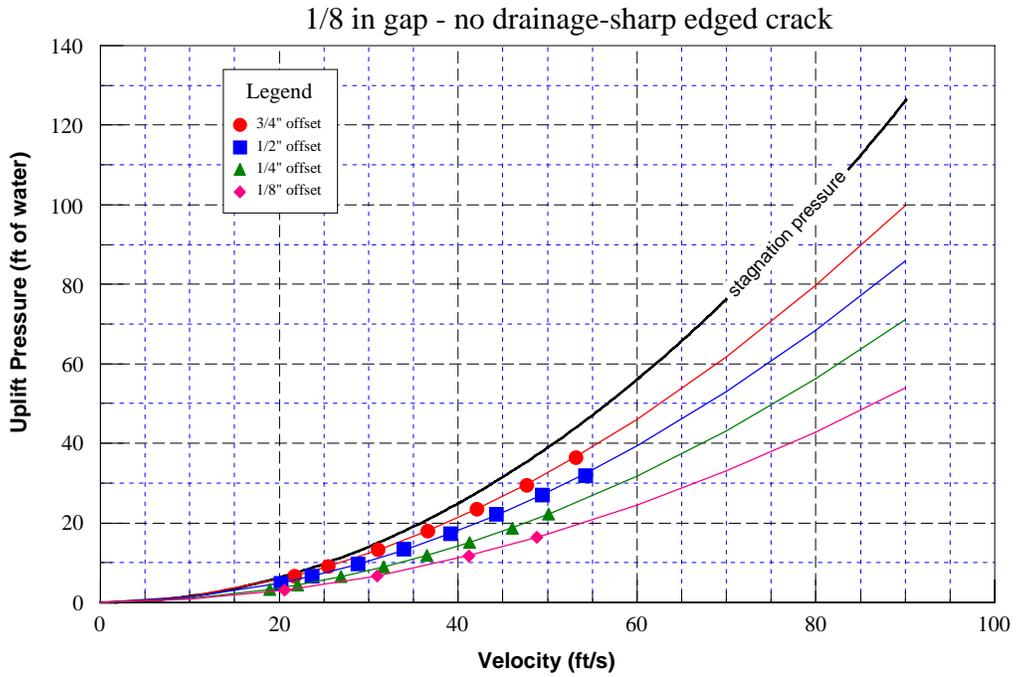
Stagnation pressure at offsets 1/8" crack, no drainage flow, offsets into flow.

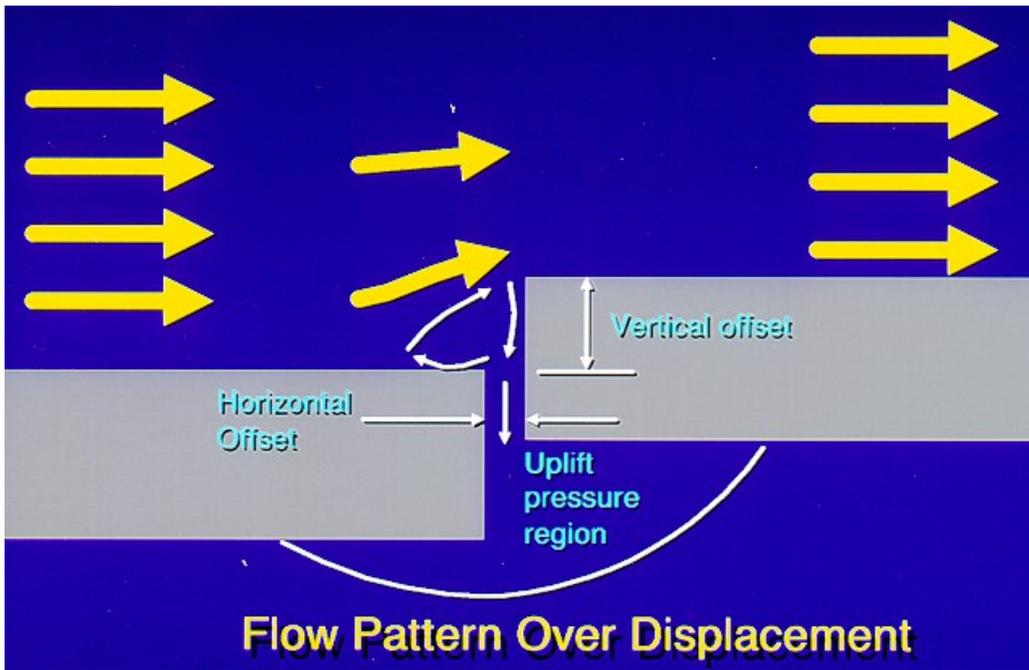
Stagnation pressure.

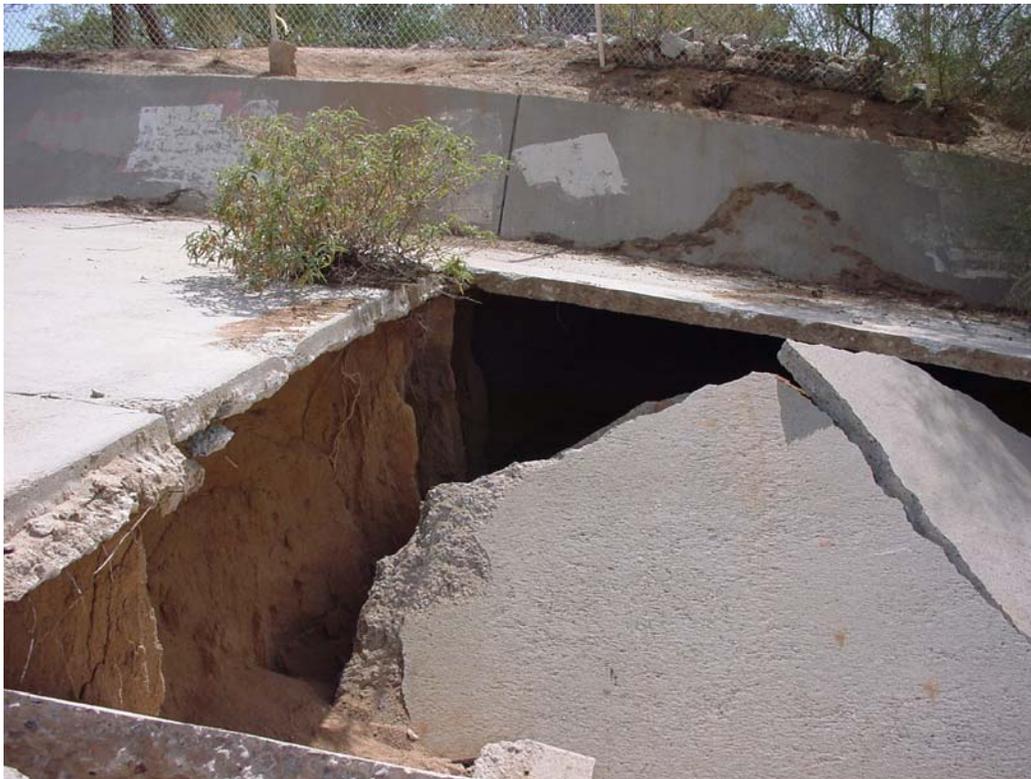
Structural collapse.

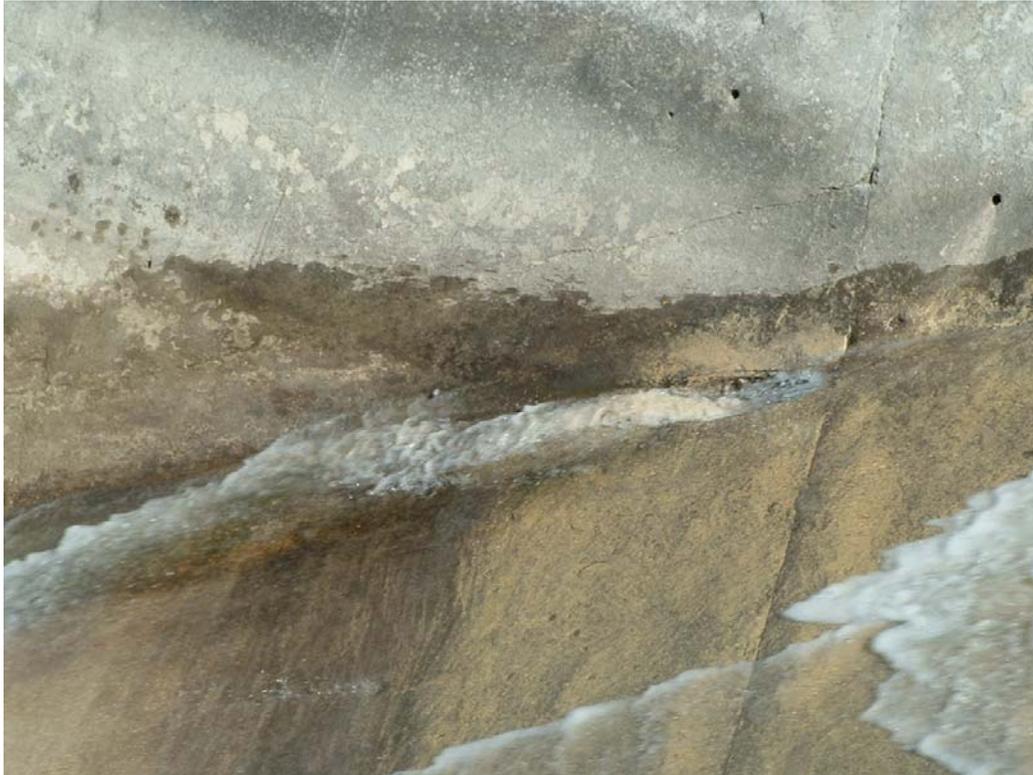
Structural damage – foundation materials discharging from drains  
(Hyrum Dam Spillway).

Temporary bridging of foundation voids occurred at Hyrum Dam Spillway near Logan, Utah. The potential for voids beneath the invert slab was not identified during early inspections of the Hyrum Spillway because the visual signs of a design deficiency were not well understood. Observed surface cracking was

thought to be minor, and further investigation was not recommended. During a 2003 inspection, the surface cracking was again observed in the invert slab. The spillway design details had been carefully evaluated prior to the inspection, and it was concluded that there was significant potential for foundation erosion. Once this potential failure mode had been identified, the cracking pattern provided visual indication that voids were possibly forming in the foundation. Discolored discharge from the drain outfall was observed during a test flow. Subsequent investigations that included drilling through the spillway slab revealed the voids in the foundation, and repairs were made.

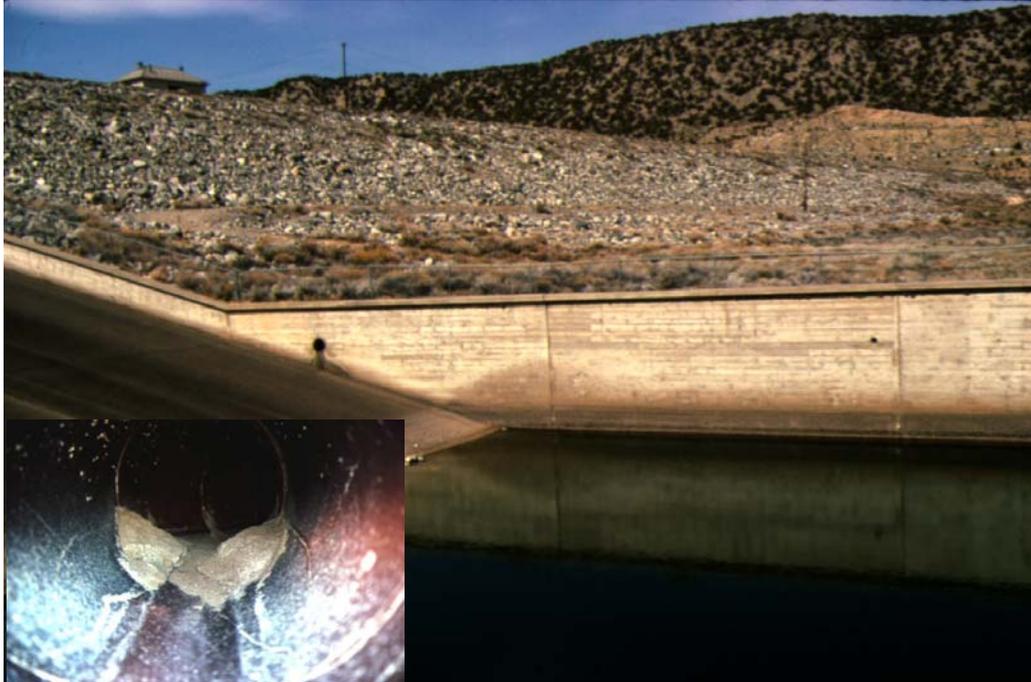
Structural damage – foundation materials discharging from drains (Bull Lake Dam Spillway).

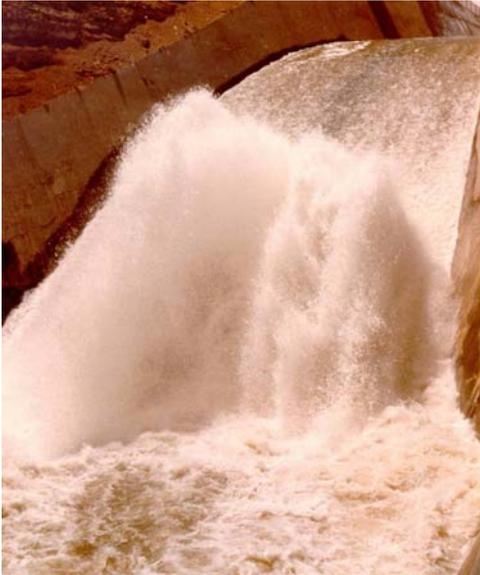
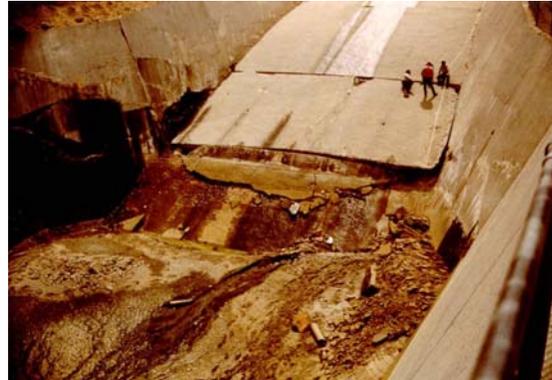
Hydraulic jacking (Big Sandy Dam Spillway).

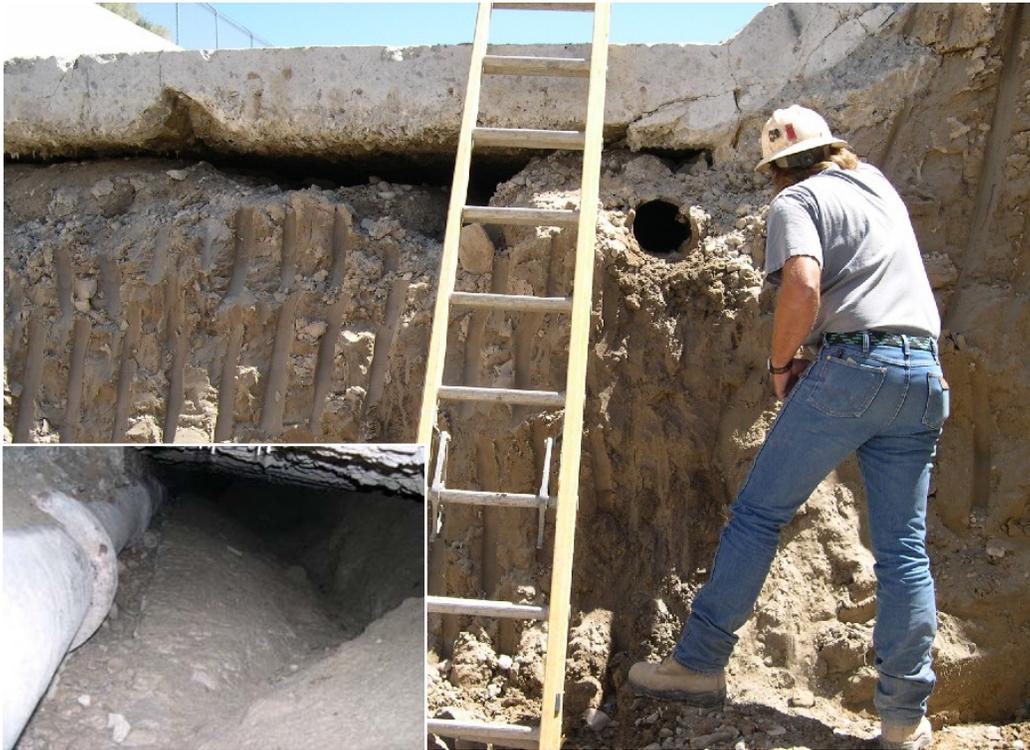
Groundwater related erosion (Hyrum Dam Spillway).
