Water Operation and Maintenance Bulletin

No. 220

Post-Earthquake Dam Inspections in Hawaii, October 2006

Post-Earthquake Dam Inspections in Hawaii, October 2006¹

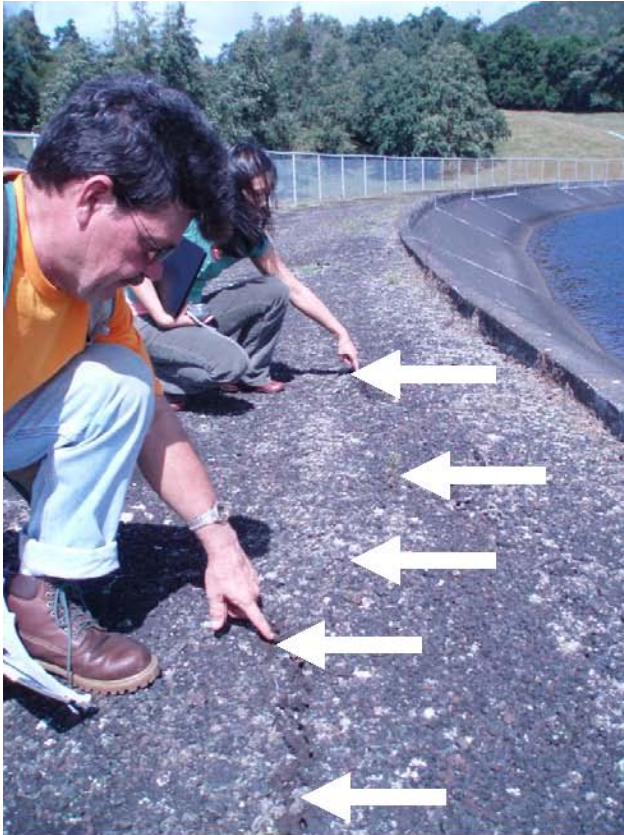
The inspection of Reservoir II began on the dam crest. Significant earthquake damage was immediately evident. Numerous new longitudinal and transverse cracks were evident on the crest of the dam, measuring up to about 2 inches wide, 40 feet long, and up to 3 feet deep (photos 1 and 2). The cracks are likely deeper and could have opened and then closed up during the earthquakes. In order to determine the depth of the open portion of the cracks, they were probed with a steel tape measure. Bulging of the crest asphaltic material up to a few inches high was evident between the parapet wall and many of the longitudinal cracks (photos 1 and 2). Earthquake shaking caused areas of separation, or openings, between the parapet wall and adjacent crest material that measured up to 1 inch wide, 20 feet long, and 1 foot deep at about 6 locations (photos 2 and 3). The bulges and areas of separation were caused by the earthquake-induced movement of the dam embankment and concrete liner. Several new cracks were evident on the asphalt-paved access road where the road connects to the dam crest.

Photo 1.—Waikoloa Reservoir II Dam – Earthquake-induced new longitudinal crack in the dam crest (arrows denote alignment). Note new bulging of the crest in the area of the crack caused by earthquake shaking of the dam. Numerous other new longitudinal cracks and bulged areas are evident on the dam crest.

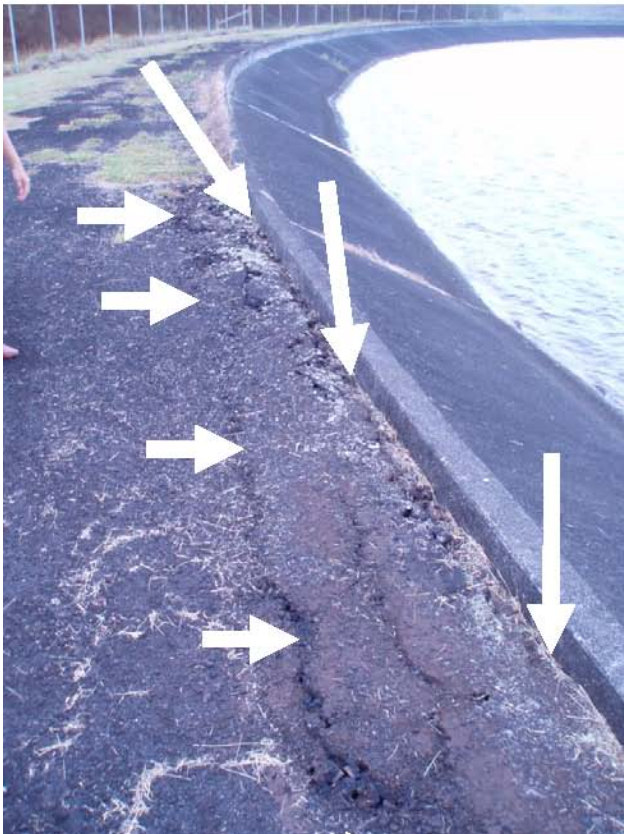
Photo 2.—Waikoloa Reservoir II Dam – Earthquake-induced new longitudinal crack in the dam crest (short arrows denote alignment). Note new bulging (area between long arrows and short arrows) of the crest paving caused by earthquake shaking of the dam and the 1-inch wide separation (long arrows) between the reservoir concrete lining parapet wall and the crest embankment material. Numerous other new longitudinal cracks, bulged areas, and areas of separation are evident on the dam crest. New transverse cracks are evident at several other locations on the dam crest.

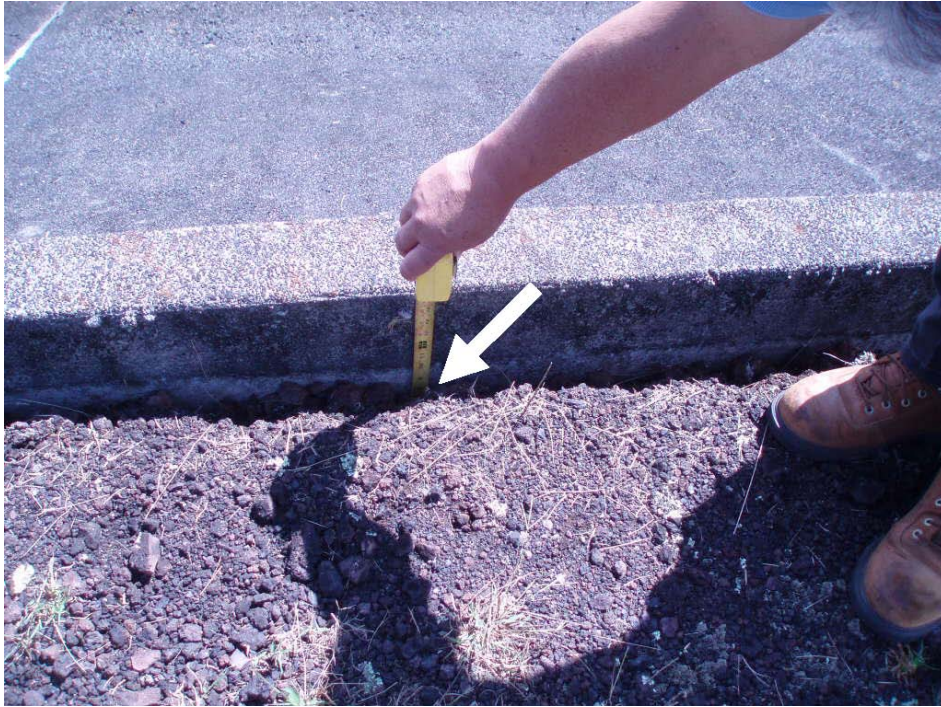
Photo 3.—Waikoloa Reservoir II Dam – Closeup view of the new typical earthquake-induced 1-inch wide, 20-foot-long separation between the reservoir concrete lining and the crest embankment material (arrow), shown in the previous photograph, evident at numerous locations and of various lengths on the crest.

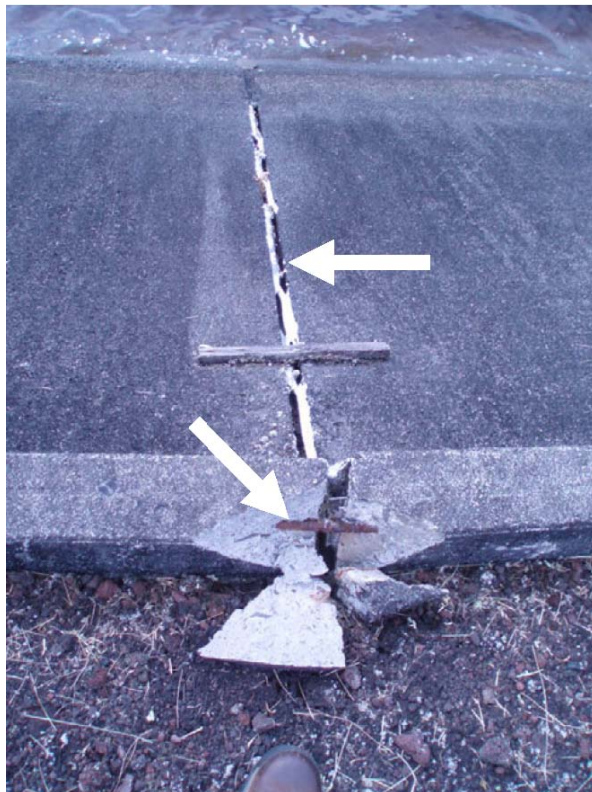
The concrete liner had numerous old vertical and angled cracks that had been patched with white silicone-type sealant material placed in and/or across the cracks, and there were old joint openings with silicone sealant material in them and/or joint filler packing material that had been placed in the joints. However, the inspection revealed new vertical and angled cracks in several liner panels (photo 5). The cracks measured up to about 0.1 inch wide, extending up to the top of the parapet wall from an undeterminable depth down the panels (limited by visibility into the reservoir). Additionally, several of the joints between concrete liner panels had separated due to the earthquake and were opened less than about 1 inch, and at two joints the most significant new joint openings were 2 inches wide (photo 4). The 2-inch joint openings exhibited old 1-inch-wide white

silicone-type joint filler material that had been pulled apart where the joints had opened up to 2 inches wide during the earthquakes (photo 4). Operating personnel reported that the repairs were completed about 20 years ago because of leakage concerns, and the joints were open about 1 inch prior to the earthquakes. The concrete parapet wall at one of these new 2-inch-wide joint openings exhibited new cracking and spalling with exposed reinforcing steel (photo 4). Numerous other joints in the parapet wall exhibited new cracking and spalling with exposed rebar.

Photo 4.—Waikoloa Reservoir II Dam – New opening at joint (upper arrow) about 2 inches wide (evident at this and one other joint, note old white joint filler material where joint used to be open about 1 inch), and typical new concrete damage with exposed reinforcing steel bar (lower arrow) at the concrete reservoir liner panels caused by earthquake motion. New concrete spalling damage (lower arrow) such as this is evident at numerous joints in the concrete liner panels.

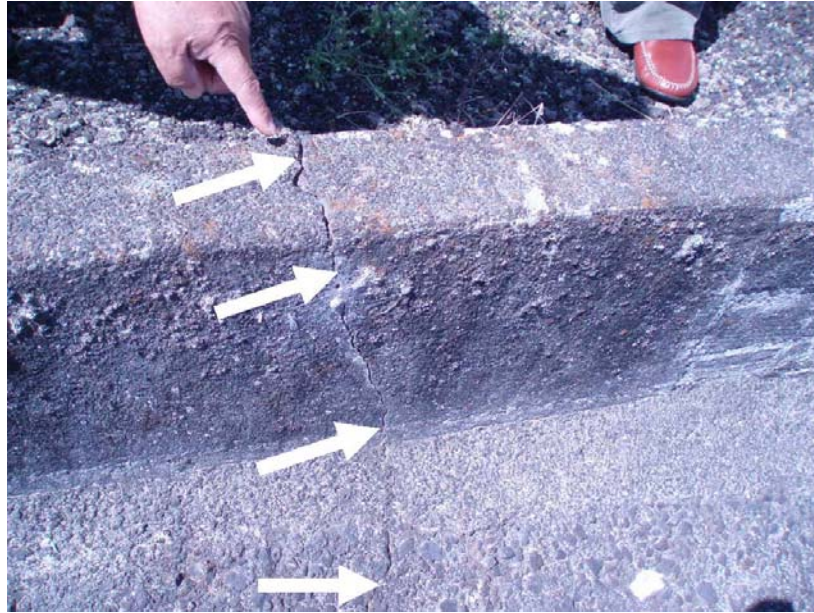
Photo 5.—Waikoloa Reservoir II Dam – Typical earthquake-induced new crack (arrows) in the reservoir concrete liner and parapet wall.

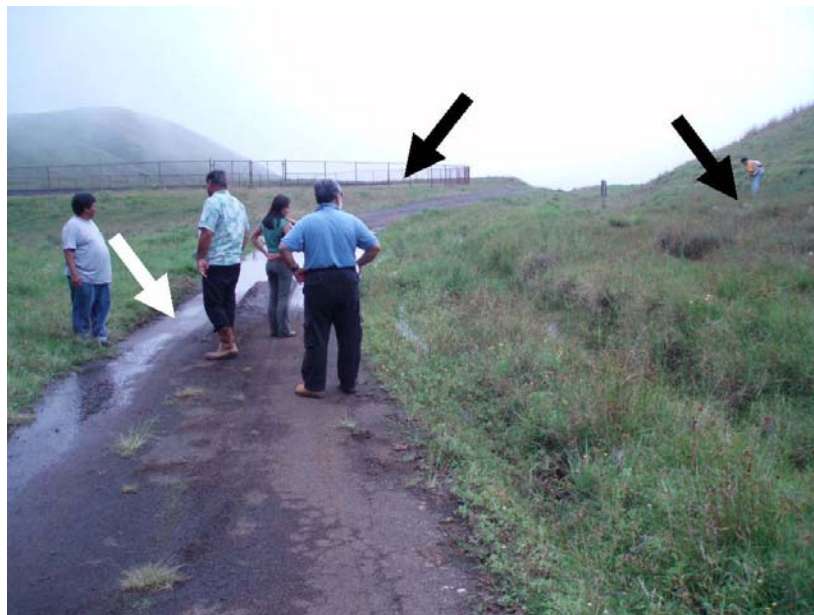
The dam operators reported that this was the first time these flows and the increased pond size had been observed, and that no flow had been observed in this area when examined by them a week prior to the earthquakes. In this area, the downstream toe of the dam embankment was observed to be moist for a distance of about 8 feet above the foundation/dam toe contact (photo 6). The moist toe

area was about 70 feet long, and there was standing water about 2 inches deep on the foundation near the toe. These conditions were also reported by dam operators to be new since the earthquakes. These new moist and standing water conditions “raised a red flag” of concern for this inspector because of previous experiences with dams exhibiting similar seepage conditions. The inspection team immediately directed their efforts to a close examination of the moist toe area. This inspector and one other team member began walking the toe of the dam in two lines, and in less than 1 minute after the “red flag” alert, two new active sandboils were located at the maximum section of the dam on the southwest side of the downstream toe about 1.5 feet above the foundation contact with the toe (photos 6 through 8).

Photo 6.—Waikoloa Reservoir II Dam – Two earthquake-induced new sandboils (right arrow) at downstream toe of Reservoir II Dam. Note ponded water inundating the paved access road (left arrow) between Reservoirs I and II. About 10 percent (1 gallon per minute) of sandboil seepage was flowing into the ponded water, and 90 percent was flowing into southwest drainage area in background of photo located between right and middle arrows. Note Reservoir I Dam (middle arrow).

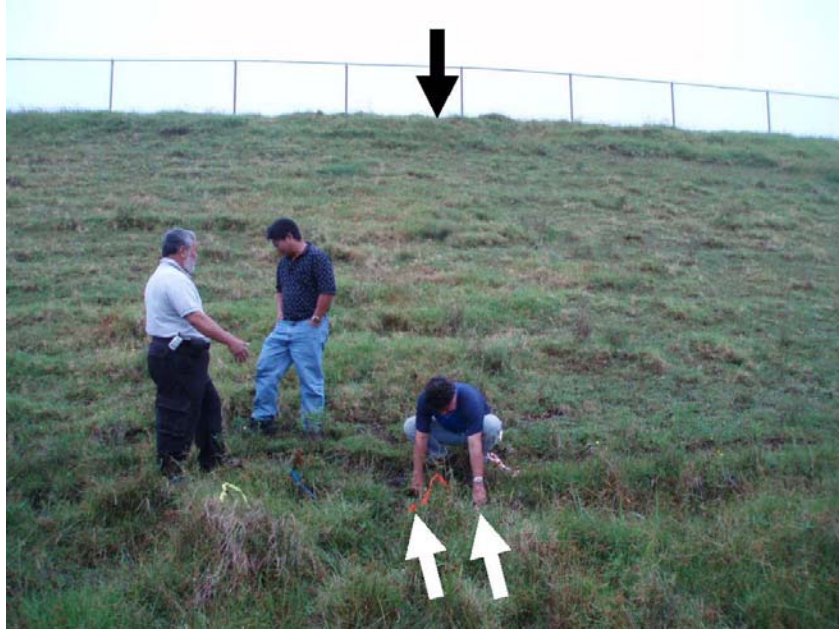
Photo 7.—Waikoloa Reservoir II Dam – Two earthquake-induced new sandboils (lower arrows) at the downstream toe of the dam shown in the previous photograph, facing upstream. Upper arrow denotes crest of Reservoir II Dam.

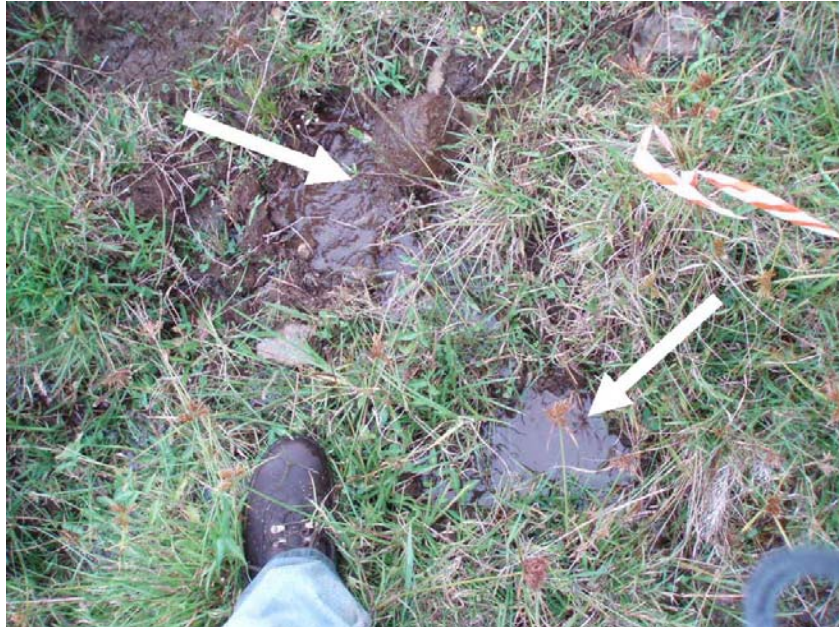
The two new sandboils were each about 2 to 3 inches in diameter and were located about 18 inches apart (photos 6 through 8). The sandboils had a combined seepage flow of about 10 gallons per minute, and the flows were transporting small amounts of fine-grained material (photos 7 and 8). About 10 percent of the seepage was flowing into the ponded water, inundating the access road between Reservoirs I and II, and the rest of the seepage flowed to the southwest drainage area (discussed above) and away from the pond between Reservoirs I and II (photos 6 through 9). Dam operators had not seen these sandboils previously and confirmed that the sandboils were new since the earthquakes because the operators examined the dam a week before the earthquakes and there were no sandboils in this area at that time. The sandboils were located on the dam toe at 29.5 feet below the top of the crest of dam parapet wall, or about 1.5 feet above the foundation at the maximum section (photos 6 through 8). The sandboils were not clearly visible, being hidden by 6-inch-tall grass covering the downstream face of the embankment. The sandboils were then marked with flagging for future monitoring and inspection.

Photo 8.—Waikoloa Reservoir II Dam – Closeup view of the two earthquake-induced new sandboils (arrows) at the downstream toe of Reservoir II Dam flowing at a total visually estimated rate of about 10 gallons per minute, shown in the previous photograph.

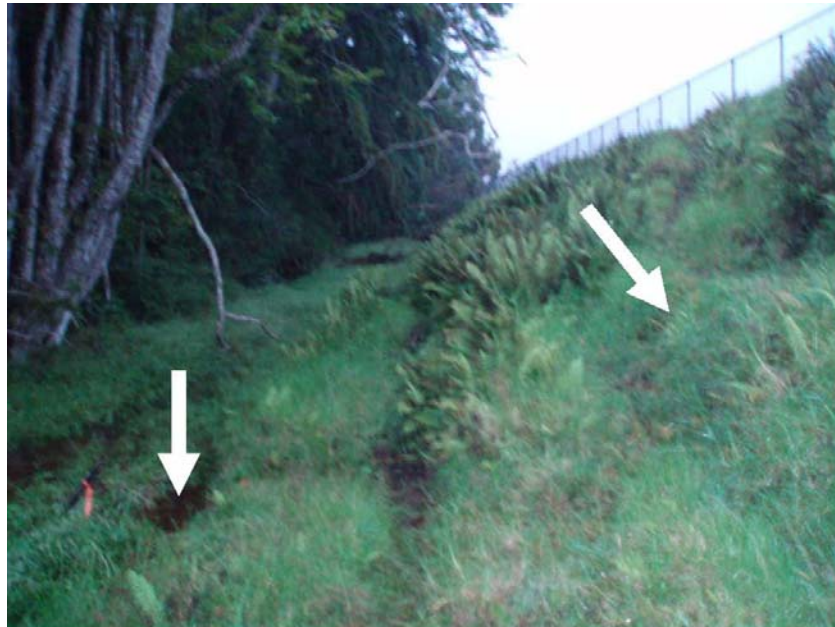
Photo 10.—Waikoloa Reservoir I Dam – Earthquake-induced sandboil area (left arrow) at the downstream toe of the dam. Right arrow denotes the downstream face of the dam. Dam is 17.5 feet high at this location. Photograph is blurry due to low light conditions and rainfall.

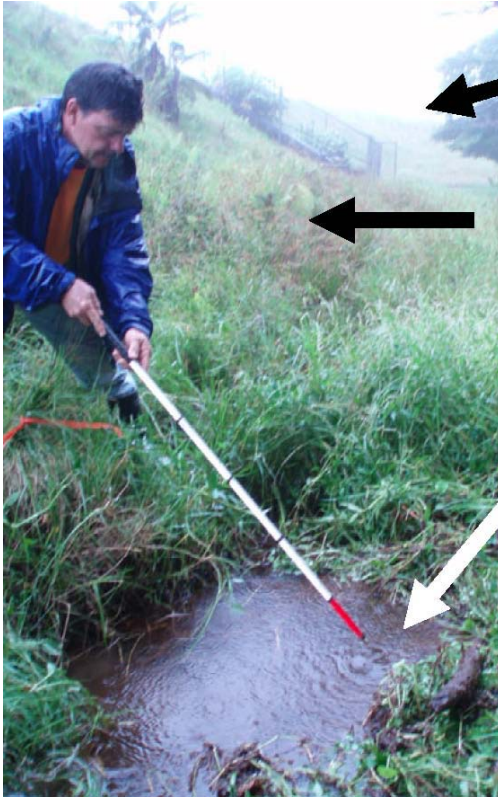
Photo 11.—Waikoloa Reservoir I Dam – Earthquake-induced sandboil area (lower arrow) at the downstream toe of the dam with three sandboils. Middle arrow denotes the downstream face of the dam, upper arrow denotes downstream face of Reservoir II Dam.

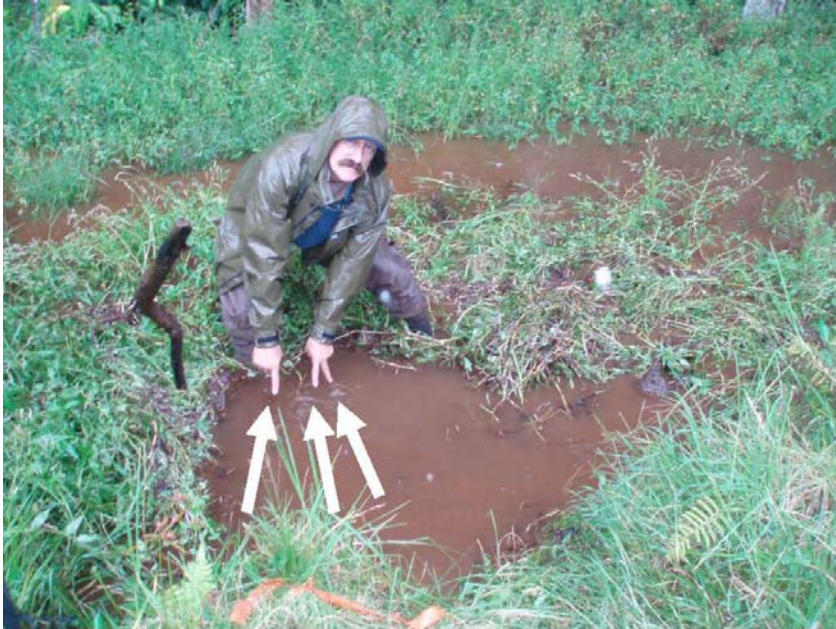
Photo 12.—Waikoloa Reservoir I Dam – Sandboil area (arrows denote three sandboils) at the downstream toe of the dam, facing downstream. Three sandboils are flowing at total visually estimated rate of about 30 to 40 gallons per minute, with soil particles suspended and accumulated around the sandboils.

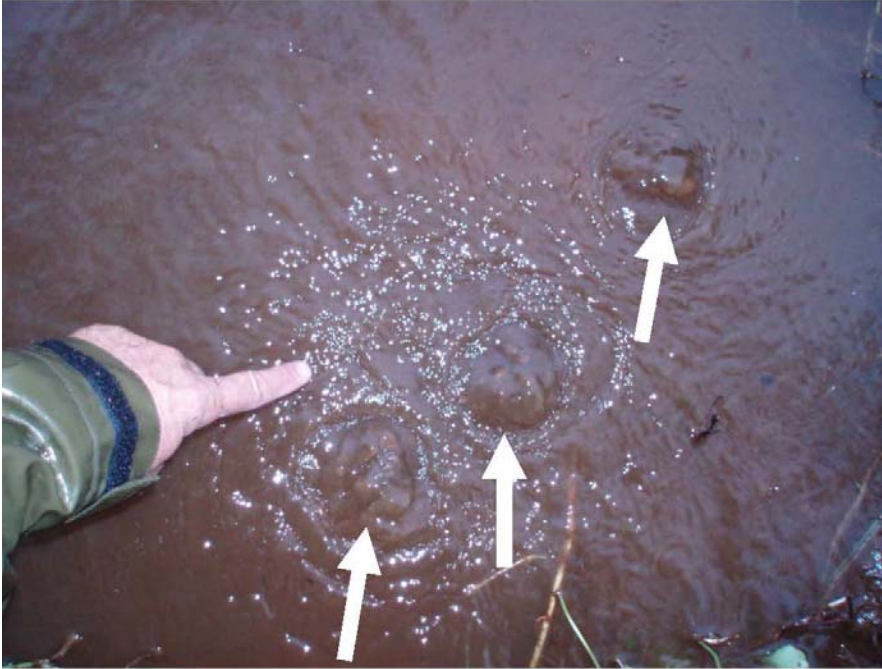
Upon inspection of the downstream toe of the dam in this area, a significant amount of lush old aquatic vegetation was evident in 12 inch-deep ponded water (photos 9 and 10). After a few minutes of inspecting the toe area in hip waders, this inspector found moving water that was barely noticeable as it was surfacing, flowing to the right and to the left as it reached the surface. The aquatic vegetation covering the pond partially obscured the seepage flow from view. Upon clearing the vegetation in about a 6-foot-diameter area, flow from three sandboils was visible breaking the surface of the pond at a visually estimated combined flow rate of about 30 to 40 gallons per minute (photos 9 through 14). The sandboils were transporting and depositing sediment materials in classic sandboil fashion (photo 14). The sandboils were each about 4 to 6 inches in diameter and were located within a 3-foot-diameter area (photos 11 through 14). The sandboil flow was breaking the pond surface and rising to about 1 inch above the surface of the pond (photos 11 through 14).

The sandboils were probed by hand, and it was possible to insert an arm into them up to the shoulder with no resistance except for flowing seepage. The eroded paths of the seepage curved upstream toward the dam embankment. The sandboils were then probed with the total length of a 5-foot-long stick with little or no resistance. At this time, it was decided to probe the sandboils no further because the sandboils were new, and it was not known if further probing would cause a significant increase in seepage flow and sediment transport. The story about the Dutch boy with his thumb stuck into the leaking dike came to mind. The 5-foot stick with flagging material attached was inserted into the ground in the ponded water, a few feet to the left of the sandboils, to mark the location for future inspection and seepage monitoring.

Photo 13.—Waikoloa Reservoir I Dam – Closeup view of the three sandboils (arrows) shown in the previous photograph. Note soil materials in suspension (arrows) in the rising flow from the sandboils breaking about 1 inch above the pond surface.

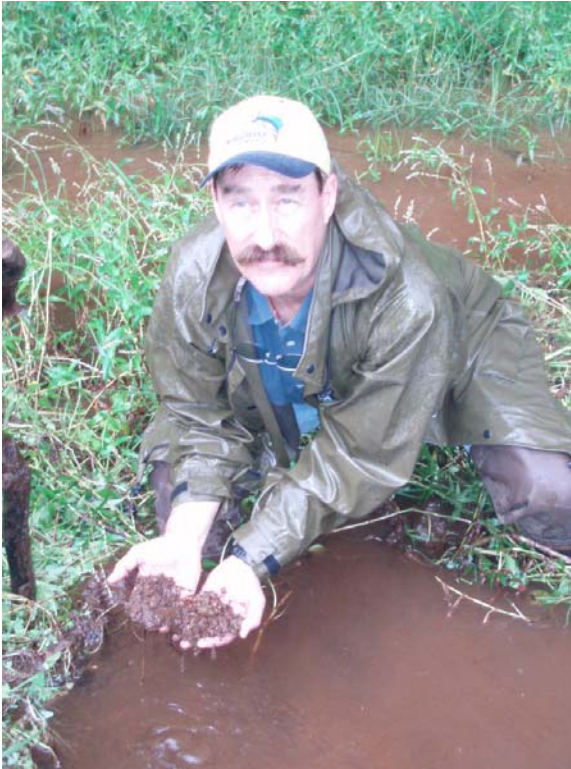
Photo 14.—Waikoloa Reservoir I Dam – Sandboil area shown in previous photographs, prior to lowering the reservoir. Inspector is collecting and examining soil materials from the earthquake-induced sandboils. The three sandboils are flowing at a total combined visually estimated rate of about 30 to 40 gallons per minute, with transported soil particles in suspension and accumulated around the sandboils.

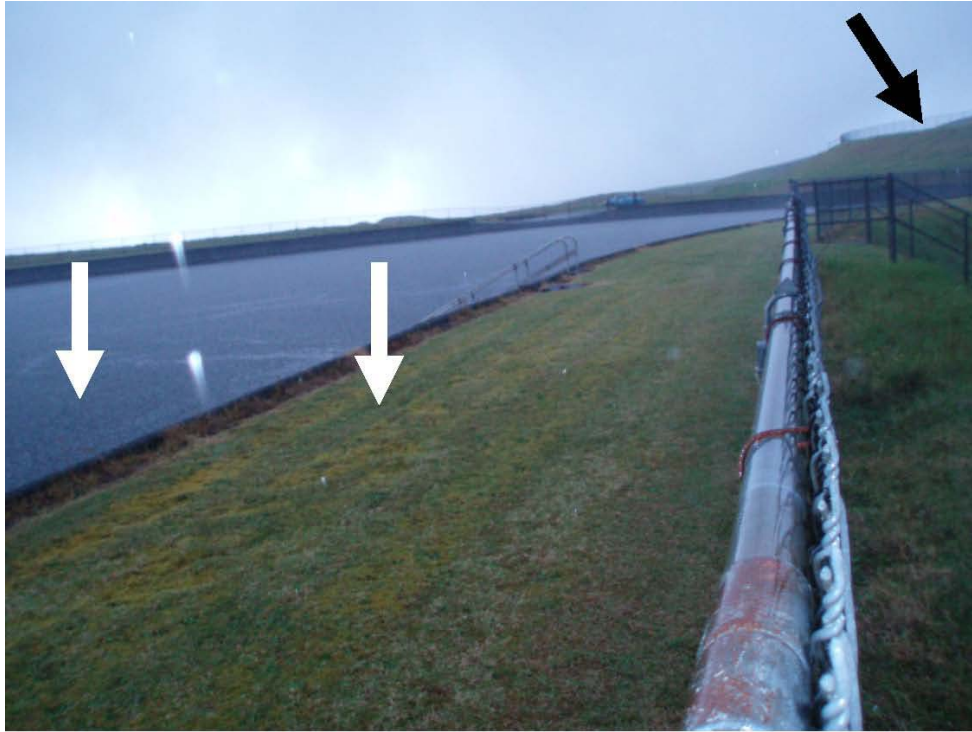
Photo 15.—Waikoloa Reservoir I Dam – Crest of Reservoir I Dam with cracking (middle arrow). Right arrow denotes Reservoir II Dam crest. Note the reservoir concrete lining parapet (left arrow). The Reservoir I sandboils are located at the downstream toe about 20 feet to right of photograph.

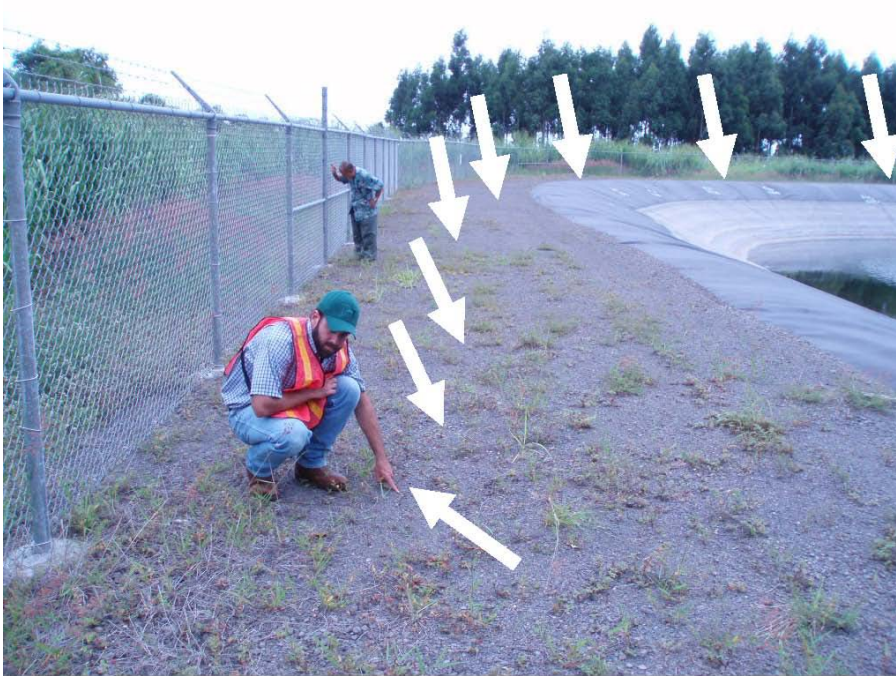
The crest of the dam exhibited several significant new earthquake-induced longitudinal cracks (photos 16 through 18). The largest crack was 460 feet long, up to 4 inches wide at the dam crest, and was probed to a depth of 12 inches (photos 16 and 17). This crack began at 135 feet to the right of the spillway and extended around the corner of the oval-shaped reservoir (photos 16 and 17). A second crack located on the opposite side of the dam crest from the spillway was about 100 feet long, a maximum of about 1 inch wide, and a few inches deep. This crack ran along the location where the reservoir liner material was keyed into

Photo 16.—Paauilo Dam – Lower arrow denotes the left end of the new 460-foot-long earthquake-induced crack (bottom arrow) located 135 feet to the right (facing downstream) of the spillway. Arrows denote the alignment of crack around the corner of the reservoir.

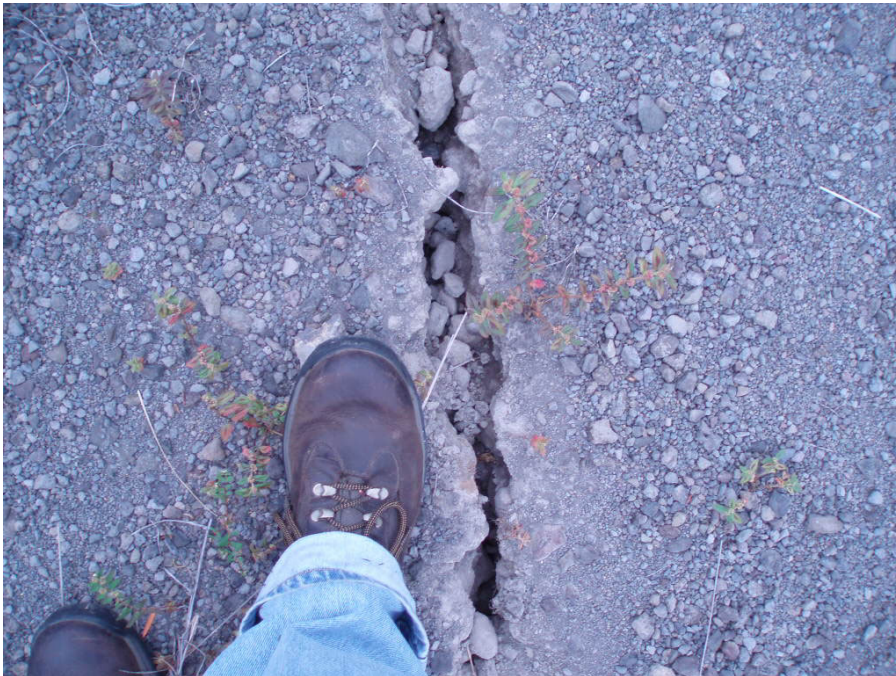
Photo 17.—Paauilo Dam – Closeup view of the new crack shown in previous photograph, with a maximum surface width of about 4 inches.

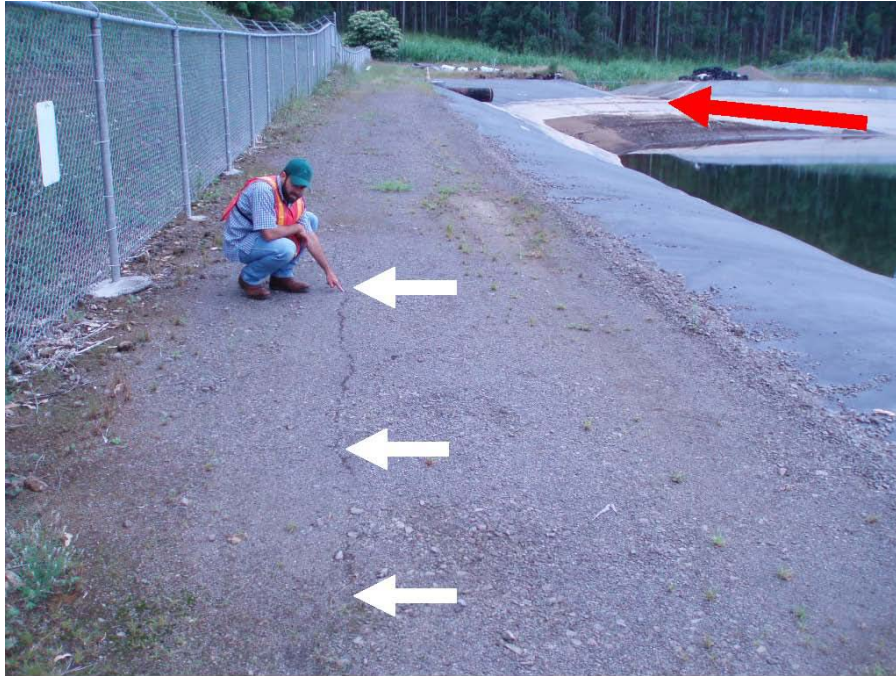
Photo 18.—Paauilo Dam – Short arrows denote the alignment of the new 25-foot-long earthquake-induced crack located 220 feet to the left (facing downstream) of the spillway. The long arrow denotes the spillway.

the dam crest. A third crack located 220 feet to the left of the spillway was 25 feet long, 0.1 inch wide, and a few inches deep (photo 18). The cracks are likely deeper than probed because they could have opened and closed during the earthquakes.

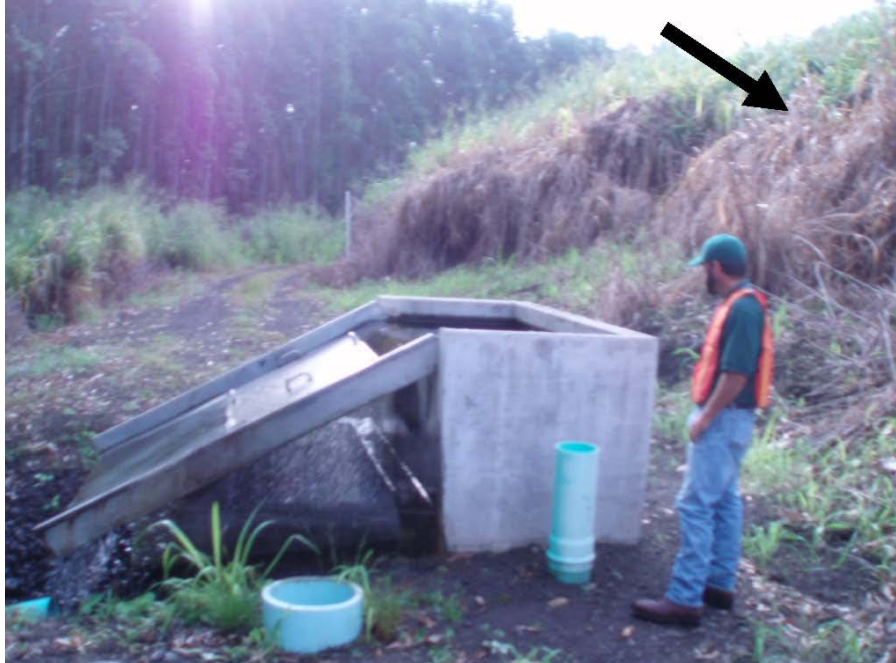
Photo 19.—Paauilo Dam – Outlet works discharge structure with no earthquake damage. Arrow denotes downstream face of the dam. Note significant amount of tall vegetation on the face.

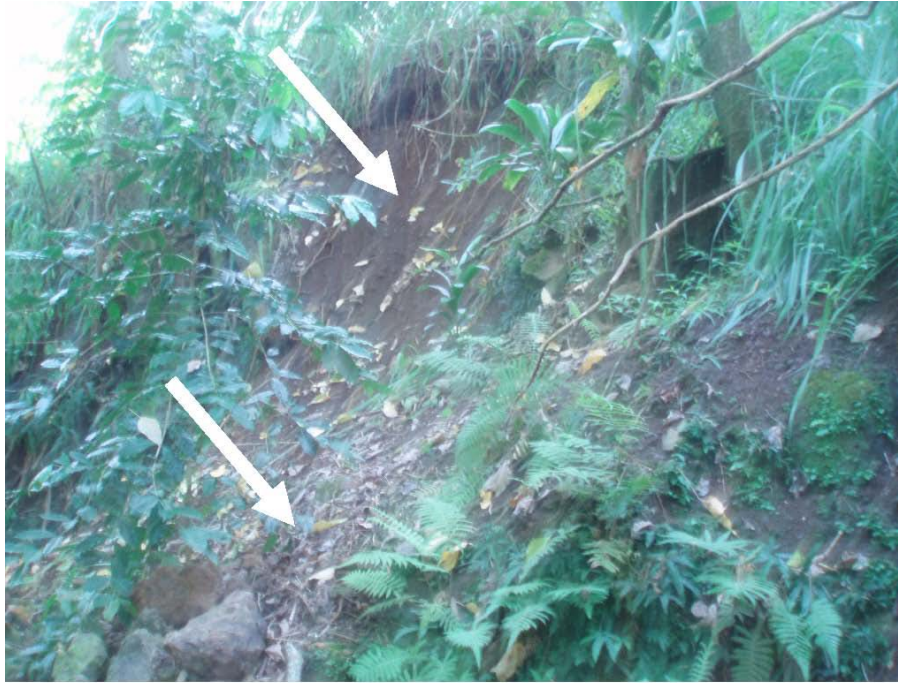
Photo 20.—Paauilo Dam – Typical earthquake-induced new rock and soil slide area (arrows) on the open cut side slopes of the spillway discharge channel.
10/18-19/2006

The only visible new earthquake-induced damage at the spillway was several areas of minor rock and soil slides, each less than 3 cubic yards, on the unlined open cut side slopes of the spillway discharge channel between the dam and the highway culvert (photo 20).

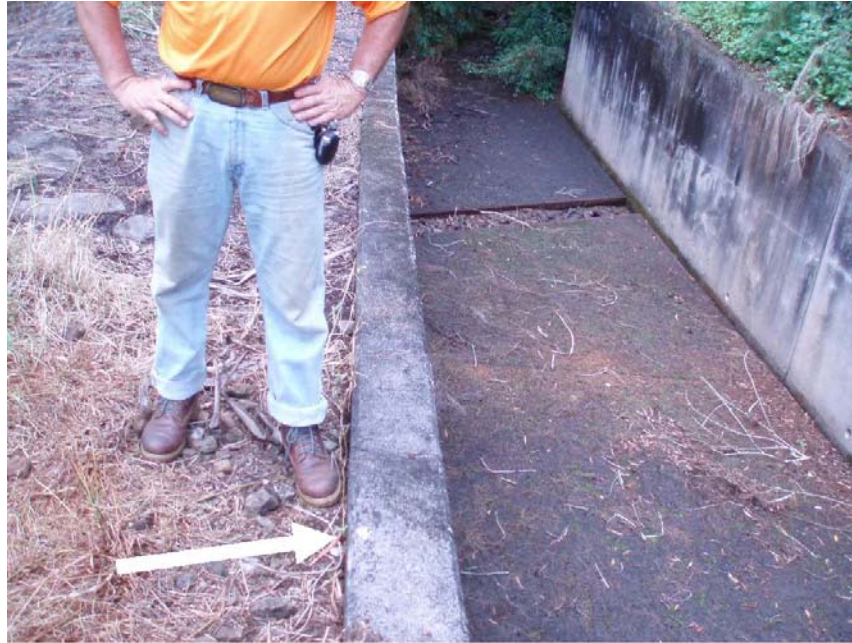
Photo 21.—Puukapu Dam – Minor earthquake-induced separation (arrow) between the backfill and right concrete wall of the Puukapu Watershed Canal facing upstream. The separation is earthquake-induced damage 15 feet long, 0.25 inch wide, and of unknown depth. This is the only location where separation is evident at the canal. The damage is about 300 feet upstream from the dam. 10/20/06

During the inspection, the reservoir was dry. Minor, new earthquake-induced damage was evident at the Puukapu Watershed Canal. The damage was minor separation between the right concrete canal wall and the adjacent backfill material (photo 21). The separation measured 0.25 inch wide, 15 feet long, and of unknown depth. The minor damage was about 300 yards upstream from the dam.

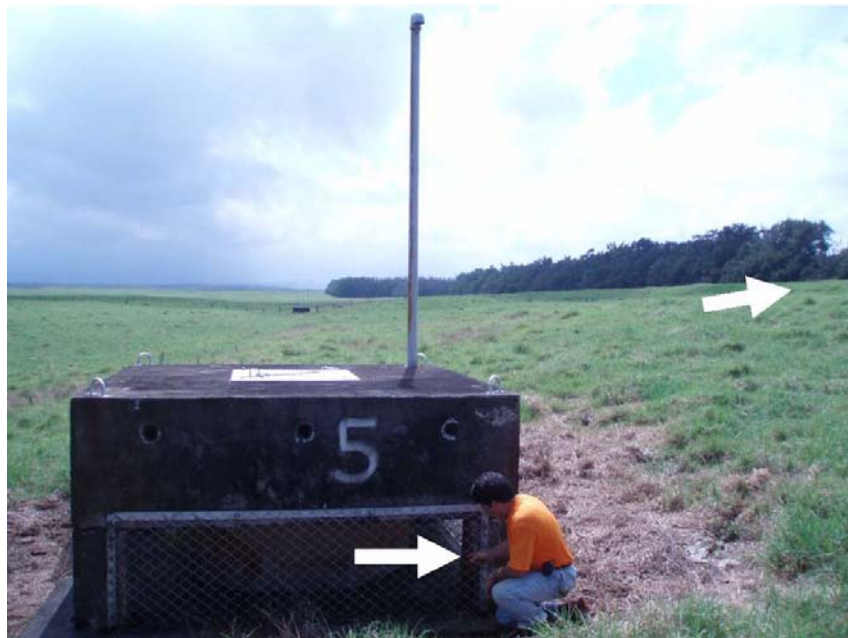
Photo 22.—Puukapu Dam – Spalled concrete and exposed reinforcing steel (left arrow) at the right downstream support column of dry well No. 5. Right arrow denotes the upstream face of the dam embankment. 10/20/06

The only other new earthquake-induced damage was evident at a few minor cracked and spalled concrete areas on concrete columns of the drop inlet structures at dry wells No. 1 and No. 5 (photos 22 and 23). The spalled concrete pieces were between about 8 to 12 inches long (photos 22 and 23). The spalled areas had exposed reinforcing steel bars (photos 22 and 23). It was not possible to enter the dry wells because there were no provisions for confined space entry.

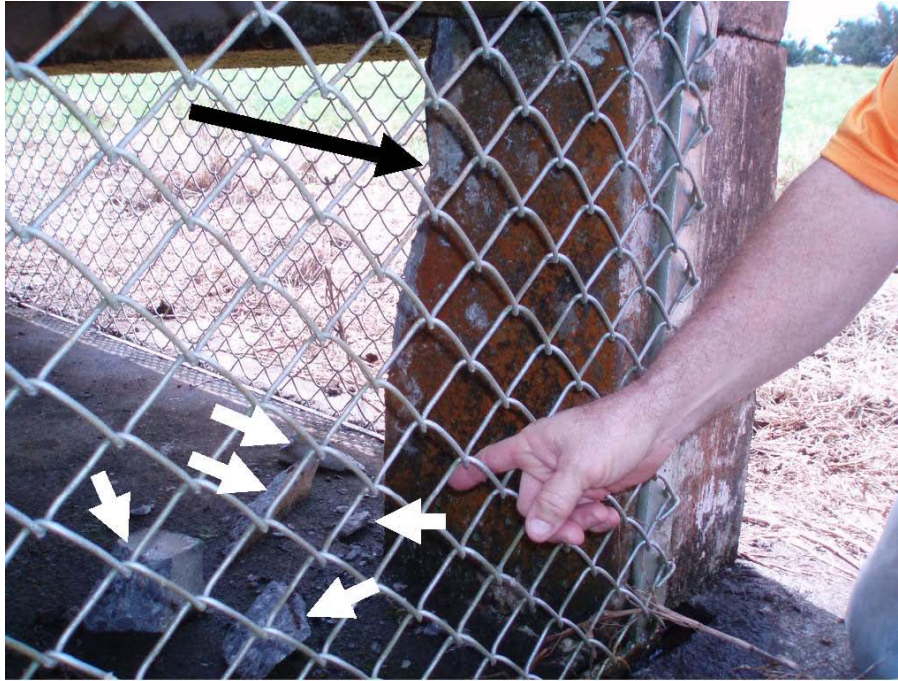
Photo 23.—Puukapu Dam – Closeup view of the spalled concrete and exposed reinforcing steel (long arrow) near top of the right downstream support column of dry well No. 5 shown in previous photograph. Note spalled concrete pieces (short arrows) on floor where man is pointing.

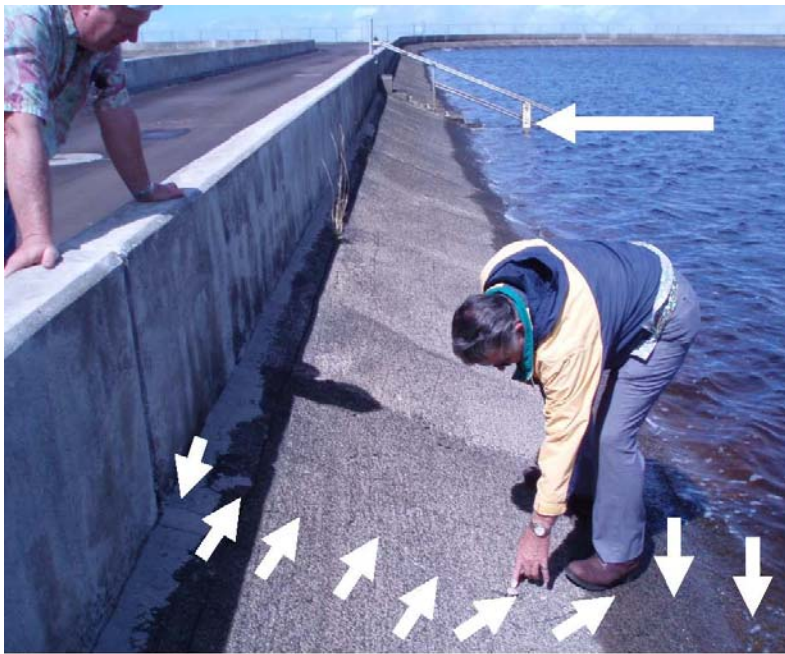
Photo 24.—Kahakapau Dam – New earthquake-induced crack (short arrows) in the concrete lining of Reservoir No. 2 facing downstream. The crack is located 55 feet upstream from the reservoir water surface elevation staff gage (long arrow).

The dam was inspected with assistance from one DLNR and two MCDOWS employees. The MCDOWS personnel provided valuable information regarding the post-earthquake conditions observed. New earthquake-induced damage consisted of a few new transverse cracks in each reservoir's liner shotcrete coating and several cracks in the parapet wall at the same location as the cracks in the shotcrete (photo 24). The cracks in the shotcrete were about 0.1 to 0.2 inch wide and extended from the top of the shotcrete down as far as could be seen into the reservoir water (photo 24). It is unknown if the cracks extend into the dam

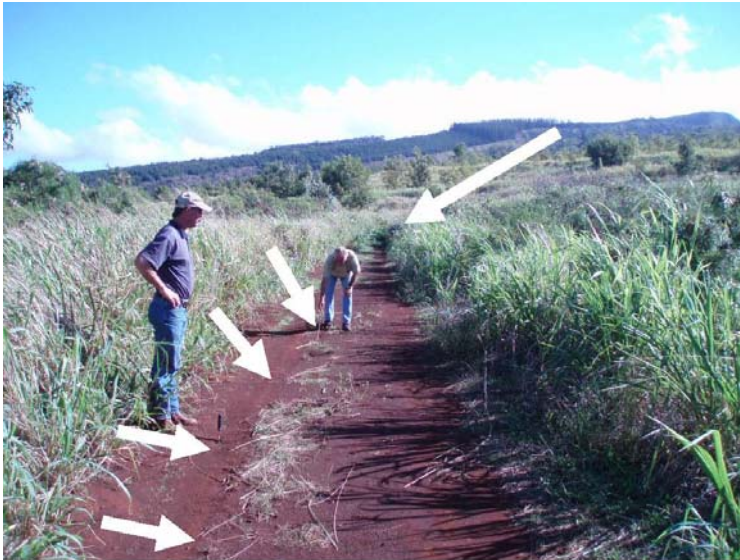
The only new earthquake-induced damage evident was a crack on the dam crest located about 50 feet from the right abutment (photos 25 and 26). The 60-foot-long, 2-inch-wide, 4-foot-deep crack was located in the middle of the crest (photos 25 and 26). It should be noted that the downstream face could not be completely inspected due to the significant tree and bushy vegetation growth.

Photo 25.—Hanakoo Dam – Right end (short arrows) of a 60-foot-long, 4-foot-deep earthquake-induced crack (probed 4 feet with coffee tree stick, crack could be deeper) on the crest of the dam facing the right abutment. Coffee tree stick is slender and stiff, good for probing. Right end of crack starts 50 feet to the left of the spillway (long arrow denotes spillway pipe).

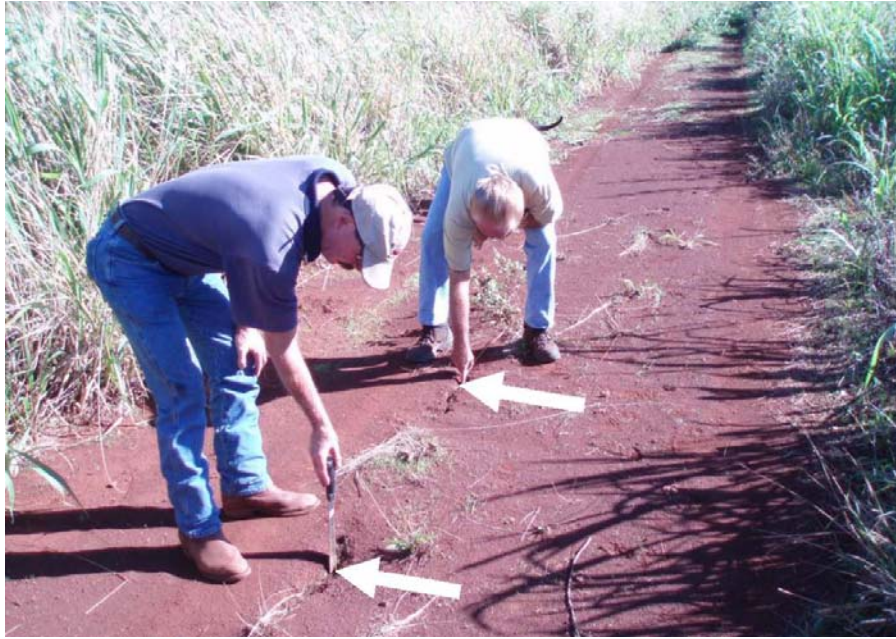
Photo 26.—Hanakoo Dam – Closeup view of the right end of the 60-foot-long crack (arrows) shown in previous photograph. Note the machete inserted into the crack at lower arrow.

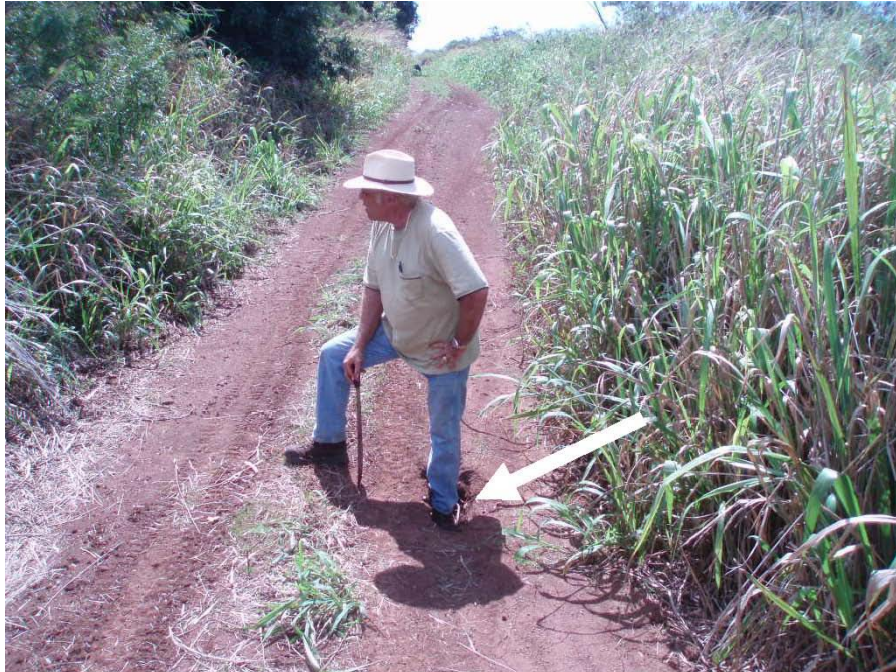
Photo 27.—Horner Dam – 2-foot-long, 1-foot-wide, 2-foot-deep sinkhole (arrow) on crest of dam of the left basin (dry reservoir) facing the left abutment. Sinkhole is 108 feet to the left of the berm dividing the left and right basins of the reservoir. 10/26/06

The only new earthquake-induced damage evident was a minor sinkhole on the crest of the left (dry) basin (photo 27). The sinkhole was 2 feet long, 1 foot wide, and 2 feet deep, and was located 108 feet to the left of the berm dividing the left and right basins (photo 27). A 12-inch-diameter eroded hole on the downstream face of the basin was located 5 feet below the dam crest and was connected to the sinkhole. The hole was caused by water entering the sinkhole and exiting at the downstream face. The hole on the downstream face was located by this inspector by crawling on hands and knees through wild pig “tunnels” in the dense vegetation on the downstream face. The face was otherwise inaccessible due to the vegetation. The Kaanapali Farm Services employee noted that the sinkhole was located at the same location where the dam breach failure occurred and that the failed area was repaired in 1992 with embankment material that might not have been adequately compacted in place.

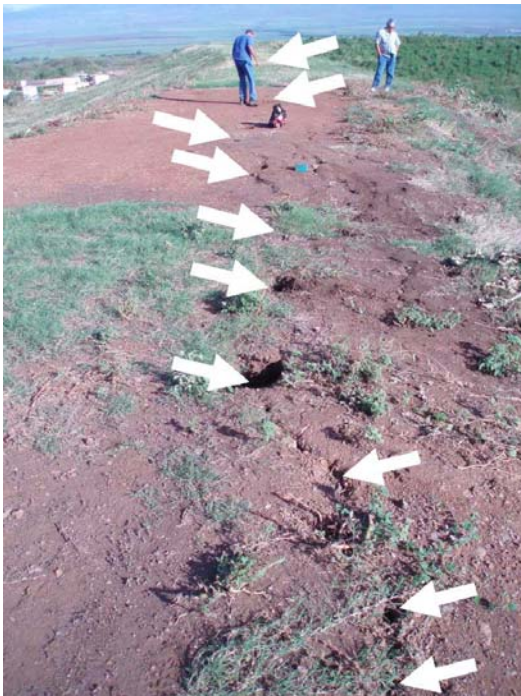
Photo 28.—Kehalani Offsite Retention Dam – Crest of the dam facing the right abutment from 40 feet right of the left end of the dam. Arrows denote a 150-foot-long, 10-inch-deep earthquake-induced longitudinal crack on the crest that starts at 40 feet to the right of the left end of the crest. Note the 12-inch-diameter, 10-inch-deep holes along the crack.

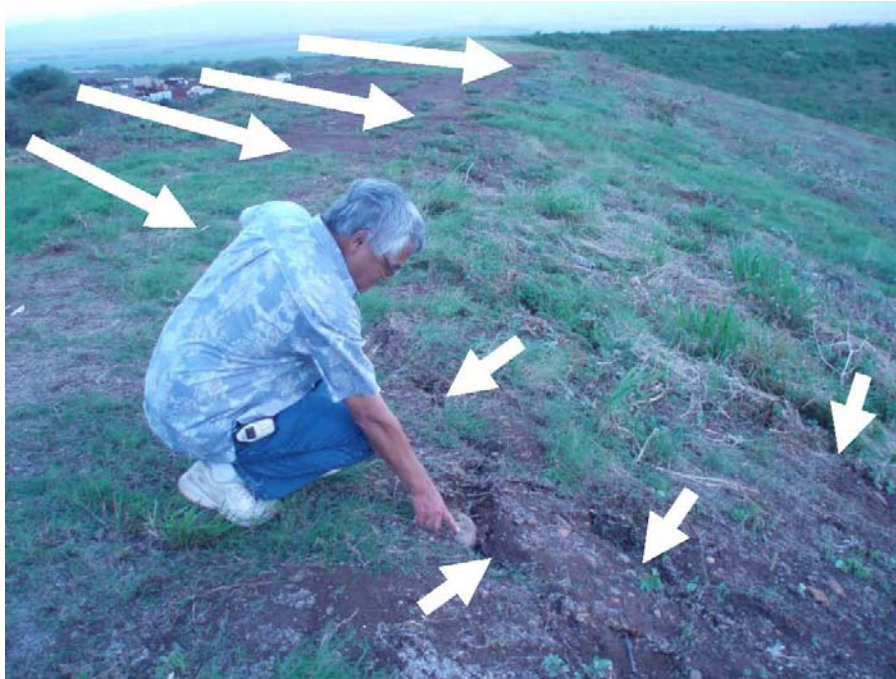
Photo 29.—Kehalani Offsite Retention Dam – Earthquake-induced cracking and sloughing (short arrows) on the upstream shoulder of the dam located about 20 feet left of the cracking shown in the previous photograph, facing the right abutment from about 20 feet to the right of the left end of the crest. Long arrows denote the 150-foot-long crack on crest shown in previous photograph.
