Water Operation and Maintenance Bulletin

No. 227

Carbon Fiber Reinforced Polymer Repair of Reinforced Concrete Pipe

December 2011

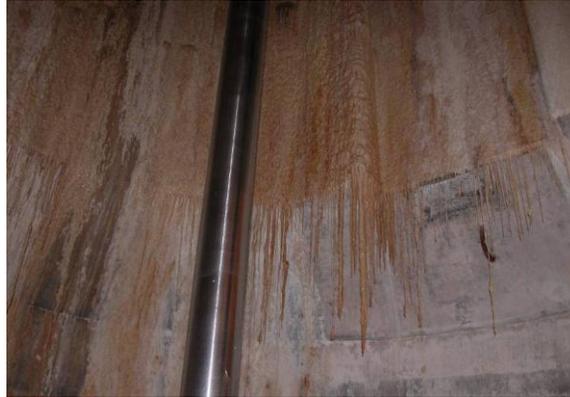
The walls of the shaft and bonnet chamber are covered with calcite as shown on figure 2. The calcite has an average deposit thickness of 0.5 to 1 inch as shown on figure 3. Calcite has been measured as thick as 6 inches in some locations. There is standing water on the bonnet chamber floor due to seepage, and corrosion of the air inlet pipe and bonnet cover has occurred. The extent of the calcite deposits is preventing the operation of the door to the chamber as shown on figure 4. If the door cannot be sealed and the gate and bonnet cover fails, then water directly from the reservoir will flow through the door, down into the penstock tunnel, and then out into the powerplant yard.

Figure 2.—Calcite deposits observed on the walls of the bonnet chamber. Excessive seepage over time has resulted in stalactites.

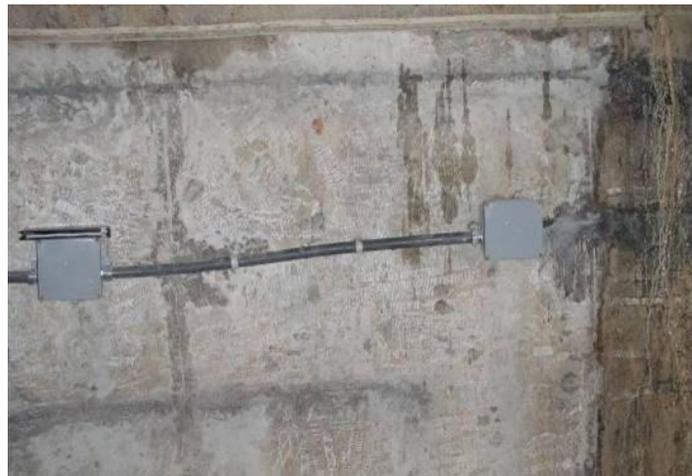
The as-left condition of the wall of the chamber where the test section was located showed a saturated or wet concrete both to sight and touch. After about 2 weeks of operation, the system was evaluated and data collected from the SD card. Figure 10 shows dry areas of concrete after 2 weeks of operation. The humidity in the chamber is nearly 100 percent due to high levels of water and moisture. The weather strip installed to act as a drip tray was full of water and had calcite in it and was not draining as designed, which resulted in water dripping down onto the wall below in some areas.

Figure 10.—Concrete wall at location of installation after 2 weeks of operation. The wall was dry to sight and touch over most of the test section.

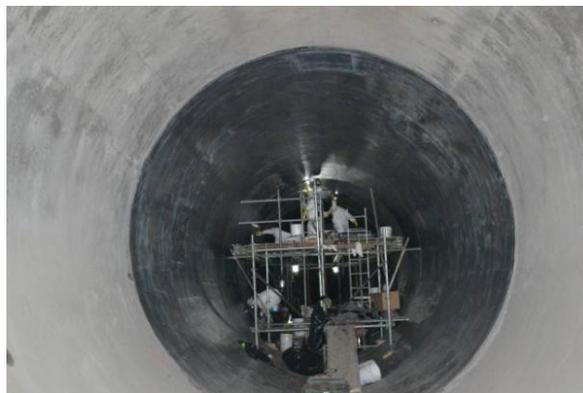
Figure 1.—Completed CFRP-lined section of the siphon.

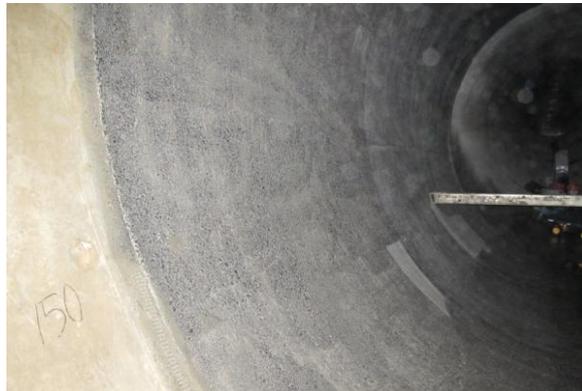
Figure 3.—Hydroblasted surface showing repaired areas of pipe.

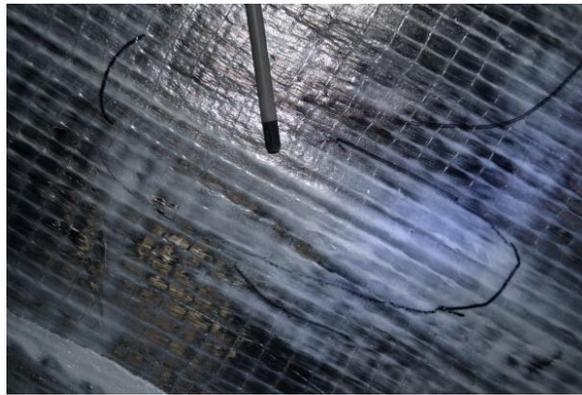
After the CFRP had cured for 24 hours it was inspected for bubbles, delaminated areas, and fabric tears. It was inspected using a sounding method, and repair areas (figure 12) were identified. The repair method was selected based on the size of the defect. Defects smaller than about 2 to 3 inches in diameter were repaired by using epoxy injection. A hole was drilled in the defect as shown on figure 13, and Tyfo® S epoxy was injected into the defect (figure 14). For defects larger than 2 to 3 inches in diameter, the delaminated layers of CFRP material were removed. Figure 15 shows the removal of a delaminated CFRP layer. Squares of saturated fabric were applied to the surface as shown on figure 16, with one layer of new fabric for each layer removed. The patch applied was larger than the defect such that there was a 4-inch overlap onto the surrounding area, and each additional layer of fabric applied had a 4-inch overlap onto the area surrounding the previous layer. The CFRP will be inspected after 1 year of service and then every 5 years during the required pipe inspection.

Figure 12.—Delaminated area of CFRP identified for repair.
