Water Operation and Maintenance Bulletin

No. 238

Cedar Bluff Dam Outlet Works Leaking Tunnel Repair

Grand Coulee Dam – John W. Keys III Pump-Generating Plant Unit P2 Discharge Tube Stiffener Replacement

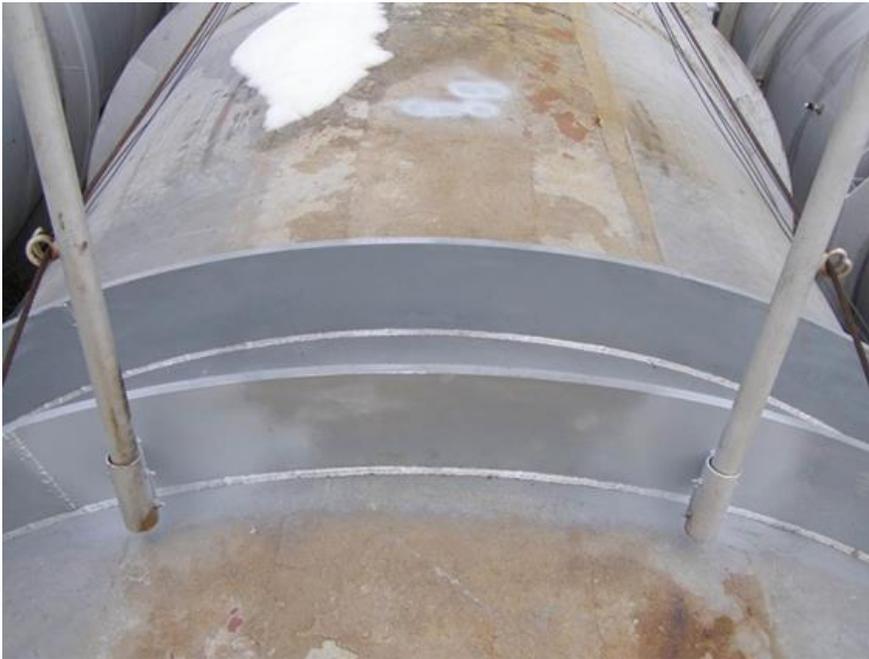
Cover photograph: Completed installation of new stiffeners, coating of exterior adjacent pipe shell, and installation of life line poles on the Unit P2 discharge tube at Grand Coulee Dam.

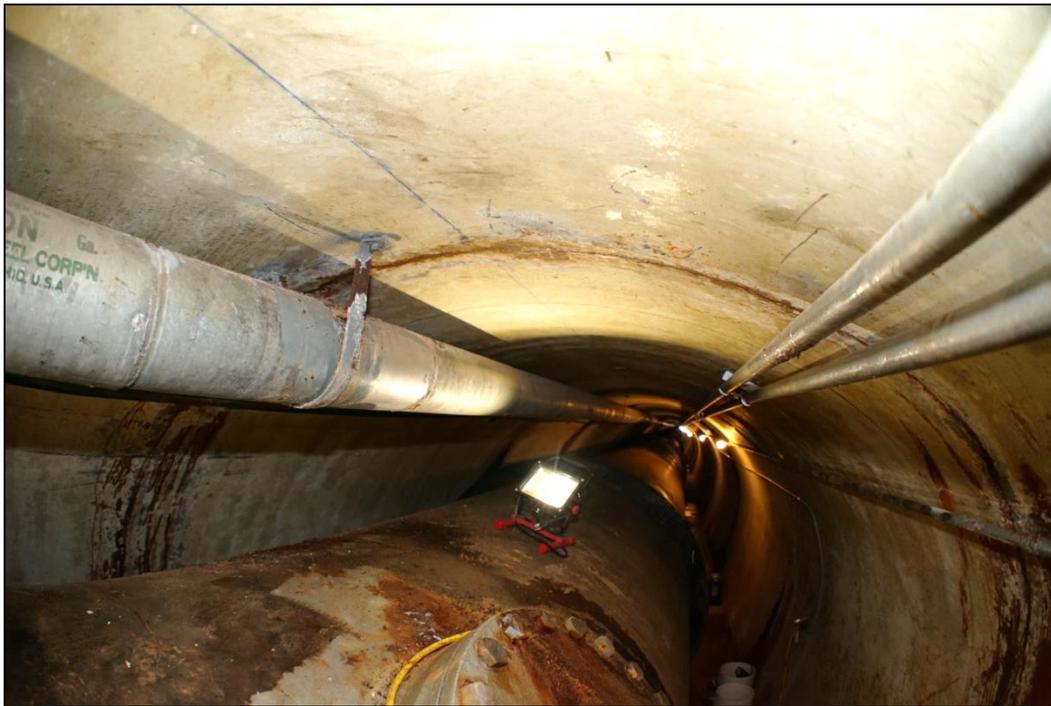
The crack was over the outlet pipe access hatch about 500 feet upstream of the control house (figure 1) and was actively leaking and contributing to excessive corrosion on the hatch, limiting its use. The CGSL recommended using chemical grouting to seal the crack over the hatch.

Figure 1.—Crack location over outlet pipe access hatch.

The crack at Cedar Bluff was likely due to shrinkage stress concentrations at construction joints. Several cracks were observed at regular intervals and were oriented radially. There were no other issues, such as settlement, defective

The chemical grouting solution chosen to keep the crack sealed even with future movements was a flexible hydrophobic polyurethane grout. The grout is a moisture-activated polyurethane resin that is a hydrophobic grout; it can withstand repeated wet/dry cycles and does not shrink in the absence of water. Unlike typical hydrophobic grouts, this particular grout has the ability to remain flexible and stay watertight if the crack moves.

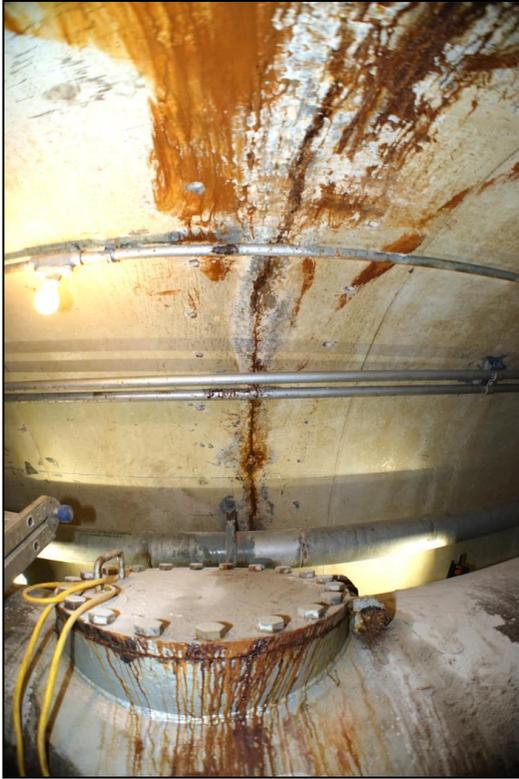
Figure 2.—Repair procedure showing drilled holes (the cover is coated with concrete dust).

Design drawings indicated that the concrete tunnel wall thickness was 2 feet 6 inches. Grouting is performed to intersect the crack at the midway point in the concrete thickness to force grout inside and outside of the tunnel. Eighteen-inch-long injection holes were drilled about 12 inches from the crack at a 45-degree angle to intercept the crack at about 12 inches deep (figure 2). Since the clearance between the pipe and wall was limited on the backside of the pipe, the injection holes were started with shorter bits, and the longer bits were switched out when depth permitted.

A total of 23 holes were drilled along the crack. The holes were staggered and located about 6 inches apart. Once the holes were drilled, concrete dust was cleaned out using air pressure. Plastic hammer-in packers were placed in the holes and Zerk fittings attached to the packers. Water was used to test and prime the injection holes and to test for connectivity between the holes and the crack. During the water connectivity test, water was observed draining through the crack from all ports, indicating good connectivity.

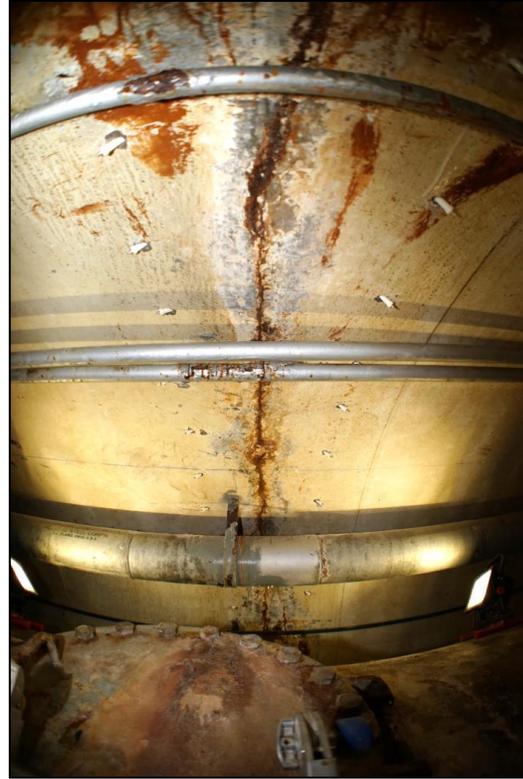
Figure 3.—Repair procedure showing ports.

The grout was catalyzed and injected using an airless paint sprayer fitted with a Zerk connection port and a check valve and ball valve to control flow. In this case, the catalyst was dosed at the maximum allowed since the moisture in the crack was minimal. This allowed for a quick set time, which was verified with a cup test. A cup test consists of adding the catalyzed grout to water, mixing, and observing the time to set.

The injection assembly is kept on a port using pressures of about 50 to 100 pounds per square inch until the grout begins seeping from the crack opening. Then the assembly is moved to the next port until all ports are injected. In places where water is still seeping, the assembly is reattached, and additional

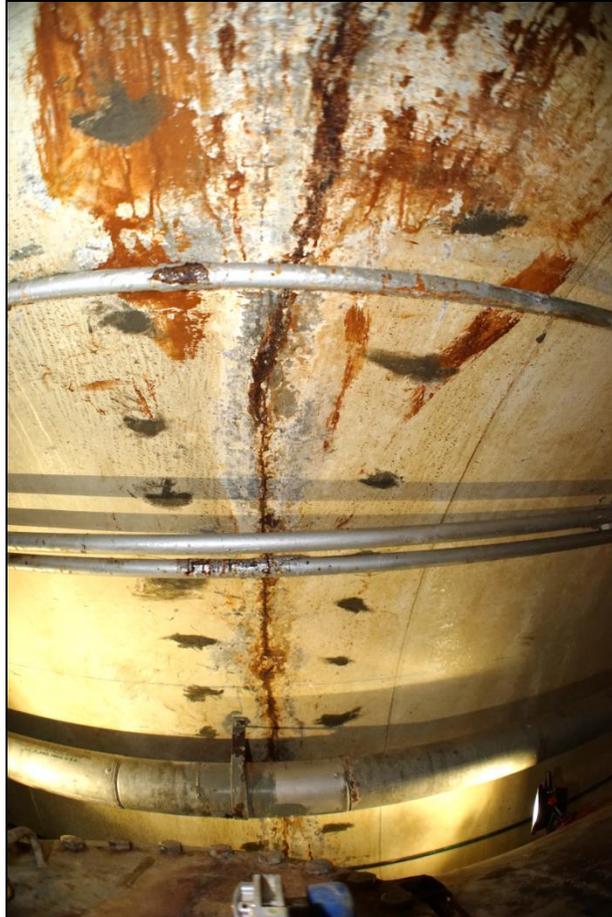
The repair was allowed to cure overnight, and when the repair team arrived the next morning, the crack was completely dry. The next step was to remove the hammer-in packers from the ports. The Zerk fittings were removed; then, a slide hammer fitted with a threaded end was used to remove the packer. The grout holes were then filled with a stiff non-shrink cementitious grout (dry pack) (figure 4), which was mixed in small amounts so that it didn't set up before it was able to be used.

Figure 4.—Finished repair showing grouted injection holes.

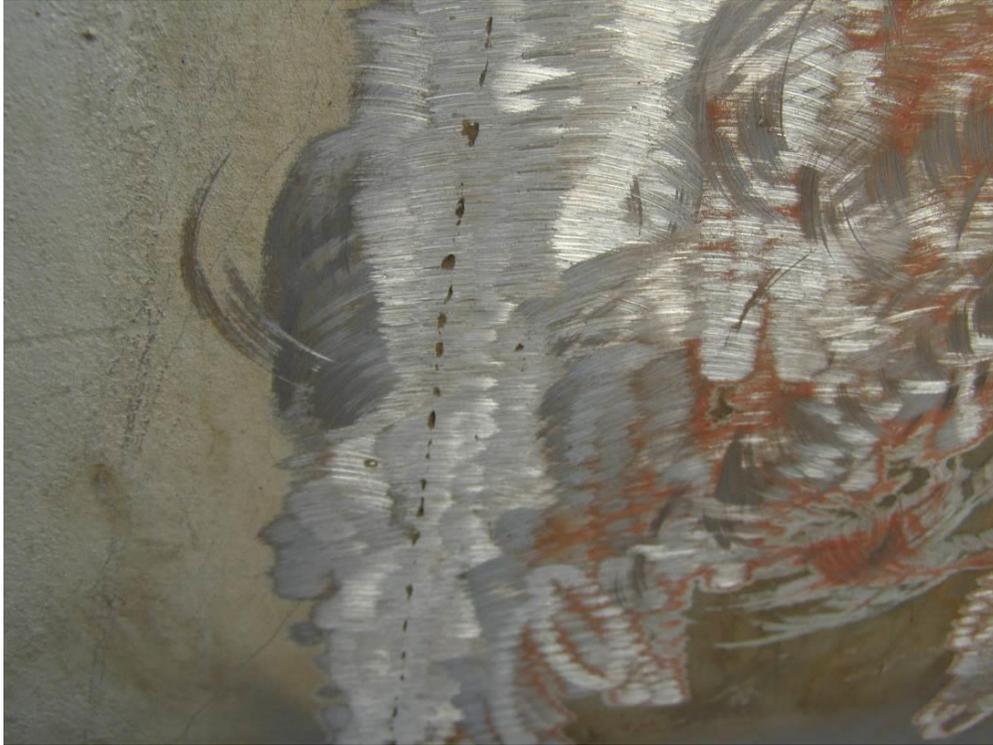
Replacement of the 5B-H stiffener began on October 14, 2014, shortly after the conclusion of the irrigation season. The crew at Grand Coulee began by removing the existing H-stiffener. Once the stiffener was removed, it was discovered that there was significant undercutting in the pipe shell along the fillet welds that held the stiffener in place (figures 1 and 2). The undercutting needed to be ground down and then weld repaired. The crew discovered a 7-inch crack near the pipe crown during the process of grinding out the undercutting. The crack became larger during grinding from the outside of the pipe. The crack was ground away and completely re-welded for a full repair. The repair of the crack required 1 root pass and 5 cover passes to complete and was subsequently ground flush and penetrant tested.

Figure 1.—Undercutting in pipe shell observed along H-stiffener fillet weld after stiffener removal.

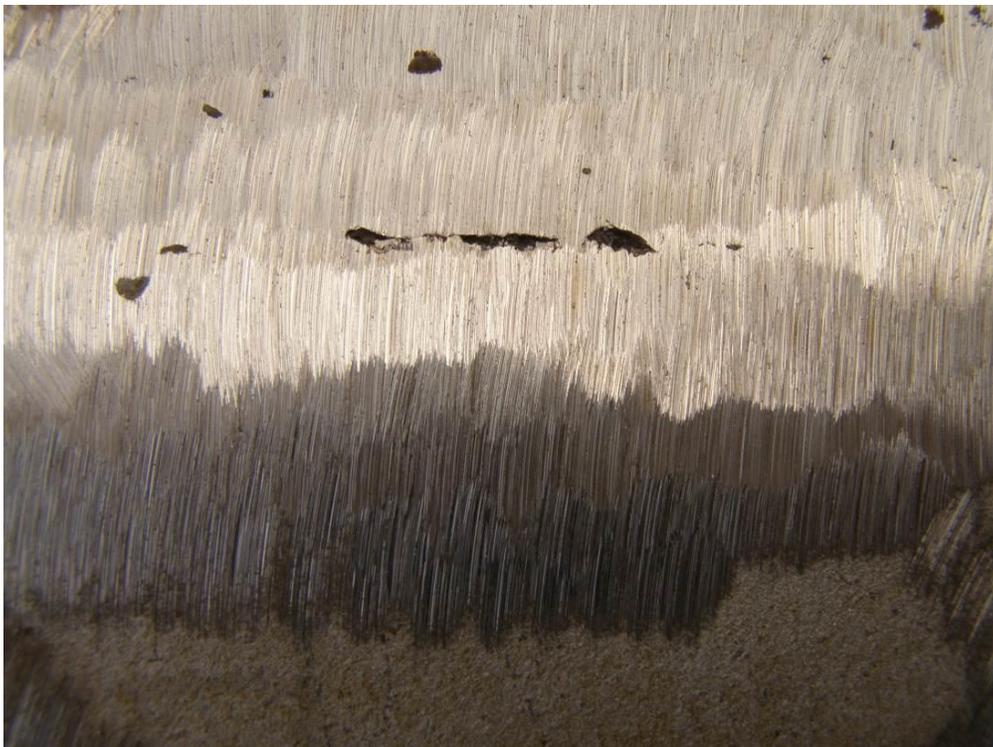
Figure 2.—Undercutting observed on weld under flange after H-stiffener removal.

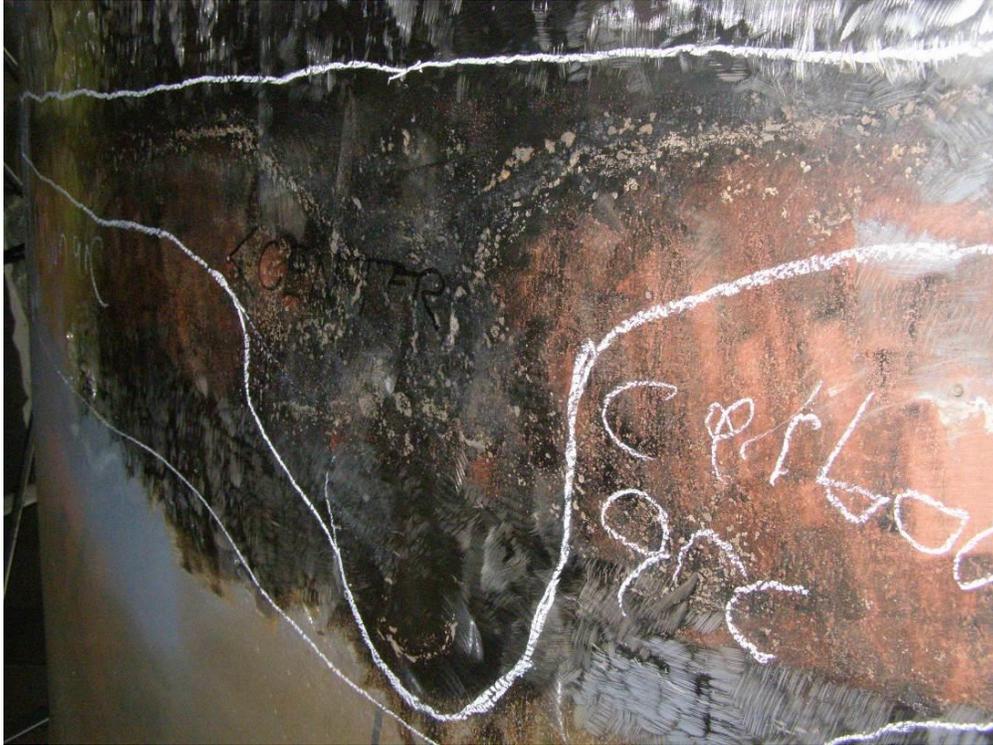
In addition, the leakage through the crack at the pipe crown had created a large area of crevice corrosion in the 7/16-inch-thick pipe shell under the stiffener flange, near the pipe invert, approximately 3 feet long by 6 inches at the widest (figure 3). The metal losses and pits up to 1/8 inch in depth necessitated repairs. Two options were considered: (1) cut-out the compromised portion of the pipe shell and replace with new 1/2-inch-thick steel plate or (2) arc gouge the corrosion and repair the cavity using a weld procedure similar to cavitation repairs. The latter option was chosen, and a carbon arc was used to remove the existing corrosion (figure 4). The approach did not require welder access to the inside of the pipe. The average depth of gouging was 1/8 inch, with several spots going up to 3/16 inch.

Figure 3.—Corrosion pitting 1/8 inch in depth under the H-stiffener flange.

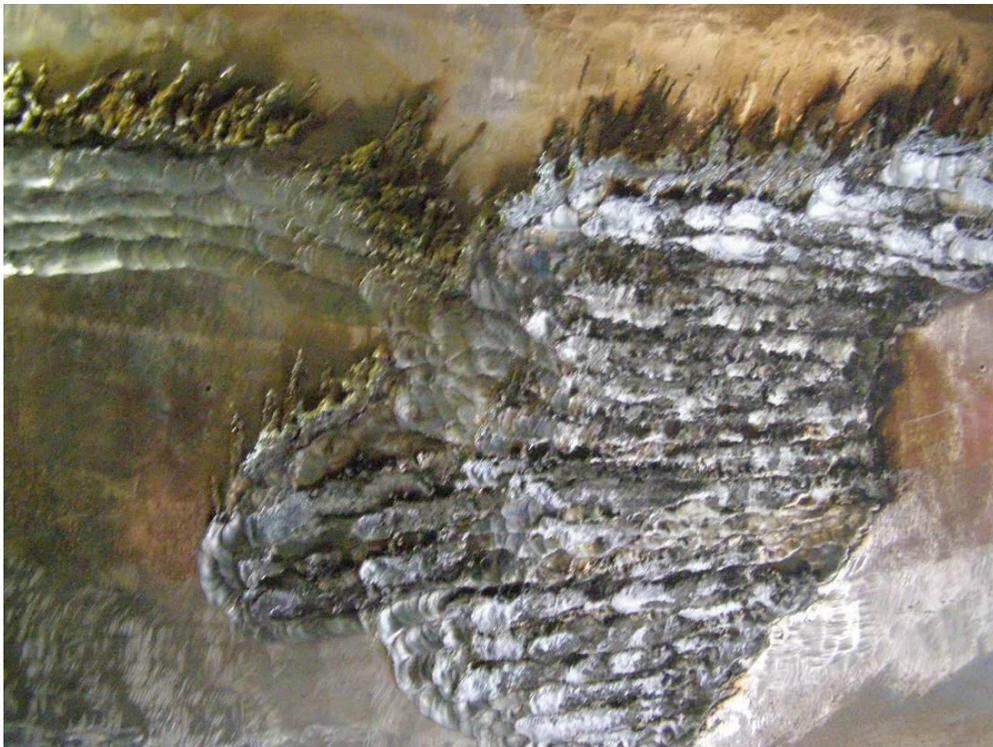
Figure 4.—Corrosion area under stiffener flange after arc gouging.

Arc gouging was followed by grinding and penetrant testing for additional surface defects. Welding required significant time and approximately 30 pounds of weld rod to completely fill the area.

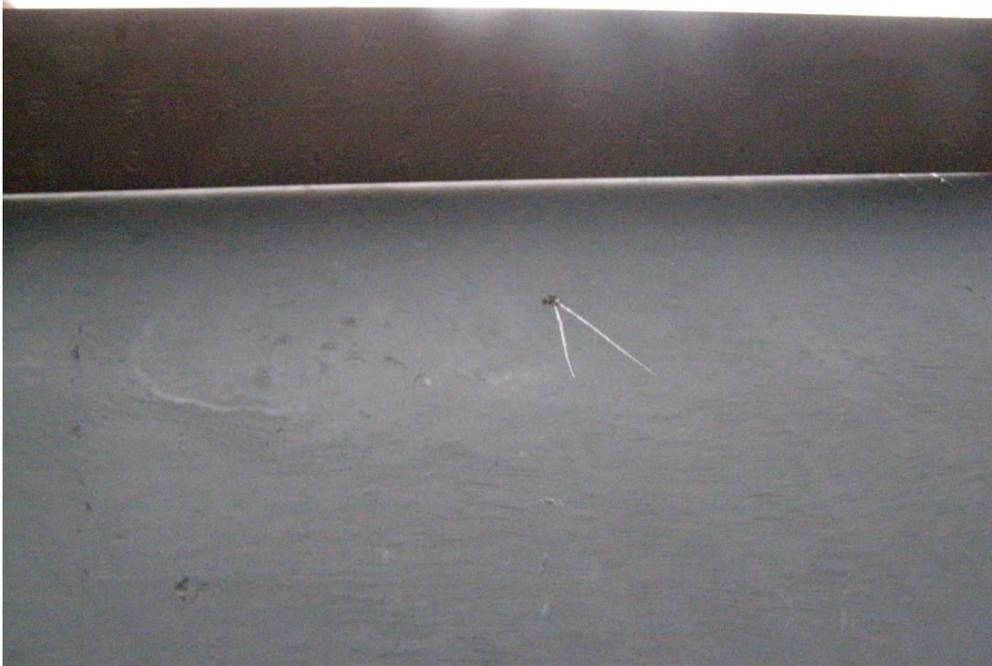
The original plan was to replace the 5B-H stiffener with a single 1-inch-thick plate stiffener 9 inches in height. However, once the original stiffener had been removed, field staff noted that the pipe appeared to be deformed in the area where the H-stiffener had been installed. The field team described the pipe at that location as “appearing like a balloon with a rubberband around it.” Figures 5 and 6 illustrate the pipe deformation that was observed. In other words, the pipe in the areas upstream and downstream had bulged out. In addition, portions of the pipe from 20 to 45 degrees from the top on either side appeared to be deformed, creating fit-up issues for the new stiffeners. The decision was made to provide two similar plate stiffeners to create a pair of stiffeners (14–16 inches apart) on either side of the affected area. The welded overlay used to repair the corroded pipe shell near the invert also factored into the decision to provide two new stiffeners.

Figure 5.—It was noted that the pipe in the area of removed stiffener had bulged out both upstream and downstream in a manner analogous to a rubberband around a balloon.

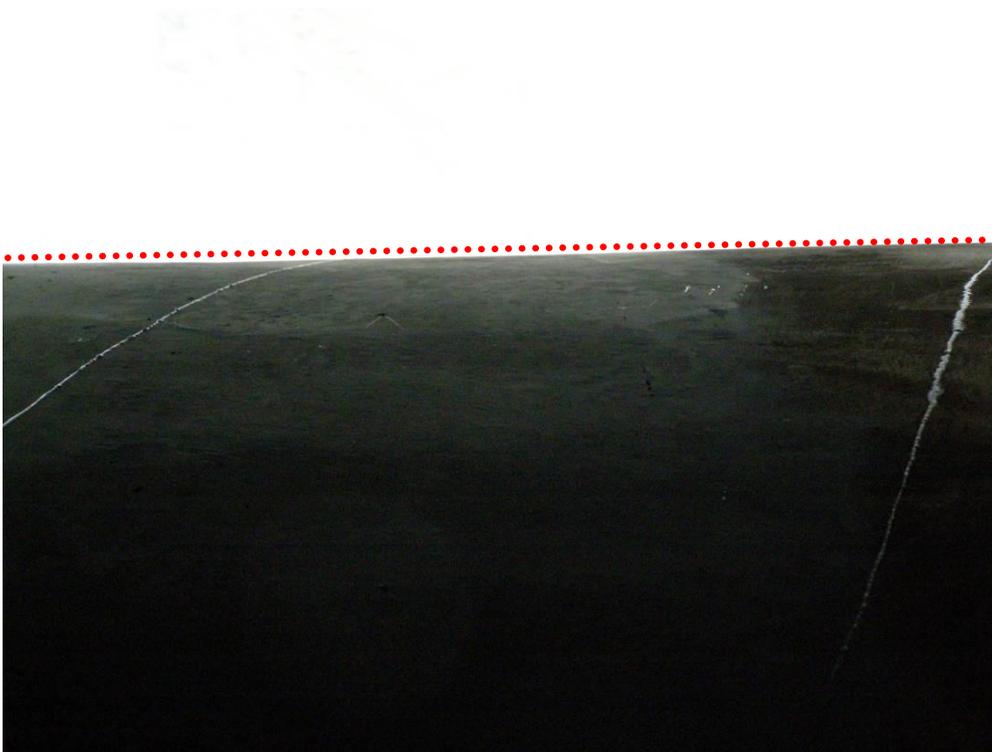
Figure 6.—Pipe deformation is evident near previous stiffener location.

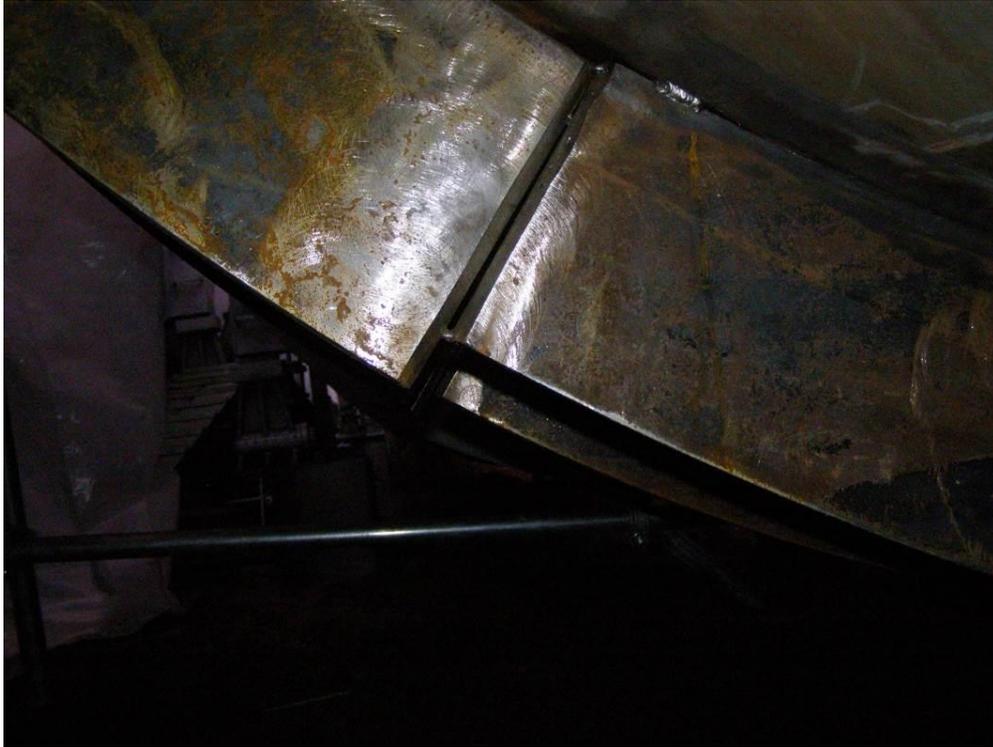
Figure 7.—The first two segments were field fit and required cut and feathering to achieve a smooth transition between segments.

Although the new stiffeners were located away from the pipe shell deformed area where the old H-stiffener had been installed, some pipe out of round was noted when it was time to begin tacking the new segments to the pipe. The first approach was to field fit the machined stiffener segments to the existing pipe by adjusting the inside diameter of the stiffener segment to match the pipe curvature. This was initially done for two segments but ultimately proved to be time consuming for the remaining stiffener segments. Also, field fitting the bottom segments on each stiffener created an offset with the adjacent stiffener segments (figure 7). This offset required cutting and feathering to smooth the transition. Instead, a clamp was tack welded to the pipe and to each new stiffener segment. The clamp was then adjusted to reduce the gap between the pipe and the stiffener segment.

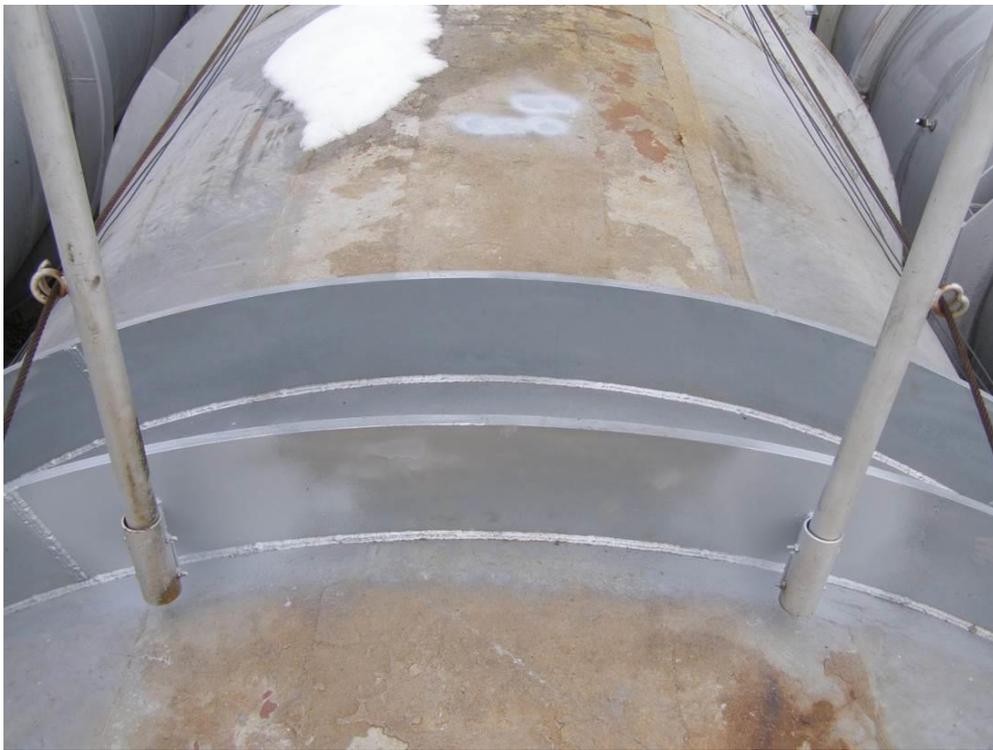
Figure 8.—Completed installation.

Once welding was complete, the new stiffeners and exterior of the adjacent pipe shell were coated, and life line poles were installed (figure 8). No inspection or repair of potential damage to the paint on the inside of the pipe shell at the stiffener repair areas was performed.
