Water Operation and Maintenance Bulletin

No. 239

Reservoir Sedimentation: Impacts to Operations and Maintenance,
and Potential Solutions

Leadville Mine Drainage Tunnel Treatment Plant Unwatering Under
the Retention Pond

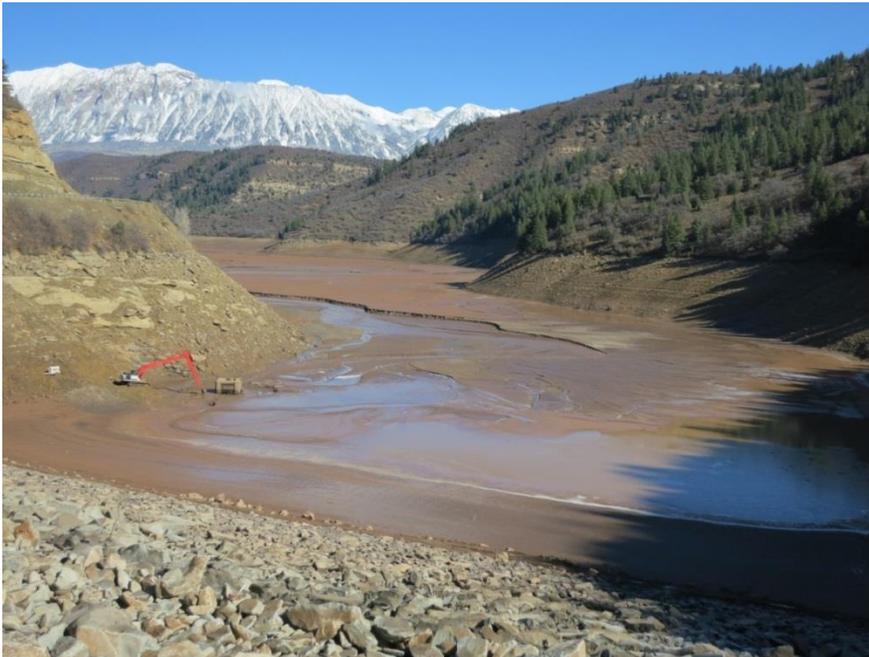
Cover photograph: View looking upstream of Paonia Dam showing the arrival of reservoir sediment and partial burial of the outlet works in November 2014.

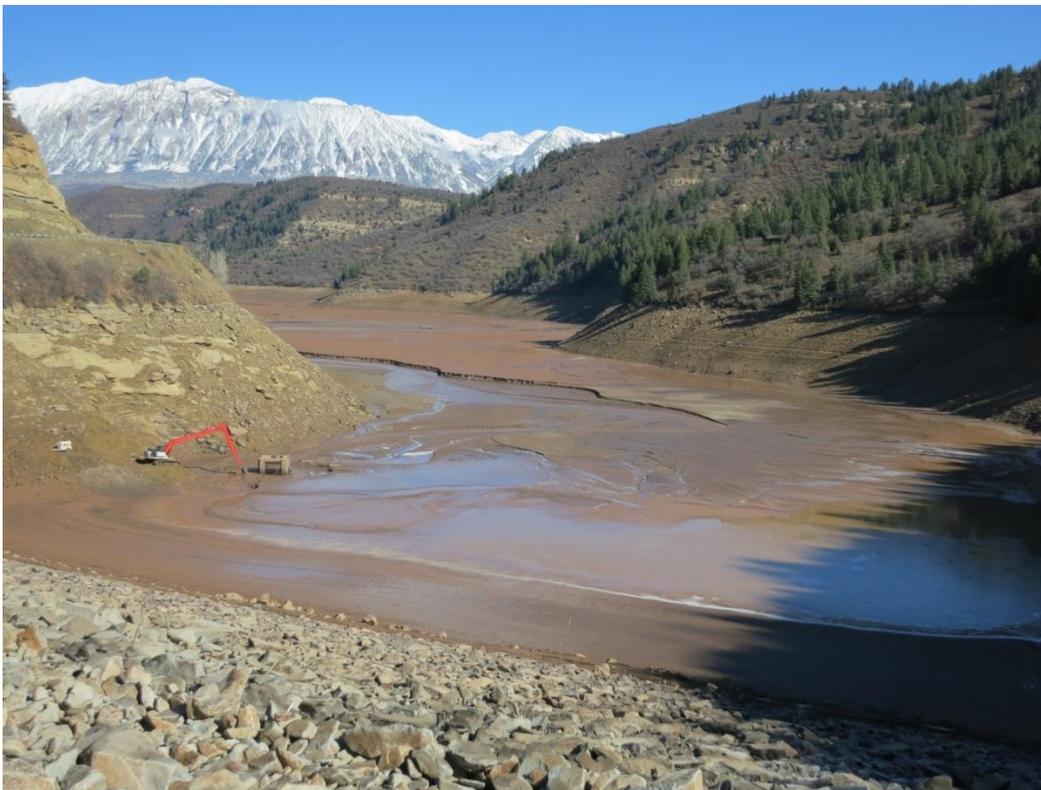
Until fall 2014, the flushing strategy was able to pass a measurable amount of sediment through the long, narrow reservoir (approximately 3 miles long and 0.2 mile wide) and downstream. However, reservoir drawdown in late October 2014 revealed the entire reservoir dead pool and 6 feet of the active pool

Figure 3.—View looking upstream of Paonia Dam showing the arrival of reservoir sediment and partial burial of the outlet works in November 2014 (photo courtesy of Philip Ipson, Western Colorado Area Office).

had filled with sediment (figure 3), and the outlet works intake trashracks became partially plugged with a mixture of submerged debris and sediment (figure 4). Due to the recent discovery of lost dead pool capacity and sediment levels above the intake sill elevation, the original study objective of developing a long-term reservoir sustainability plan to manage inflowing and deposited sediment more efficiently was altered to include short-term strategies for water delivery during the 2015 irrigation season.

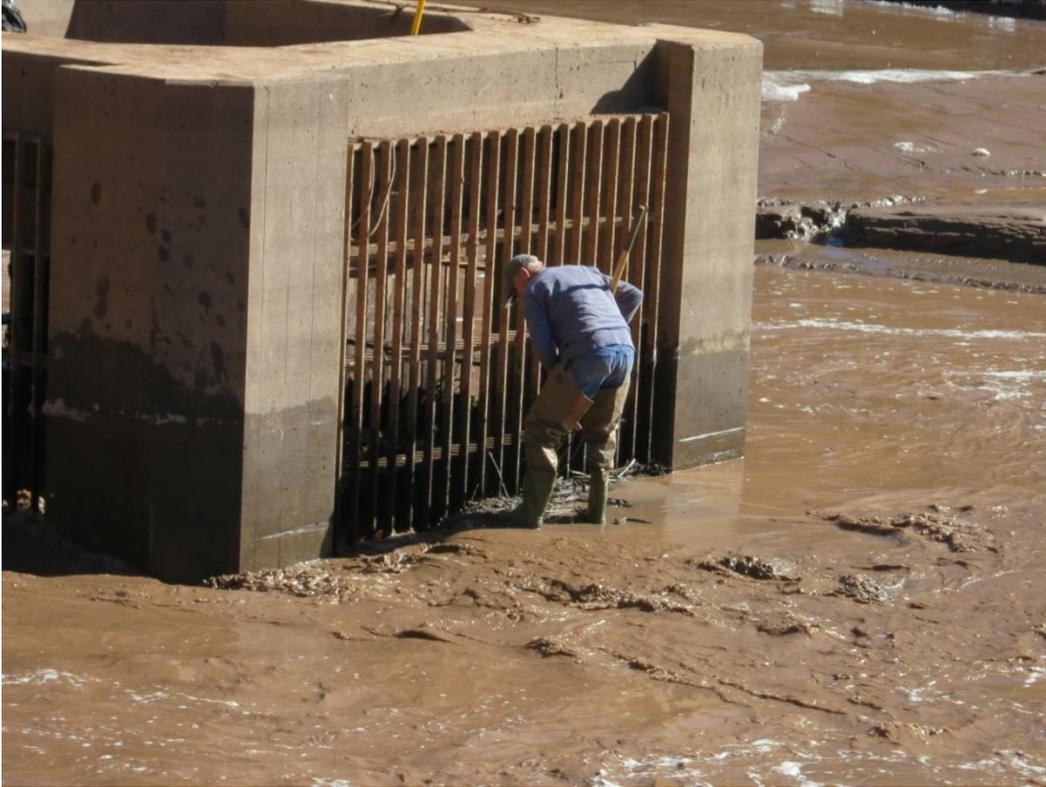
Figure 4.—Photo showing the manual removal of saturated debris and sediment at the Paonia Dam outlet works intake (photo courtesy of Philip Ipson, Western Colorado Area Office).

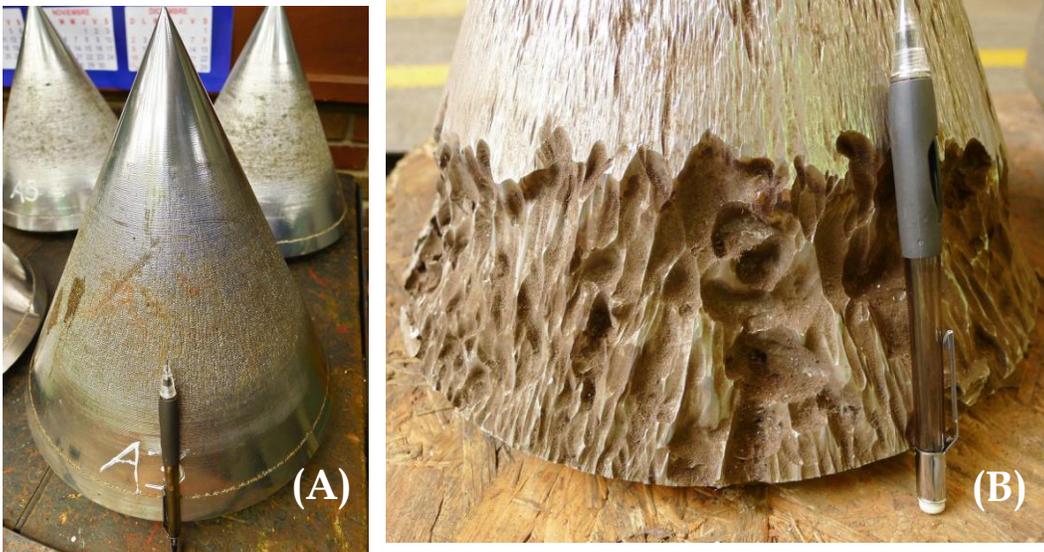
The arrival of coarse reservoir sediment (sands and gravels) can also abrade outlet works and hydropower features. As an example, figure 5 shows the damage to a Pelton wheel needle valve during (A) 10,000 hours of normal operation and (B) after 24 hours of operation while passing coarse sand as a result of extreme drawdown and incoming floodflows at a facility in the country of Colombia. The damage to the needle valve was extensive enough to prevent the successful closure of the valve itself, and more than a month of downtime was required to repair the valve, resulting in lost hydropower generation.

Figure 5.—Pelton wheel turbine needle after (A) 10,000 hours of normal operation and (B) 24 hours of operation with the passage of sand (photo courtesy of Greg Morris, GLM Engineering-COOP).

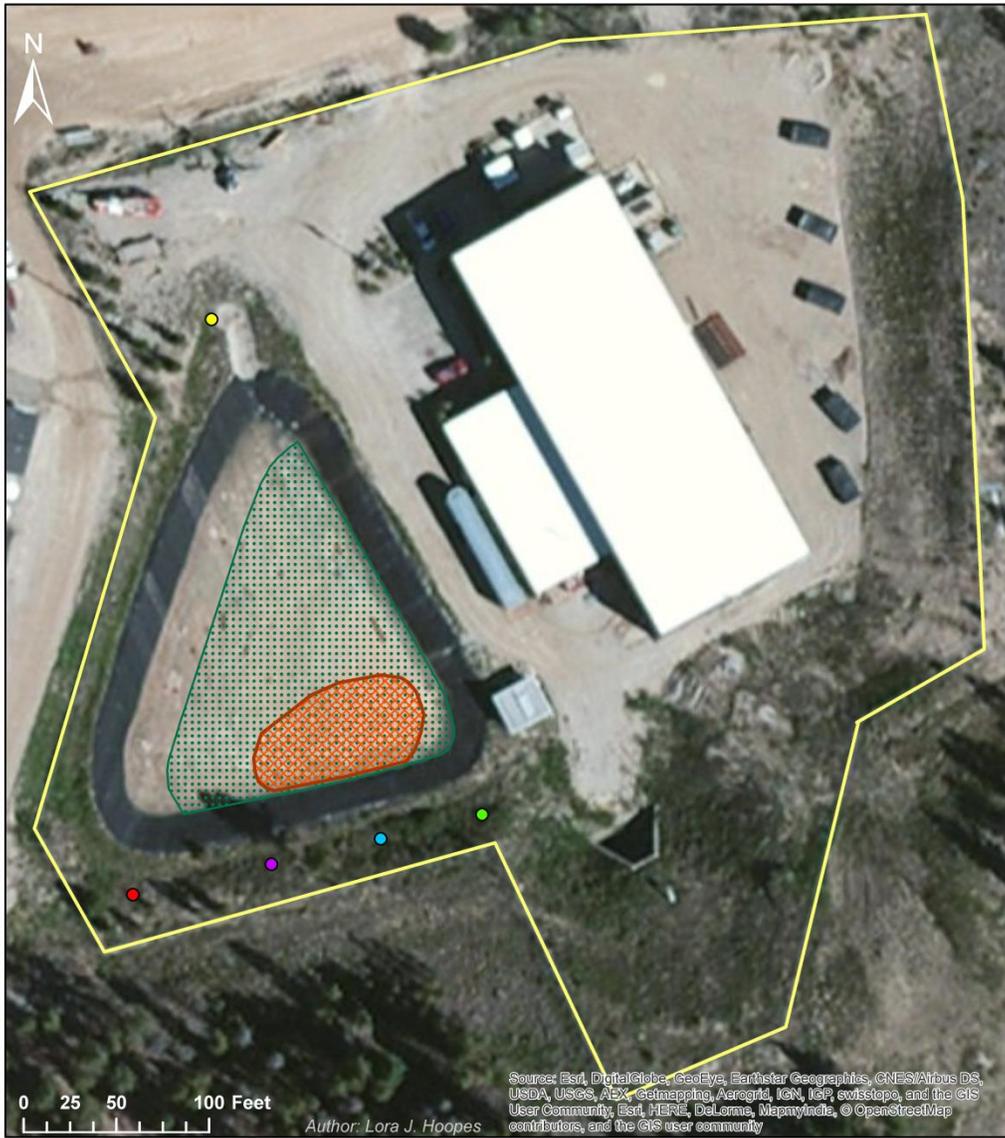
Figure 1.—Aerial view of the LMDT retention pond.

- The liner in the southern portion of the pond was observed to be floating at the time of the inspection (area highlighted in red on figure 1). Floating could be detected by a trampoline effect when these areas were walked over. These areas were slightly convex (raised) and would bounce when one of the team stood or jumped on them.

- Water is collecting in the southeast corner of the pond from the wells (figure 1) that are pumping groundwater from under the pond.
- The gravel is discolored in the bottom of the pond, especially near the southeast corner (area highlighted in green on figure 1). This discoloration is likely due to sediment in the LMDT water.

Based on information available at the time of this report, we recommend installing a deeper pumping and backup well around the retention pond to lower the groundwater under the pond (Alternative 1).
