Water Operation and Maintenance Bulletin

WHAT WE LEARNED!

Haste Makes Wasteway Failures

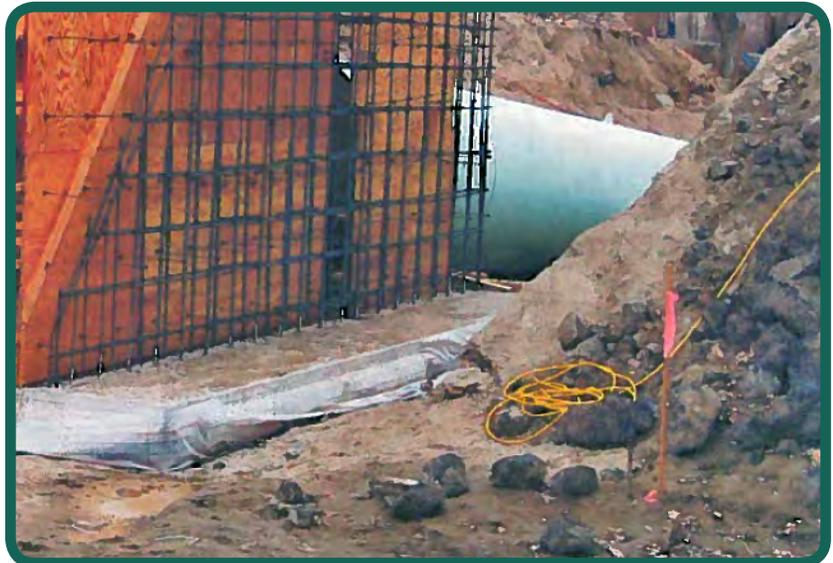
Original construction was not to Reclamation standards. For example, plastic sheets were used on the right side of the gate structure. (Photo 2/17/2015 by Reynaldo Garcia).

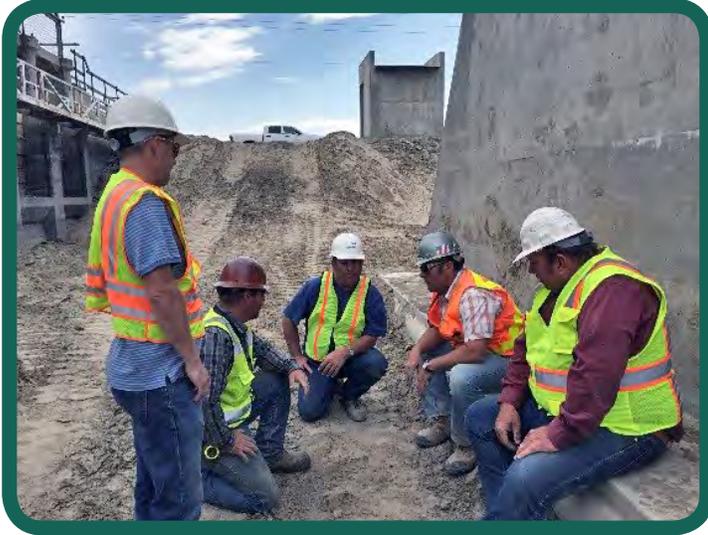
Reclamation and TCID discussing the next phase of the repairs.

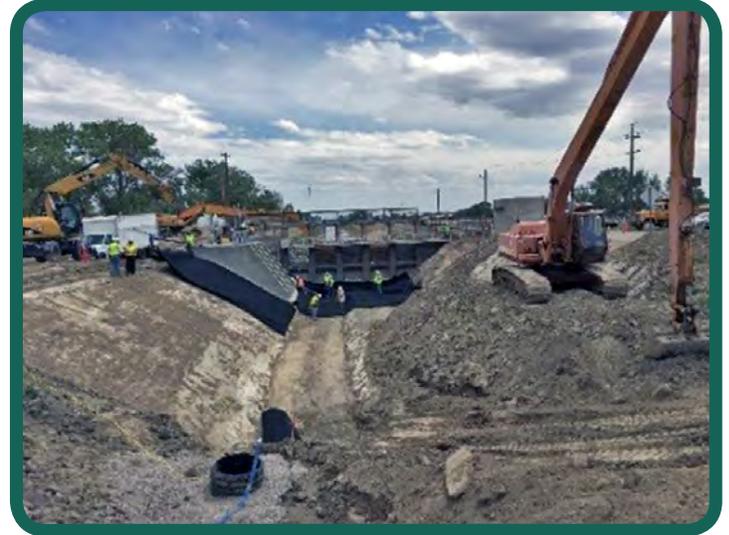
Reclamation and TCID installing geotextile liner during the repair operations.

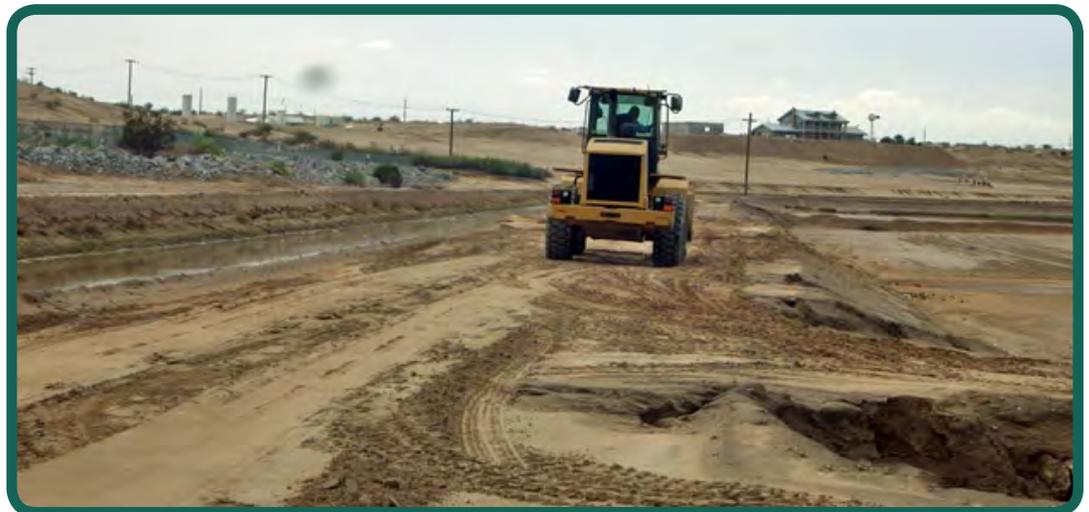
Facing southerly observing YCWUA O&M personnel repairing a breach in the East Main Canal on September 9, 2015, the day after the storm event occurred.

Heavy construction equipment such as front-end loaders, excavators, road graders, and dump trucks, was used to remove debris from within the canal embankment and to rebuild damaged portions of the canal. No state-of-the-art equipment was used nor were new types of construction methods used. Having direct access to equipment facilitated the repair process and minimized the need to rent or purchase equipment and materials, which could have slowed down the process.

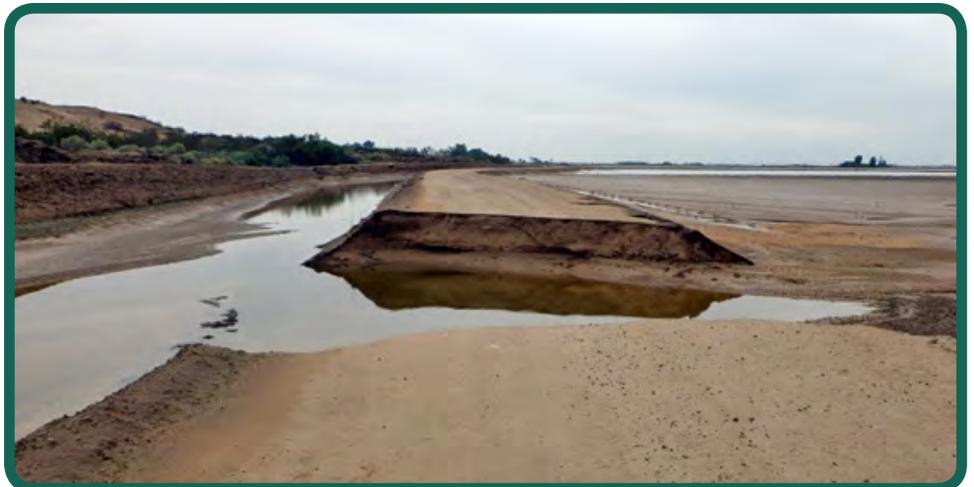
Facing southerly observing a breach in the East Main Canal embankment about ½ mile downstream of the Yuma County Water Users' Association Headquarters near County 15th Street and Avenue C in Somerton, Arizona. Sediment, storm and canal waters flowed into agricultural fields to the right (west).

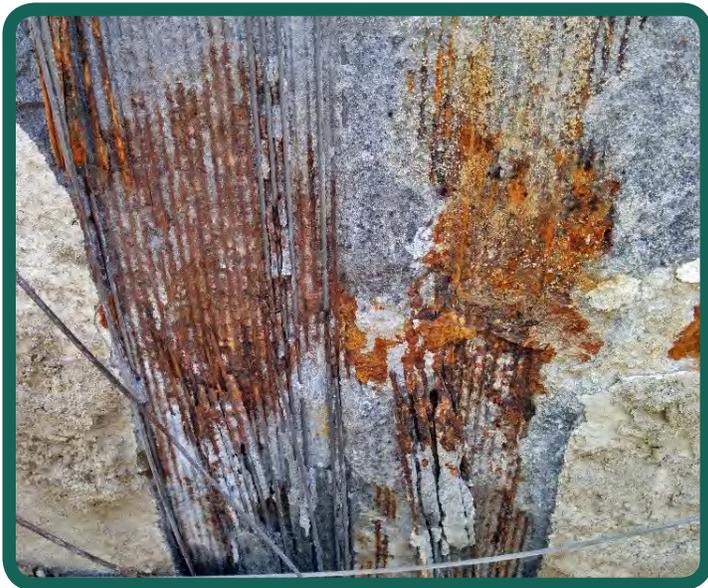
On Friday the 13th, May 2016, a 17.5 foot-diameter prestressed concrete pipe (PCCP) failed in the Navajo Nation near Farmington, New Mexico. This PCCP featured a double-wire wrap with a 16-gauge steel liner. The pipe was manufactured in the field and installed in 1972. Previous electromagnetic inspections indicated 30 broken wires in 2002 and 60 broken wires in 2010 at this section of pipe.

Corroded wires on PCCP.

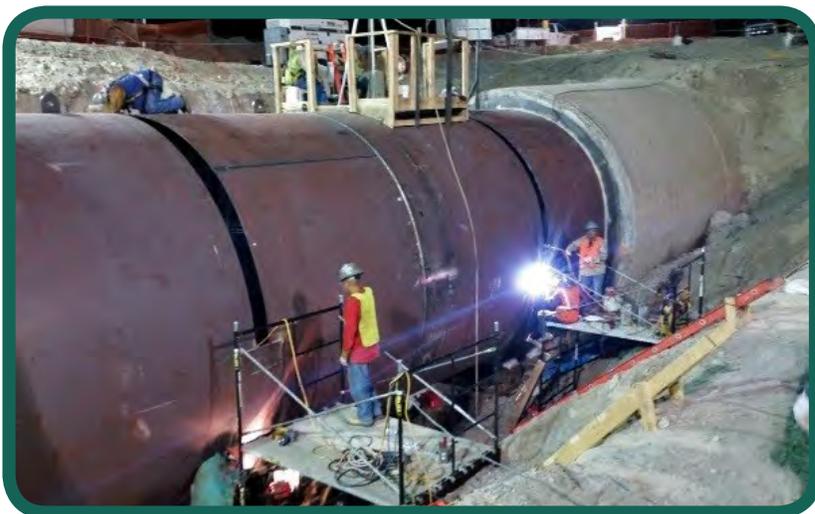
Welders working outside the siphon piping right of centerline.

Technical Service Center (TSC) designed the steel pipe replacement sections and worked directly with Ameron to develop manufacturing details and welds.

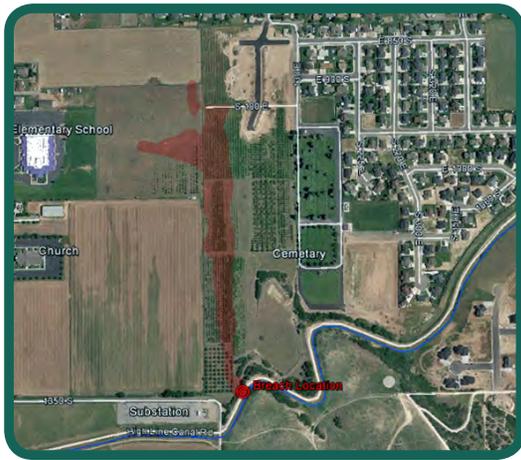
Breach location and path of water—just upstream of a school, church, and houses.

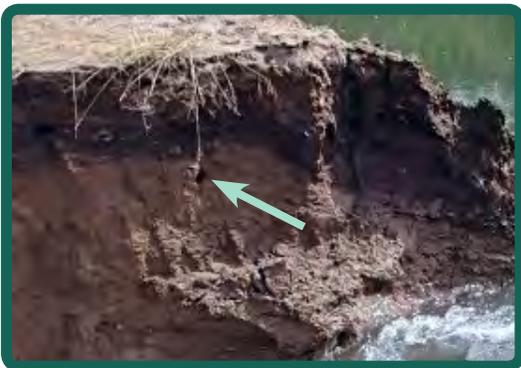
Rodent holes, vegetation on the downhill embankment, and a fence on the downhill embankment that obscured inspections and restricted access likely contributed to the breach. After the breach, the Strawberry High Line Canal Company (SHLCC) has instituted an aggressive system-wide vegetation removal program.

View of the breach from the crest of the canal embankment. A 2 to 3-inch rodent hole was noticed on the right side of the breach.

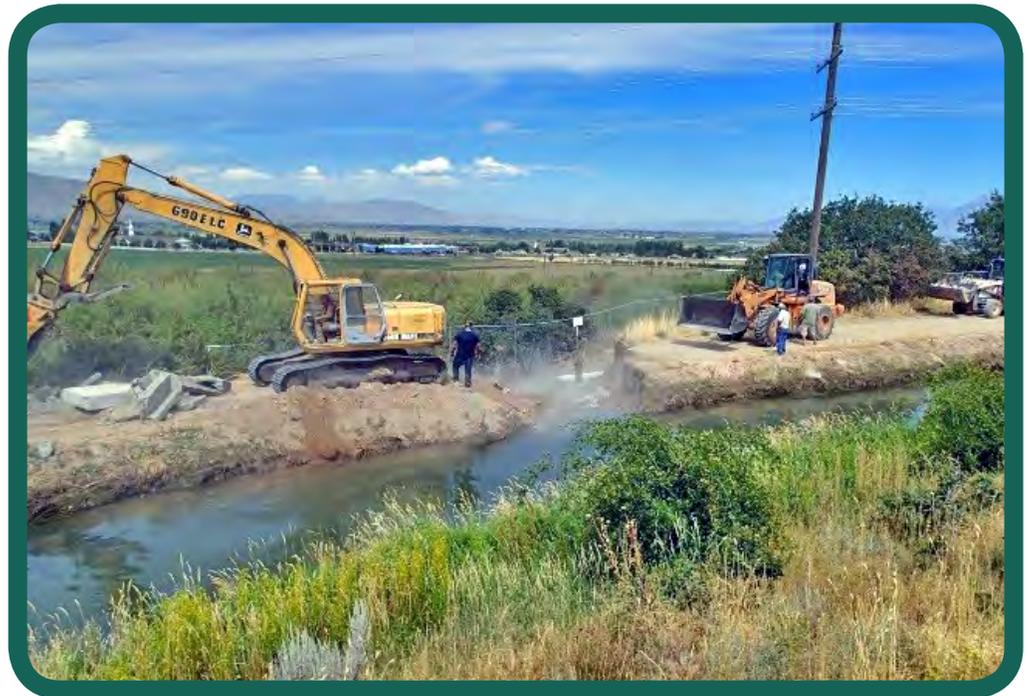
View of the breach from the uphill side of the canal, 12:06 pm, August 25, 2015.

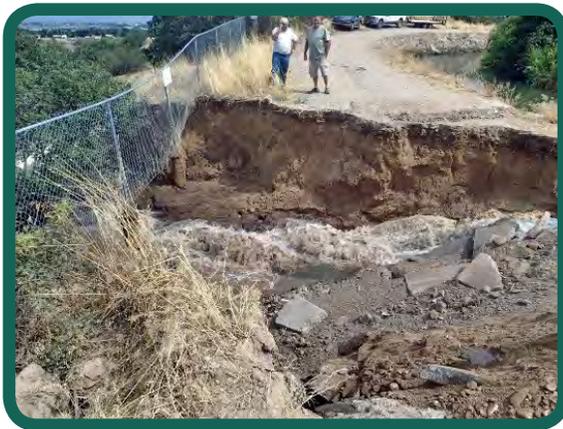
View of the breach from the crest of the canal embankment. 12:02 pm, August 25, 2015. Note the large pieces of concrete used to stop the flow out of the breach.

The emergency fill was excavated and inspected.

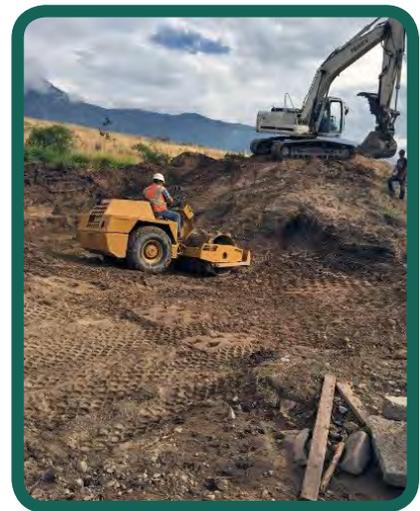
Placing the first fill lift of embankment material. —8/27/2015.

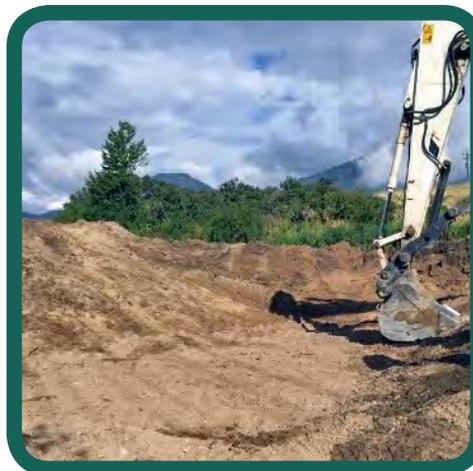
After compacting the foundation, one lift of material was placed over the bottom of the excavation from the downstream catch to the key trench.

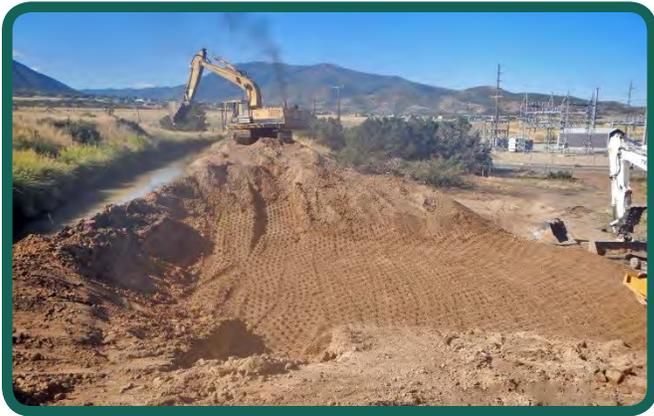
Embankment repair—8/27/2015.

A clay liner was placed about 2 feet below the bottom of the canal. The inside clay liner extended 5 feet from the inside wall of the canal into the fill for 4 lifts and then was reduced to 2.5 feet in width for the remaining lifts.

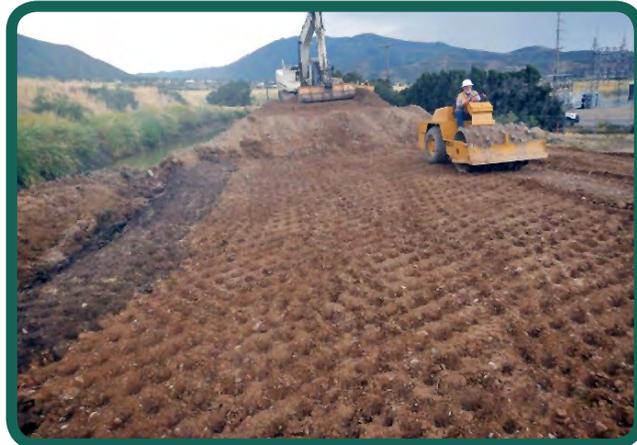
Backfill operations showing neat line of clay liner and fill material —8/27/2015.

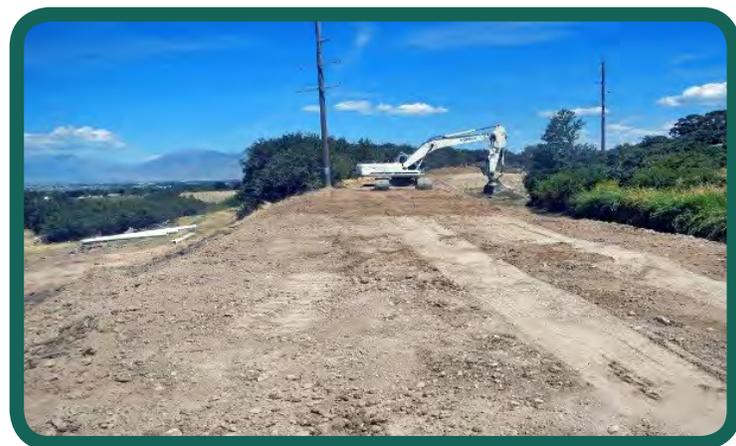
Finished canal embankment— 8/28/2015.
