Hot Springs Canyon Fish and Amphibian Monitoring

Paul C. Marsh and Jason C.G. Marsh

November 7, 2013

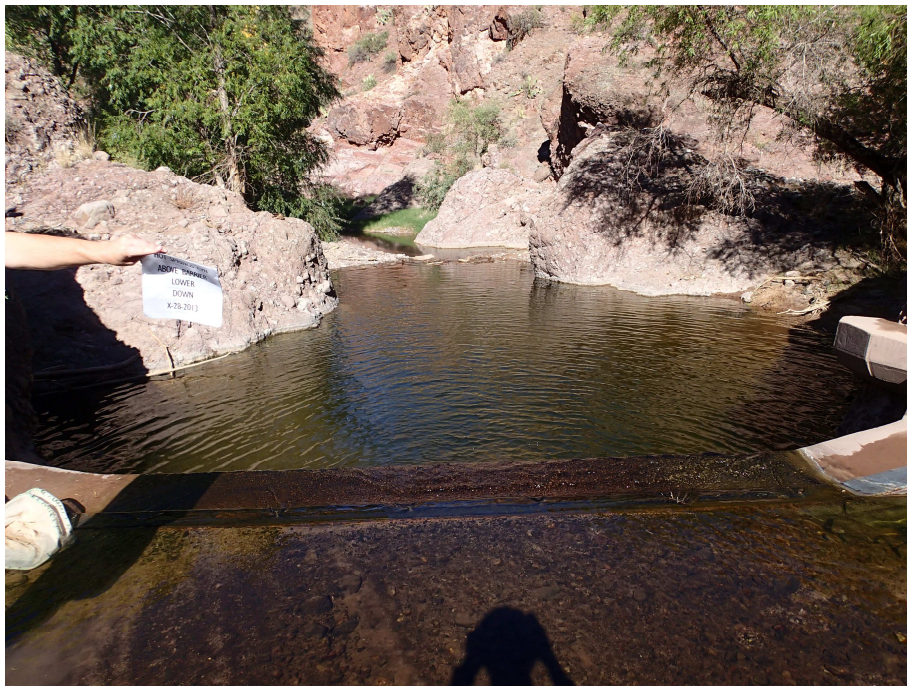
Debris high in the riparian vegetation was evidence of scouring flood flow of unknown but substantial magnitude since October 2012 when we last visited the area or prior to that time. There was a large, sand-bottomed plunge pool immediately below the barrier that measured approximately 25 m long, 5 m wide and > 1.5 m deep (Fig. 2). There was no indication that the channel downstream was incised as had been observed in October 2011 and October 2012 but not present in April 2011. The channel above the barrier was level with the top of the structure and appeared "normal" in every respect.

Fig. 2. Hot Springs Canyon, Cochise Co., Arizona, showing persistent pool habitat immediately downstream of the constructed fish barrier. Photo taken from top of barrier, October 28, 2013.

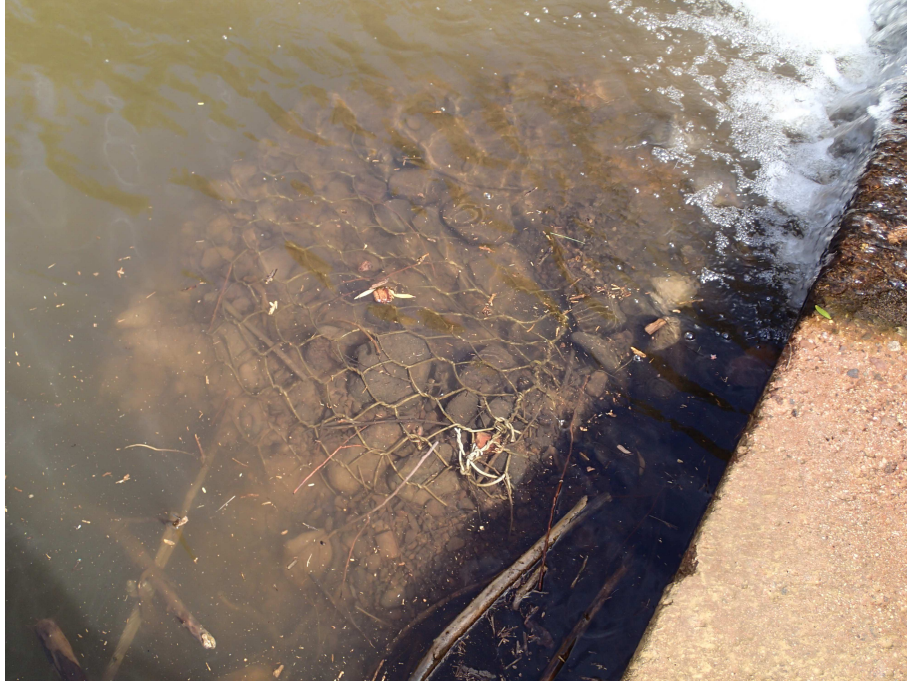
The barrier structure was carefully inspected and photographed. Wire gabion on both sides immediately downstream of the apron was exposed (e.g., Fig. 4); this condition is unchanged from October 2011 and October 2012. It is unknown if this exposure also represents a maintenance issue. The structure itself appeared intact and there was no

evidence of cracking or other failure, or of erosion of material. However, access around the barrier now requires difficult scaling of the near-vertical adjacent bedrock walls or wading/swimming through the deep scour hole below the barrier. This is because the channel bed has been lowered by removal of stream sediments across the entire stream width between the walls immediately downstream of the barrier apron.

Fig. 4. Hot Springs Canyon, Cochise Co., Arizona, showing exposed wire gabion at the base of the constructed fish barrier apron on river left; October 28, 2013.
