El Vado Dam repairs

*Mary Carlson, Public Affairs Specialist,
Albuquerque Area Office, Upper Colorado Region*

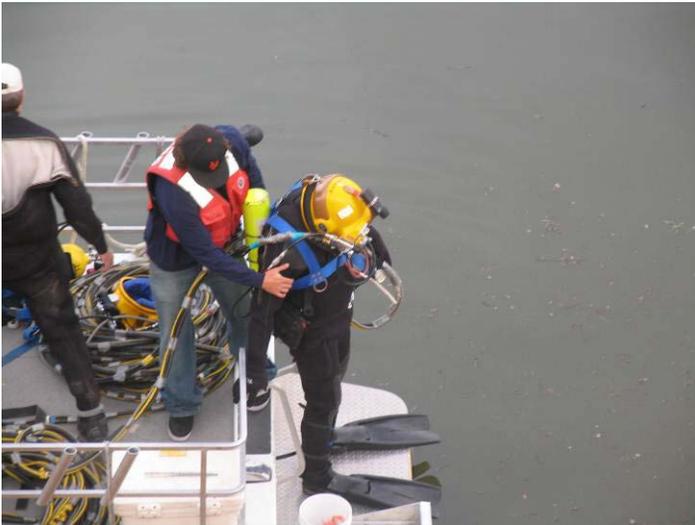
Members of a Reclamation dive team entering or coming out of the water during the repair at El Vado reservoir on April 26.

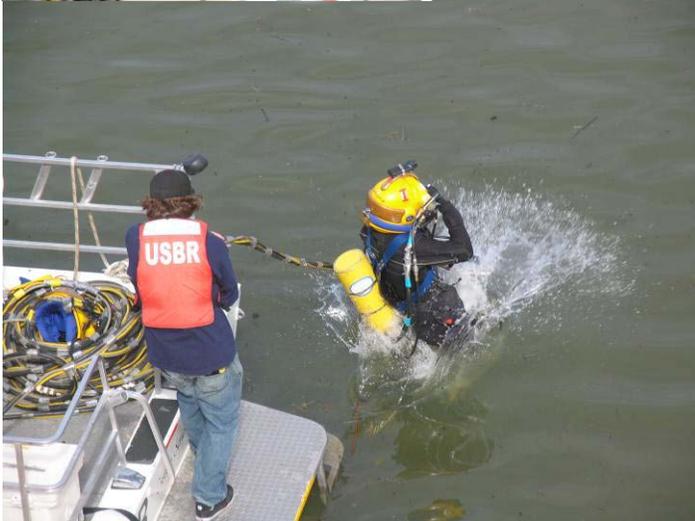
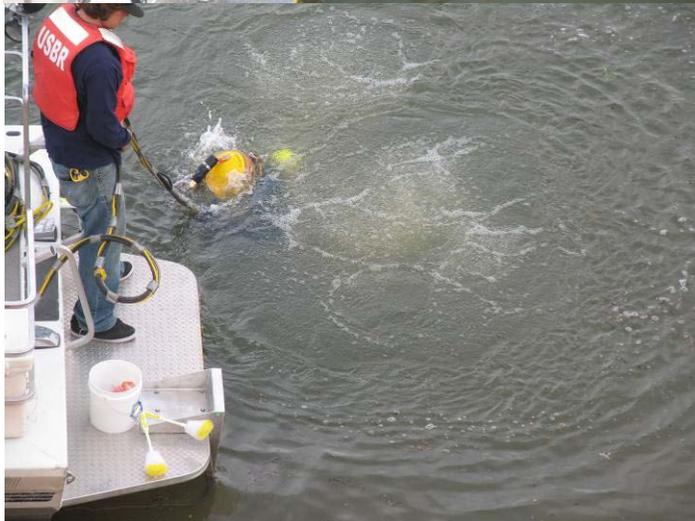
Members of a Reclamation dive team entering or coming out of the water during the repair at El Vado reservoir on April 26.
