**ENVIRONMENTAL COMPLIANCE AND  
FACILITY CONDITION ASSESSMENT REPORT,  
SEVEN CONCESSION AREAS  
LAKE BERRYESSA, CALIFORNIA**

**U.S. Department of the Interior**

**KLEINFELDER**

**December 19, 2002**

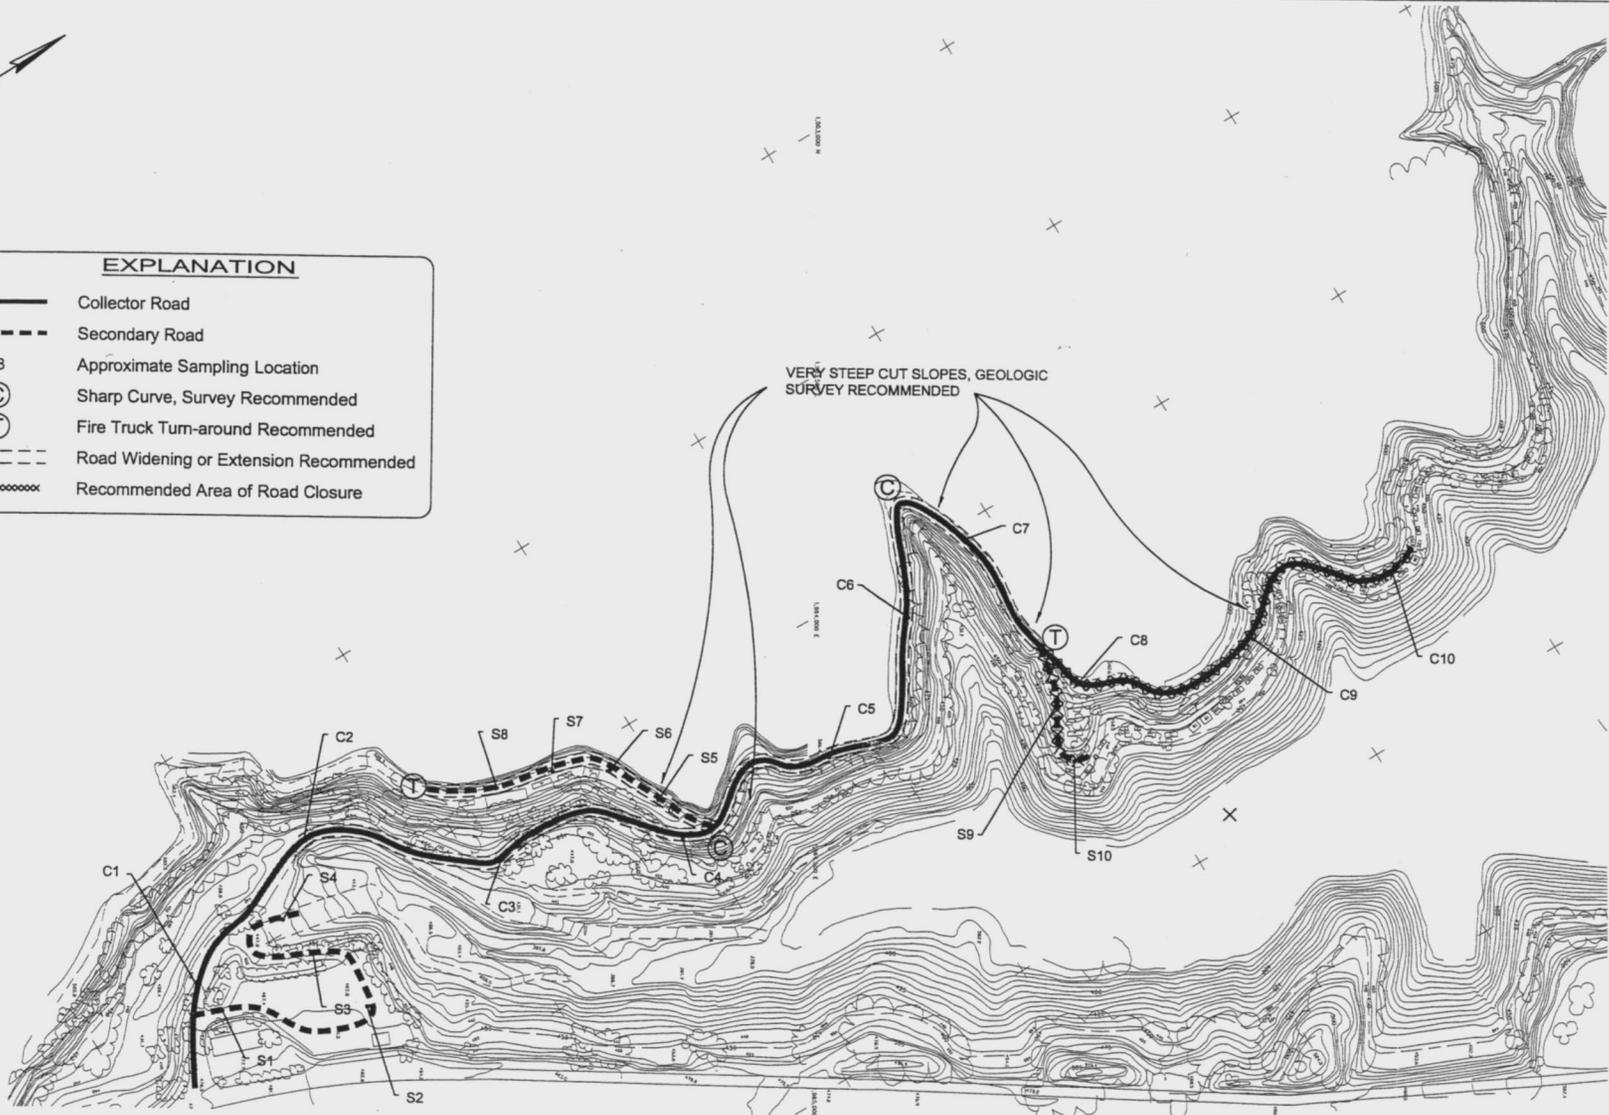
PLATE  
**8**

VERY STEEP CUT SLOPES, GEOLOGIC SURVEY RECOMMENDED
