**ENGINEERING EVALUATION OF THE RED BLUFF RESEARCH
PUMPING PLANT ON THE SACRAMENTO RIVER IN NORTHERN CALIFORNIA:
1995-1998**

**A Summary Report
Red Bluff Research Pumping Plant
Report Series: Volume 6**

September 1999

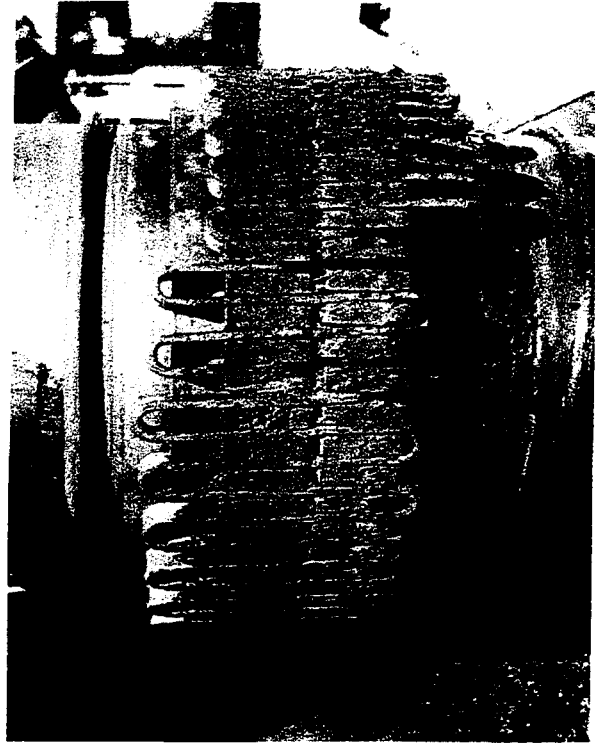
Low-Speed Coupling Failure. In late May 1996, both pumps were dewatered and a major inspection was performed. The inspection began with the low-speed couplings due to the known failure on pump 2. The low-speed couplings, manufactured by Falk Couplings, are used to couple the gear box reducer to the pump thrust bearing. The couplings used in the Archimedes pumps were model 1000T series tapered grid steel flex couplings with split covers, type T10, size 1200T. The service manual gives the alignment limits for installation of the couplings as a maximum offset of 0.015 inch and within 0.027 inch of angular alignment. Lubrication specifications also require the coupling to be filled with 12.5 lbs of grease prior to operation. Upon disassembly of the unit, it was noted that the coupling cover of pump 2 had a circumferential break between the center coupling fastener and the fastener on the driven side. After removal of the cover, subsequent inspection showed the grid had broken into several pieces, figure 16. Wear marks on the cover indicated that the coupling had broken and was rubbing on the cover. An estimated 1-2 lbs of grease was recovered from the coupling. The grease was very thick and extremely dry. Excessive wear was observed on the hub grid teeth on both the drive and driven hubs. Measurements of the mean tooth thickness for the new coupling had been 0.765 inch on both coupling halves. The measured thickness of the disassembled driven coupling hub teeth was between 0.610 to 0.630 inch and for the drive hub 0.657 to 0.682 inch, indicating a maximum wear of 0.155 inch and 0.108 inch, respectively. The low-speed coupling offset and angularity were then measured. The offset was 0.110-inch top to bottom and 0.21-inch side to side. The face-to-face angularity measurement looking toward the driven unit are given in Table 1. These measurements reflect a maximum angularity of 0.226-inch top to bottom and 0.033-inch side to side.

Figure 16. Damaged low-speed coupling. Damage to low-speed coupling, Pump 2 (broken grid)

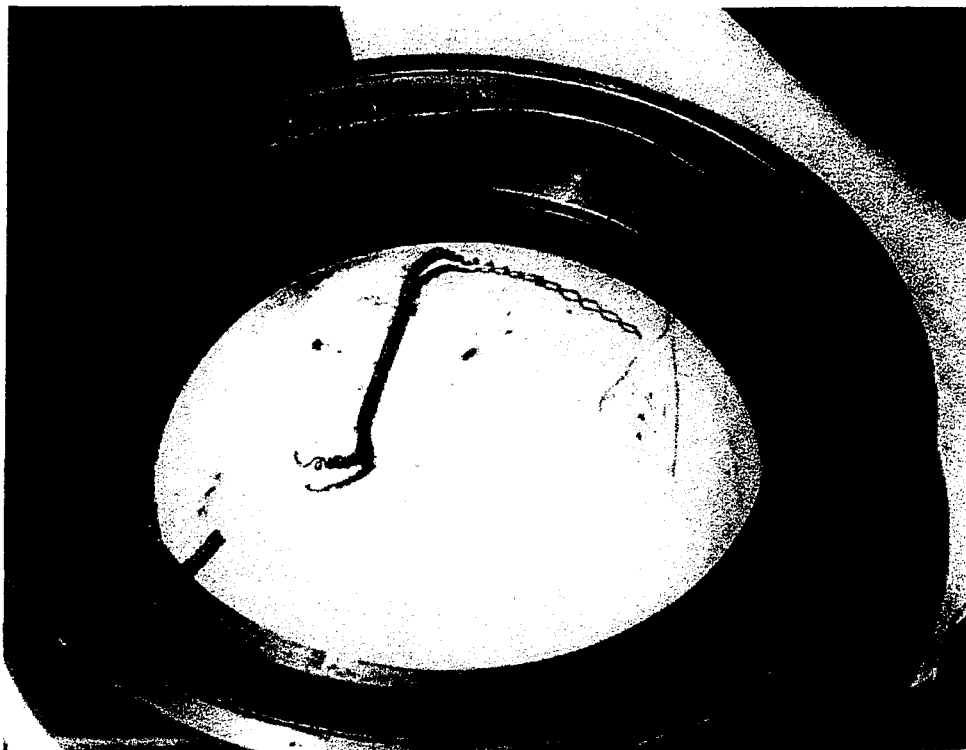
Due to the discovery of the metal shavings in the pump 2 thrust bearing housing, pump 1 was checked to determine if there were metal shavings in the housing. The oil was drained from Pump 1. Inspection of the oil showed a large amount of small metal flakes in the oil. Analysis of the oil was inconclusive as to the source of the metal flakes, but there were elevated levels of copper and iron as well as large particles detected in the oil. The FAG Bearing representative was contacted and the analysis of the oil discussed. The level of large particles obtained from the sample was of great concern to the bearing manufacturer, but the level of copper and iron were not greater than might be expected during initial running of the pump. Upon removal of the lip seal, visual observations indicated that the seal had suffered severe damage at some time. The steel shell was partially crushed, the rubber torn in many areas, and the garter spring was broken with portions missing. Damage also included a portion of the steel shell that had the appearance of a pry mark on it, figure 17. The lip on the cover that the seal rides on was grooved from seal wear and required machining. The missing portion of the spring and part of the rubber were in the bottom of the housing laying next to the roller bearing. The only way to inspect the internal surfaces of the bearing itself was to disassemble the bearing from the housing. There also had been deformation of the set screw on the locknut. The barrel and thrust bearing assembly of pump 1 were removed from the bay, figure 18. The thrust bearing assembly was shipped to Allied Engineering in Alameda, California for disassembly and inspection. Inspection of the bearing showed a small piece of the broken spring in between

Figure 17. Damaged seal ring from thrust bearing. *Damaged seal ring, note broken spring and pry marks on steel shell.*

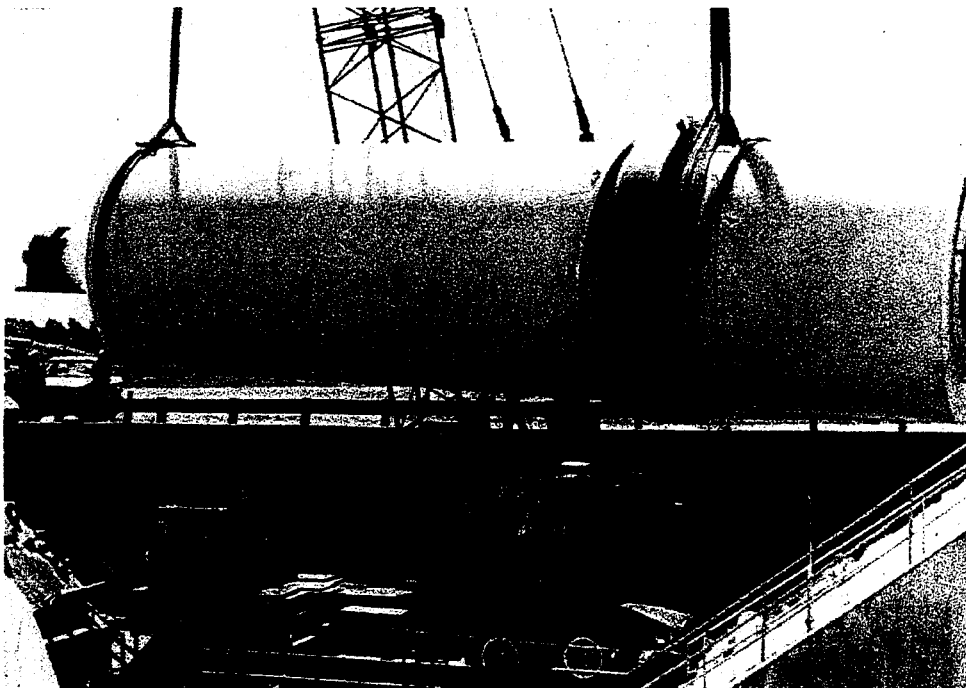
Figure 18. Removal of Pump 1 from bay. *Removal of pump 1 by mobile crane in order to repair thrust bearing.*

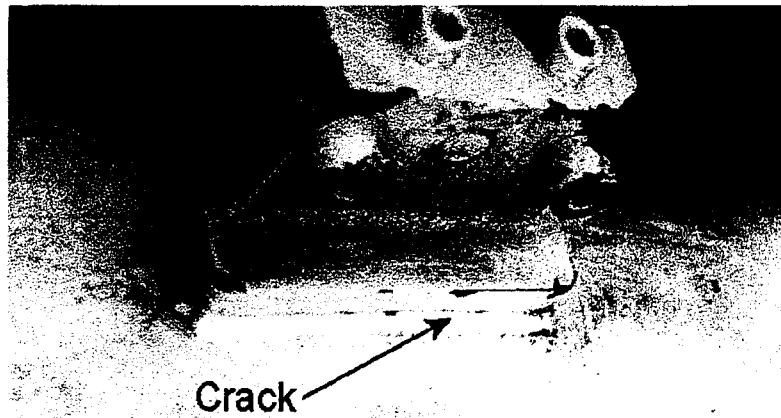
Saddle plates and self-aligning roller bearings. During the removal of pump 1 it was discovered that the welds between the saddle plate and pump barrel on saddle plates 15 and 16 were cracked, figure 19. The connection between the pump barrel and the power wear ring consists of 18 saddle plates welded to the exterior of the barrel with spacer blocks that are bolted to the saddle plates and pinned and bolted to the power wear ring. The power wear ring is a forged steel ring 5-inches thick and 19-inches wide. The inside radius of the ring is 3 inches larger than the external radius of the pump barrel. The crack on saddle plate 15 extended around the entire plate, and on 16, one end was cracked. Measurements of the welds showed that the weld on saddle block 15 was a 1/4-in fillet, and on saddle block 16 the weld was 3/8-in. Inspection of the remaining saddle block welds showed that all were undersized. It was apparent that during the manufacturing of the pumps, the welds were not correctly sized to allow insertion of alignment shims between the saddle plates and pump barrel at erection.

Figure 19. Saddle blocks on Pump 1. Saddle blocks used to attach wearing ring at lower bearing location. Note crack along perimeter of weld.
