ENGINEERING GEOLOGIC EVALUATION OF THE NEWMAN WASTEWAY AND STRUCTURES

DELTA MENDOTA CANAL RECIRCULATION FEASIBILITY STUDY

JANUARY 2009

U.S. DEPARTMENT OF INTERIOR
BUREAU OF RECLAMATION
MID PACIFIC REGION GEOLOGY BRANCH
SACRAMENTO, CA

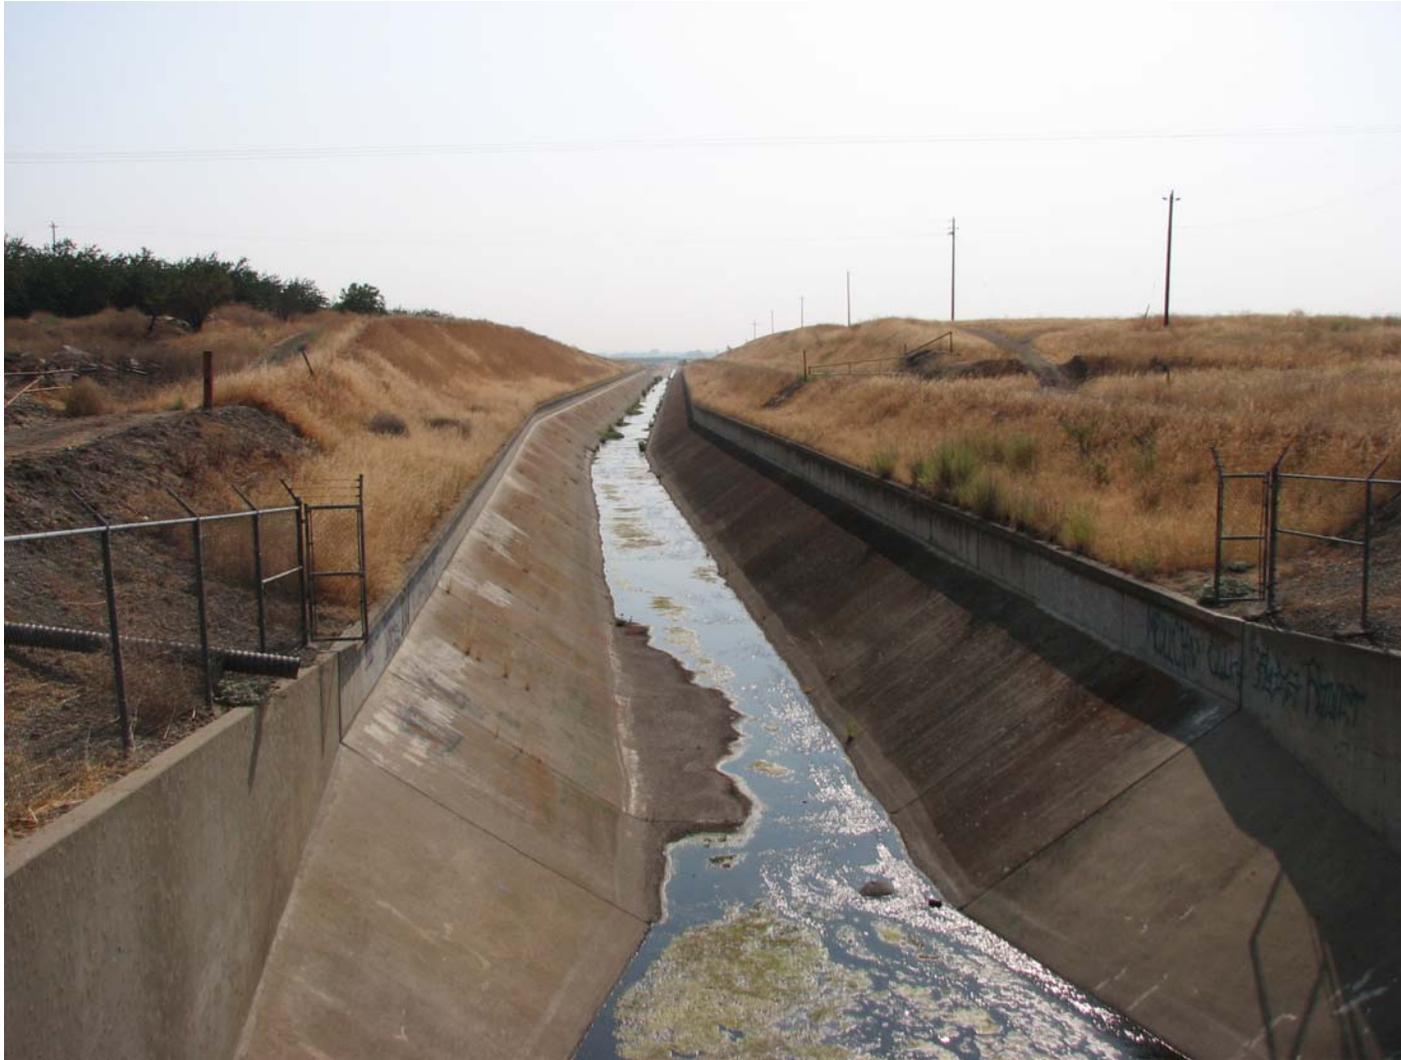
Photo 1

The reinforced lining is in excellent condition (Pre-, Test and Post-Test Flow Photos 1, 2 and 3). No cracking, offset or separated construction joints, spalling or erosion was observed. Minor plant growth and slight concrete deterioration is evident at numerous construction joints where the sloping lining intersects the invert (the cove section).

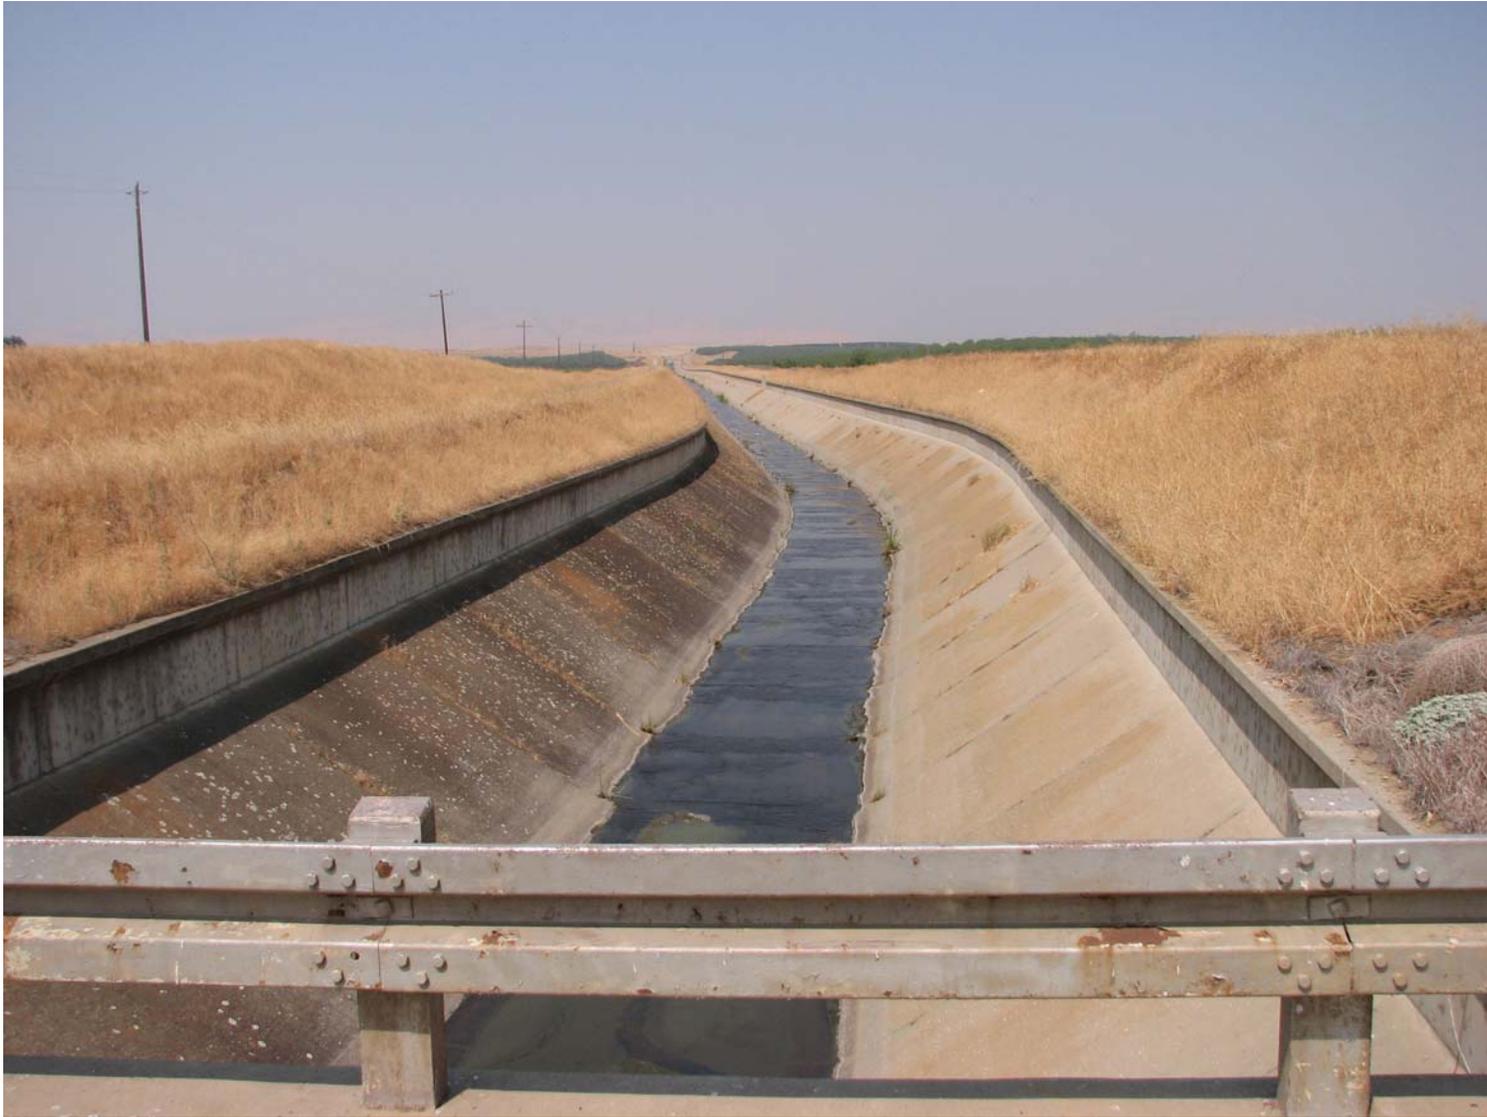
Photo 2

View looking west (upstream) from Eastin Road at the concrete lined section.
J. Sturm

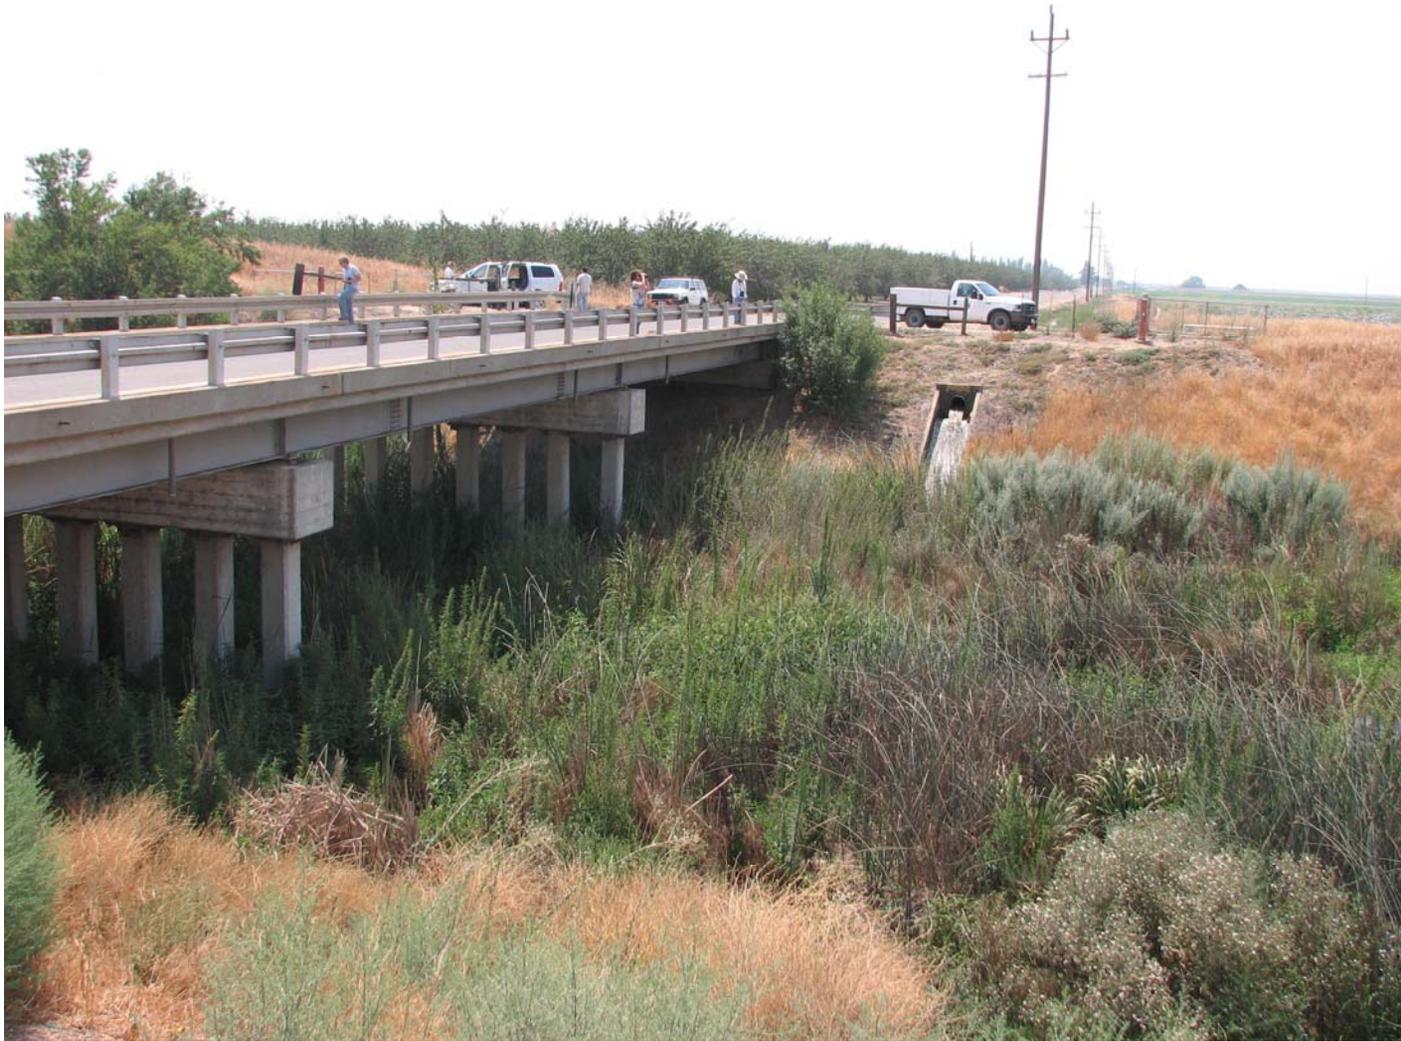
Concrete piers are in excellent condition and show no cracking, evidence of scour or spalling (Pre-Test Flow Photo 9). Bridge decks and superstructure appear to be in generally good condition but were not carefully inspected.

Wasteway flow is primarily irrigation runoff discharged by over 20 drains and a far lesser amount of leakage from the DMC past the radial gates at the Newman Canal headworks (Pre-Test Flow Photo 9). Flows steadily increase in the downstream direction in response to an increase in the number of drains discharging into the wasteway. A flow of 6 cfs was estimated just upstream of the MP 4.21/Hwy 33 Drop Structure on July 25 (Photo 19).

As was also observed on July 25, during low flow, baseline conditions, wasteway flow is primarily irrigation runoff and a far lesser amount of leakage from the DMC (Pre-Test Flow Photo 9 and Post-Test Flow Photo 4).

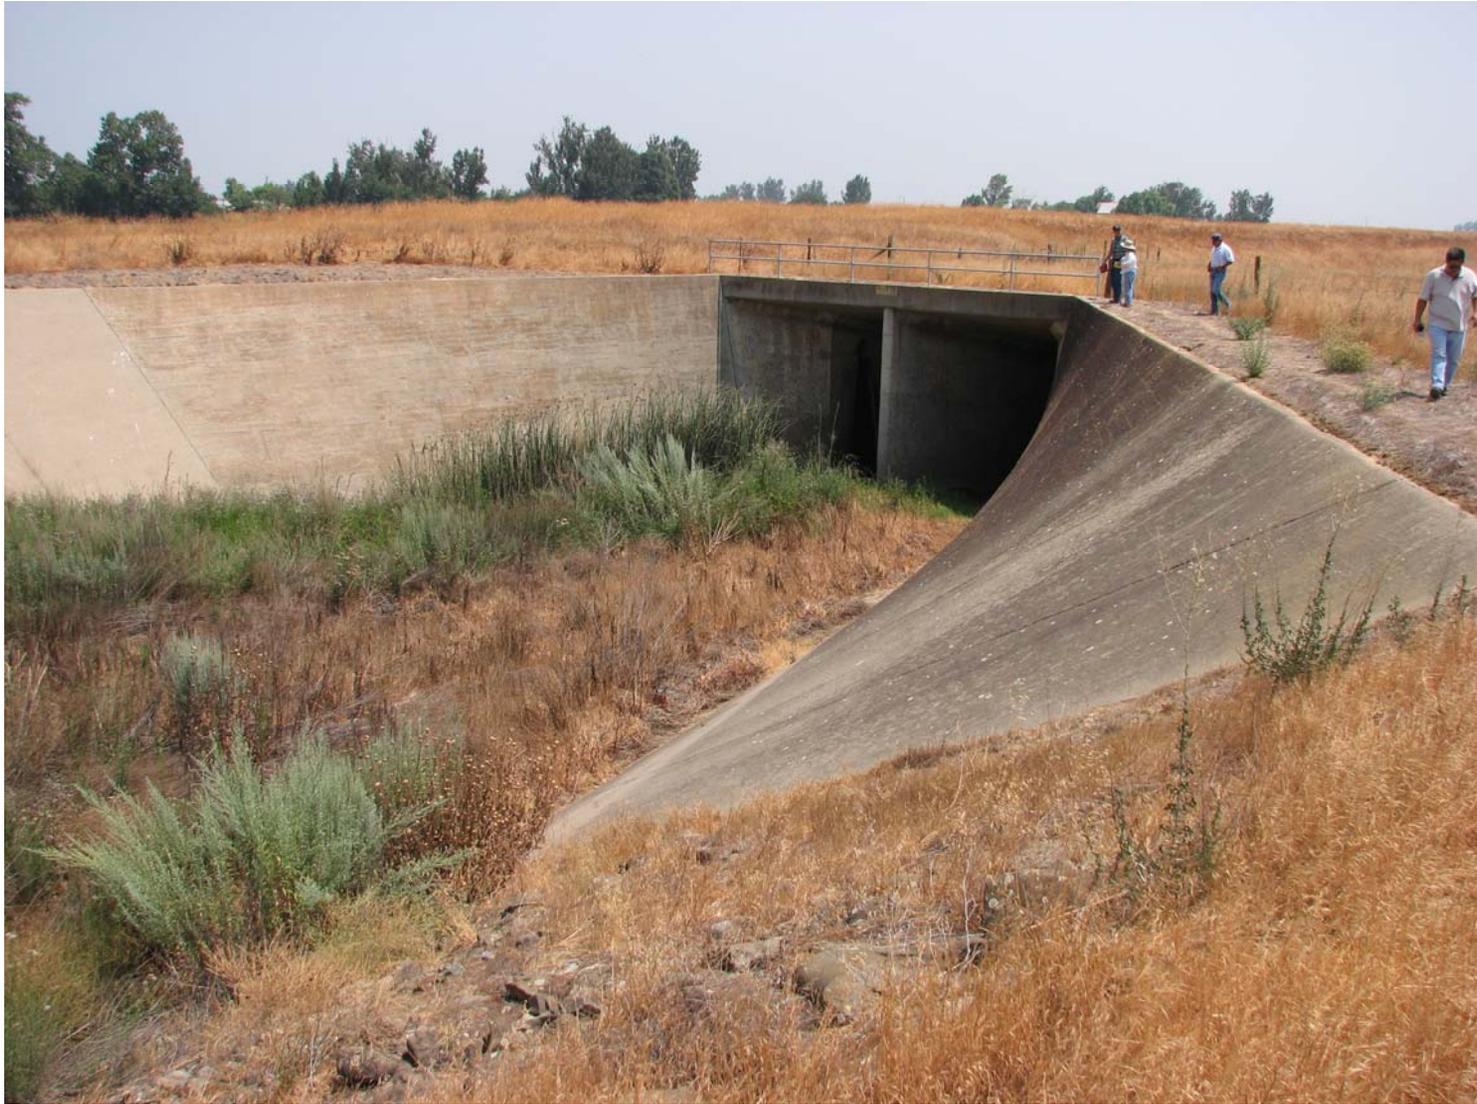
Photo 12

The nearly 60-year-old reinforced concrete structures are in excellent condition. Inlet and outlet wing walls show no significant cracking, spalling or evidence of erosion (Pre-Test Flow Photos 4, 5, 12, 15, 23, 26 and 27). Construction joints are tight and show no offset. Wing walls are thoroughly embedded in the canal slopes except as noted below.

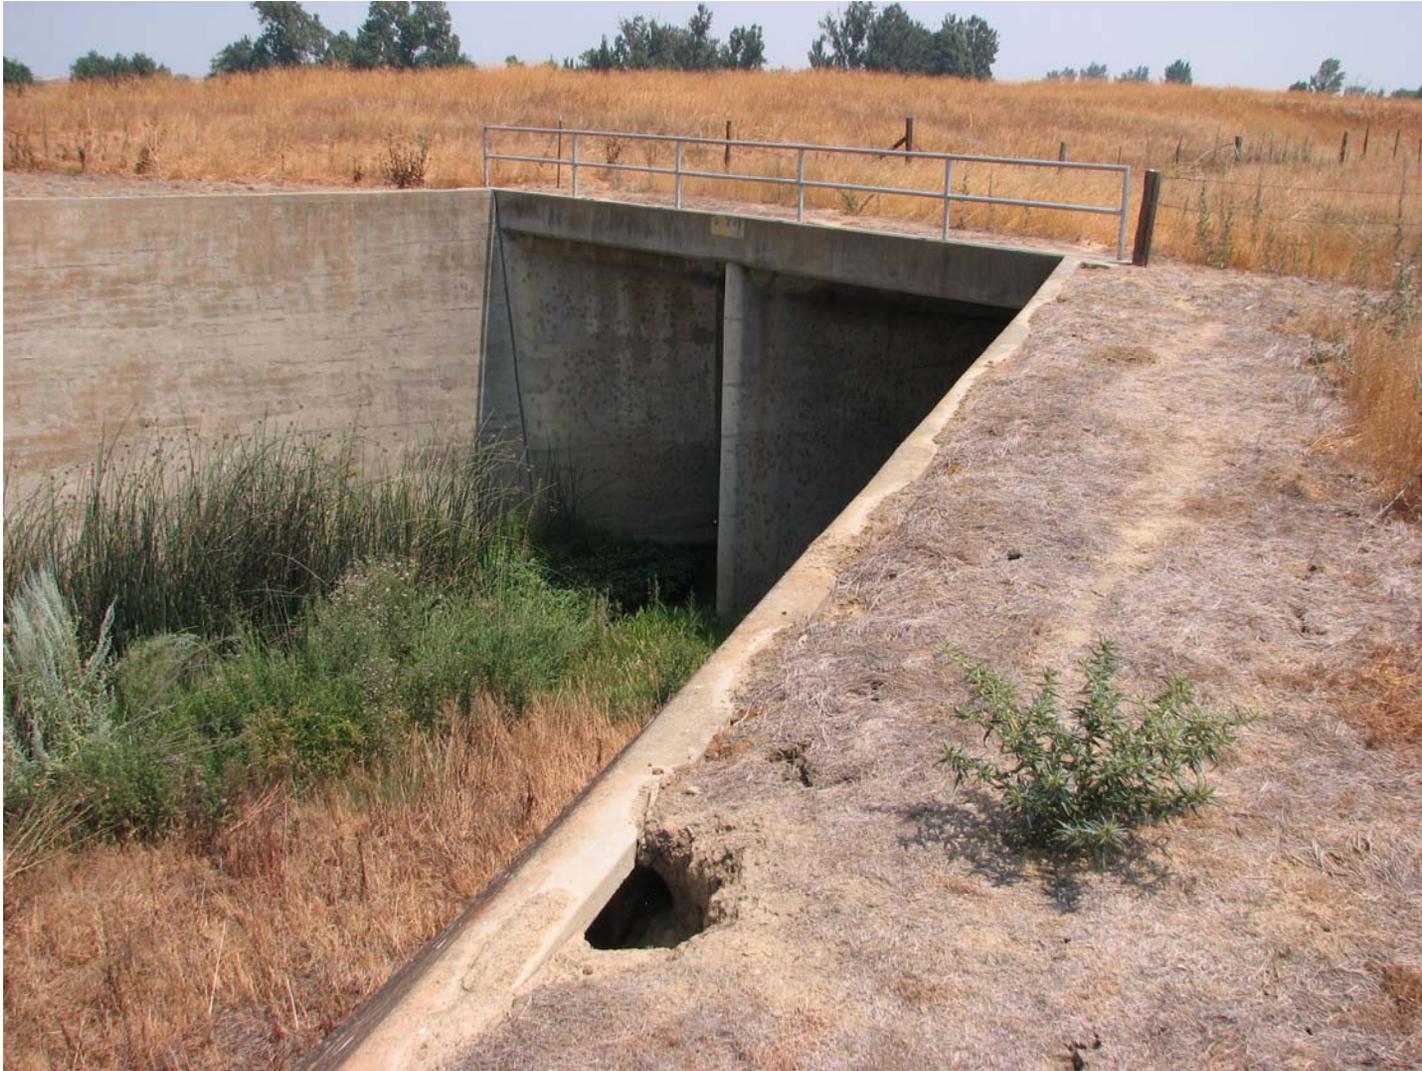
Photo 13

Erosional Voids. A few 1- to 8-inch diameter erosional voids, several feet deep, were observed in sandy clay backfill behind the left inlet wall of the MP 2.48 drop structure (Pre-Test Flow Photo 13). The voids are believed to be rodent holes that were enlarged by surface runoff eroding the erosive/dispersive soils common to the San Joaquin Valley. Similar voids were not observed at the other five drop structures. This type of erosion is unrelated to wasteway flow.

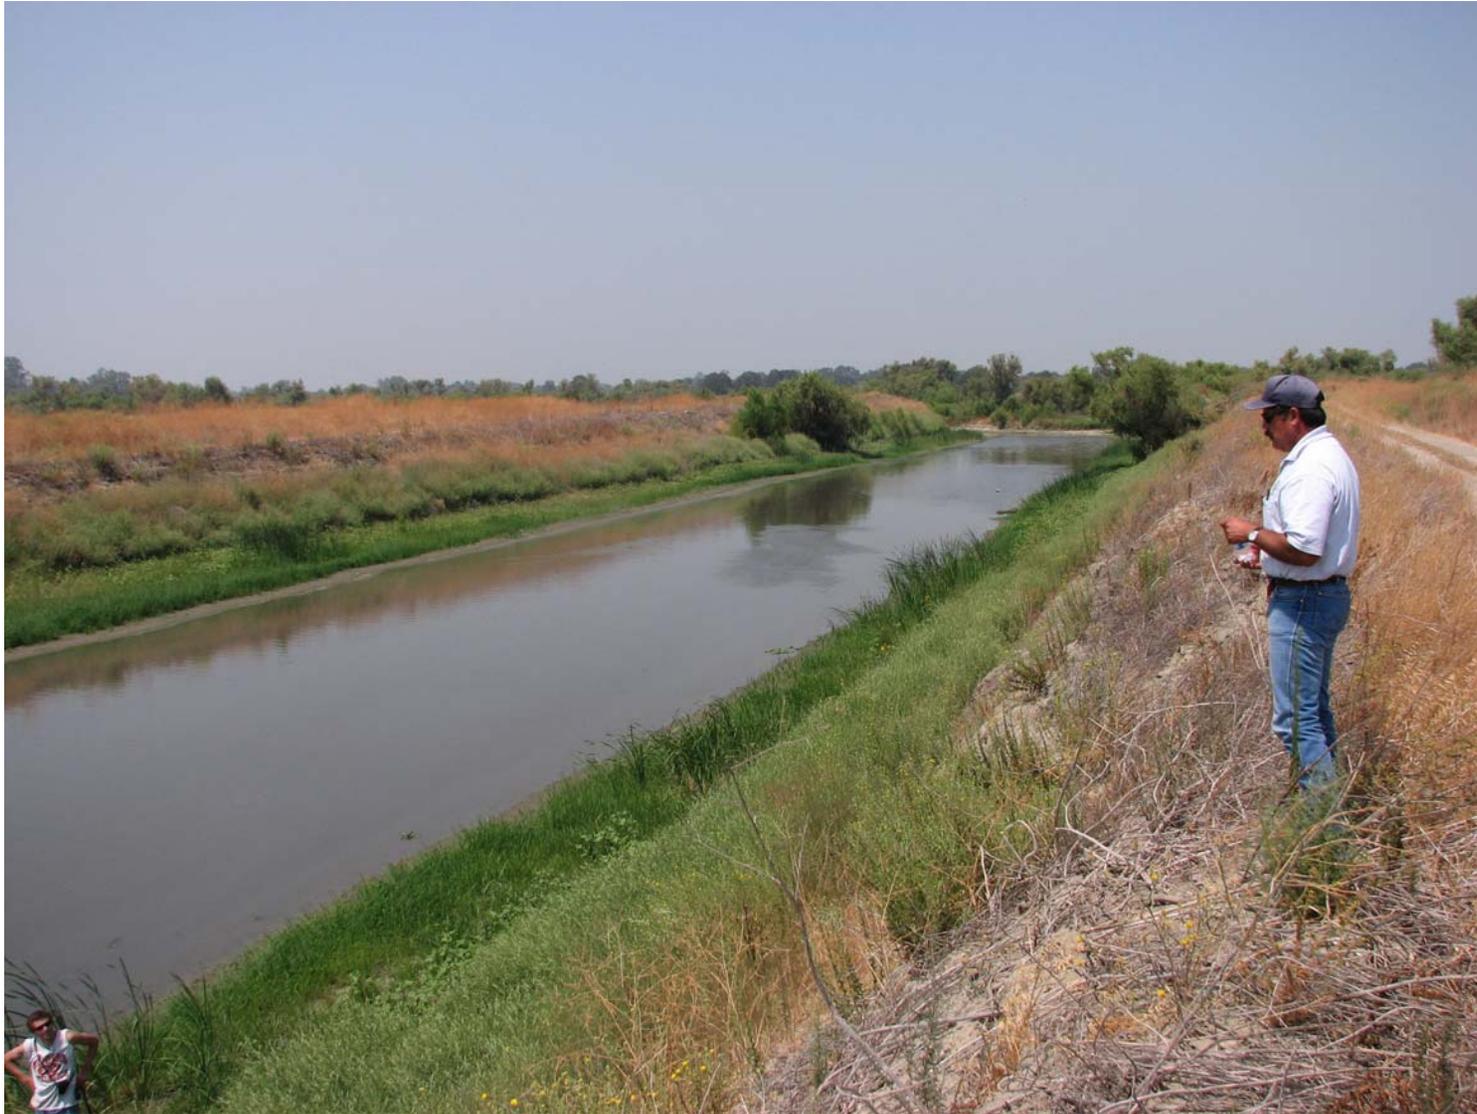
Photo 31

Primrose growth along the channel margins has expanded into 1) previously unvegetated beaches and 2) areas where high test flows had removed reeds (Post-Test Flow Photos 37 and 38). Reed growth along both channel margins appears more lush and extensive as compared to the baseline conditions observed on July 25 (Pre-Test Flow Photo 31).

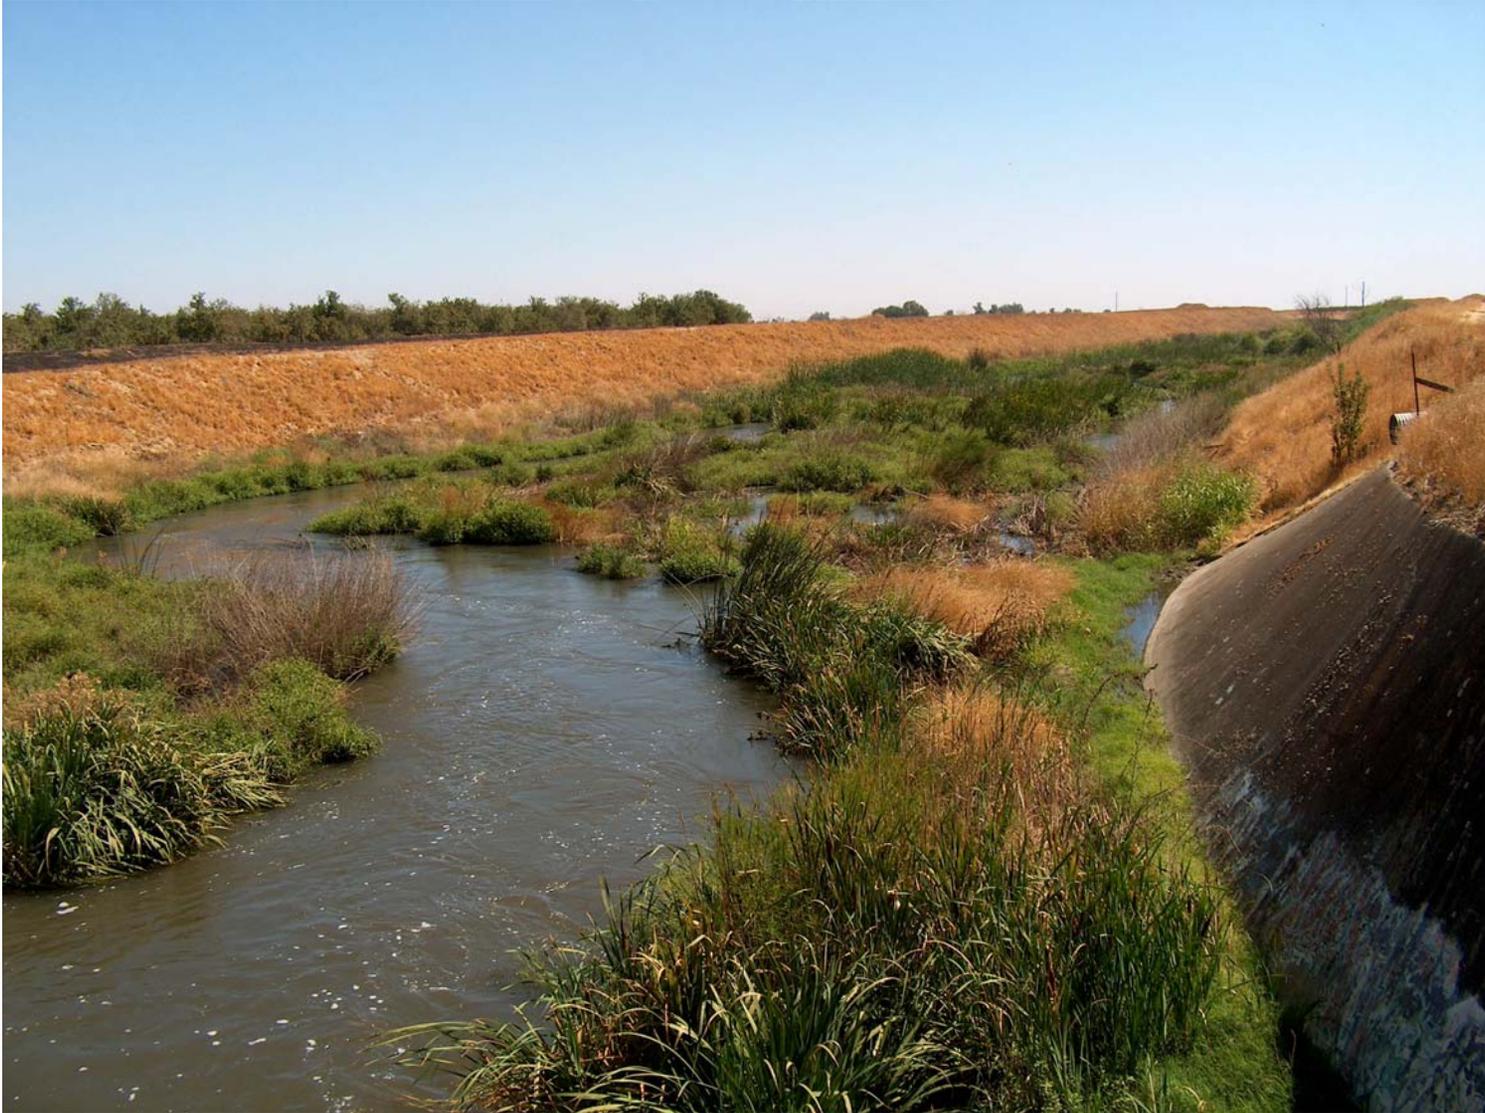
Photo 6

During the high test flows, flow typically spilled out of the central channel and covered a larger area of the wasteway invert (Test Flow Photos 6, 8, 10 to 13, 15, 16). The high flow seemed to stay mainly in the central channel in areas where reed growth flanking the channel was particularly dense (Test Flow Photos 17, 18 and 22). Flow conditions appear relatively unchanged downstream of Drop MP 6.86 where flow occupies the same broad, linear channel at both low and high flows. Flow velocity and turbidity appear fairly uniform for the entire length of the unlined wasteway (Test Flow Photos 6, 11, 22 and 23).

View northeast of the drop structure outlet and downstream wasteway channel
R. Patras

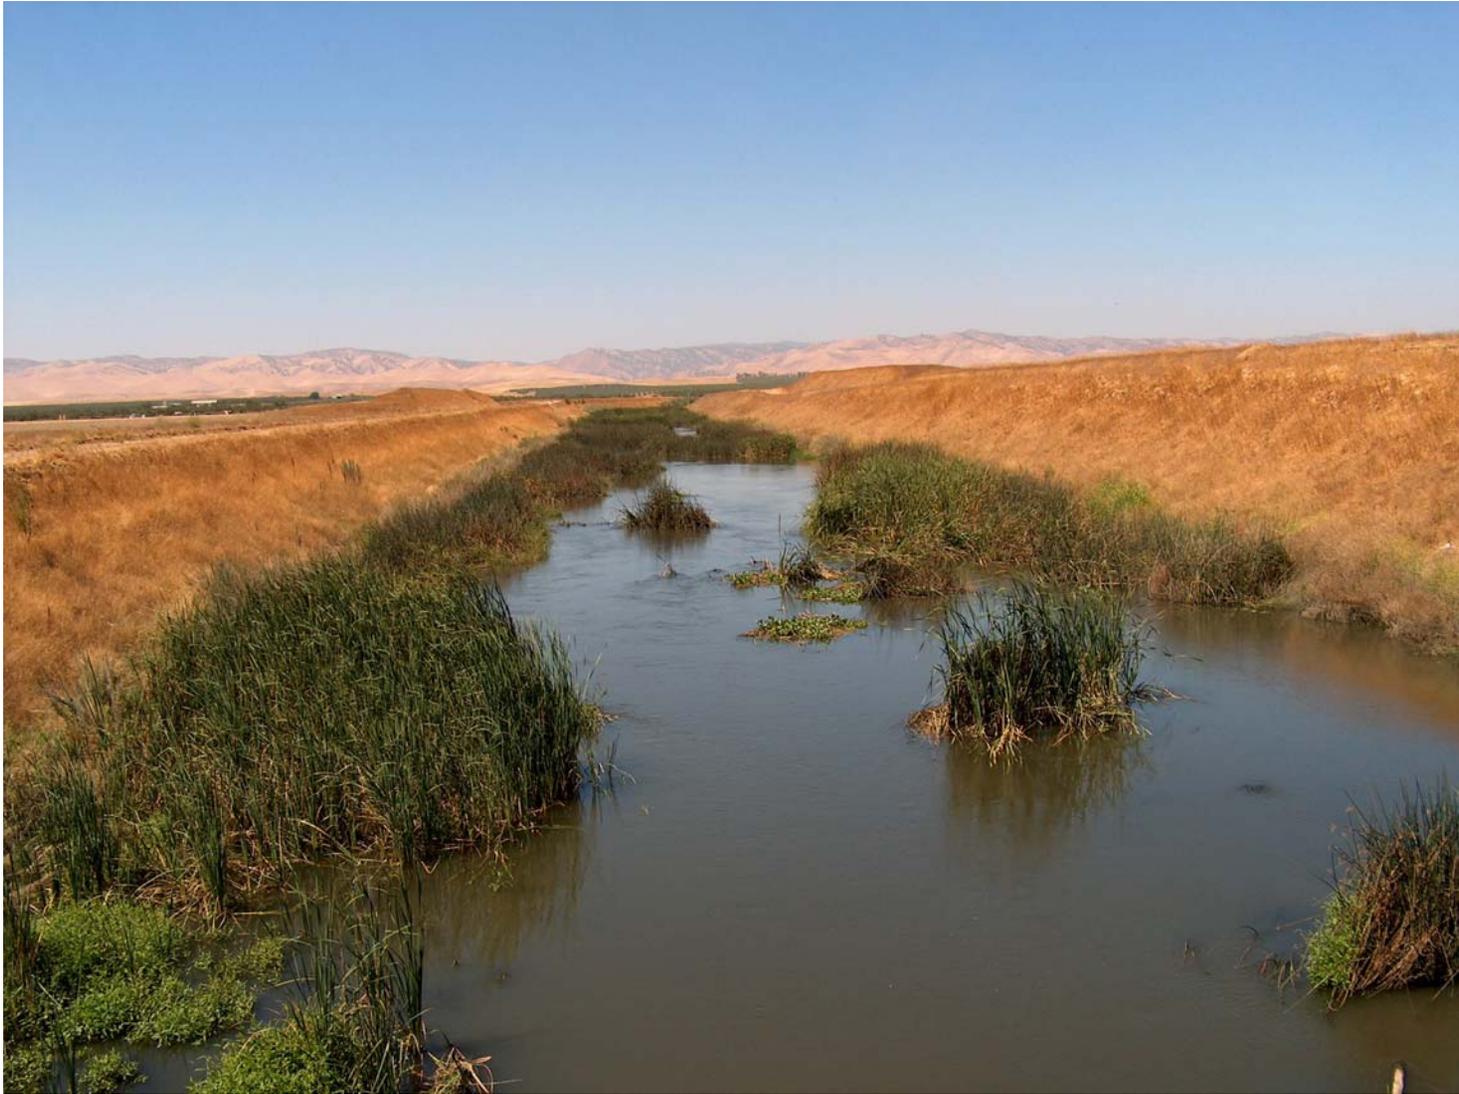
Photo 10

View west (upstream) from Draper Road Bridge.
R. Patras

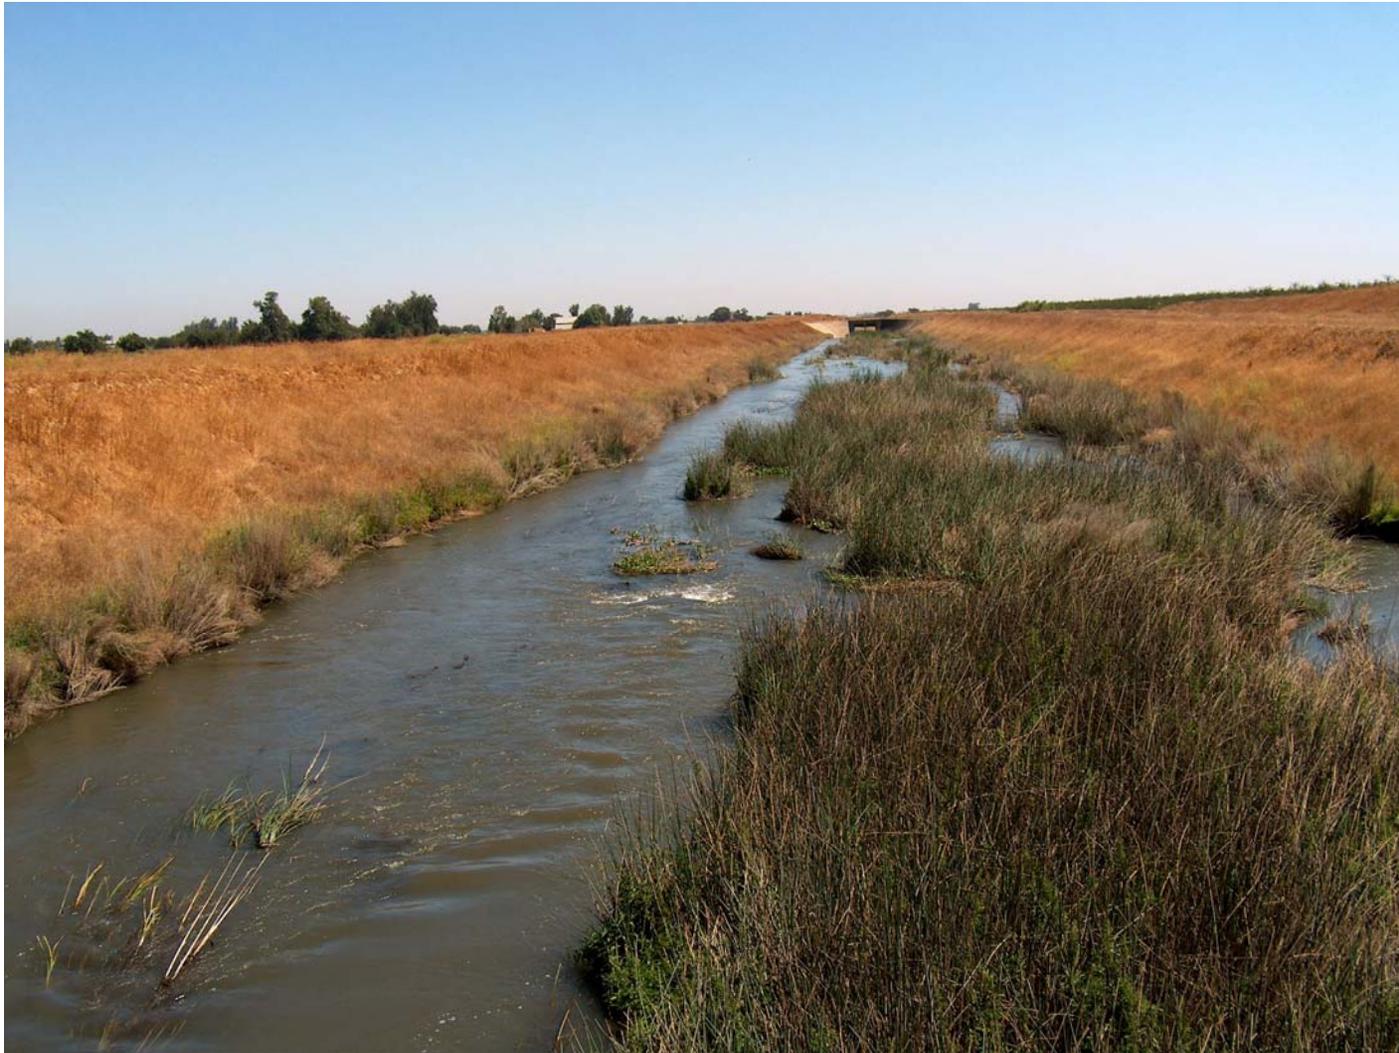
Photo 11

View east (downstream) from Draper Road Bridge.
R. Patras

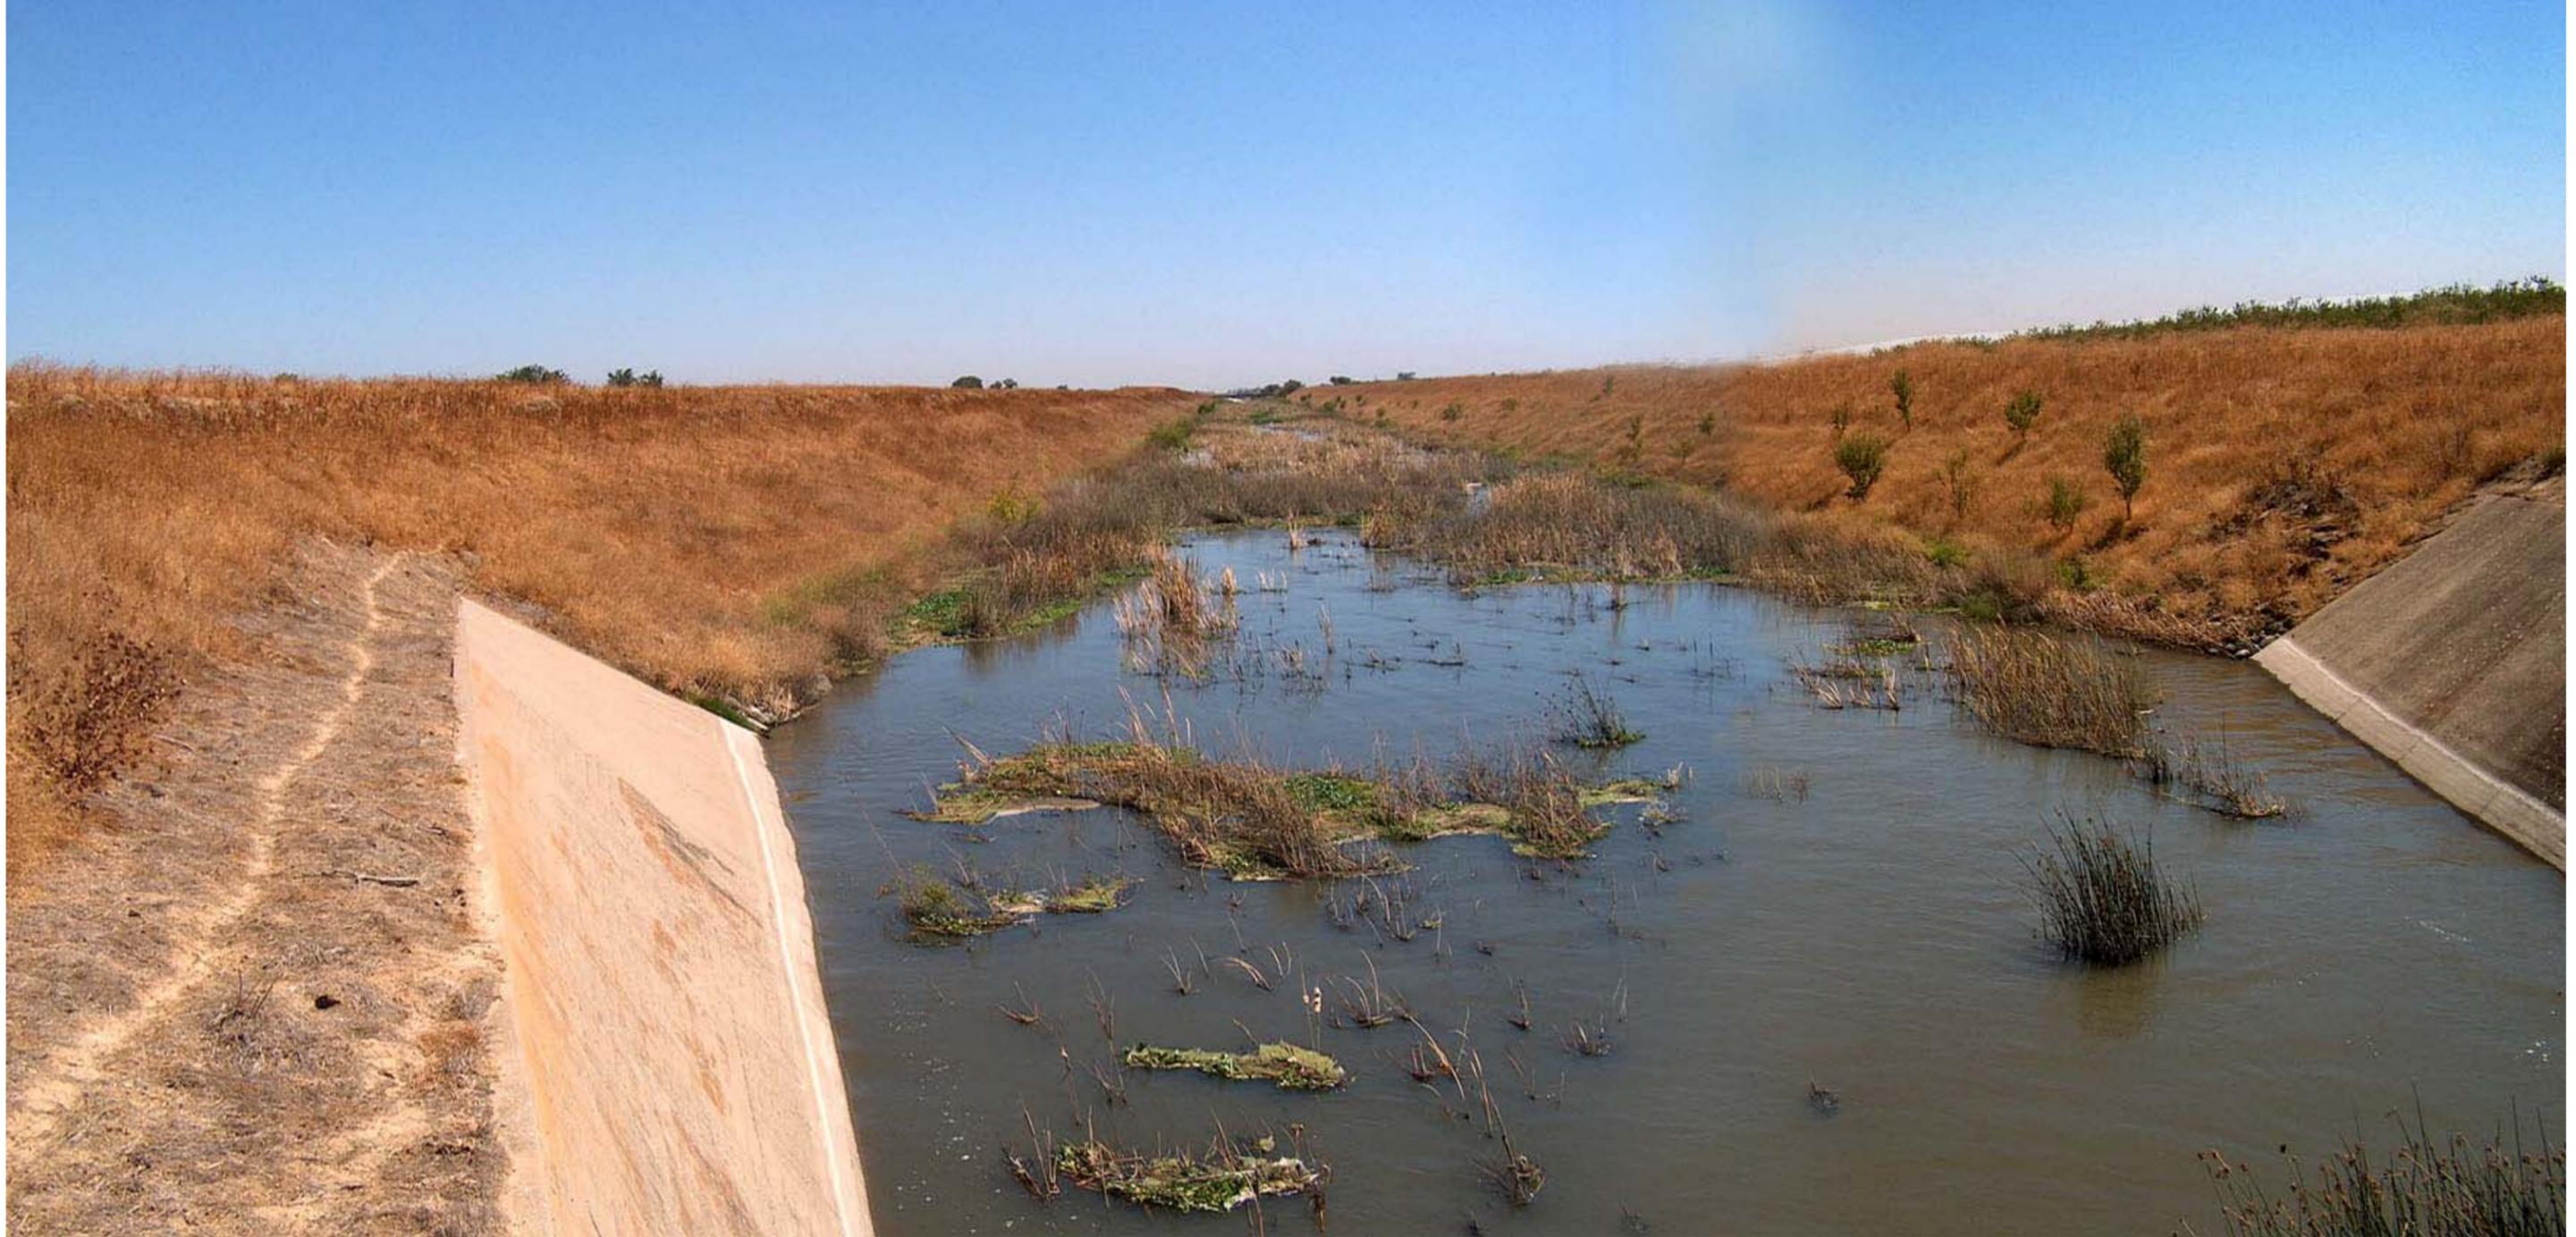
Photo 16

View east (downstream) from the MP 2.48 drop.
R. Patras

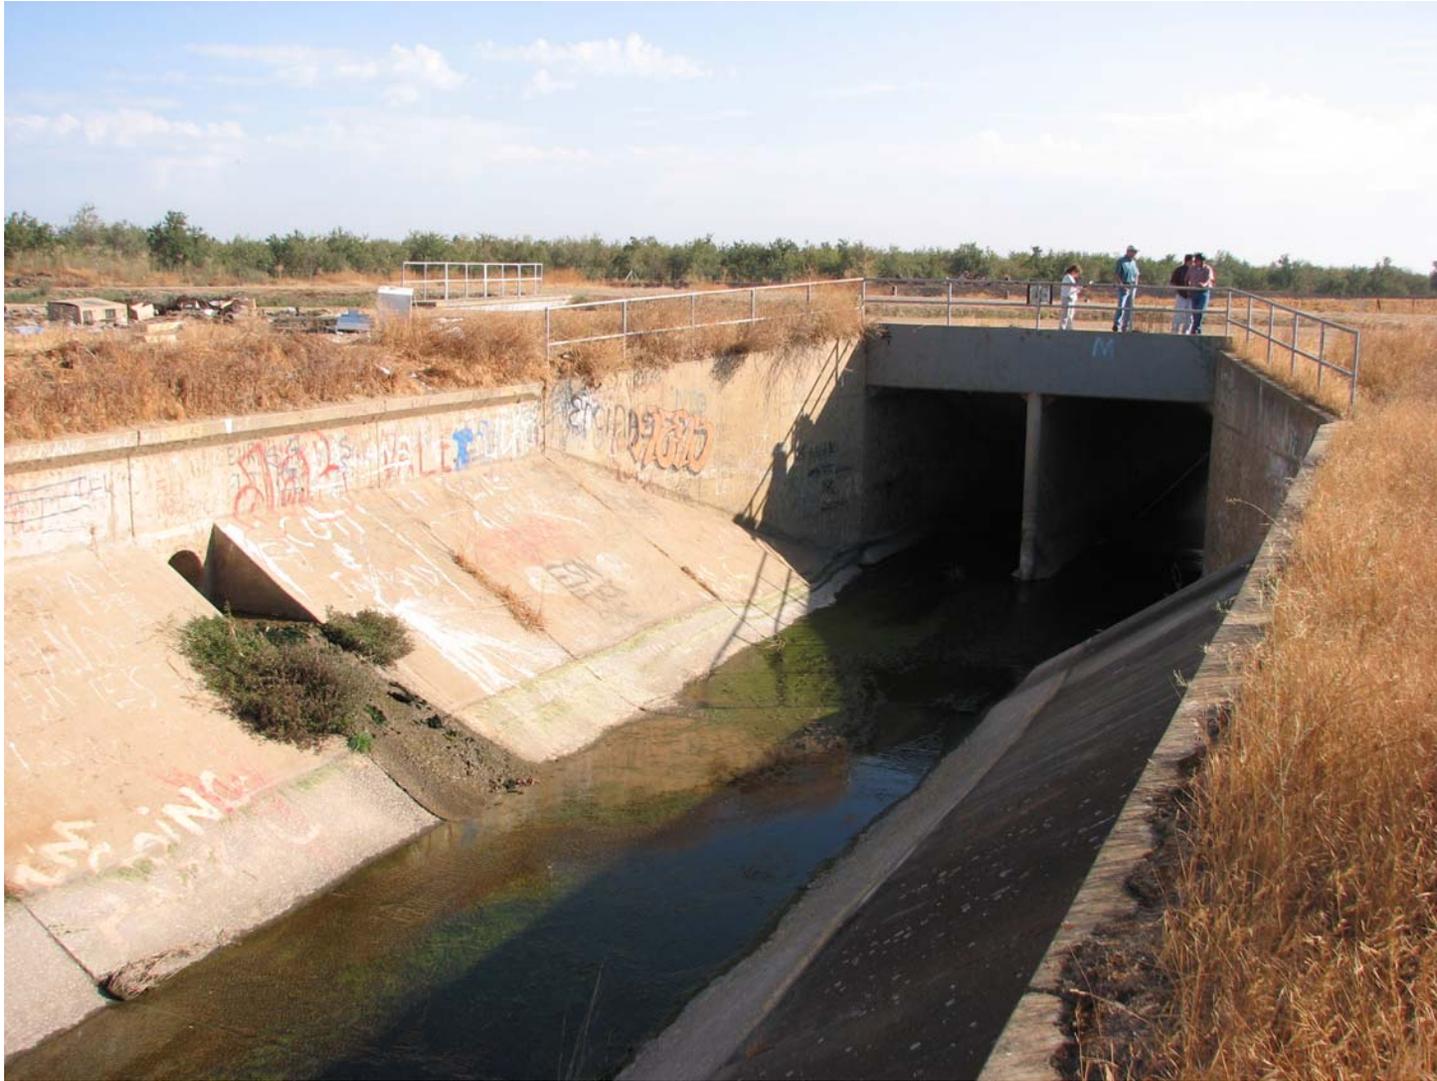
Photo 4

All concrete structures are in excellent condition and appear unaffected by the test flows (Post-Test Flow Photos 4, 5, 6, 13, 17 and 24).

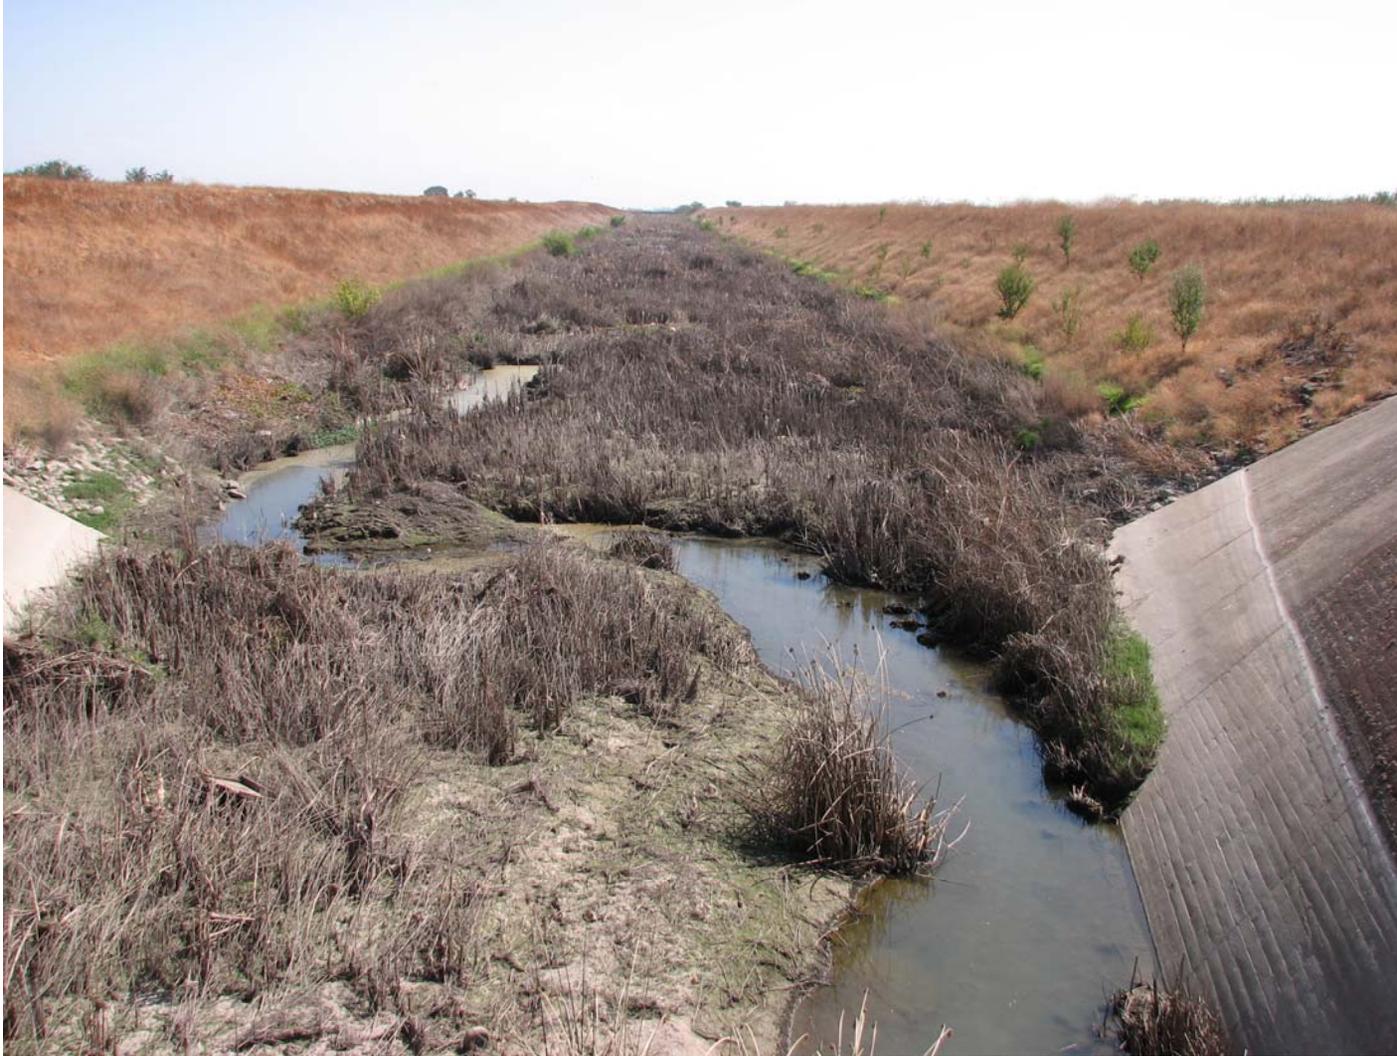
Photo 21

Only the localized deepening of the narrow, sinuous central channel by a few inches and no widening of the channel was observed (Post-Test Flow Photos 5, 18, 21, 26, 33 and 35).

All flow is within the sinuous, central channel (Post-Test Flow Photos 7, 15, 16, 18, 21 to 23 25 to 27 and 32 to 34), identical to pre-test flow conditions. Flow from Drop MP 1.44 to the Big Bend (MP 4.65) appears uniformly turbid, probably due to a loss of sediment filtering by vegetation as a result of flattening and removal of reeds and the removal of water plants within this reach by high test flows. Downstream of the Big Bend (MP 4.65), flow seems less turbid than upstream, probably due to sediment filtering by the persistent dense growth of reeds and primrose in the Big Bend area.
