ENGINEERING GEOLOGIC EVALUATION OF THE NEWMAN WASTEWAY AND STRUCTURES

DELTA MENDOTA CANAL RECIRCULATION FEASIBILITY STUDY

JANUARY 2009

U.S. DEPARTMENT OF INTERIOR
BUREAU OF RECLAMATION
MID PACIFIC REGION GEOLOGY BRANCH
SACRAMENTO, CA

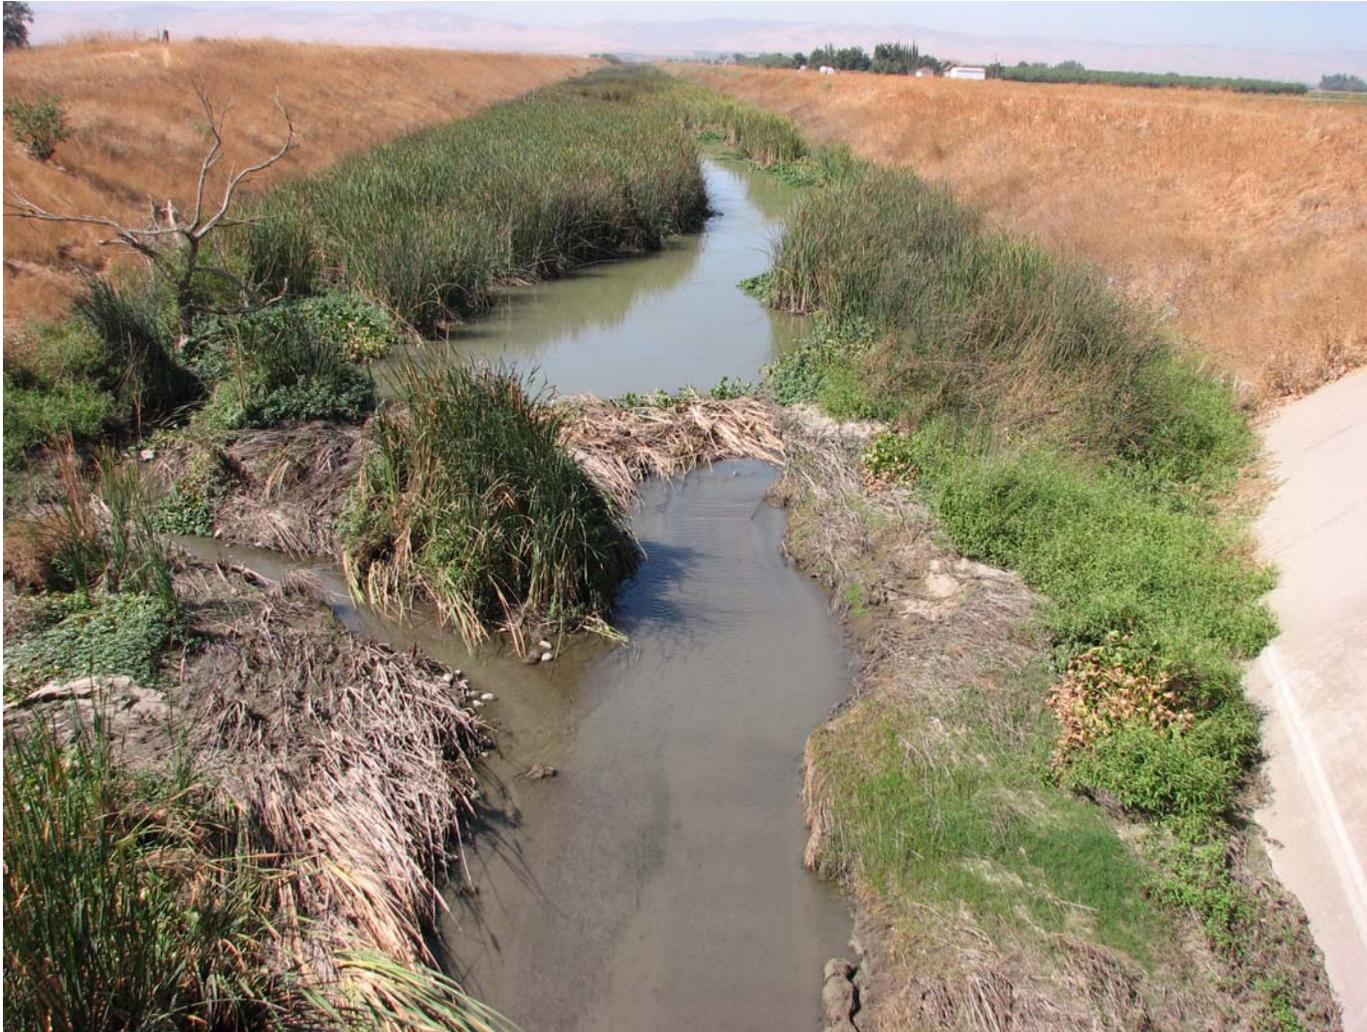
Photo 25

Beaver dams were observed at MP 1.66, MP 4.21 and MP 6.86. The most substantial dam is at MP 1.66, the same location observed on July 25. The pattern of flattened and removed vegetation indicates that the MP 1.66 dam diverted high test flows out of the central channel, impacting vegetation that might otherwise have not been subjected to the direct force of the high flows (Post-Test Flow Photos 9 and 11). A similar impact on vegetation is evident immediately downstream of the beaver dams at MP 4.21 and MP 6.86 (Post-Test Flow Photos 25 and 34). The beaver dams at MP 1.66 and MP 6.86 were either removed or

All flow is within the sinuous, central channel (Post-Test Flow Photos 7, 15, 16, 18, 21 to 23 25 to 27 and 32 to 34), identical to pre-test flow conditions. Flow from Drop MP 1.44 to the Big Bend (MP 4.65) appears uniformly turbid, probably due to a loss of sediment filtering by vegetation as a result of flattening and removal of reeds and the removal of water plants within this reach by high test flows. Downstream of the Big Bend (MP 4.65), flow seems less turbid than upstream, probably due to sediment filtering by the persistent dense growth of reeds and primrose in the Big Bend area.

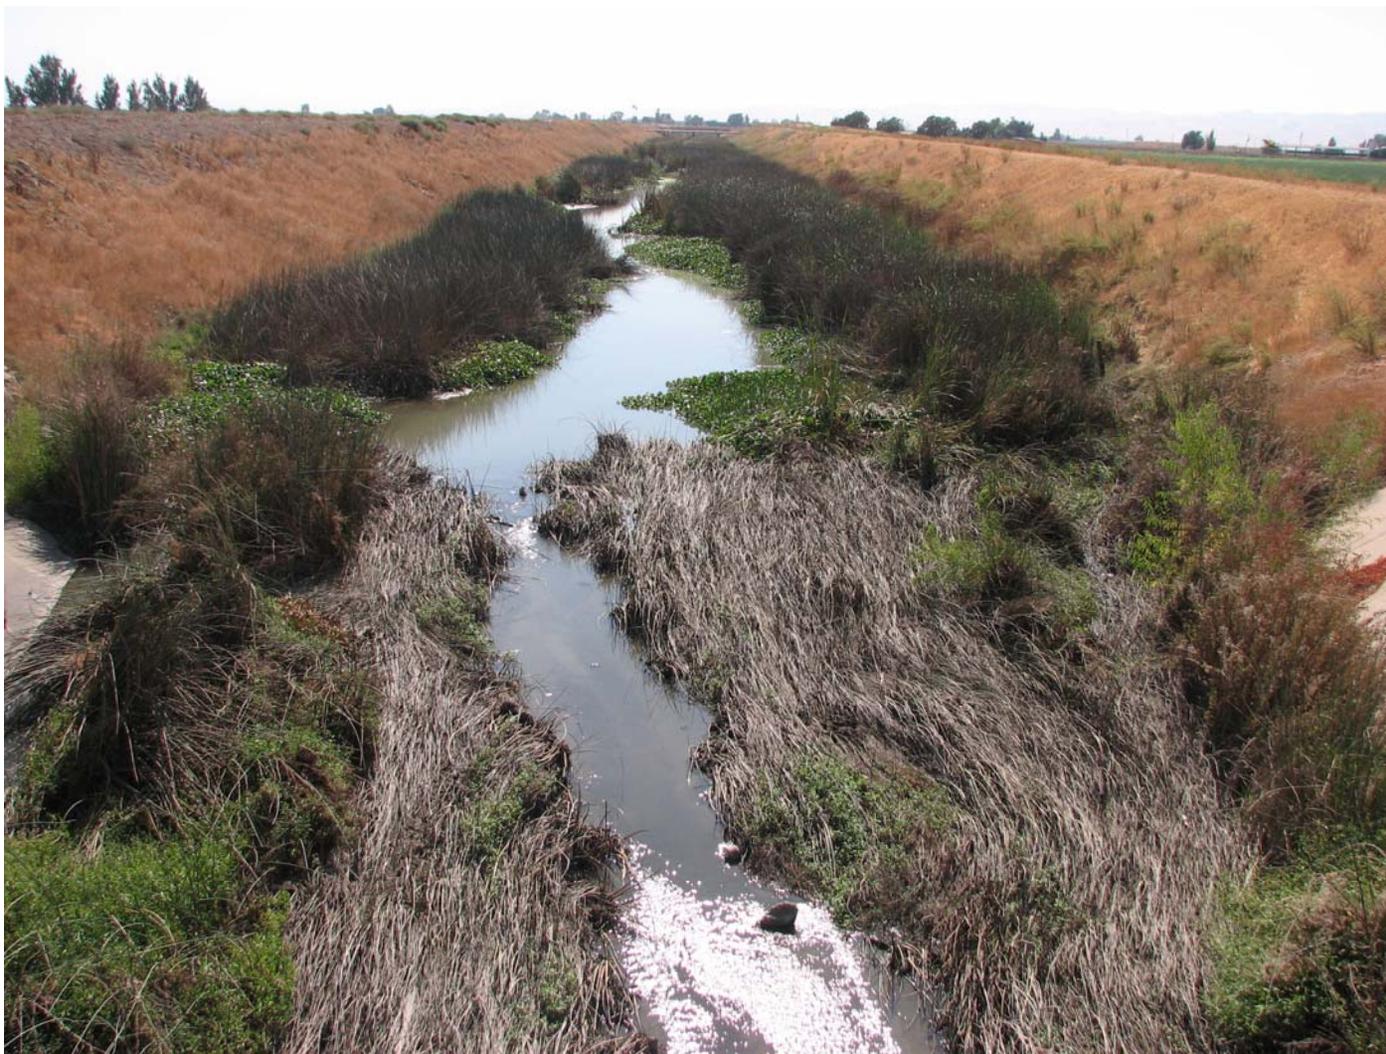
Photo 32

The same pattern of flow velocity (faster upstream and slower downstream of drops) observed on July 25 was also evident on September 29 (Post-Test Flow Photos 32 and 33).

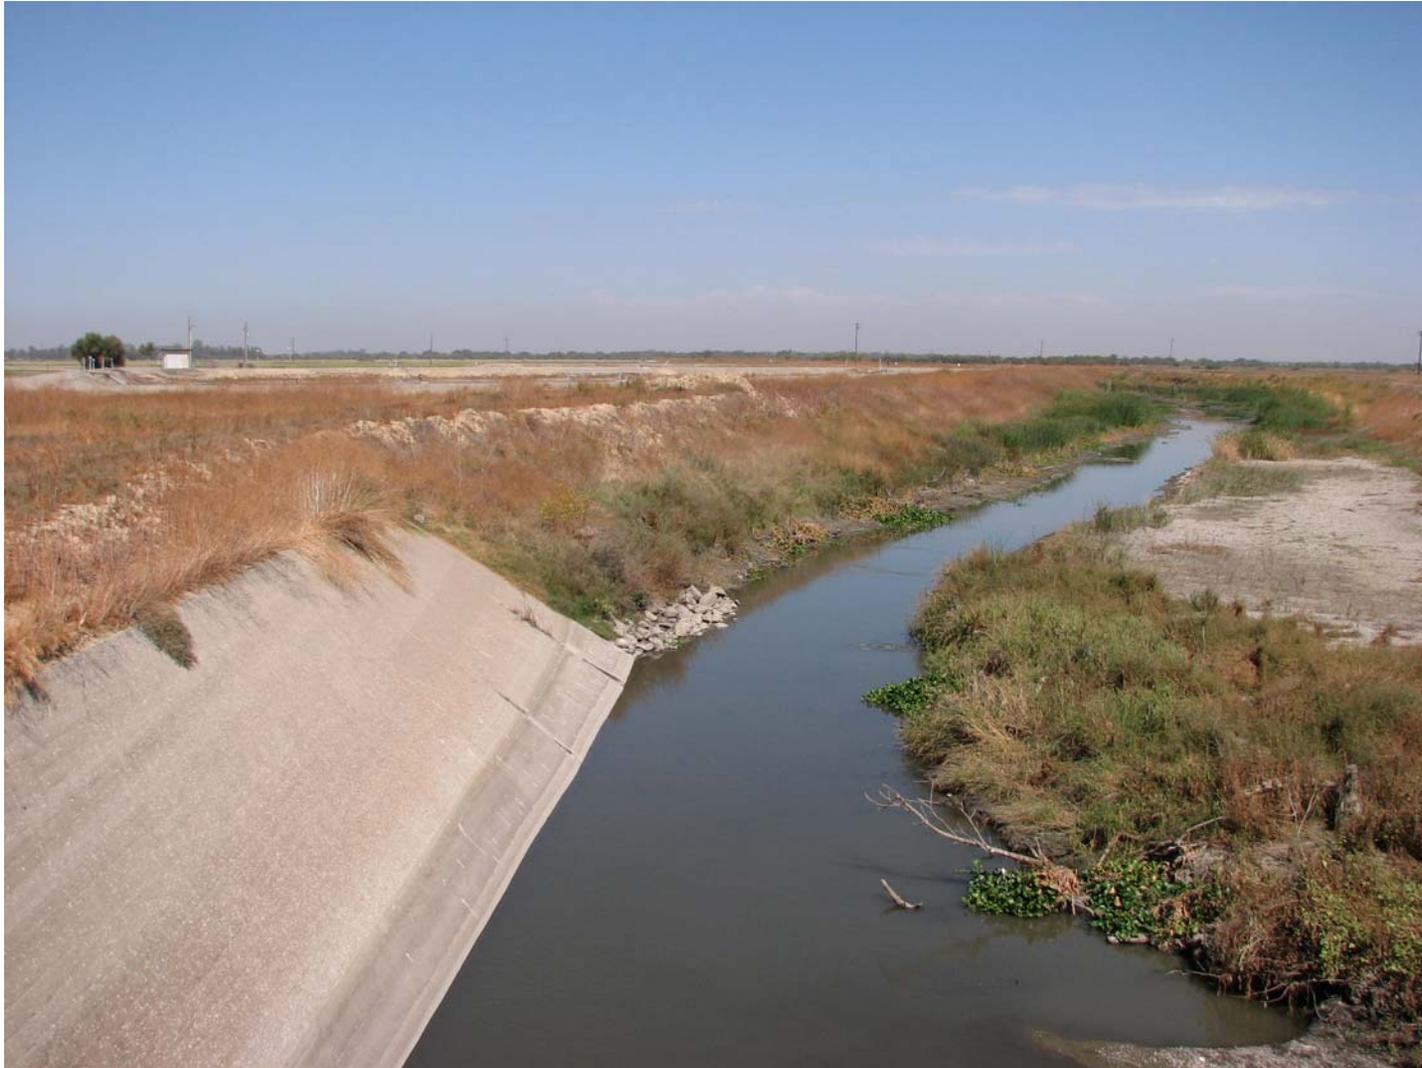
Photo 35

Only the localized deepening of the narrow, sinuous central channel by a few inches and no widening of the channel was observed (Post-Test Flow Photos 5, 18, 21, 26, 33 and 35).
