Technical Memorandum No. MERL-2014-64

## Coatings for Mussel Control — Results from Six Years of Field Testing

U.S. Department of the Interior  
Bureau of Reclamation  
Technical Service Center  
Denver, Colorado

July 2014

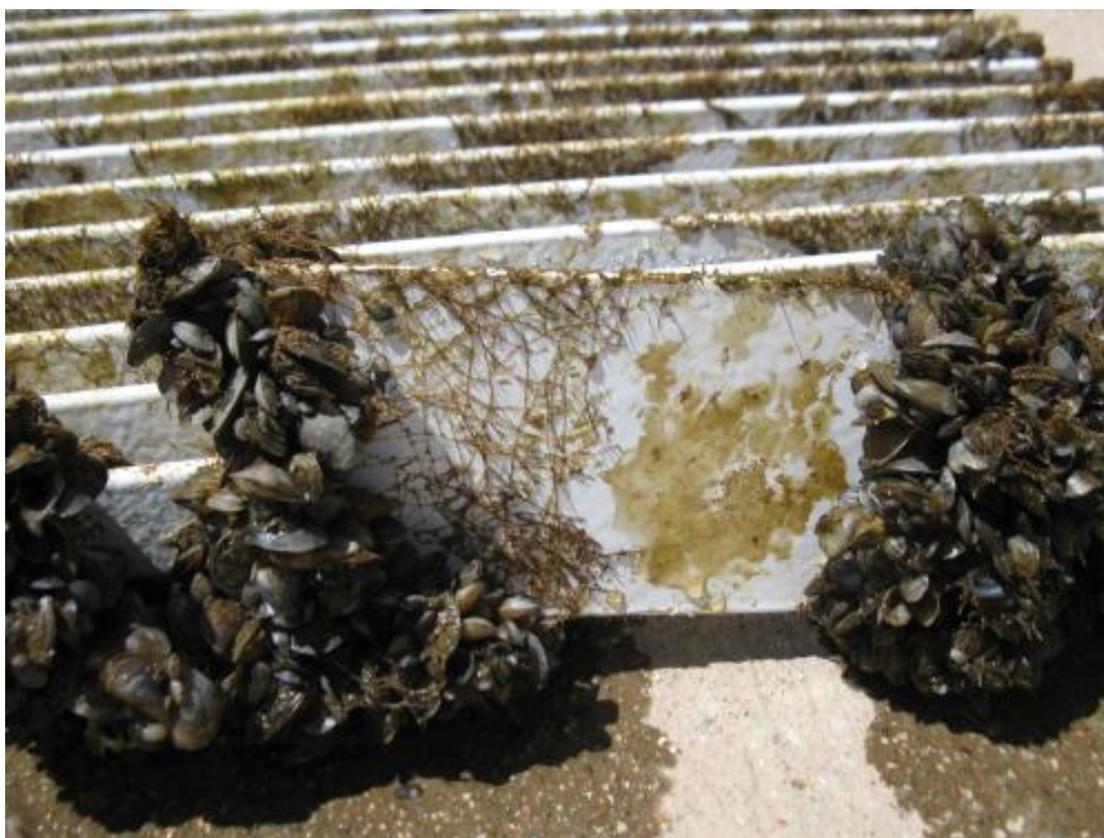
**On the cover:** Steel plate coated with a silicone oil-free version of Silicone FR #1 after 22 months of immersion in mussel-infested water. Mussels have attached to the back and sides of the plate, but not to the coated surface.

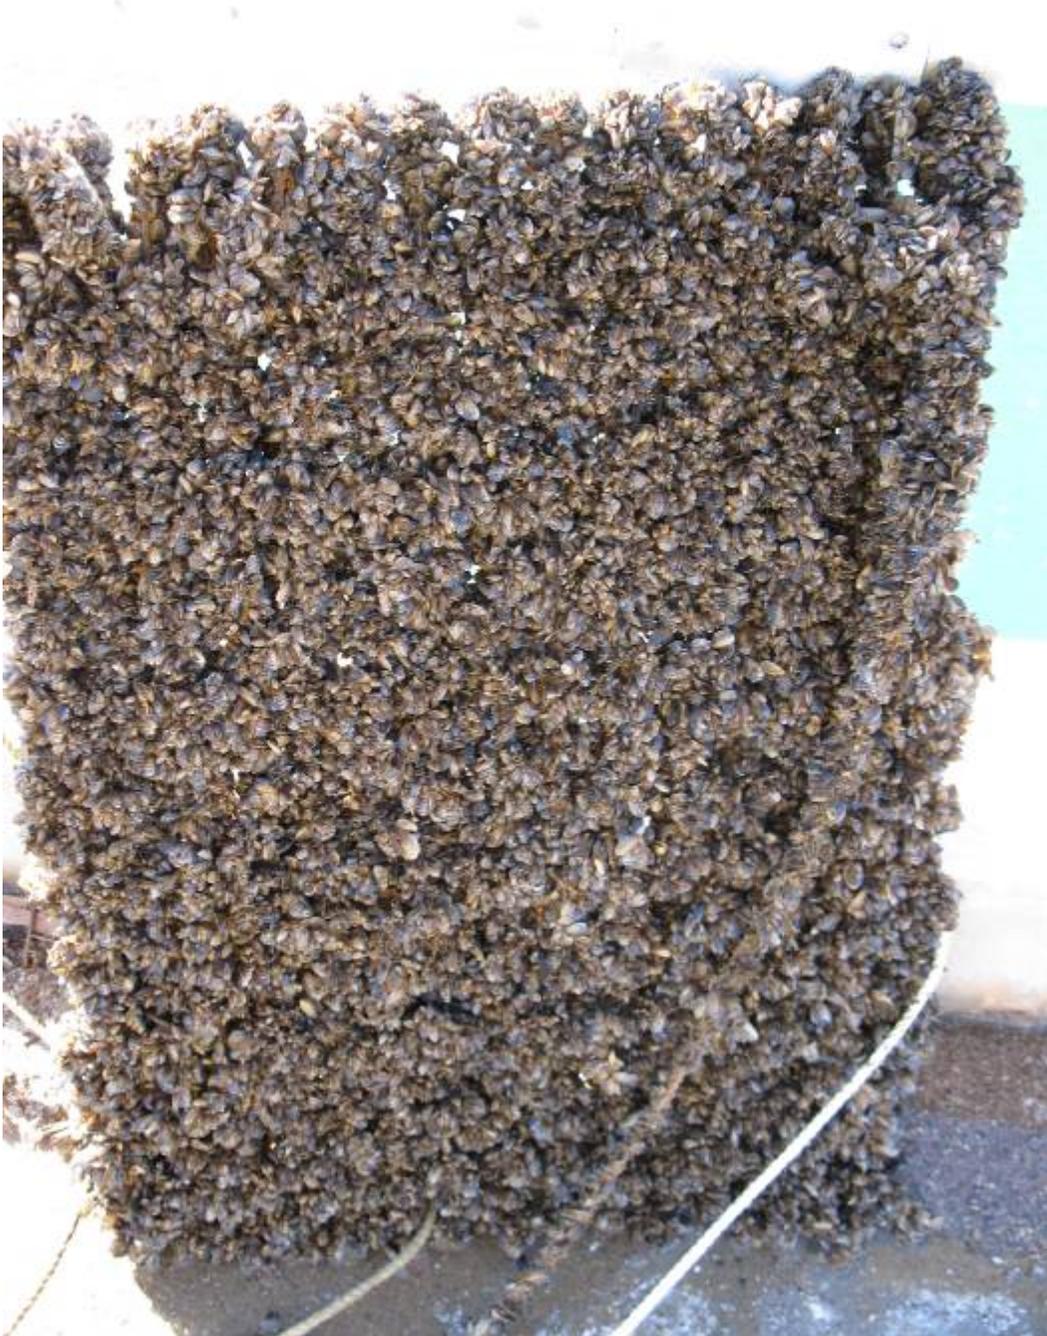
Several sets of experimental controls were used to determine fouling rates, including epoxy-coated steel, ASTM A788 steel (Figure 4) and 304 stainless steel [6, 7].

**Figure 4.** Uncoated steel after 7 months of exposure in dynamic conditions. Test period May 2008 to December 2008.

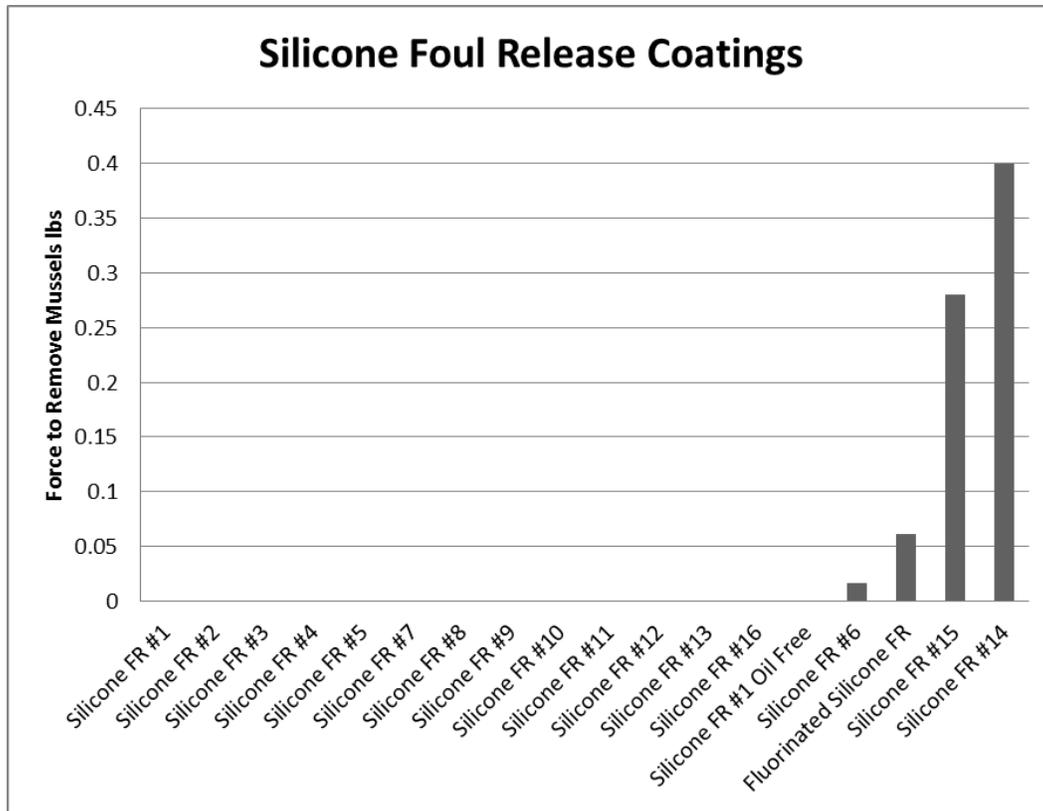
**Figure 5.** Force measurements for silicone and fluorinated silicone foul-release coatings.

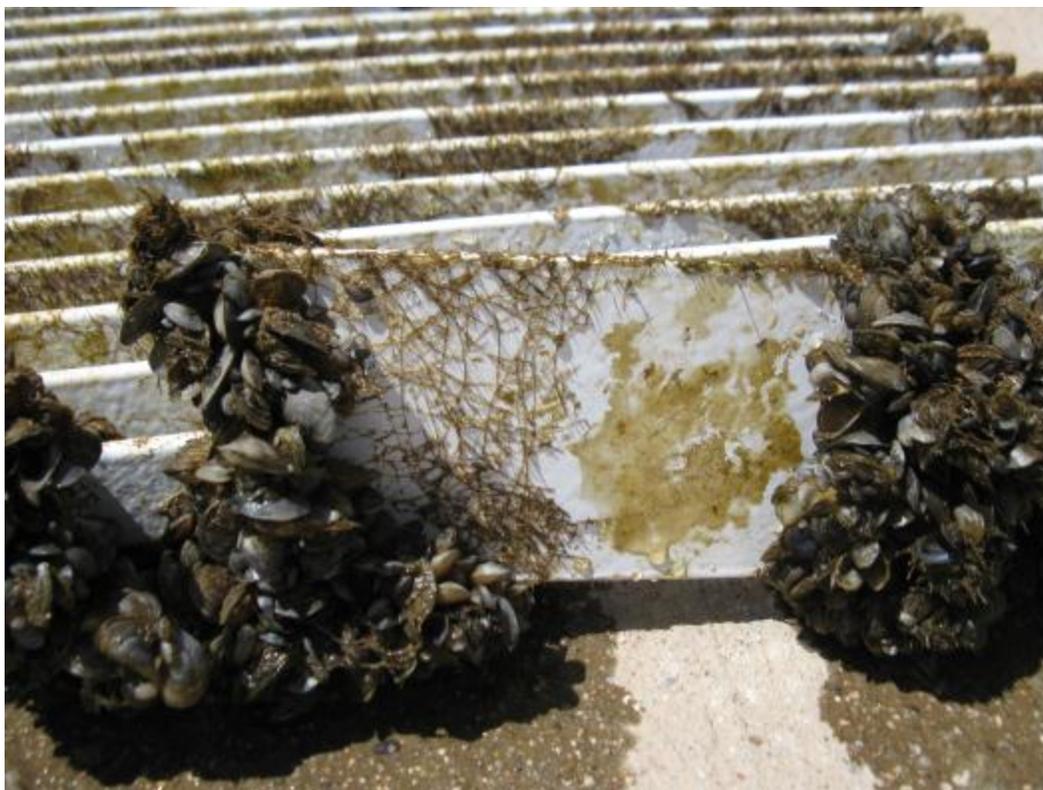
Since most silicone foul-release coatings contain a silicone oil-release additive, MERL tested a silicone oil-free version of Silicone FR #1 to determine if the mussels would attach once the oils were depleted. The results showed no mussel attachment after 22 months of exposure. (See cover photo.) The coating manufacturers use silicone oils as release agents to assist fouling release of marine organisms. Since silicone oil is designed to be consumed by leaching from the coating, foul-release performance would typically degrade over time. If oil-free coatings are effective in freshwater environments, foul-release capability may be maintained throughout the life of the coating. MERL's finding shows that the principles of foul-release coatings for marine fouling may not apply directly with freshwater fouling. Furthermore, removing the silicone oil from the formulation could provide coating manufacturers with lower-cost coatings as well as a better National Sanitation Foundation (NSF 61) approval rating for drinking water [2].

Commercially available silicone foul-release coatings contain silicone oils within the coating system that migrate to the surface over time, creating a surface that prevents adhesive wetting and bond formation. Systems are optimized to maintain oil on the surface for as long as possible, but eventually the oil becomes depleted. The performance typically degrades over time in the marine environment. MERL researchers questioned whether the silicone oil additive was essential for foul-release efficacy. The manufacturer of Silicone FR #1 agreed to provide an oil-free version for testing purposes, which was placed in testing in July 2012. The silicone foul-release coatings without silicone oil did not allow mussel attachment to the surface (shown on Figure 6 and the front cover). This new discovery may allow coating manufacturers to develop coatings with NSF 61 approval ratings for drinking water [2]. This also suggests that as long as the silicone foul-release coatings are not damaged, they will perform for the life of the coating. MERL's discovery suggests that foul-release coatings work differently in freshwater than in marine settings. This revelation could lead to the formulation of foul-release coatings designed specifically for freshwater immersion, which are better able to meet the needs of Reclamation and the industrial maintenance market.

**Figure 6.** Silicone oil-free version of Silicone FR #1 after 22 months of exposure.

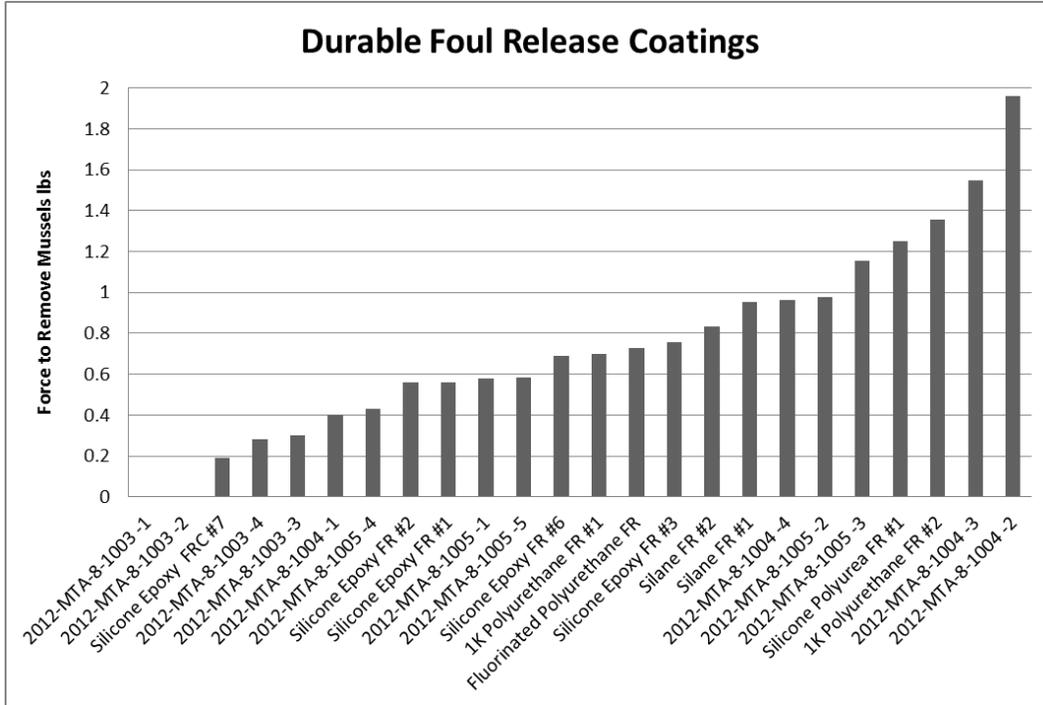
Most durable foul-release coatings that MERL tested allow mussels to attach to the coating surface with varying amounts of force, as shown in Figure 7. The mussels build up significantly and can cause 100-percent blockage and severe flow restriction through the coated grates. Although the mussels attach with varying force, they remain attached to the surface without being released under the test conditions; i.e., the tested coatings generally are not self-cleaning. The only exceptions among the systems currently being evaluated are Silicone Epoxy #7 and 2012-MTA-8-1003 #1 and #2. It is premature to make any conclusions regarding the effectiveness of these systems. Silicone Epoxy #7 allowed mussel attachment requiring 0.2 lbs of force to remove a mussel, but appears to be self-cleaning for the first 12 months of exposure, as shown in Figure 8. The two experimental formulations from the Material Transfer Agreement (MTA) prevented mussel attachment, for the first 18 months of exposure, as shown in Figure 9. In that image, mussels are attached to the backs of the panels and to zipties between the panels. In places, chains or “curtains” of mussels anchored on the backs of the panels wrap around to the front side. Up to this point, self-cleaning and prevention of attachment was only observed for silicone and fluorinated silicone foul-release systems. All other durable foul-release coatings evaluated allowed mussel attachment, as described in Table 2. The coatings listed in Table 2 would be easier to clean than a traditional epoxy coating, according to the force measurements. The self-cleaning property was not observed with the durable foul-release coatings listed in Table 2.

**Figure 7.** Force measurements for durable foul-release coatings.

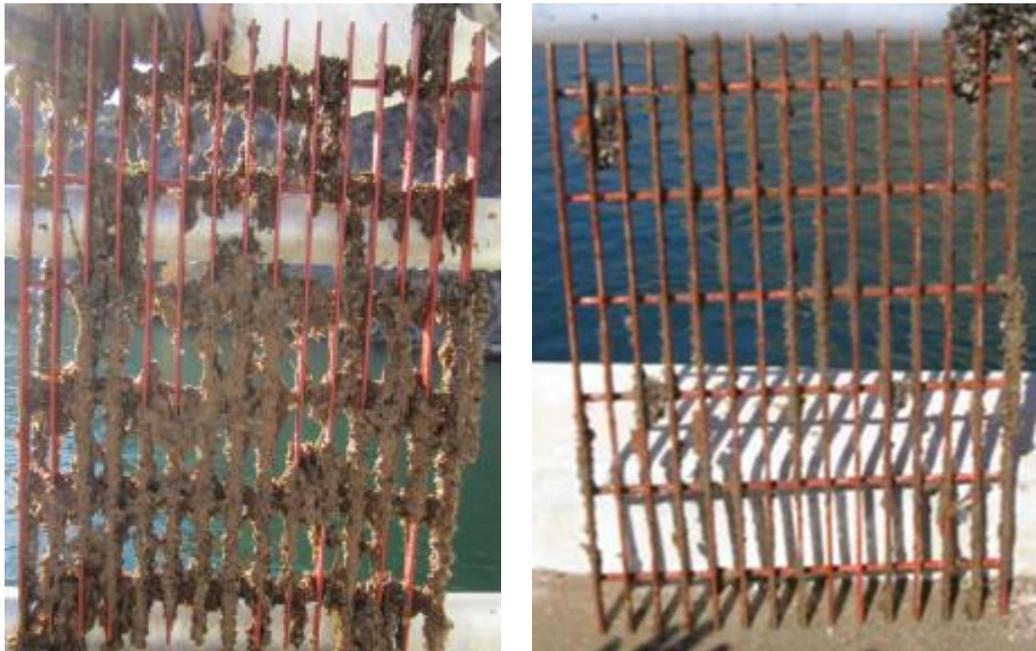
**Figure 8.** Grate coated with Silicone Epoxy #7, as seen in December 2013 (left) and in May 2014, after 1 year of exposure (right).

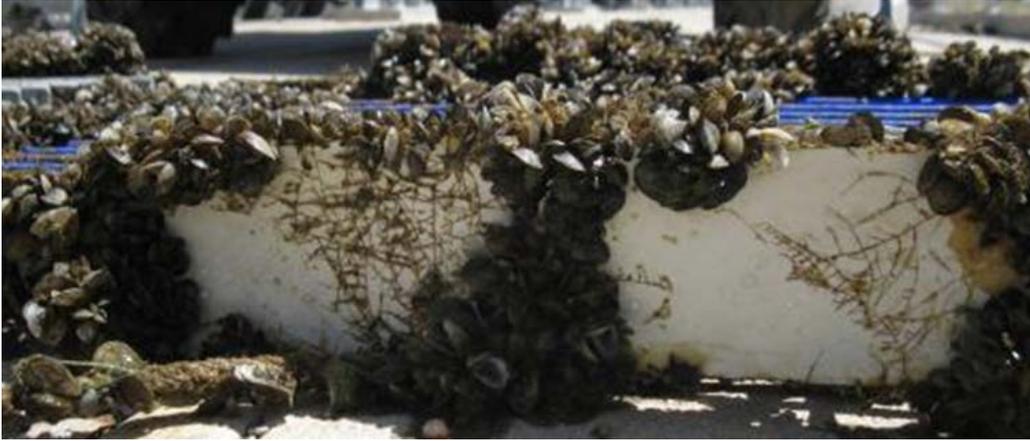
**Figure 9.** Panels coated with experimental formulations from 2012-MTA-8-1003 #1 and #2, exposure at 18 months.

Partner 2012-MTA-8-1003 provided four different experimental formulations. As shown in Figure 9, samples #1 and #2 have thus far prevented mussel attachment, after 18 months of exposure. Samples #3 and #4 had mixed results: some of the panels did not have any mussels while other replicates had mussels covering the entire surface. Both sets had very low release forces to remove clusters: sample #3 required 0.30 lbs, and sample #4 required 0.80 lbs. Samples #3 and #4 were removed from the study in May 2014.

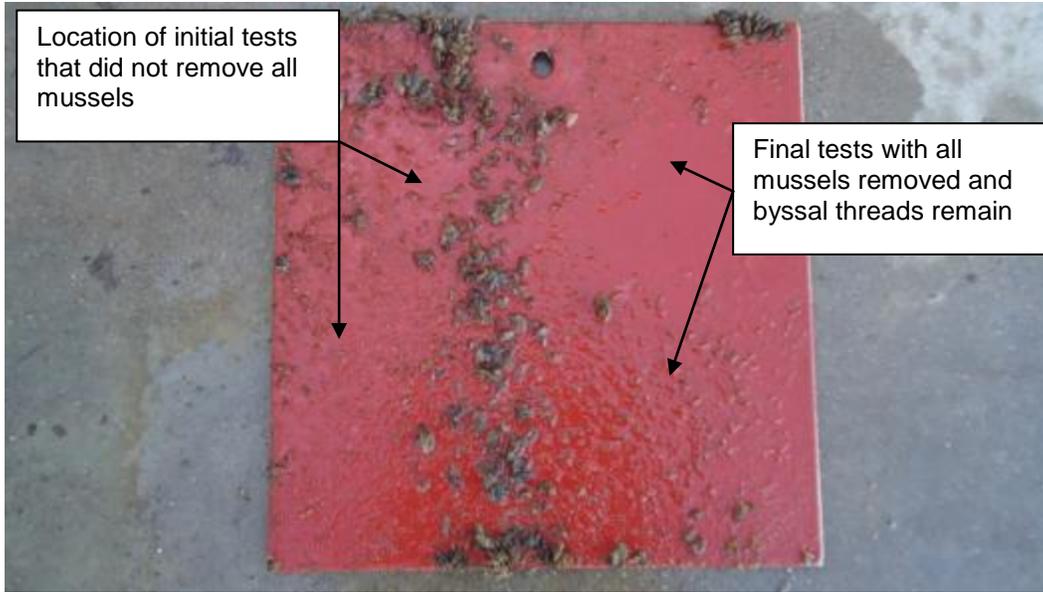
In 2011 and 2012, the Hydraulic Investigations and Laboratory performed a cleanability study including some of the durable foul-release coatings listed in Table 2. They discovered that the byssal threads remained on the surface of every hard coating or metal, which included stainless steel, coal tar enamel, coal tar epoxy, polyamide epoxy, and the durable foul-release coatings [3]. Plates with significant mussel attachment were left with byssal threads and sometimes entrails, which could not be removed with the waterjet (as seen in Figure 10). Even using a spot jet close to the surface was ineffective at completely removing the byssal threads. While it is undesirable to have threads remaining on the coating surface, it may not be necessary to have them completely removed, as they do not significantly increase flow friction or head differential. The waterjetting study suggested that the durable foul-release coatings tested offer no advantage over a conventional epoxy or coal tar enamel in situations where waterjet cleaning is expected to be utilized.

Figure 10. Silicone Epoxy FR #1 sample after release pressure testing.

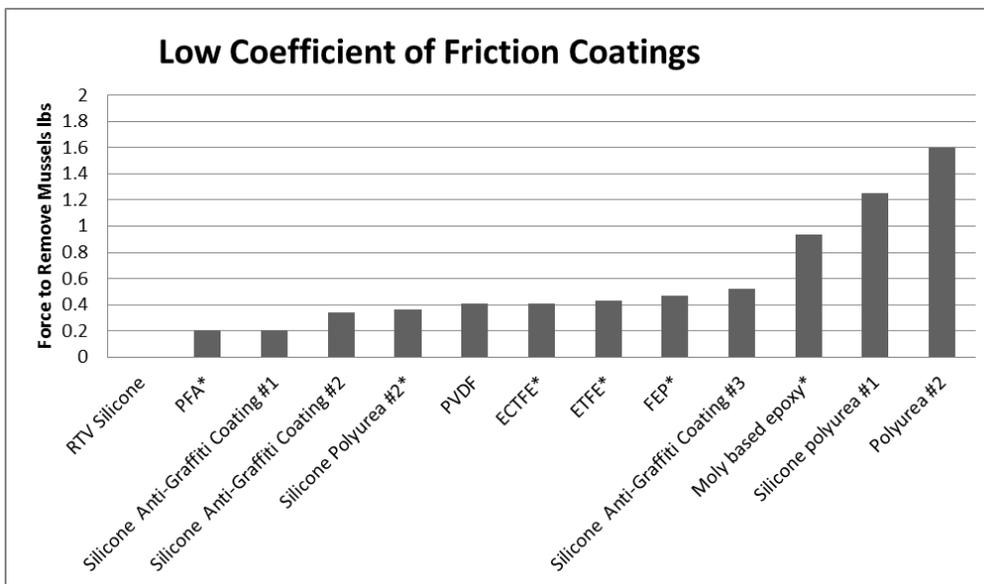
Low coefficient-of-friction coatings were not designed to prevent mussel attachment; however, MERL has found that some of them have lower release force than the most of the durable foul-release coatings. Figure 11 shows the release force for mussels of various low coefficient-of-friction coatings. Even though these coatings have low release forces, the coatings allow the mussels to attach and are not self-cleaning under the testing conditions at Parker Dam. It is unknown if these coatings would self-clean under higher flow rates.

Figure 11. Force measurements for low coefficient-of-friction coatings.

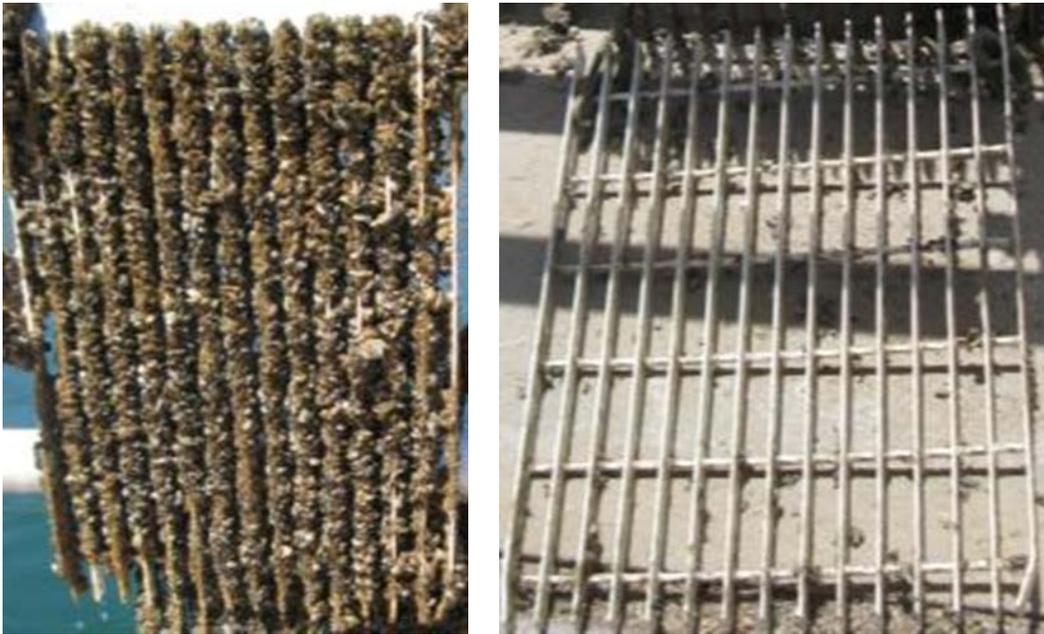
**Figure 12.** Grate treated with RTV Silicone ice phobic coating, before cleaning (left) and after cleaning (right), May 2014.
