Upper White Pine Reach Assessment Nason Creek Chelan County, Washington

Bureau of Reclamation
Pacific Northwest Region
Boise, Idaho

March 2009

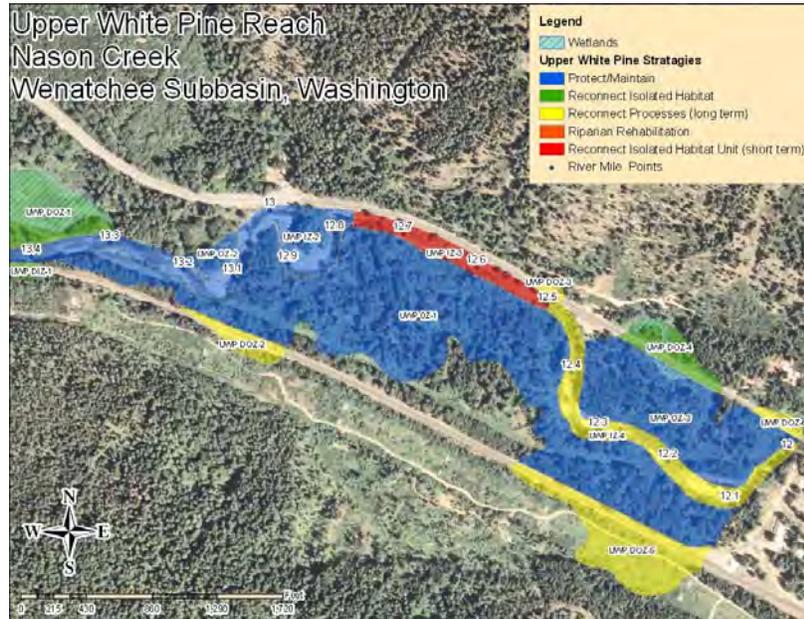
Figure 15 - UWP OZ-7 and adjacent subreaches in the Upper White Pine reach.

The inundation potential of this subreach is 1 acre or 4 percent of the inundation potential for the entire Upper White Pine reach. Rehabilitation options are listed in Table 7 and are prioritized to maximize the geomorphic potential of the subreach through the reconnection and re-establishment of both long-term and short-term processes at the subreach scale. Rehabilitation actions in this subreach should be considered collectively with rehabilitation actions recommended in other adjacent subreaches to achieve a holistic reconnection and reestablishment of processes at the reach scale.

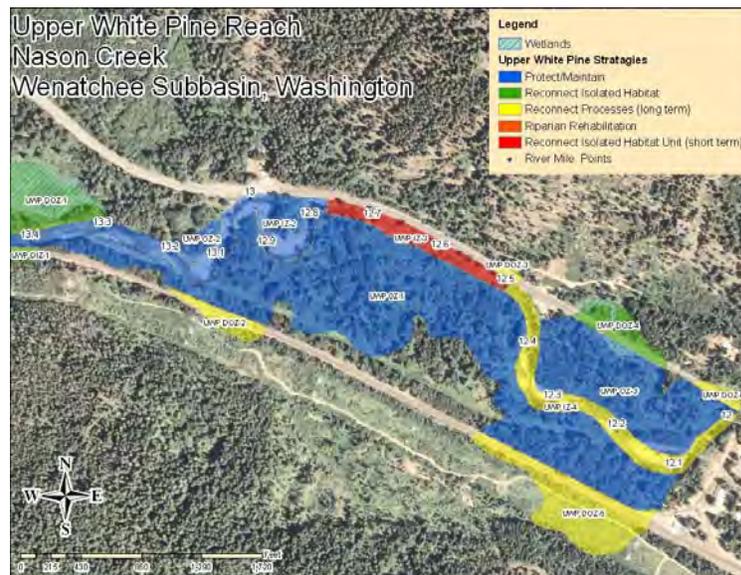
Figure 16 - UWP OZ-3 and adjacent subreaches in the Upper White Pine reach.

The potential to increase the area of inundation is low. When comparing 5,000 cubic feet per second (cfs) stream flow for existing conditions versus potential conditions (i.e., with anthropogenic features removed), the two-dimensional (2D)-hydraulic model results only show an inundation increase of 0.2 acres. Most of the subreach is inundated at both modeled flows. Rehabilitation options are listed in Table 8 and are prioritized to maximize the geomorphic potential of the subreach through the reconnection and re-establishment of both long-term and short-term processes at the subreach scale. Rehabilitation actions in this subreach should be considered collectively with rehabilitation actions recommended in other adjacent subreaches to achieve a holistic reconnection and reestablishment of processes at the reach scale.

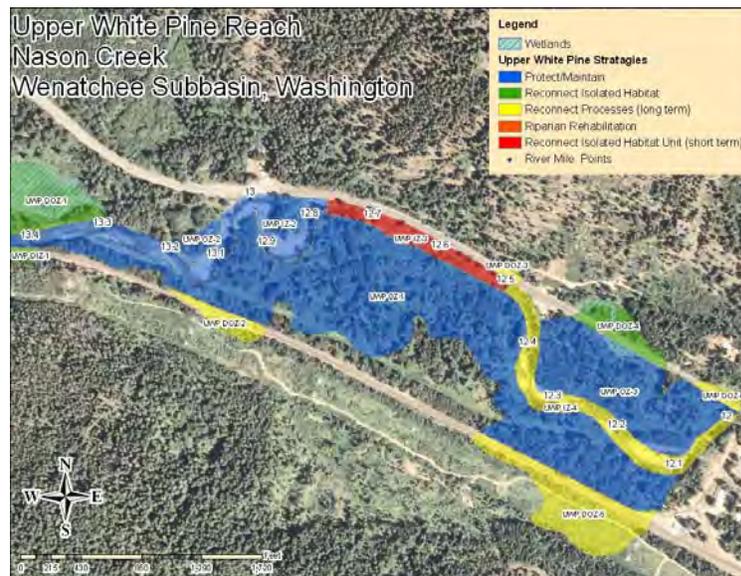
Figure 17 - UWP IZ-2 and adjacent subreaches in the Upper White Pine reach.

Rehabilitation options are listed in Table 9. Options are prioritized to maximize geomorphic potential of the subreach through the reconnection and reestablishment of both long-term and short-term processes at the subreach scale. Rehabilitation actions in this subreach should be considered collectively with rehabilitation actions recommended in other subreaches to achieve a holistic reconnection and reestablishment of processes at the reach scale.

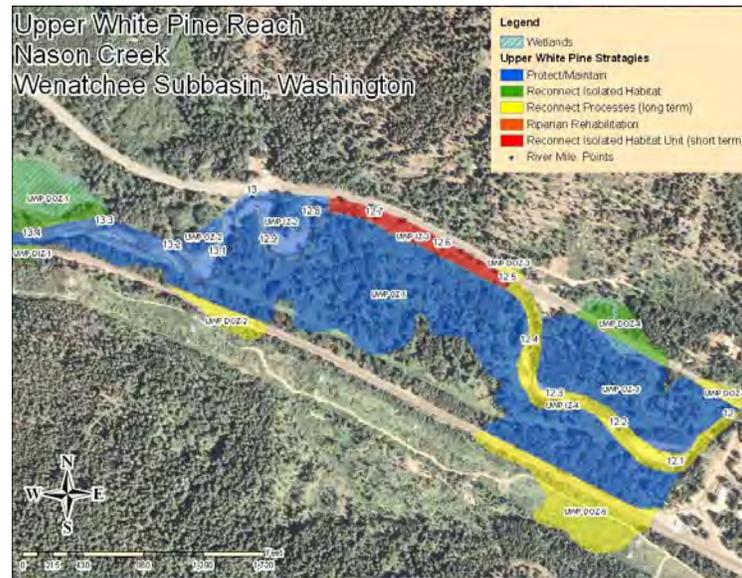
Figure 18 - UWP OZ-2 and adjacent subreaches in the Upper White Pine reach.

The potential to increase the area of inundation is low. When comparing 5,000 cfs stream flow for existing conditions versus potential conditions (i.e., with anthropogenic features removed), the 2D-hydraulic model results show little change in area of inundation. Most of the subreach is inundated at both modeled flows. Rehabilitation options are listed in Table 10 and are prioritized to maximize the geomorphic potential of the subreach through the reconnection and re-establishment of both long-term and short-term processes at the subreach scale. Rehabilitation actions in this subreach should be considered collectively with rehabilitation actions recommended in other adjacent subreaches to achieve a holistic reconnection and reestablishment of processes at the reach scale.

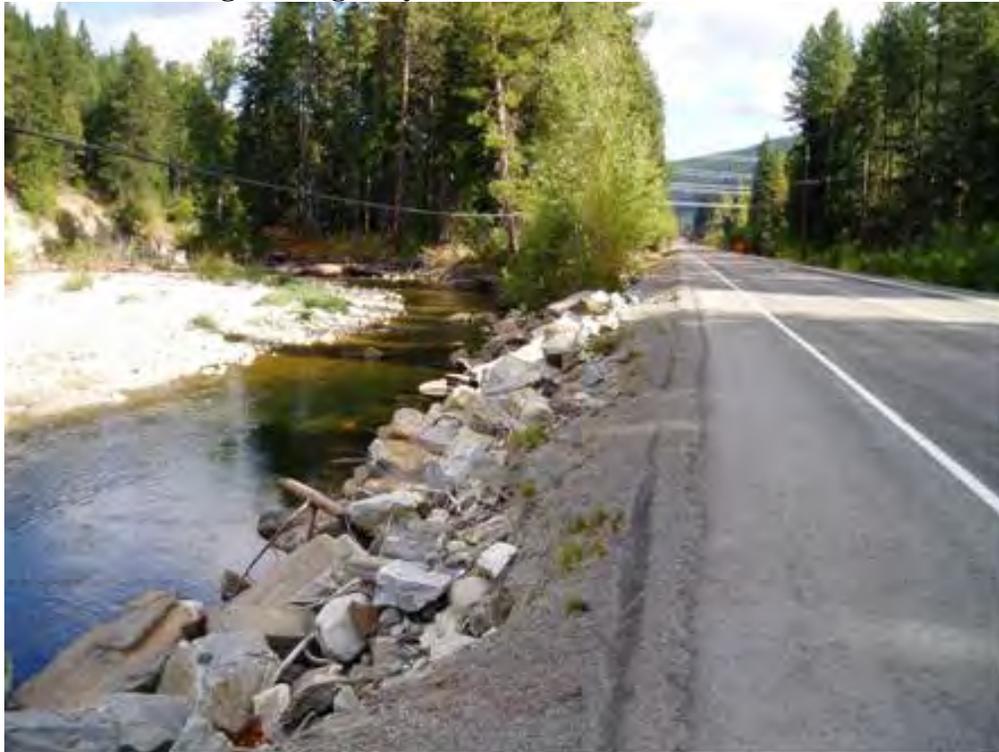
Bank erosion from power line crossing at RM 6.2

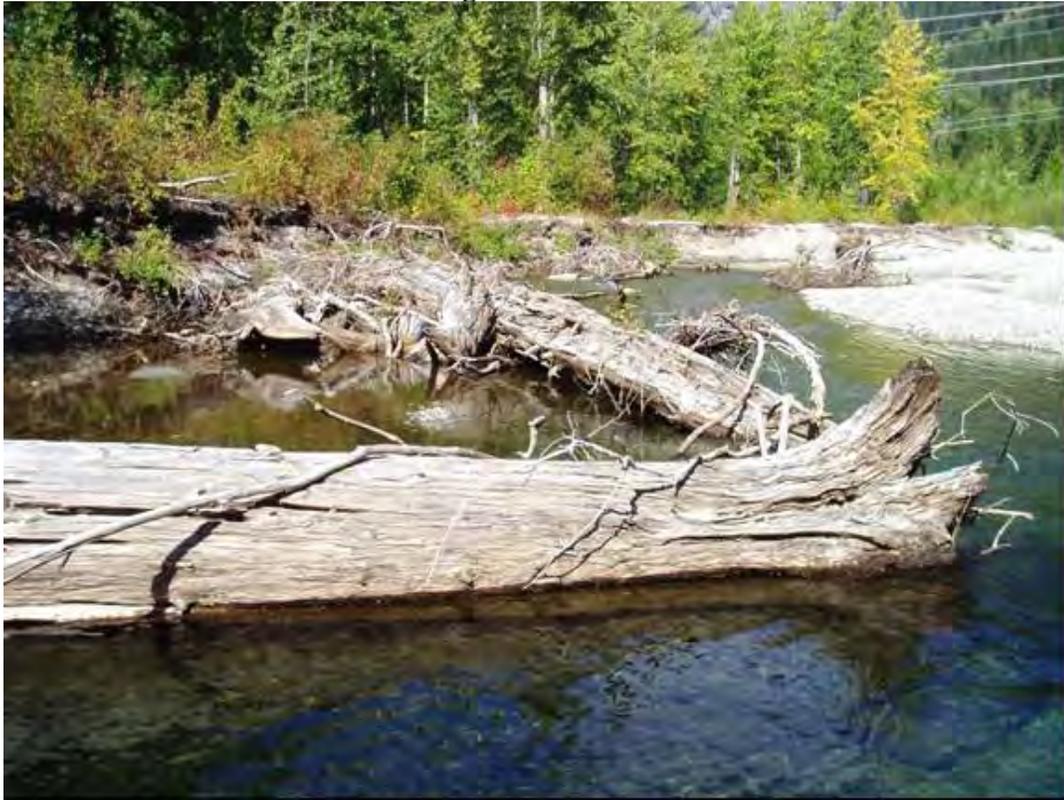
Cabled Logs in Pool at RM 10.3

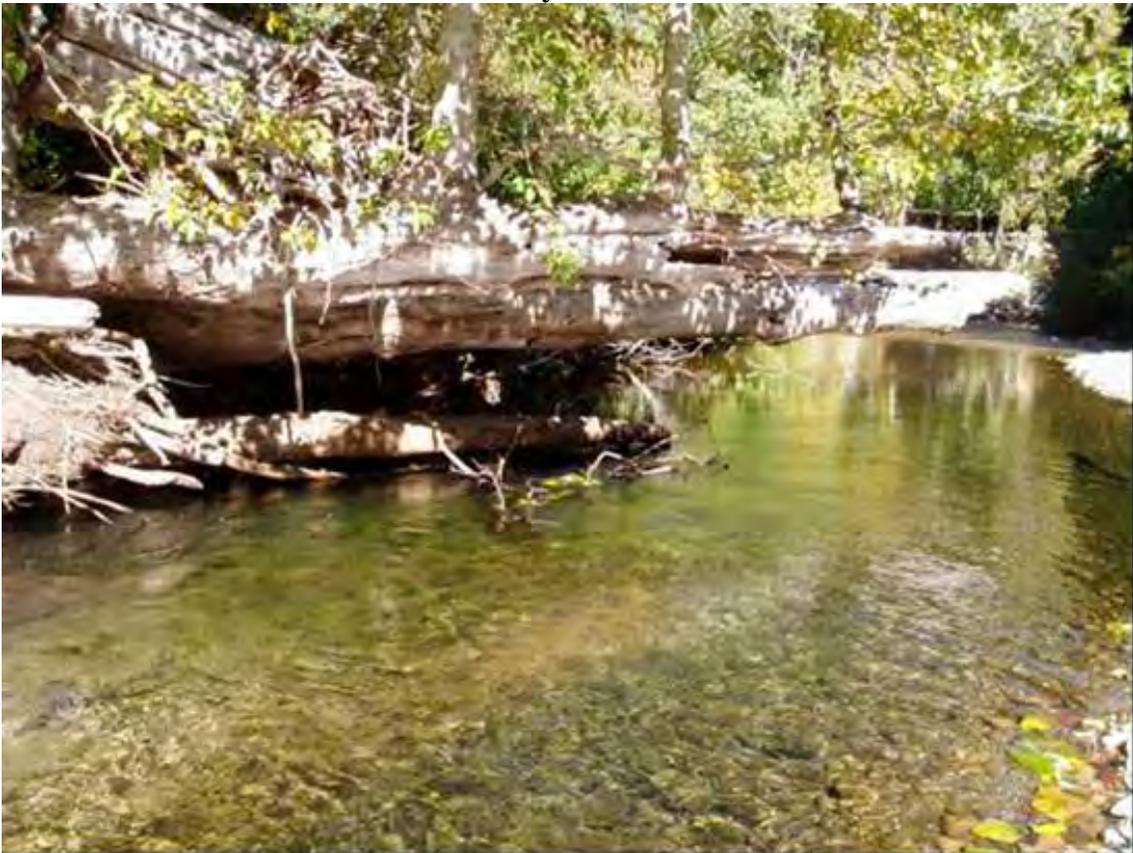
Pool formed by wood in Reach 4
