**BITTER ROOT IRRIGATION DISTRICT
MAIN CANAL**

**CANAL LINING DEMONSTRATION PROJECT
Exposed 20-mil Geocomposite
(8-oz geotextile with carbon black - 20-mil Ethyl Vinyl Acetate - 8-oz geotextile)
OCTOBER 15 - 19, 2001**

Jay Swihart and Jack Haynes
November 2002

Test Section BI-1.—

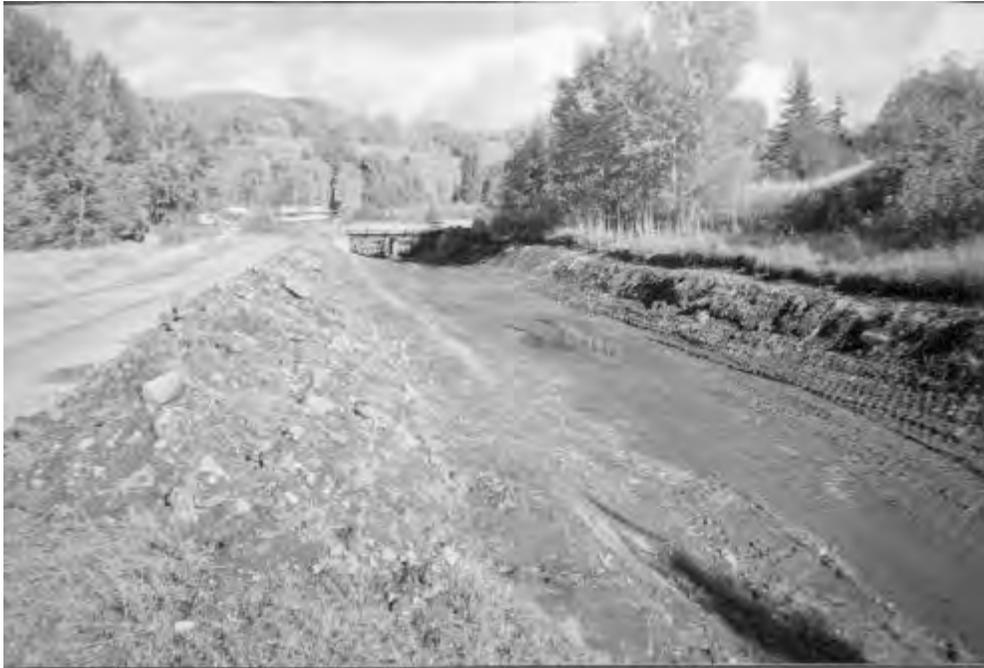
Photo 1.—The District performed extensive subgrade preparation by removing vegetation to 1 foot above the waterline, restoring the 1½:1 side slopes, and cutting a 2- to 3-foot anchor berm on each bank. The downstream section was too wet and was not lined at the time of the photograph.

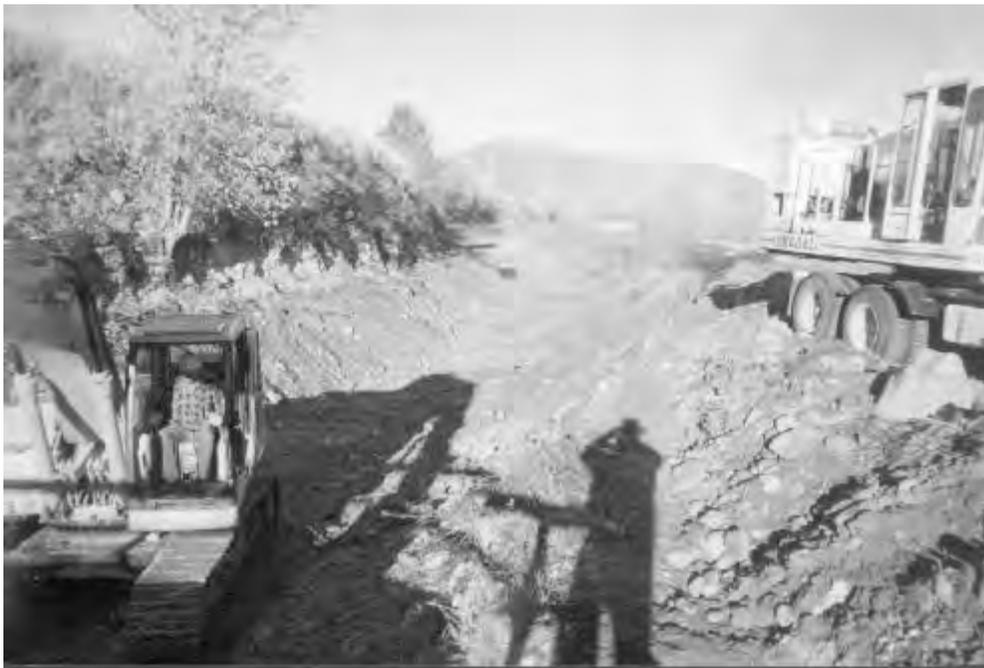
Photograph 2.—Upstream section ready for installation of lining.

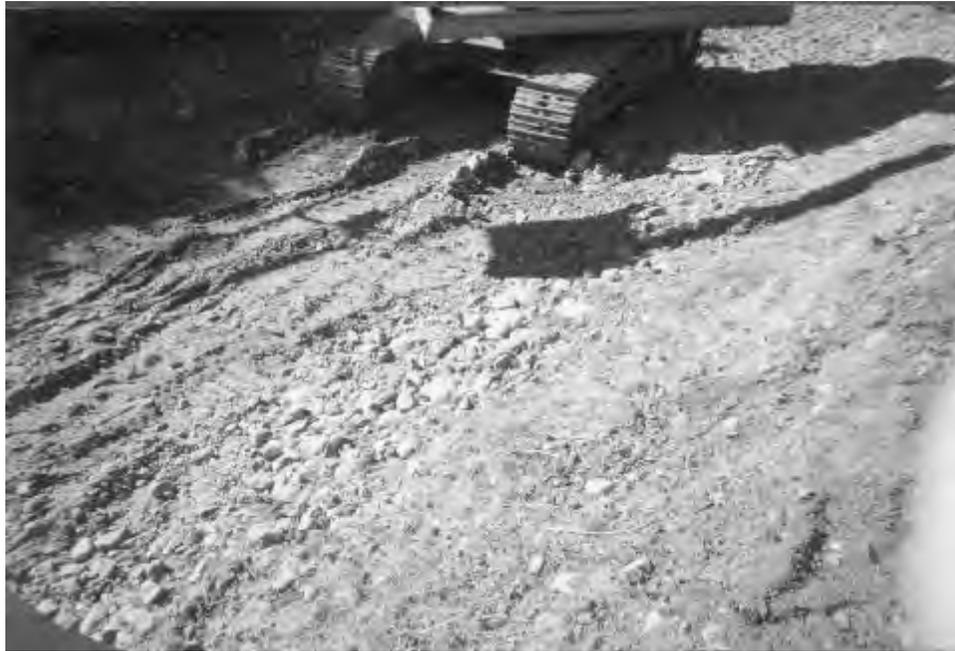
Photograph 3.—The prepared subgrade has large cobbles of up to 6 inches in diameter.

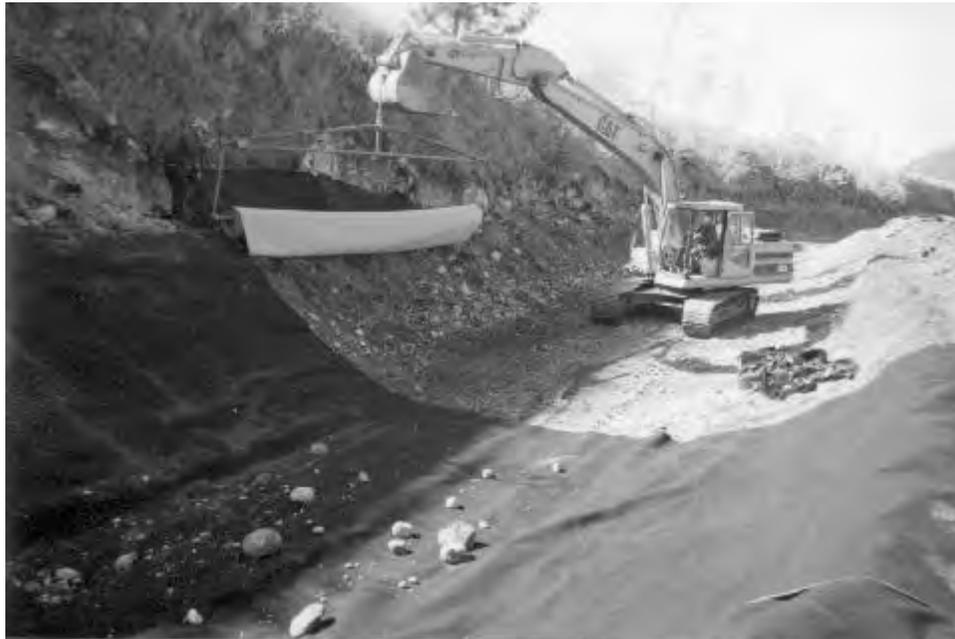
Photograph 4.—Trackhoe operating in the canal invert using a lifting bar to unroll geomembrane across the canal.

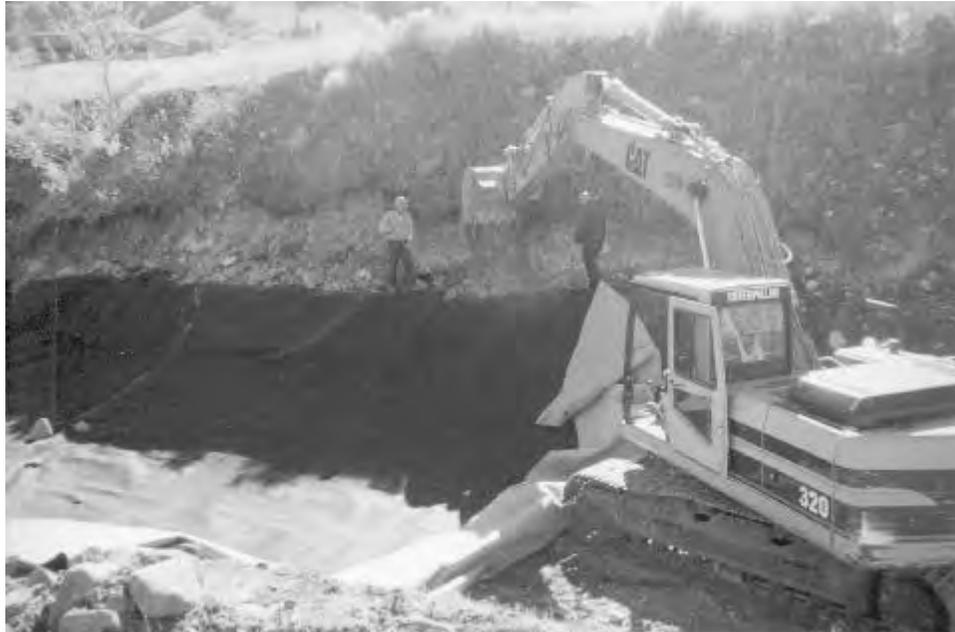
Photograph 5.—Trackhoe pulls down the far bank to cover geomembrane in the anchor berm.

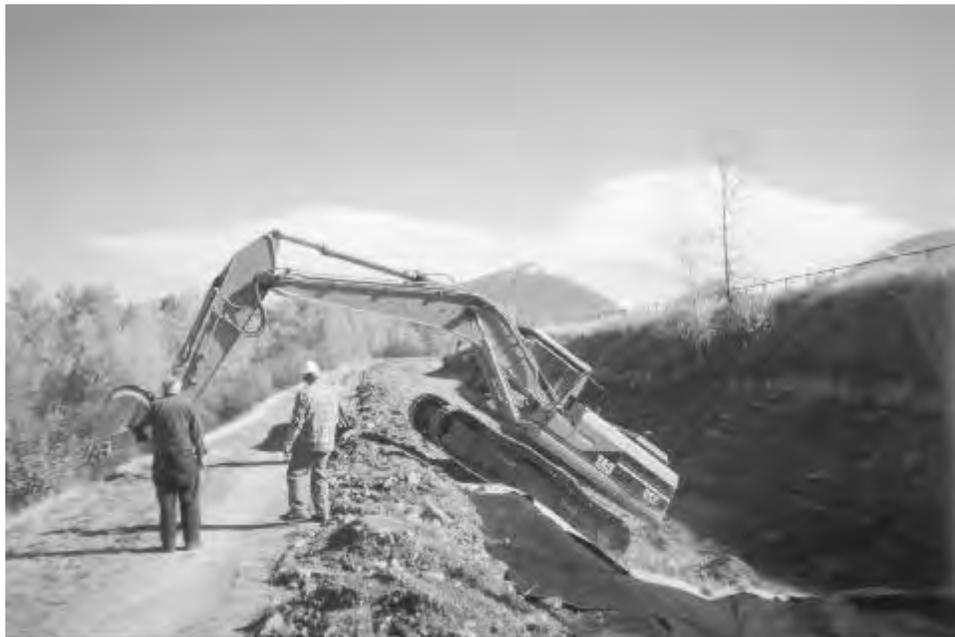
Photograph 6.—At the end of the day, the trackhoe drives up the side slope and out of the canal.

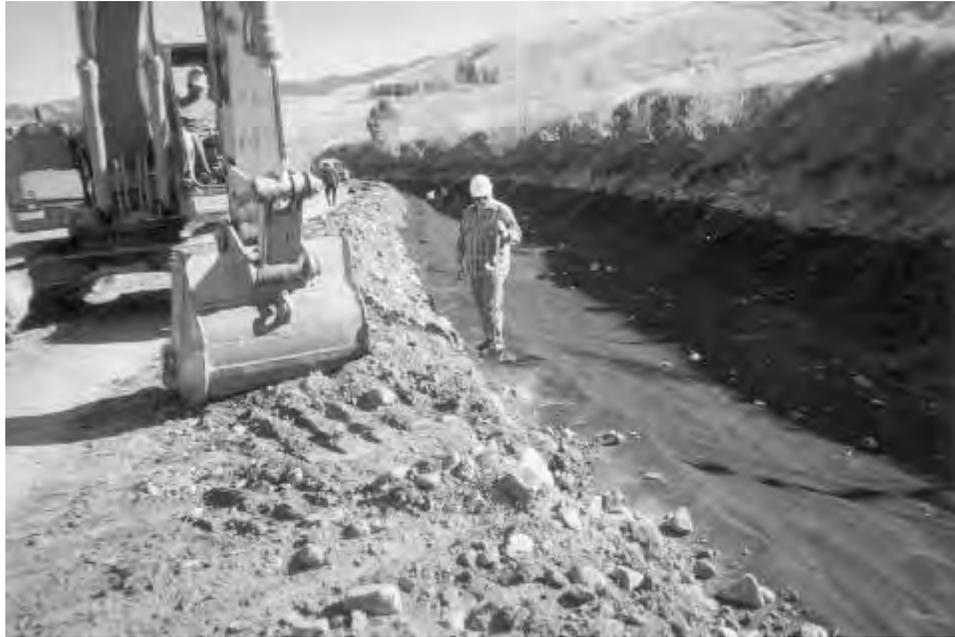
Photograph 7.—Trackhoe prepares to backfill the near anchor berm.

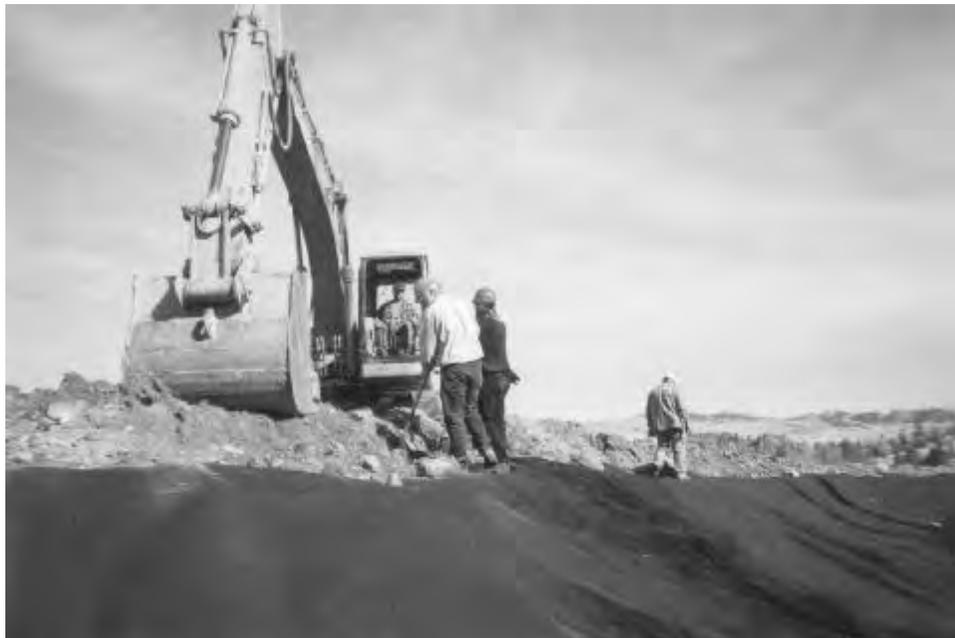
Photograph 8.—Laborers help backfill the near anchor berm.

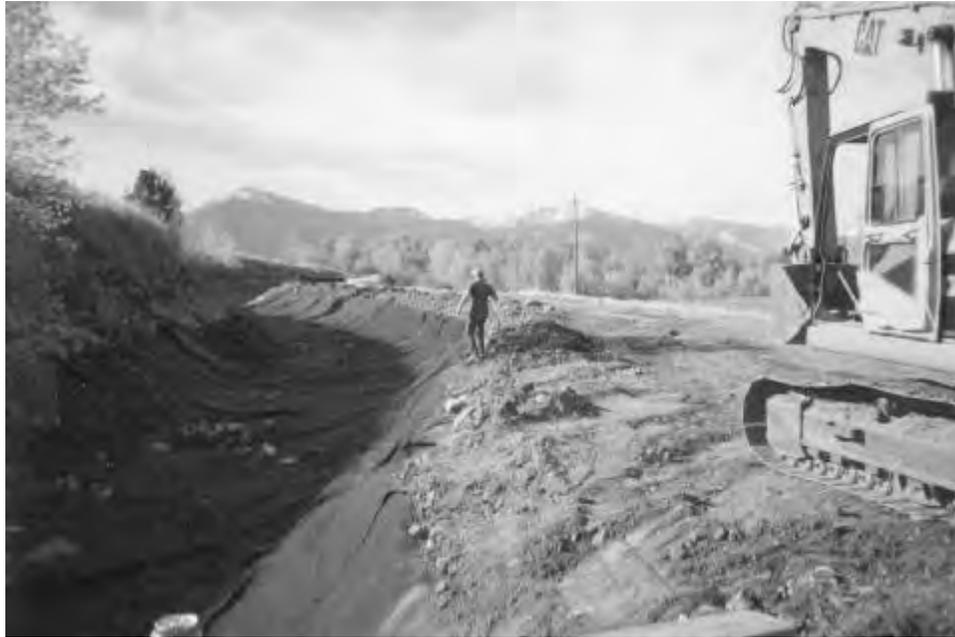
Photograph 9.—Backfill on near anchor berm is complete.

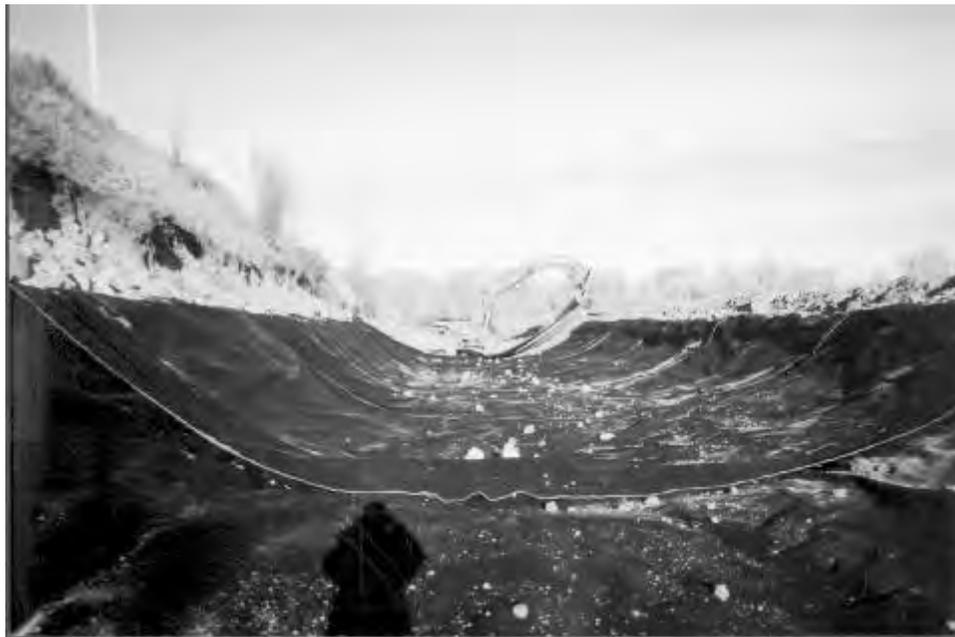
Photograph 10.—Overlapped seams are ready to be sealed. The trackhoe continues to lay geomembrane in the background.

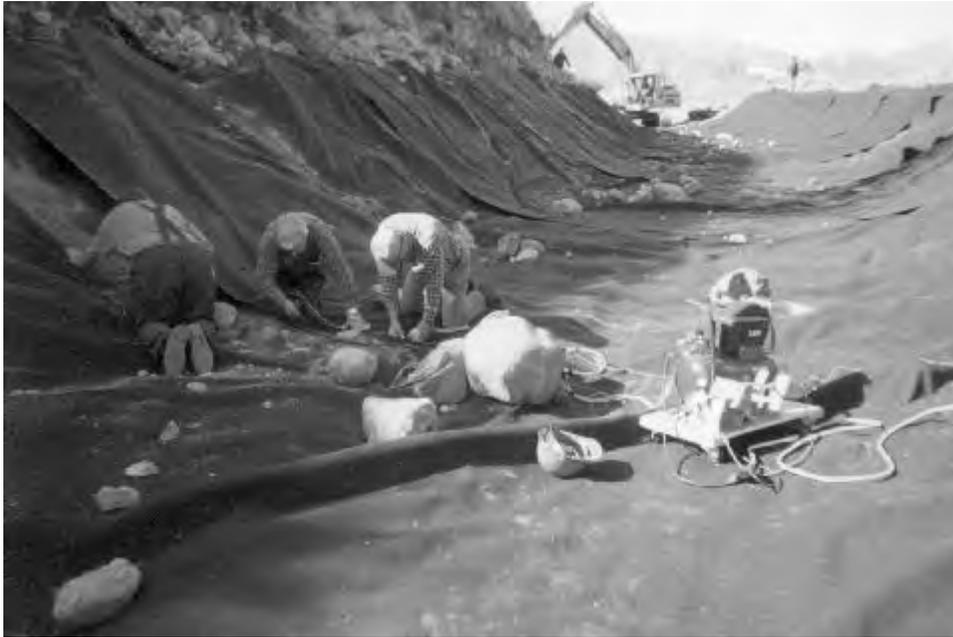
Photograph 11.—Three-man crew removes dirt from the seam and seals it with hot glue. Seams need to be held shut until the hot glue cools and sets.

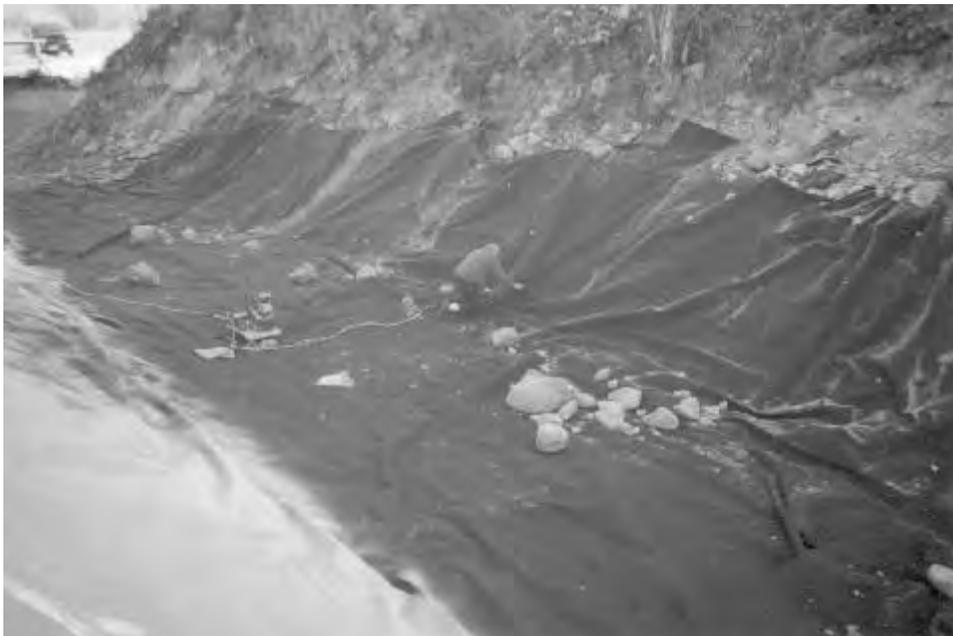
Photograph 12.—Seaming continues.

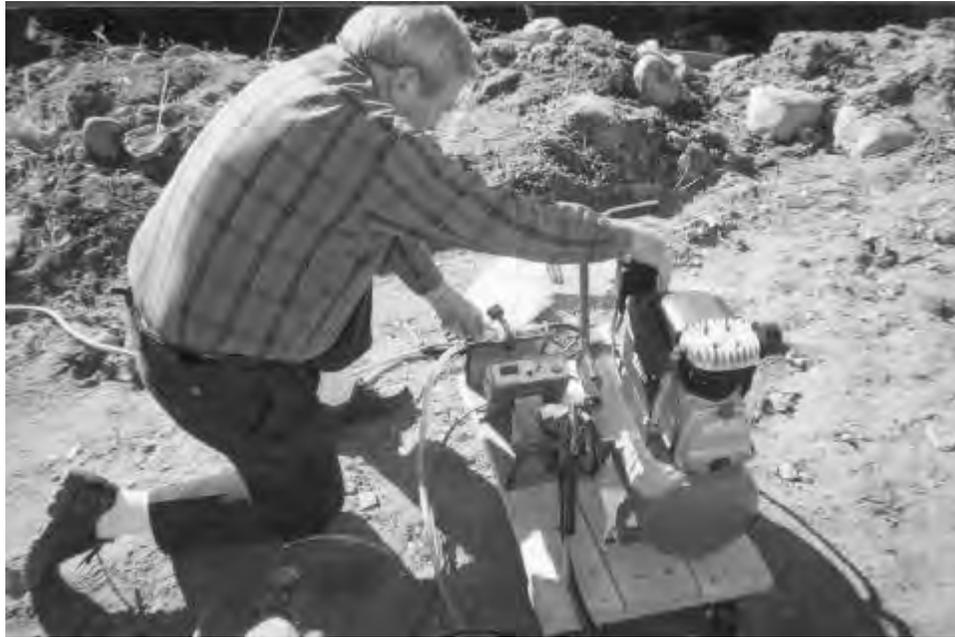
Photograph 13.—Closeup of the industrial hot-glue machine.

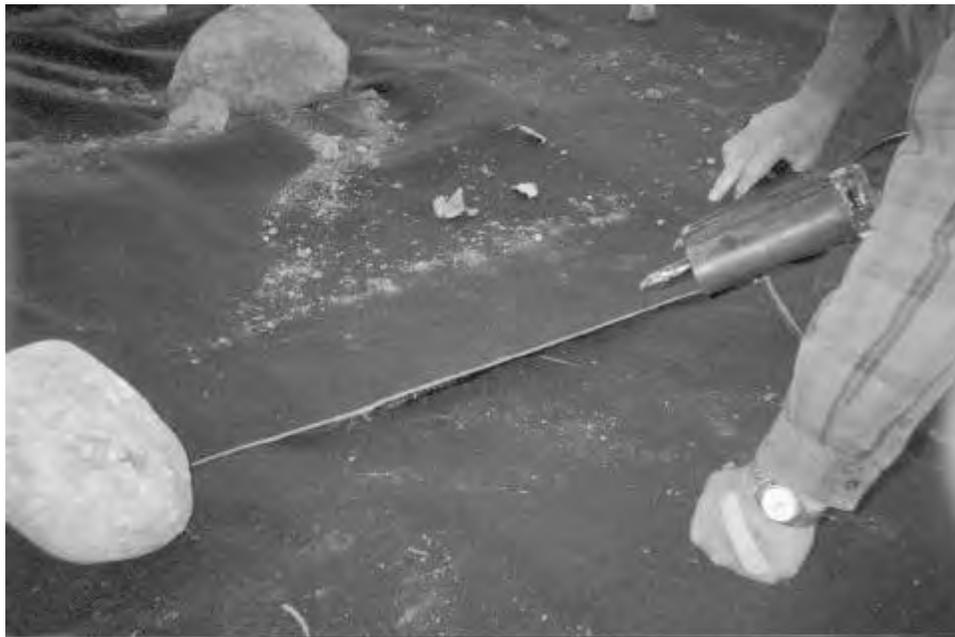
Photograph 14.—Closeup of seam with hot glue. Rock is placed on the seam to hold it together until the hot glue cools and sets.

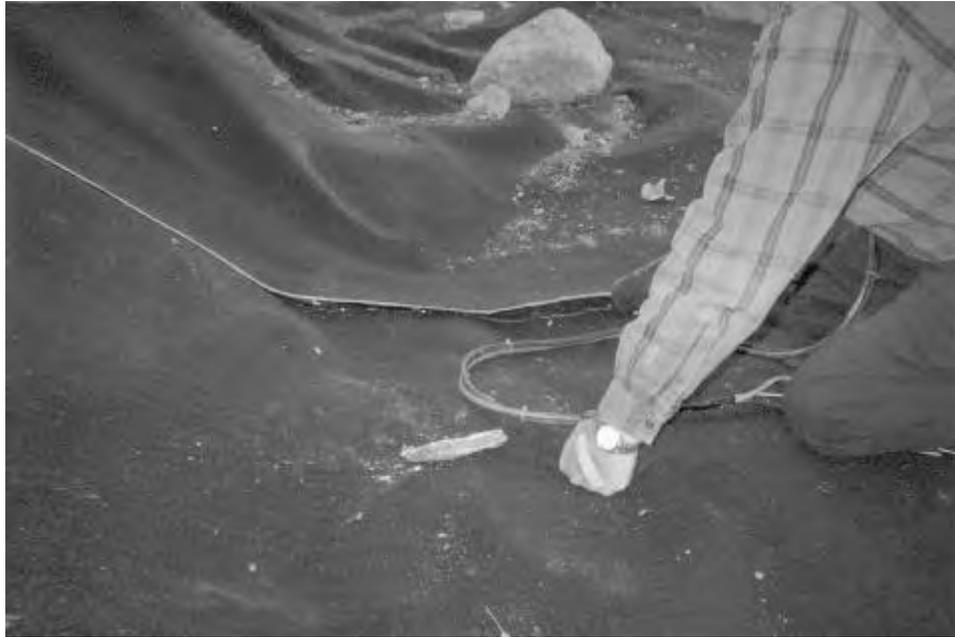
Seaming was quite slow, and the seams were inconsistent (unbonded areas) and relatively weak. The geomembrane manufacturer has a larger gun that places a 1-inch wide bead that would be more suitable for this material. The district switched over to hot roofing tar later in the week. The tar was supplied in a 100-gallon kettle. Hot-tar seaming was more labor intensive and relatively slow because of the time needed for the hot tar to cool and set. A hot-air welder may be another alternative for seaming this material.

Photograph 15.—Hot glue is extruded into the seam in a ½-inch bead.

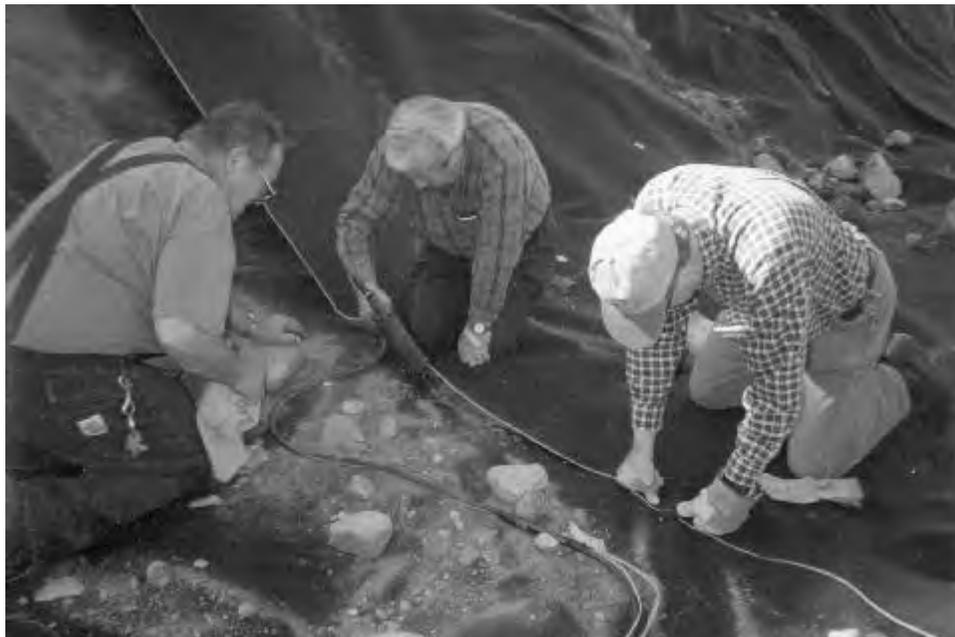
Photograph 16.—Three-man crew cleans the seam (removes loose dirt), applies hot glue, and holds seam shut until the glue cools and sets.

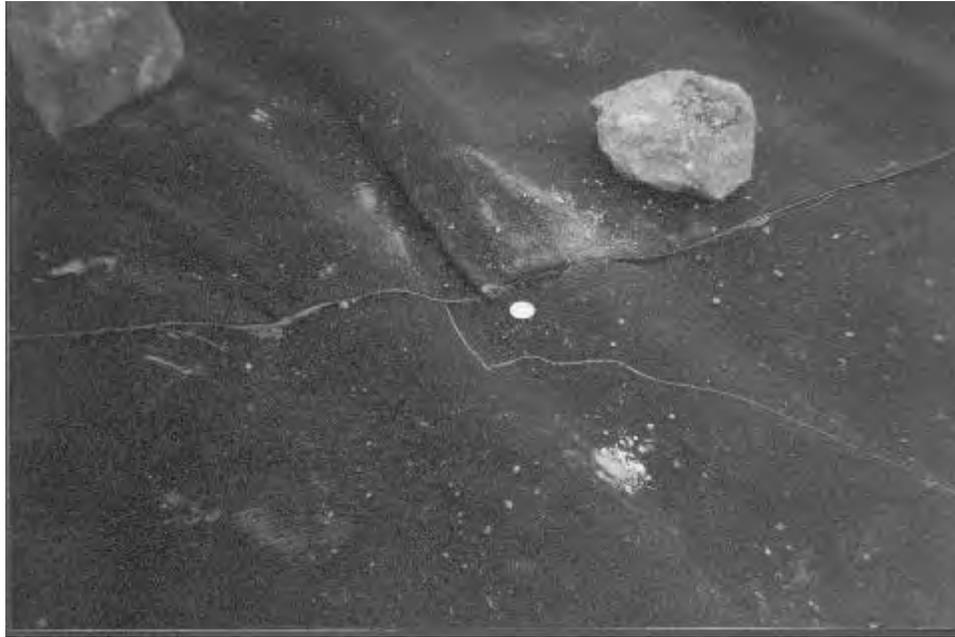
Photograph 17.—Lower portion of Photograph shows factory seam in the upper geotextile. Fishmouth in the seam has been folded over and glued shut.

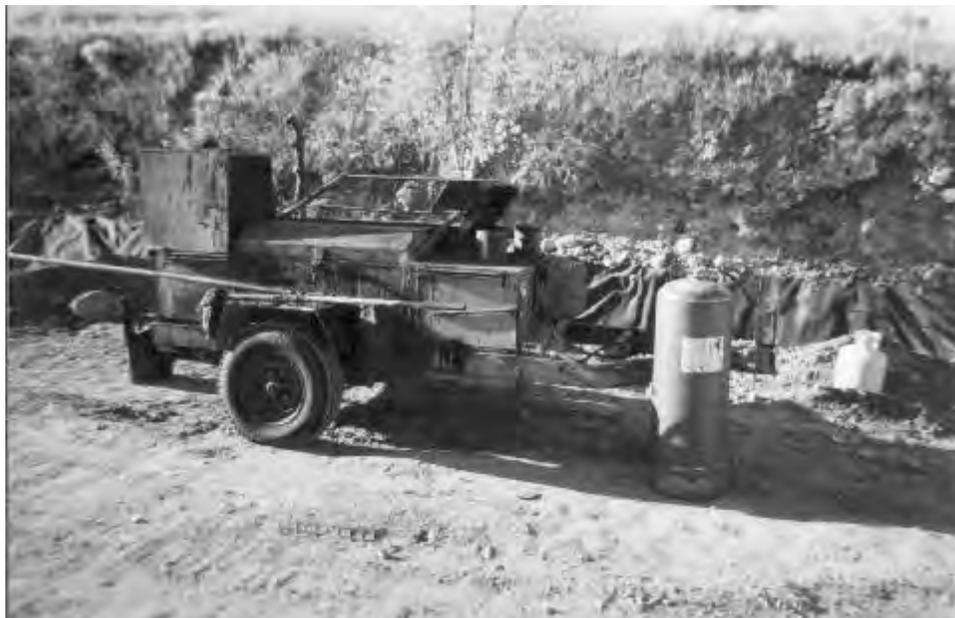
Photograph 18.—Hot tar was also used for seaming. Hot tar was supplied in a 100-gallon propane-fired kettle.

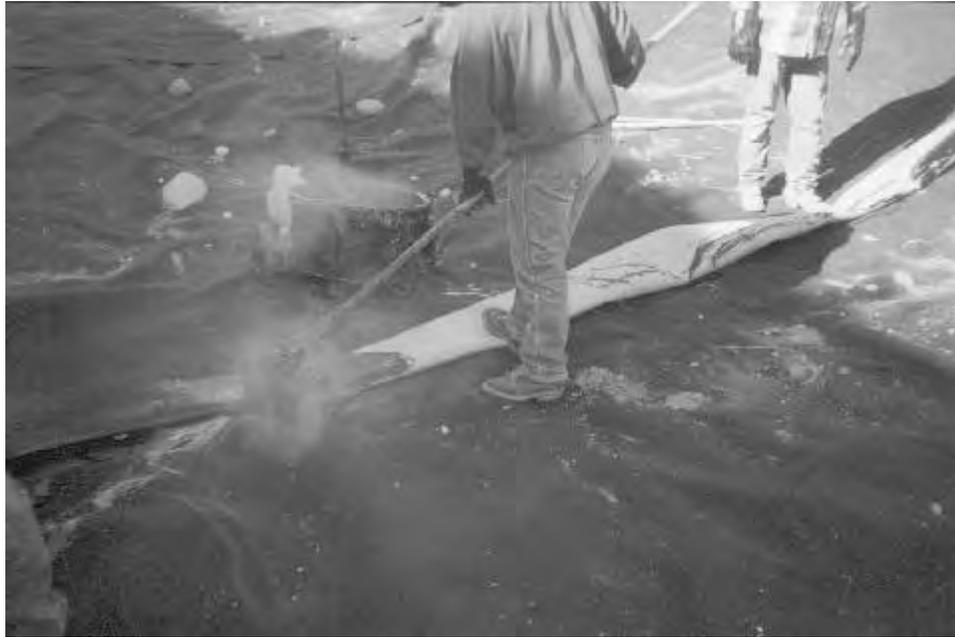
Photograph 19.—Geotextile is folded back, and hot tar is mopped onto both geotextile surfaces.

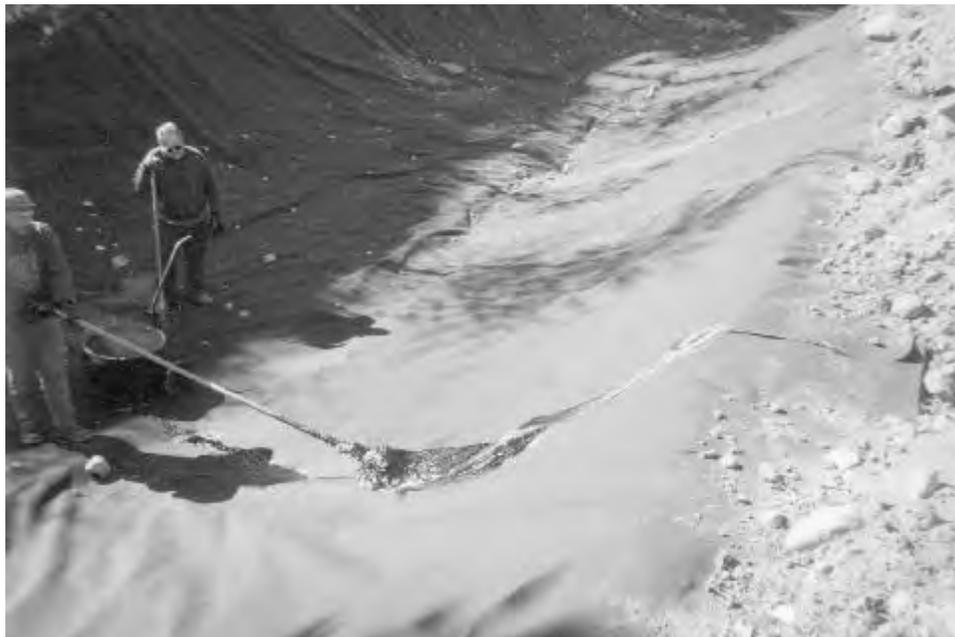
Photograph 20.—Upper geotextile is folded back into position, and the seam edge is buttered with hot tar.

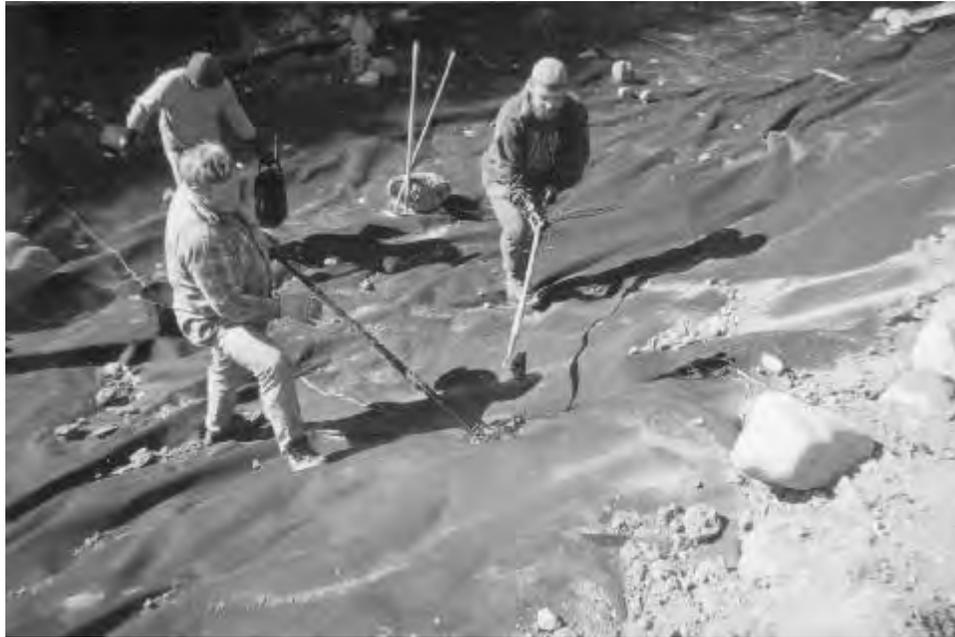
Photograph 21.—Laborer on right uses hoe to hold seam closed while hot tar cools and sets.

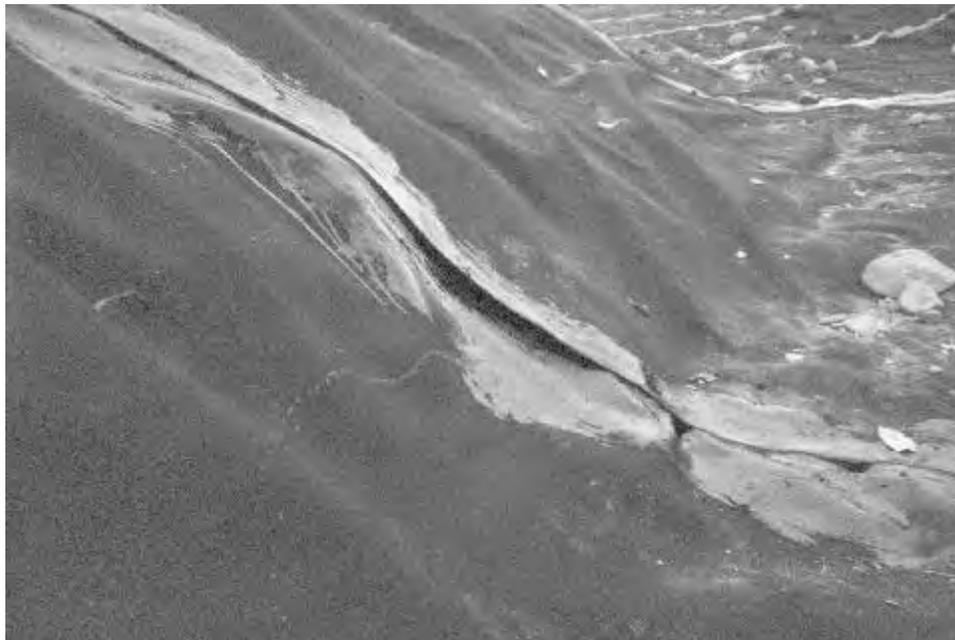
Photograph 22.—Seam with hot tar pops open if not held closed for sufficient time.

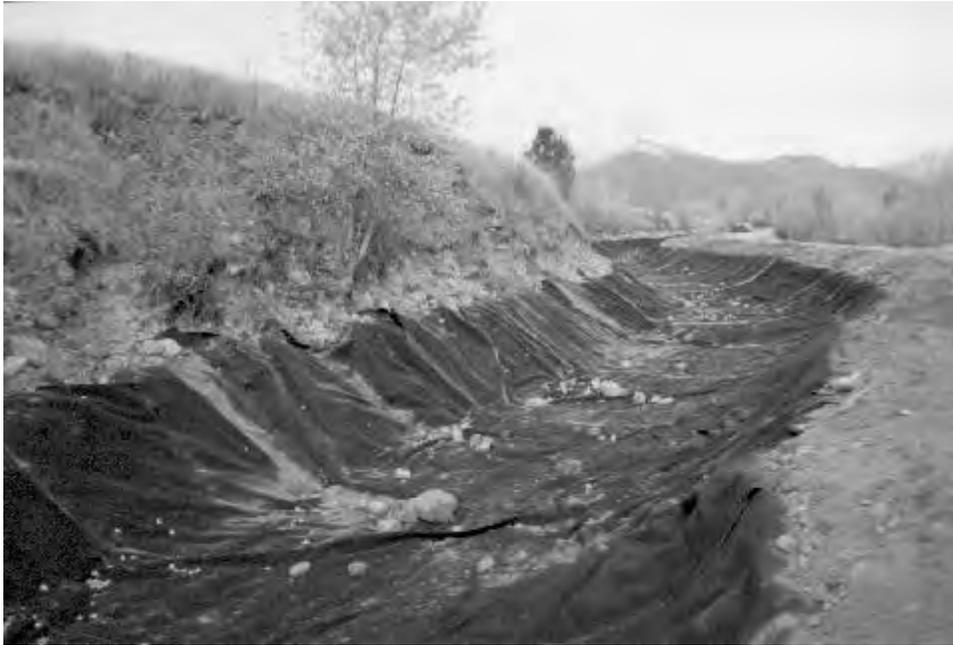
Photograph 23.—Finished installation.

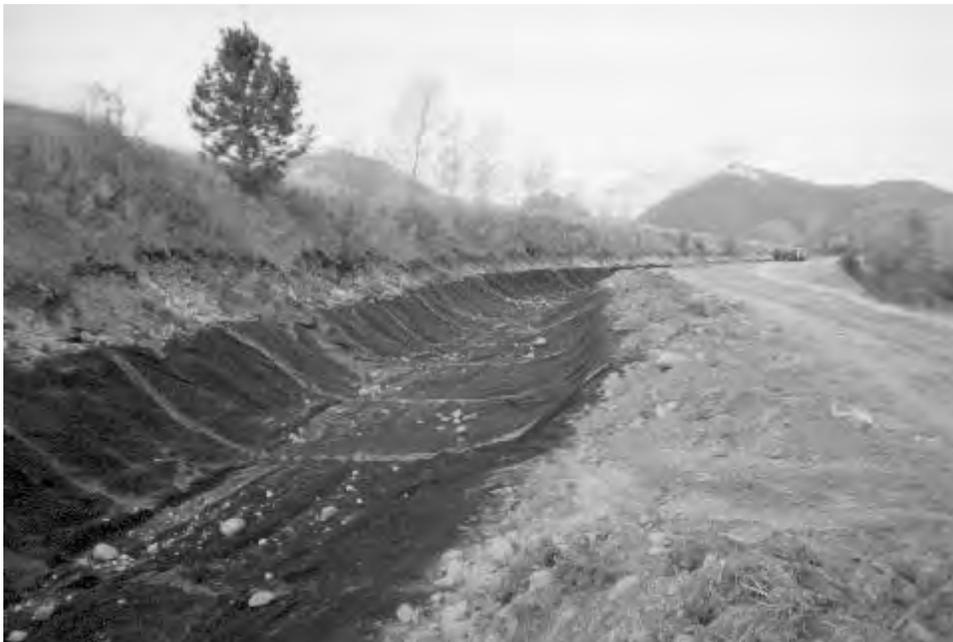
Photograph 24.—Finished installation.
