**Completion Report  
L-3 and L-3A  
Irrigation Diversion Replacement  
Lemhi River Subbasin  
Salmon, Idaho**

Prepared by  
Bureau of Reclamation  
Pacific Northwest Region  
Snake River Area Office  
Salmon Field Office

**May 2007**

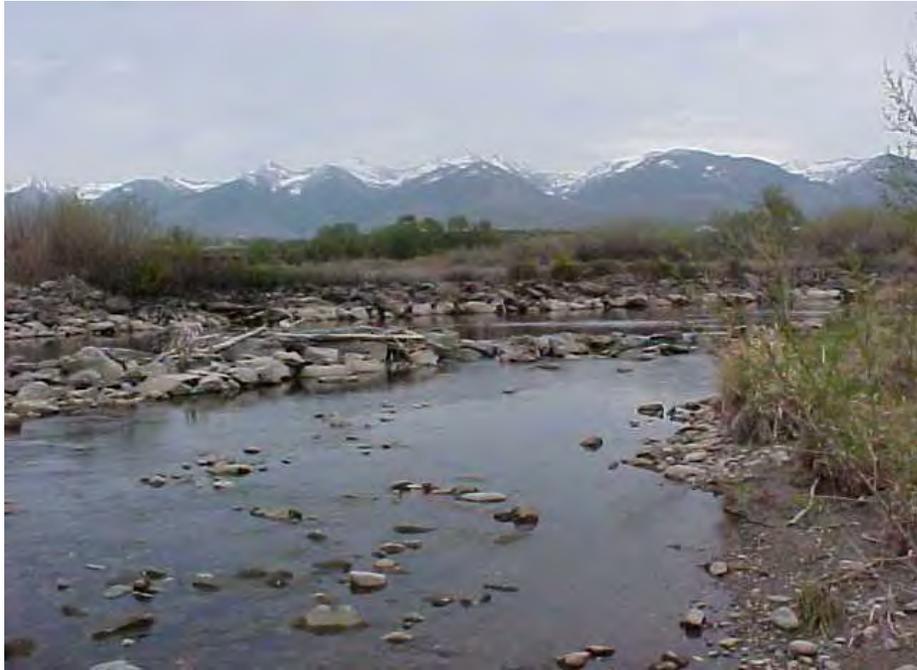
The L-3 rock weir diversion was relatively stable, required little annual maintenance by the irrigators, and effectively diverted water into the ditch. However, streamflow depletion, structure porosity, and absence of a fish passageway resulted in severe depletion of water in the river channel below this diversion and hindered the ability of adult fish to migrate upstream. The headgate at the ditch inlet was in good condition and adequate to meet the irrigator's needs and therefore was left in place.

**Figure 1. L-3 diversion, at low flow, looking downstream, before modification**

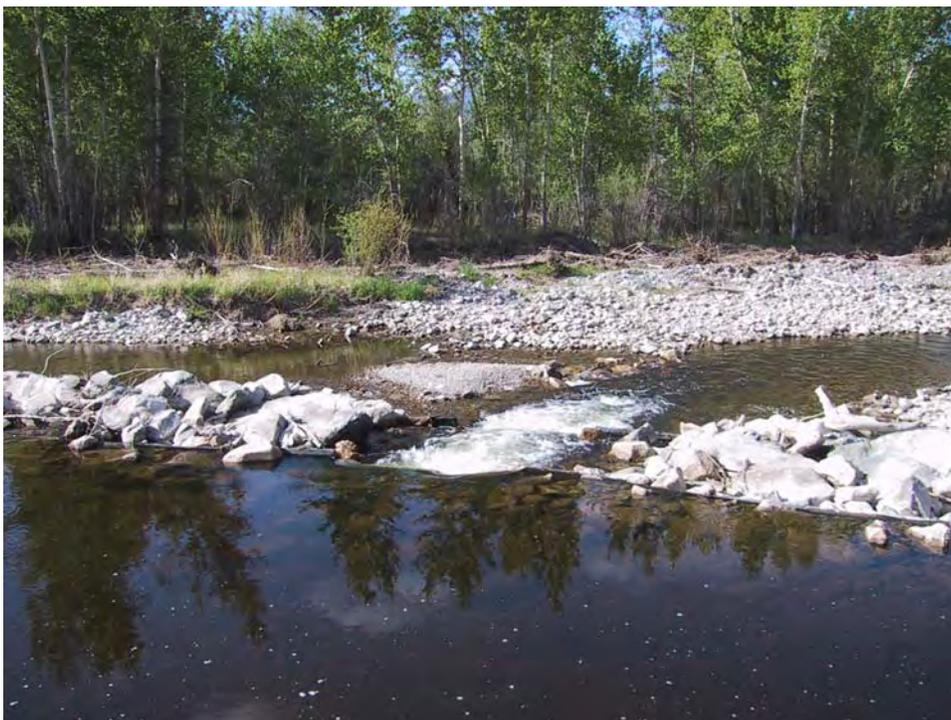
**Figure 4. L-3 diversion, fish passage notch at low flow**

In the middle of the weir structure, two notched plates were inserted and drop pools constructed to concentrate flow for fish passage in compliance with NMFS passage criteria. A narrow channel of streambed was deepened below the fish passage notch to concentrate flow and provide sufficient channel depth for fish passage in low stream flow conditions.

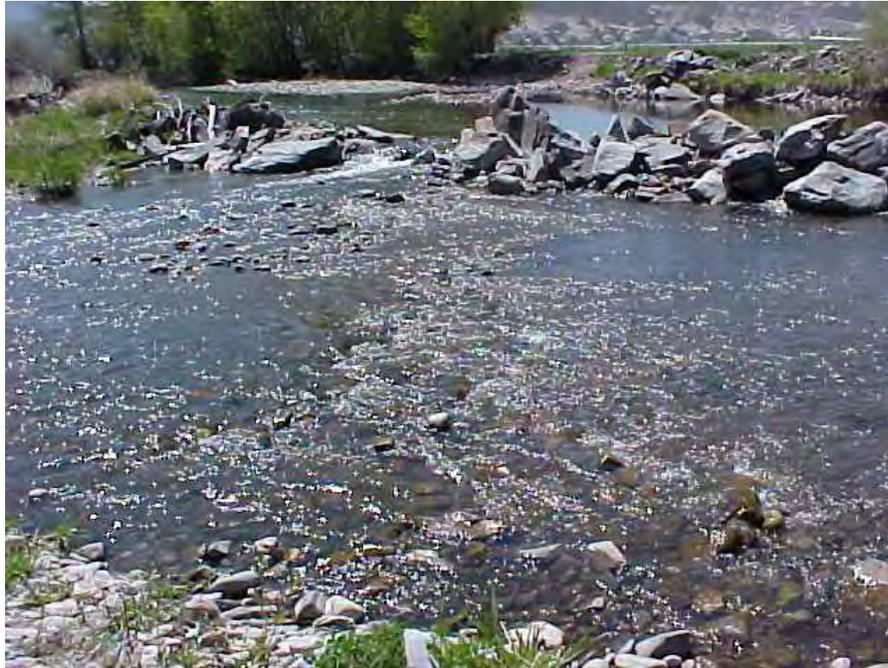
**Figure 9. L-3A diversion at 10 cfs before modification**

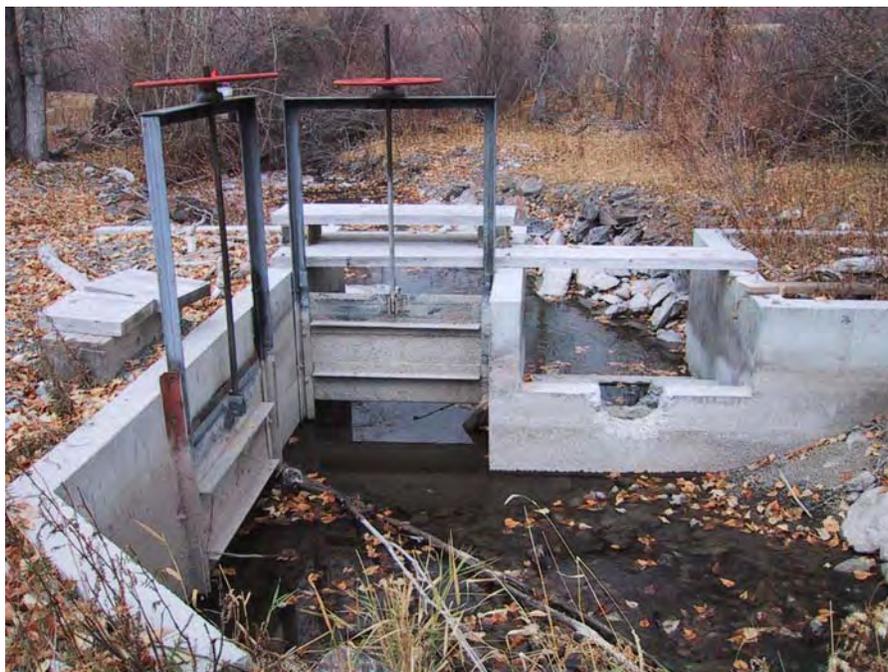
the irrigation ditch was controlled by the semi-annual construction and removal of an earthen berm near the inlet. An additional problem existed with a fish ladder-headgate structure located in the ditch just upstream of the fish screen. The structure was used to control diverted water that was in excess of what the fish screens could effectively pass. The excess water went over a fish ladder and into a channel that conveyed the water back to the river. Local biologists felt that return flow in the wasteway channel created a false attraction to migrating fish and the ladder structure was ineffective for allowing fish passage.

**Figure 10. -3A diversion wasteway fish ladder before modification**

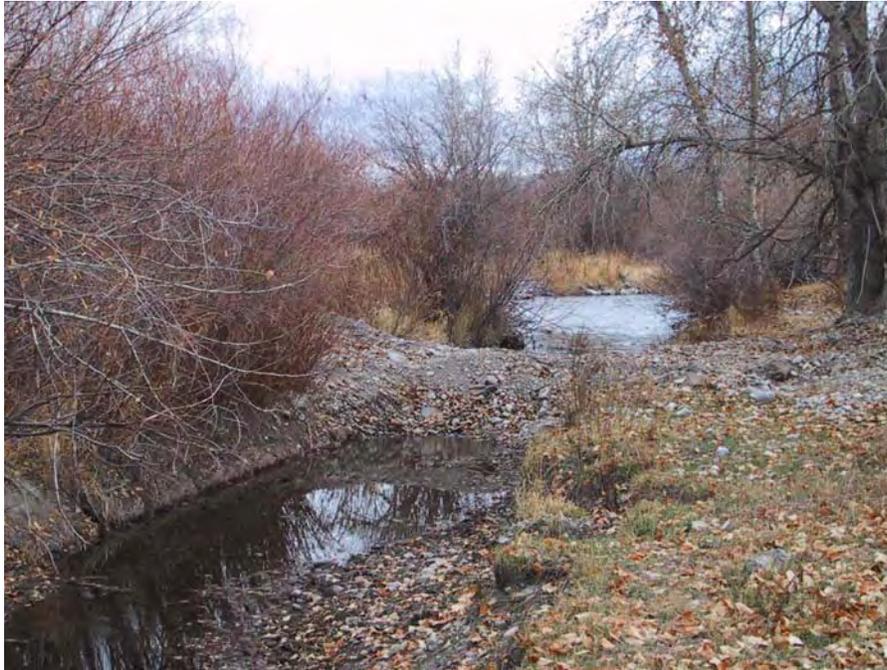
At L-3A, the rock weir diversion was less stable and seasonal maintenance to add or remove rock was needed to divert water and reduce ice formation and flooding. Also, there was no headgate at the inlet to the ditch. Streamflow depletion, absence of a fish passageway, and structure porosity were also problems with this diversion. Inflow into

**Figure 11. L-3A earth berm blocking ditch inlet before modification**

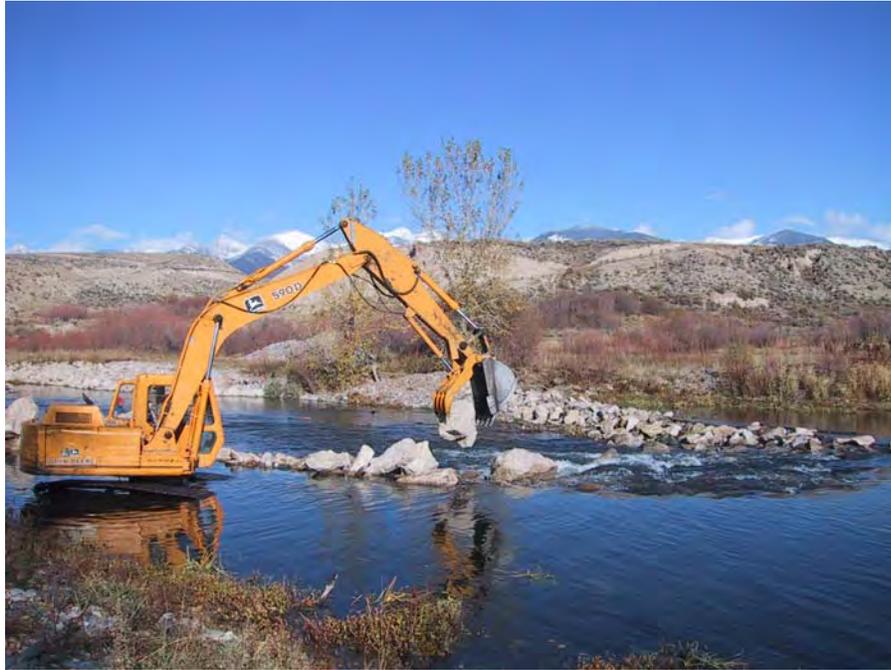
**Figure 17. L-3A repair construction**

During the first winter and subsequent spring runoff following completion of construction at L-3A, ice and high flow caused damage to the rock weirs. High flows also overtopped the headgate and eroded the fill around the headgate. Corrective measures entailed placement of additional, large rock on the weirs, and pouring concrete to increase the height of the headgate. Additional fill and rock was placed around the eroded headgate. BPA provided funding for the necessary repairs. Repairs were made in the winter of 2003 and early spring of 2004. Since the repairs were made, no further problems have either been observed or reported by the irrigator.

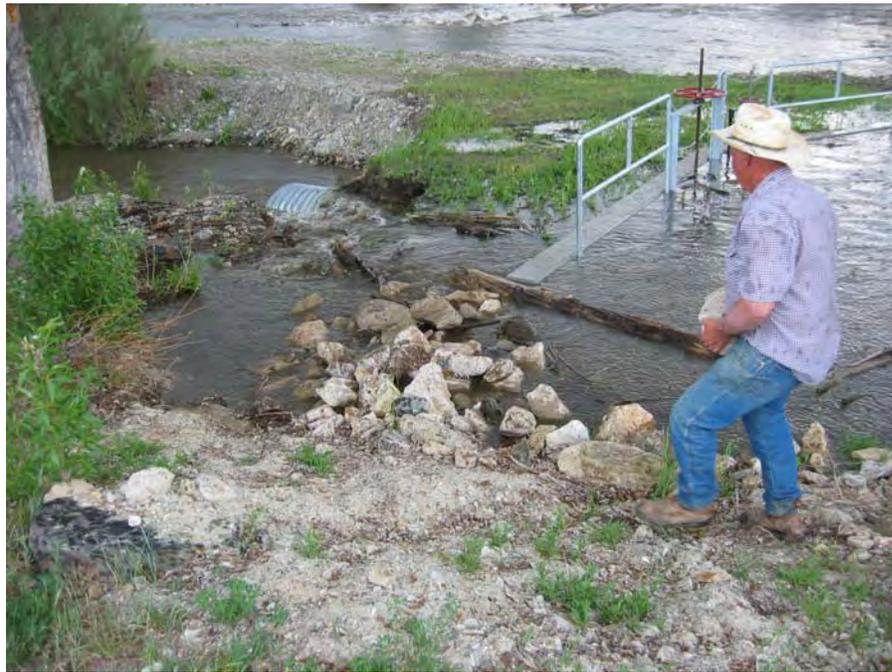
**Figure 24. L-3A headgate washout**

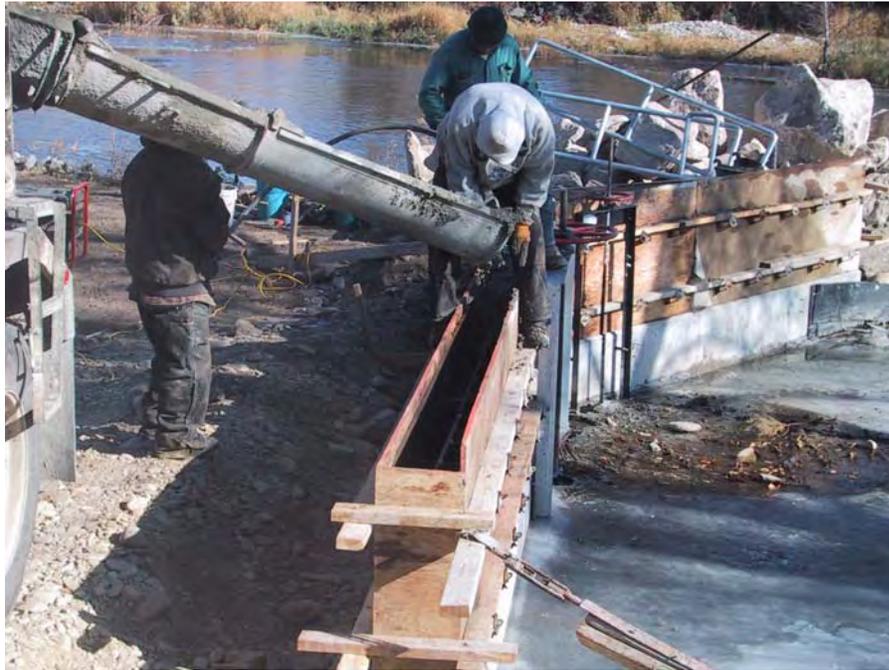
**Figure 25. L-3A repair - pouring concrete to raise headgate**

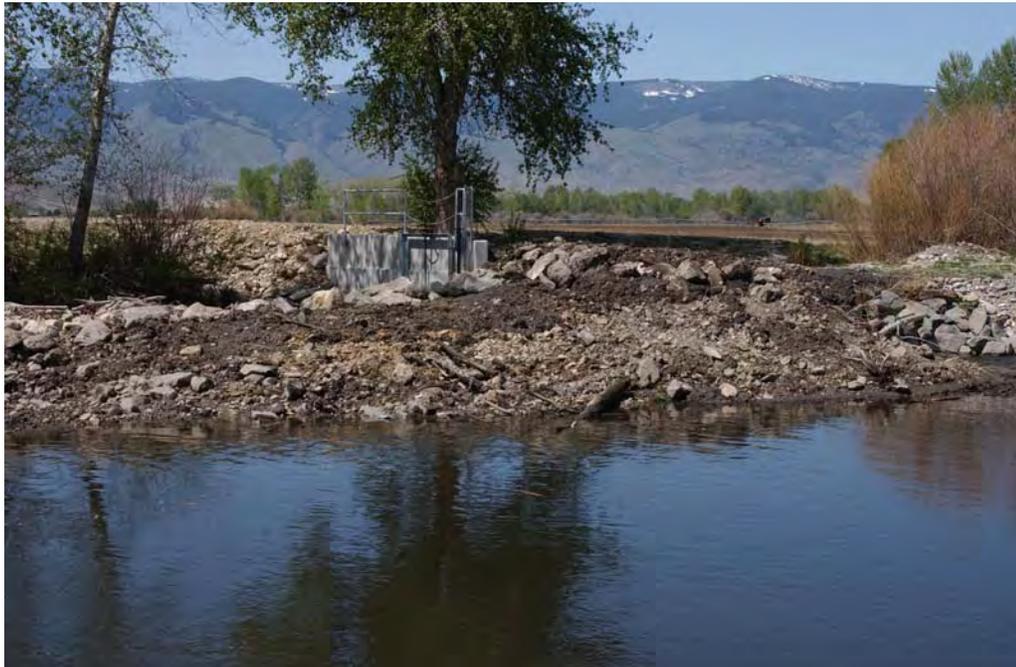
**Figure 26. L-3A headgate after repairs**
